ReCAP
Research for Community Access Partnership

Baseline Survey Report for 11 Low-Volume Sealed Roads in Kenya

Final Report

AFCAP Project – KEN2043C

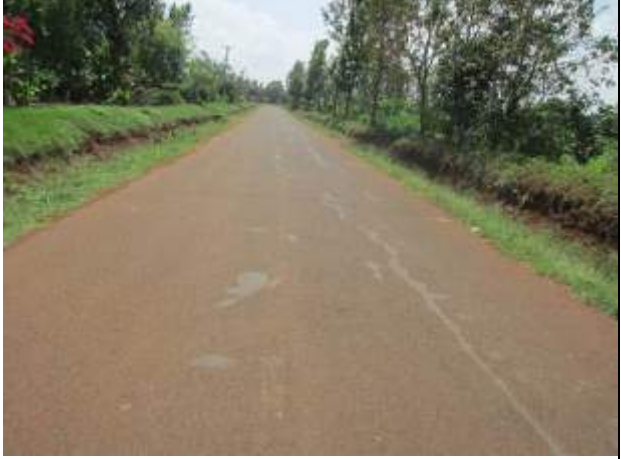
<p>Fig 8</p>	<p>Km 0+200 – 0+250 main carriage way</p>	<p>-No visible defect on the main carriage way -Vegetation on the side slope extending towards the edge</p>

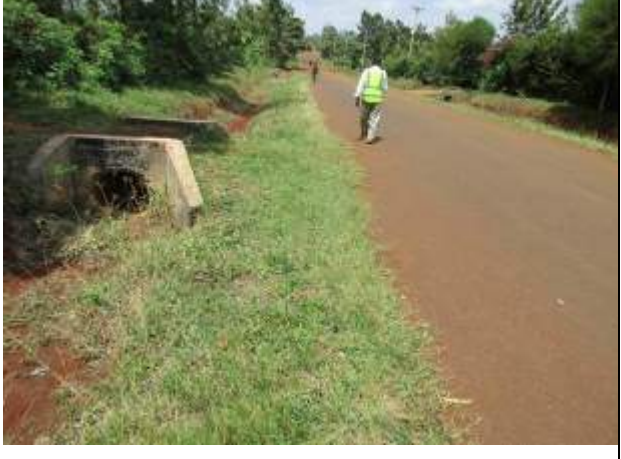
<p>Fig 9</p>	<p>Km 0+260 -0+300 main carriage way</p>	<p>- No visible defect on the main carriage way</p>

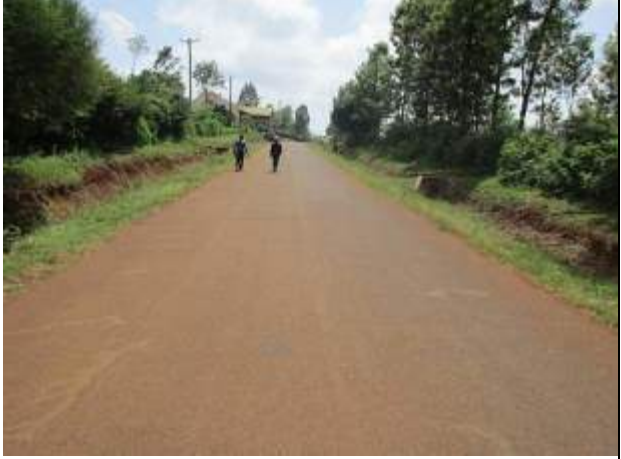
Fig10	Km 0+300 – 0+350 main carriage	-Vegetated side slope extending towards the edge and may result into moistening pavement hence premature failure	 
--------------	---------------------------------------	------------------------------------------------------------------------------------------------------------------	------------------------------------------------------------------------------------

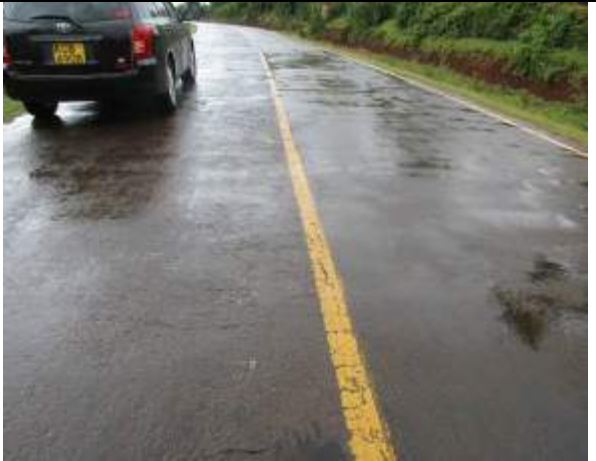
<p>Fig 3</p>	<p>Km 0+008–0+018 LHS carriage way</p>	<p>-Alligator cracks on the carriage way covering 18m long and 2m width</p>

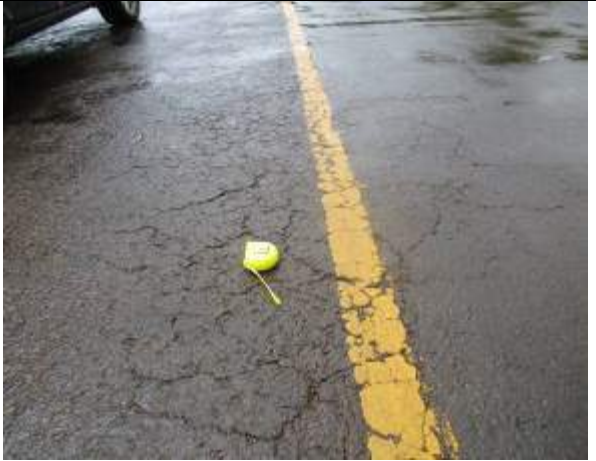
<p>Fig 4</p>	<p>Km 0+025 main carriageway</p>	<p>-Extensive alligator cracking on the carriage way</p>

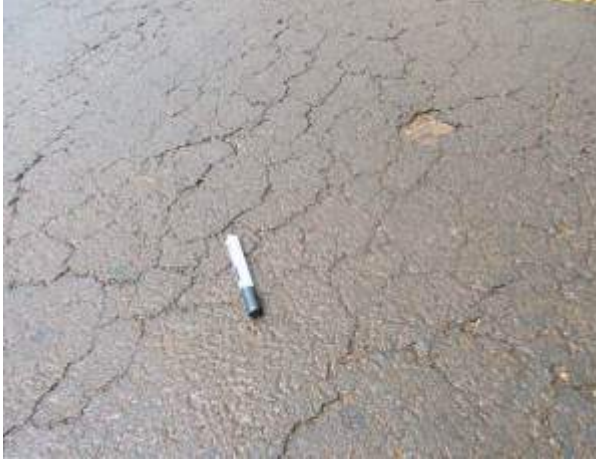
<p>Fig 5</p>	<p>Km 0+022 – 0+030 LHS</p>	<p>-Pothole and alligator cracks on the LHS lane approximately 40mm depth * 300mm*300mm</p>

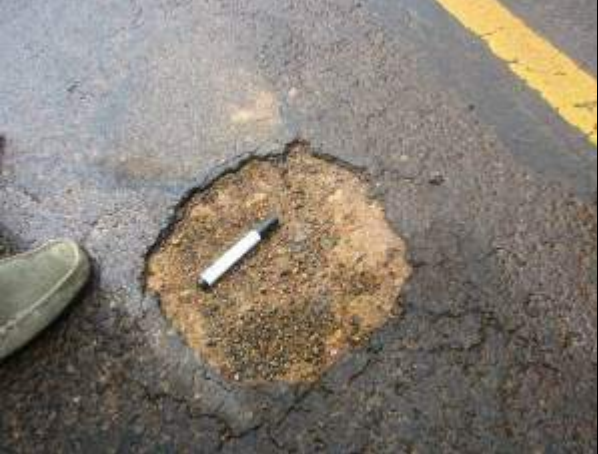
<p>Fig 6</p>	<p>Km 0+030 – 0+042 LHS inner wheel path</p>	<p>-Alligator cracks on the inner wheel path</p>

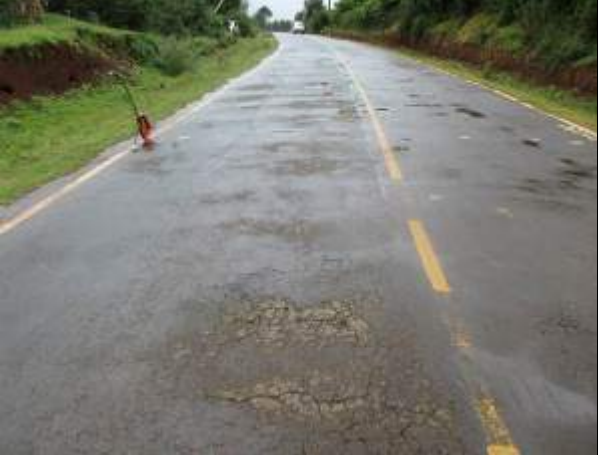
<p>Fig 7</p>	<p>Km 0+043 – 0+060 LHS main carriage way</p>	<p>-Alligator cracking and deforming on the inner wheel path</p>

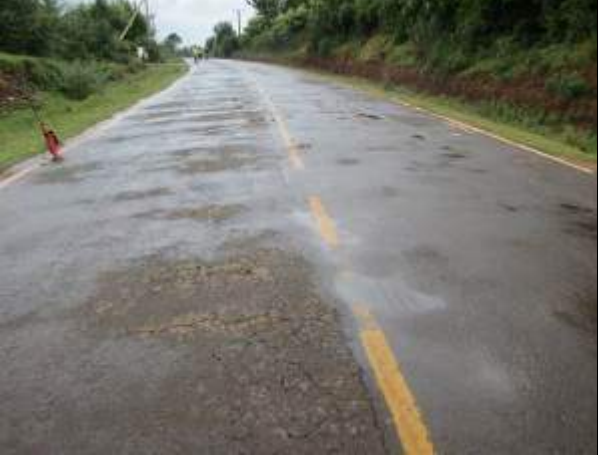
<p>Fig 8</p>	<p>Km 0+100 -0+120</p>	<p>Ponding on the potholes especially on the wheel paths caused by road poor levels</p>	 
<p>Fig 9</p>	<p>Km 0+120 -0+130 LHS</p>	<p>-Vegetation encroaching towards the RHS edge</p>	 
<p>Fig10</p>	<p>Km 0+130 -0+160 main carriageway</p>	<p>-Alligator cracking all over the road carriage way and general surface irregularity</p> <p>-Ponding on the depressions</p>

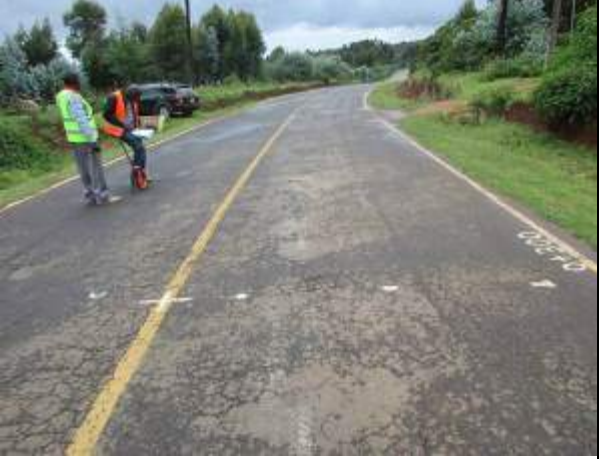
<p>Fig 14</p>	<p>Km 0+335 – 0+360 main carriage way</p>	<p>-No alligator cracks on the carriage way</p>

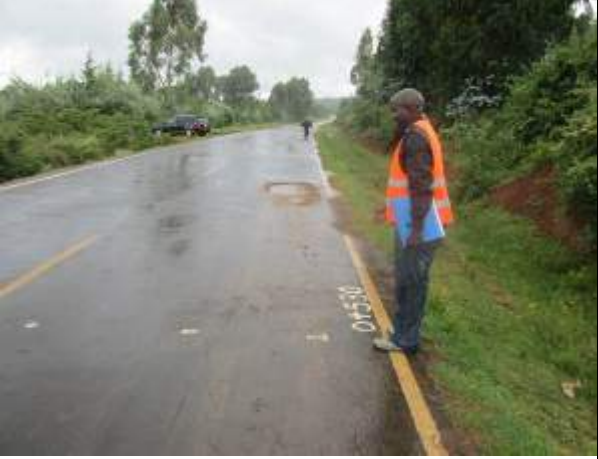
<p>Fig 17</p>	<p>Km 0+587 – 0+600 RHS lane</p>	<p>-Vegetation encroaching towards the RHS edge and shoulders -Silted & Vegetation side drain hindering free flow of water along the drain -Deformation and alligator cracks on the main carriage way</p>

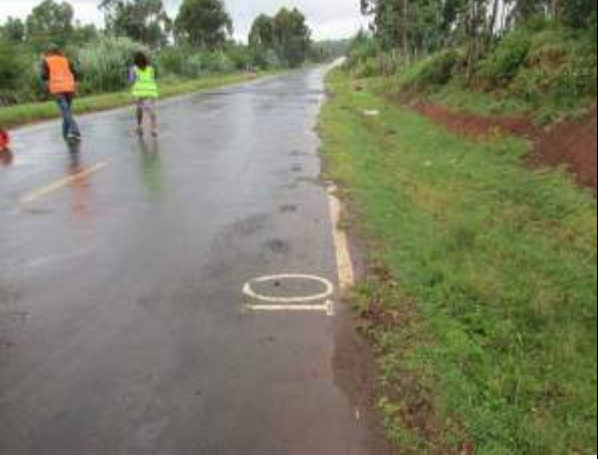
<p>Fig 18</p>	<p>Km 0+640 – 0+680 main carriage way</p>	<ul style="list-style-type: none"> -Surface bumpy and irregular -Edge deformation and subsidence on the outer wheel path covering about 20mlong and 7m width with a depth 30mm

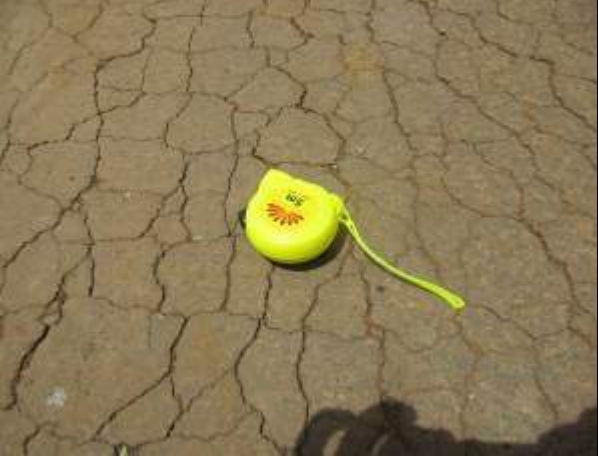
<p>Fig 9</p>	<p>Km 0+255 – 0+260 main carriage way at centreline</p>	<p>- Alligator cracks, pothole and loss of pavement material due insufficient lift thickness at centreline -3.4m*4.4m long</p>

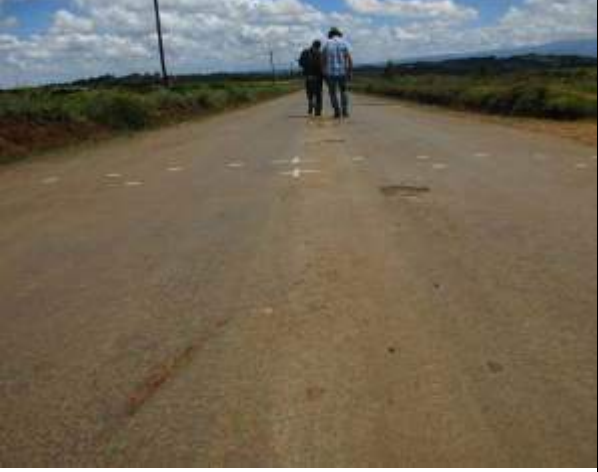
<p>Fig 14</p>	<p>Km 0+340 -0+350 Centreline</p>	<p>-Extensive alligator cracks on the surface, pothole and localized loss of asphalt layer of about 11m long *2 m width at especially at the centreline</p>

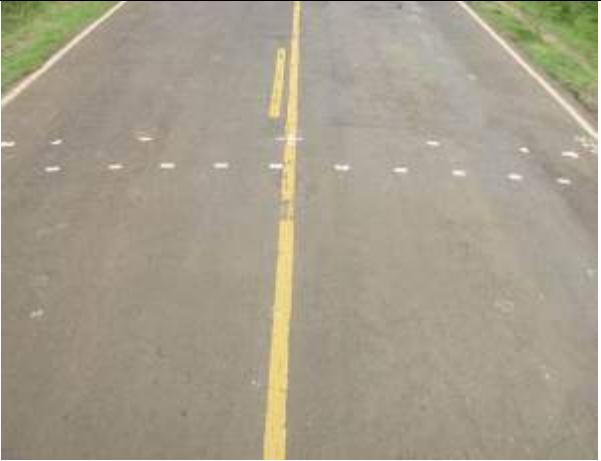
Fig3	Km 0+055- 0+095 main carriage way both sides	-Alligator cracks all over the carriage way covering approx. area of about (6m*10m)60m ² long

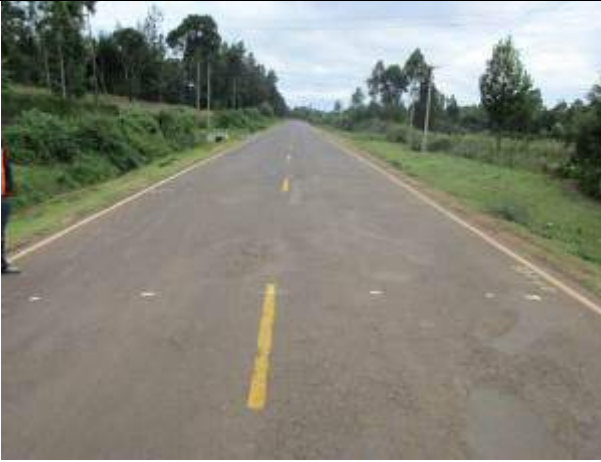
<p>Fig 4</p>	<p>Km 0+095-0+115 LHS</p>	<p>-Slightly eroded, caused by stopping matatus picking and dropping passengers</p> <p>-Slight vegetation causing ponding on the side drain</p>

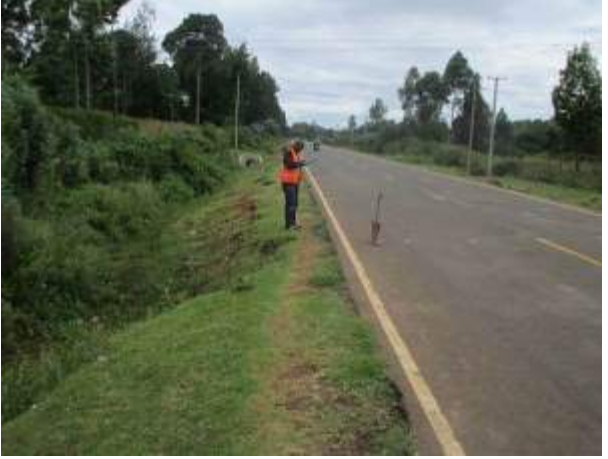
<p>Fig 5</p>	<p>Km 0+116 – 0+140 main carriageway</p>	<p>-Alligator cracks scattered in isolated areas within carriage way</p>

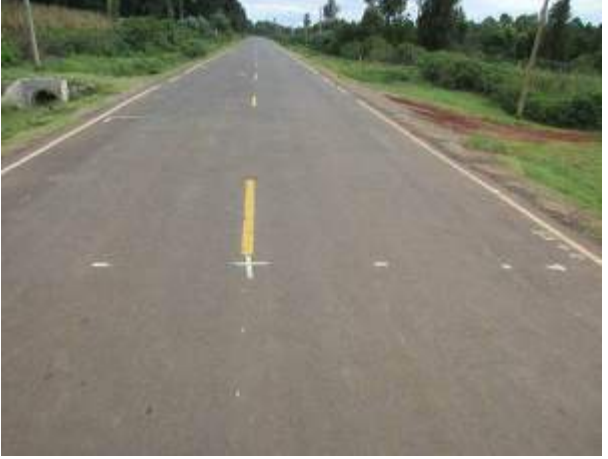
<p>Fig6</p>	<p>Km 0+100- 0+145RHS</p>	<p>- Slightly eroded, caused stopping matatus picking and dropping passengers approx. 40m long</p>

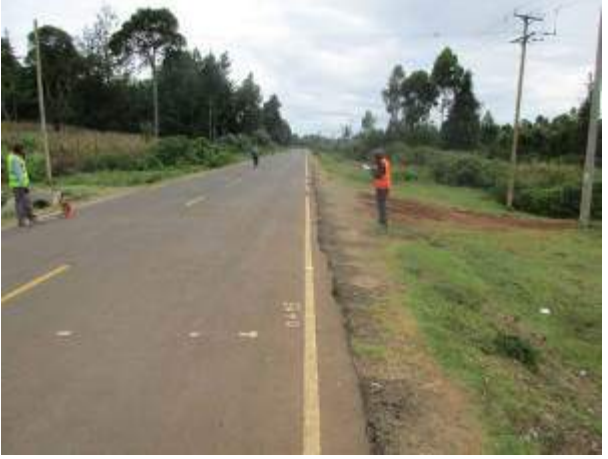
<p>Fig 7</p>	<p>Km 0+145 -0+180 RHS and main carriage way</p>	<p>-Alligator cracks scattered all over the carriage way</p> <p>-Eroded side slope</p> <p>-Spot bleeding on the main carriageway</p>

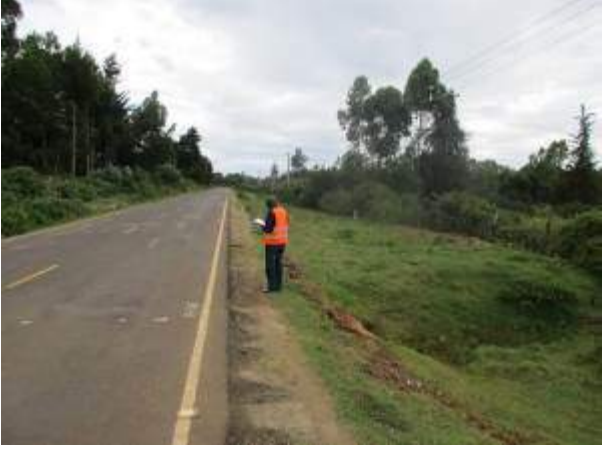
<p>Fig 8</p>	<p>Km 0+234 – 0+250 LHS</p>	<p>-Alligator cracks scattered all over the carriage way covering 16m long</p>

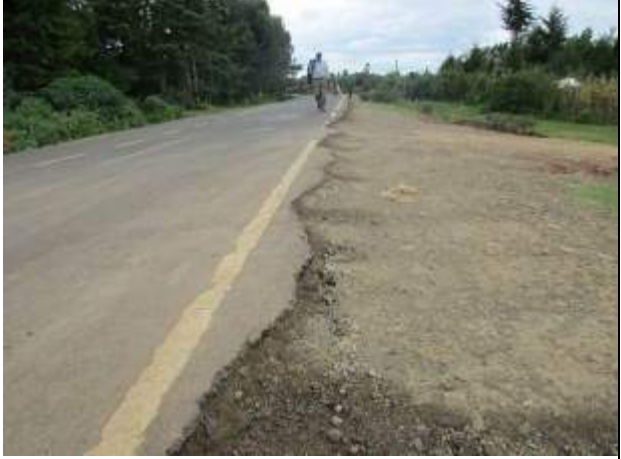
<p>Fig 11</p>	<p>Km 0+400 -0+473</p>	<p>-Vegetation on the side slope hindering free flow of water to the drain</p>

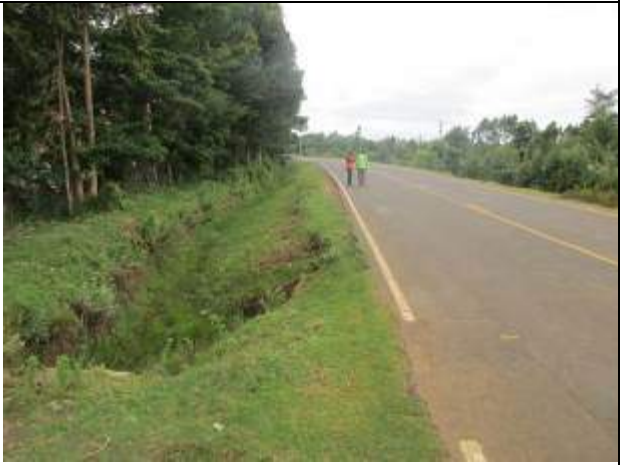
<p>Fig 12</p>	<p>Km 0+473-0+500</p>	<p>-Alligator cracks all over the carriage way covering 30m long and 3m width</p>

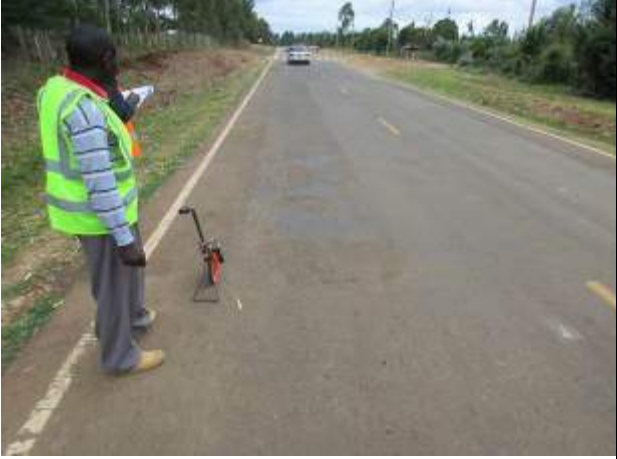
<p>Fig 17</p>	<p>Km 0+843 – 0+854 LHS</p>	<p>Alligator cracks, depression and deformation on the main carriage way on the outer wheel path 10m long and 3m width</p>

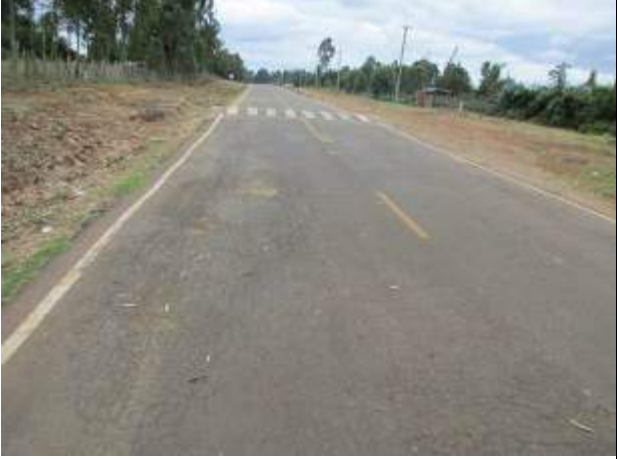
<p>Fig 18</p>	<p>Km 0+937 RHS</p>	<p>-No visible defect on the main carriage way -Loss of surface texture and aggregates $(3.0*5)15m^2$ long</p>

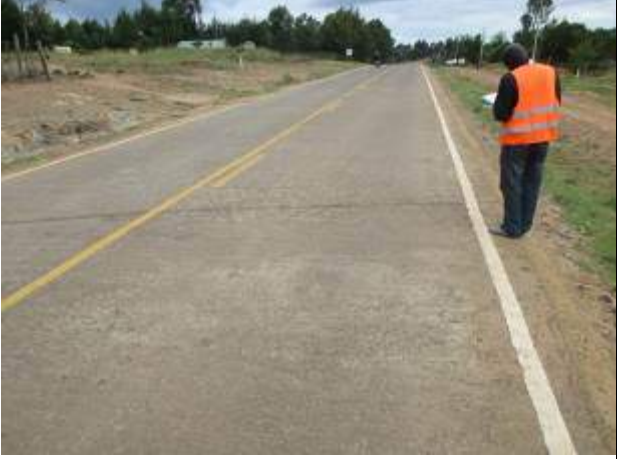
Fig 19	Km 0+963-0+990 LHS	-Transverse cracks on the concrete slab on LHS

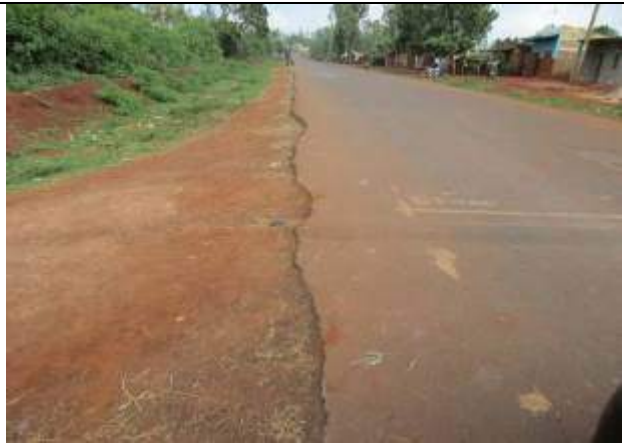
<p>Fig 2</p>	<p>Km 0+100LHS</p>	<p>-Eroded edge and shoulders of about 15cm by 500cm</p>	 
<p>Fig 3</p>	<p>Km 0+120 RHS</p>	<p>-Alligator cracks, bleeding and sticky -Patchwork and alligator cracks on the inner and outer wheel path</p>	 
<p>Fig 4</p>	<p>Km 0+140LHS</p>	<p>-Damaged shoulders towards LHS carriage covering an area of 0.3m*0.4m) M²</p>

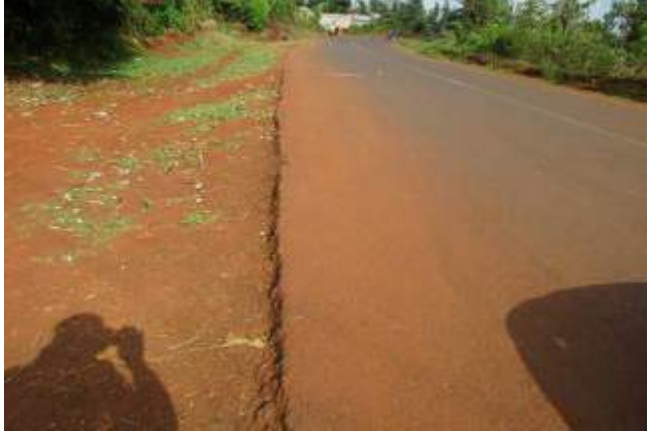
<p>Fig 9</p>	<p>Km 0+425 LHS</p>	<p>-Gulley erosion on the side slope</p>

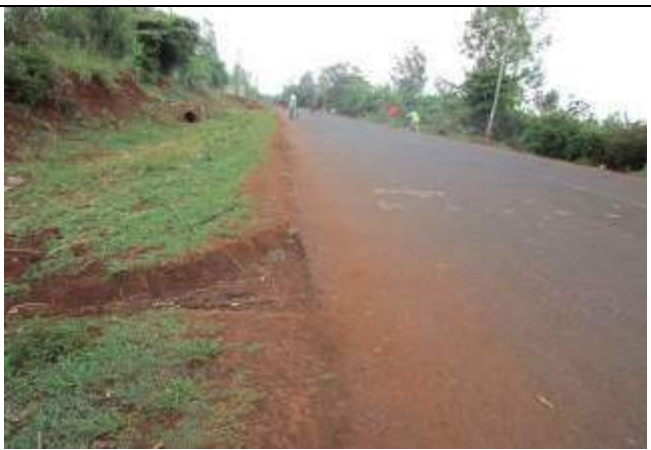
<p>Fig 10</p>	<p>Km 0+455 main carriage at the centreline</p>	<p>-Extensive alligator cracks on the carriage way especially at the centreline</p>

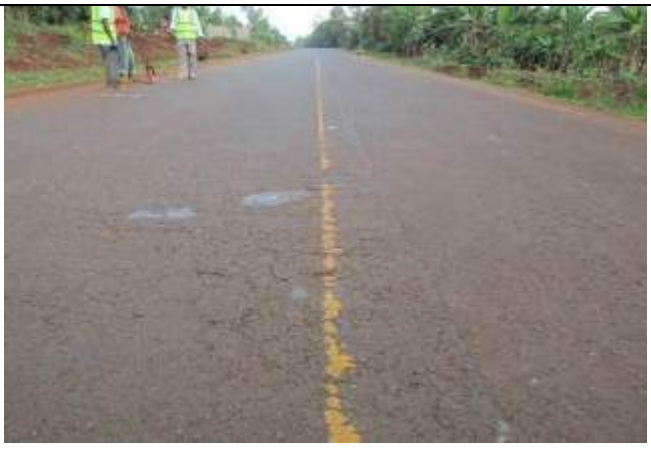
<p>Fig 11</p>	<p>Km 0+467 Centreline</p>	<p>-Extensive alligator cracks leading to the development potholes at the centreline</p>	 
<p>Fig 12</p>	<p>Km 0+540 RHS on inner wheel path</p>	<p>-Alligator cracks and pothole on the inner wheel path</p>	 
<p>Fig 13</p>	<p>Km 0+550 – 0+570</p>	<p>-Extensive alligator cracks and crack sealing done on the surface 10m long and 2.5m width</p>

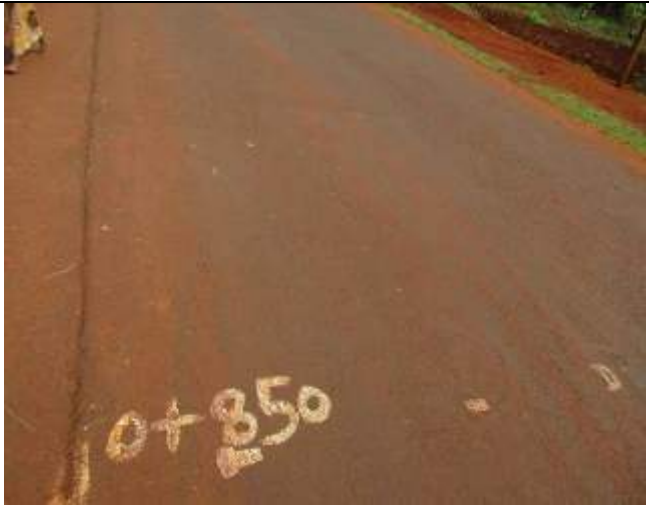
<p>Fig 16</p>	<p>Km 0+860 - 0+900 main carriage way</p>	<p>-Extensive alligator cracks all over the surface leading to penetration of water into underlying layers</p>

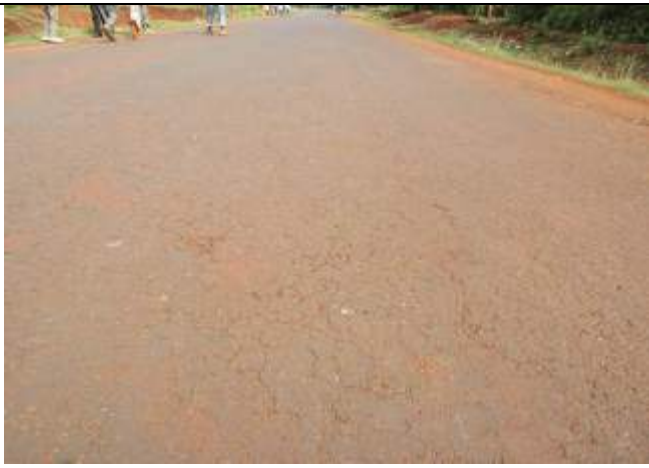
<p>Fig 17</p>	<p>Km 0+950 - 0+980 main carriage way</p>	<p>-Alligator cracks all over the surface</p>	 
<p>Fig 18</p>	<p>Km 0+980 – 1+000</p>	<p>-Alligator cracks and slight bleeding on the surface</p>

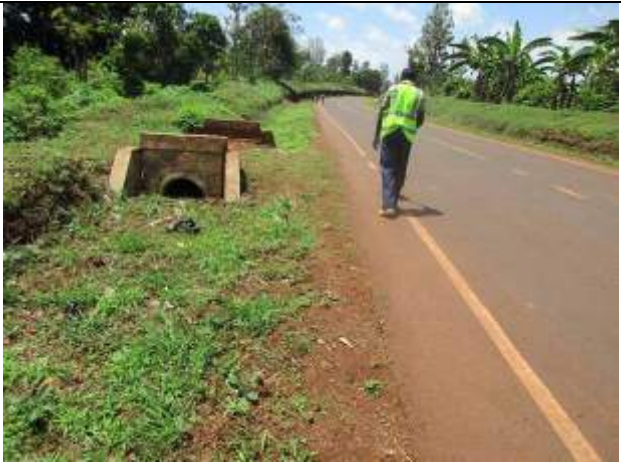
<p>Fig 3</p>	<p>Km 0+240 - 0+270LHS</p>	<p>-Silted side drain - No visible defects on the surface</p>

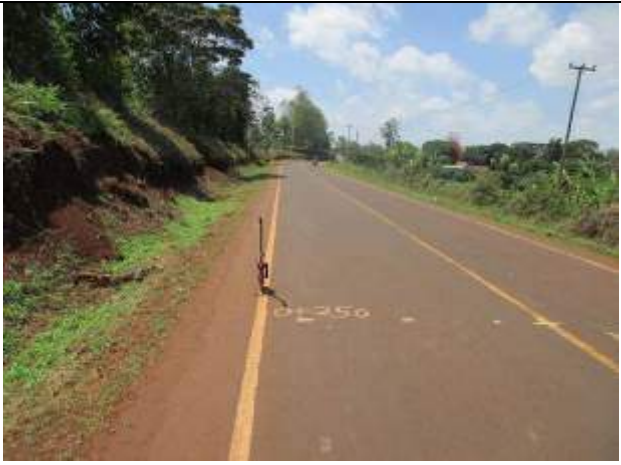
<p>Fig 4</p>	<p>Km 0+340 – 0+356LHS carriage way</p>	<p>-Stripping on the LHS lane covering 12m long and 3m width – Could have been contributed to a coarser mix</p> <p>-Noticeable inconsistency in the mix</p>

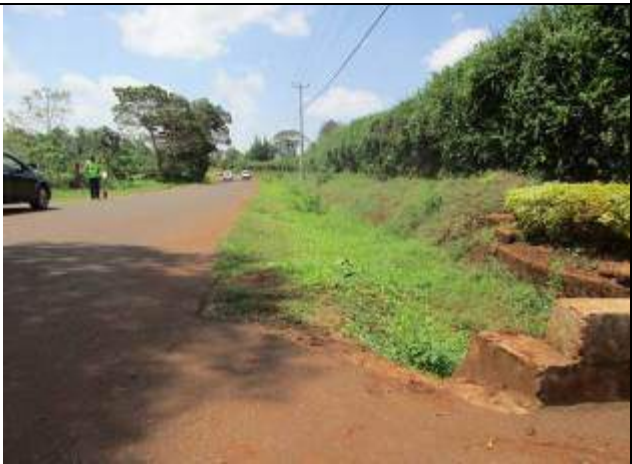
<p>Fig 12</p>	<p>Km0+778-0+800 both sides</p>	<p>-Erosion on side slope and shoulders and edge braking caused by traffic dodging the bump</p>

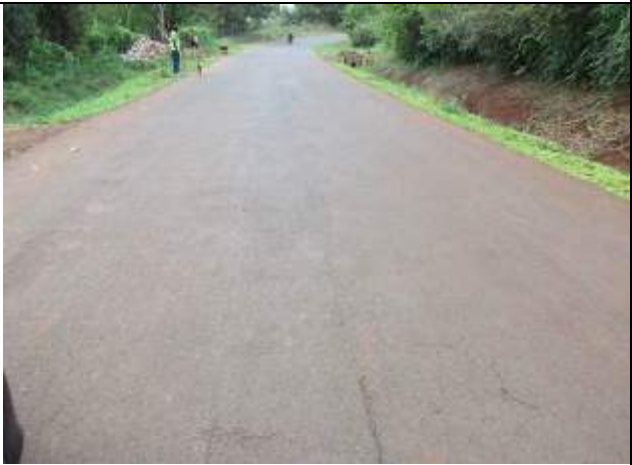
Fig 16	Km 0+970 main carriage way	Extensive alligator cracks at the centreline covering 10m long by 2m width	 
Fig 17	Km 0+970 – 1+000 main carriage way	-Swallow side drain - Vegetation on shoulders hindering free flow of water to side drain

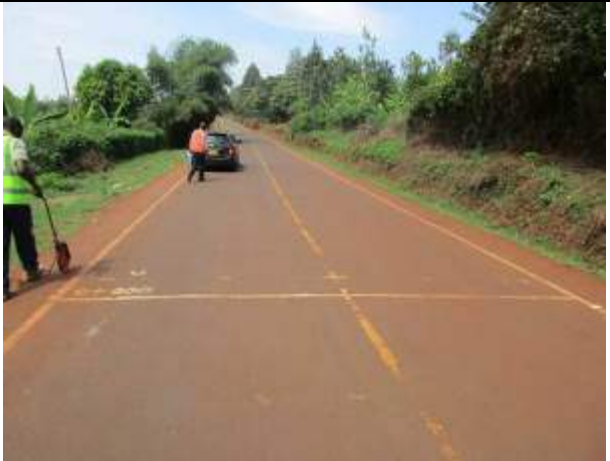
<p>Fig 2</p>	<p>Km 0+084RHS</p>	<p>-Potholes developing on the main carriage way inner wheel path</p>

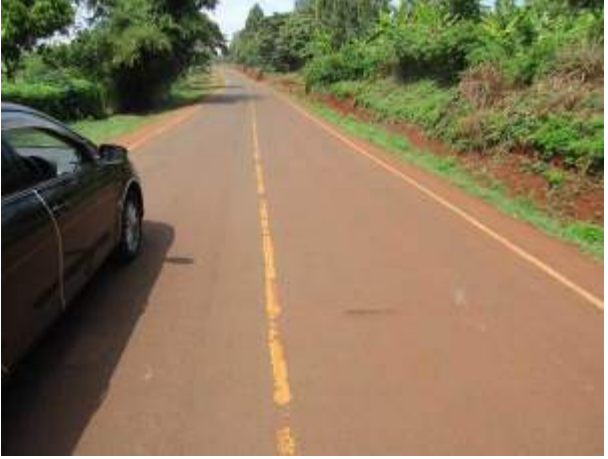
<p>Fig 3</p>	<p>Km 0+100 -0+125</p>	<p>-Potholes and alligator cracks on the surface covering an area of about 2m by 20m²</p> <p>-Faded road marking</p>

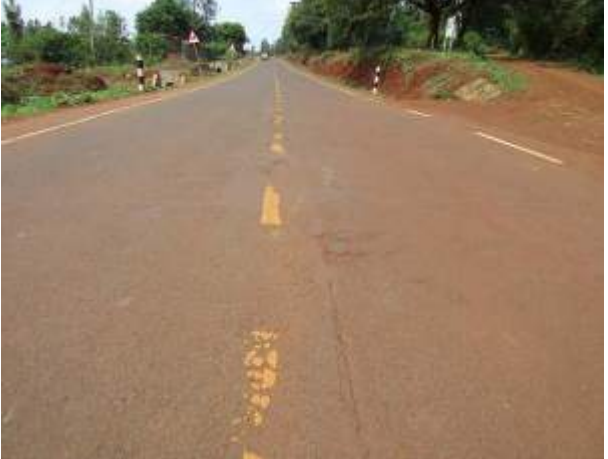
<p>Fig 4</p>	<p>Km 0+100 – 0+126 RHS</p>	<p>-Water crossing over the carriage way due to blocked drain</p> <p>-Blocked and silted side drain</p>

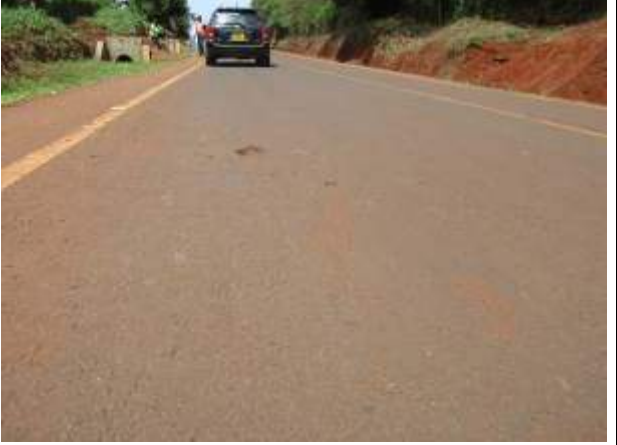
<p>Fig 6</p>	<p>Km 0+200 – 0+230 LHS</p>	<p>-Localized disintegration of ac layer leading to the potholes on the LHS carriage way on the shoulders and outer wheel path</p> <p>-Silted side drain and access culvert</p>

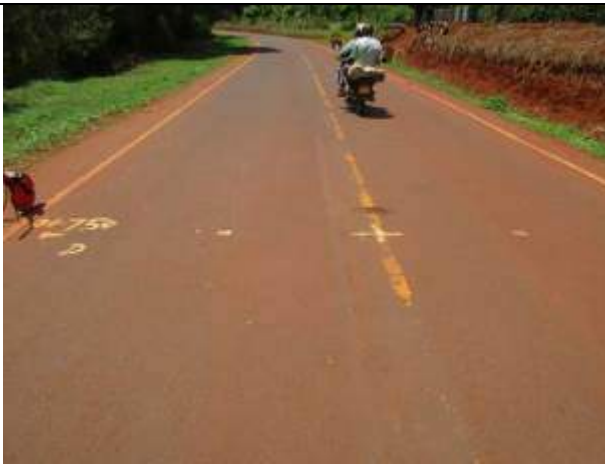
Fig 11	Km 0+890 -0+920	-Stripping and ravelling on the LHS lane covering approximately 30m long and 3.m width	 
Fig 12	Km 0+984 -1+000 main carriage way	-No visible defect on the main carriage way -Desilted drain and access culvert

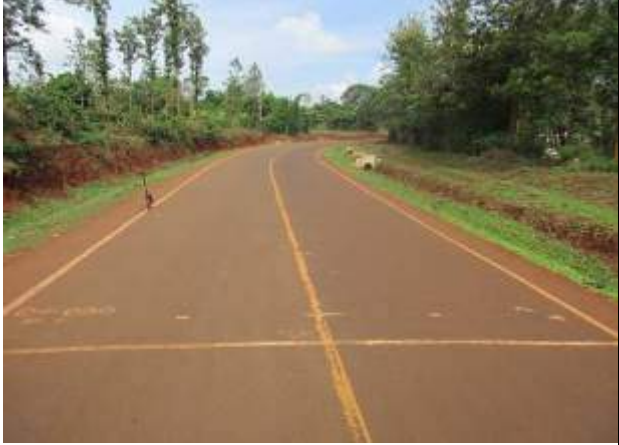
<p>Fig 2</p>	<p>Km 0+150 – 0+250 main carriage way</p>	<p>No visible defect on the carriage way</p>	 
<p>Fig 3</p>	<p>Km 0+600 – 0+650 main carriage way</p>	<p>Slight stripping on the carriage way</p>	 
<p>Fig 4</p>	<p>Km 0+720 – 0+740 Main carriage way</p>	<p>-Poor longitudinal joint visible at the centreline</p>

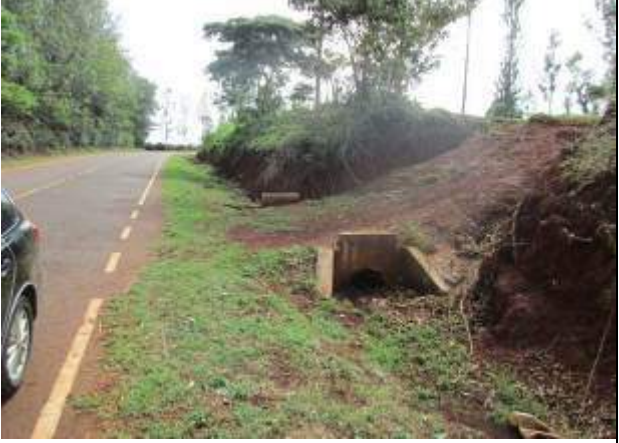
<p>Fig 6</p>	<p>Km 0+754 – 0+758 RHS</p>	<p>-Blocked and silted side drain and access culvert</p>

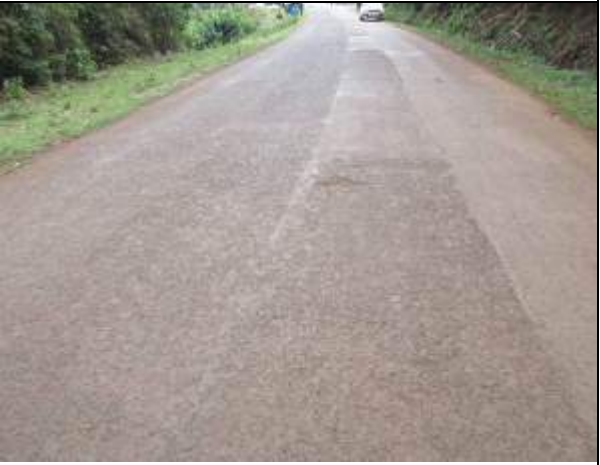
<p>Fig 4</p>	<p>Km 0+100 – 0+177</p>	<p>-No visible defect on the carriage way</p>

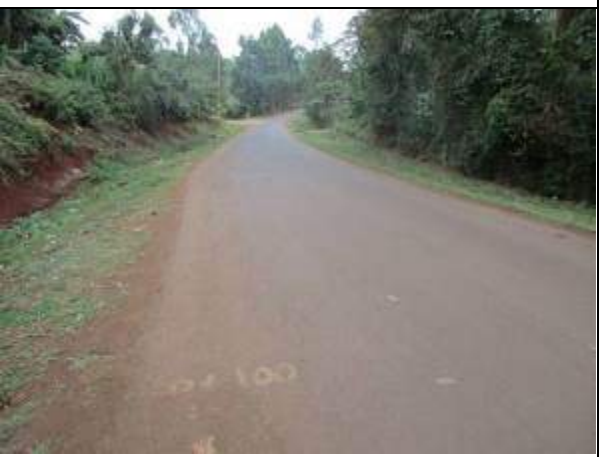
<p>Fig 5</p>	<p>Km 0+058 – 0+150LHS drain</p>	<p>-Blocked and silted on the LHS drain</p>

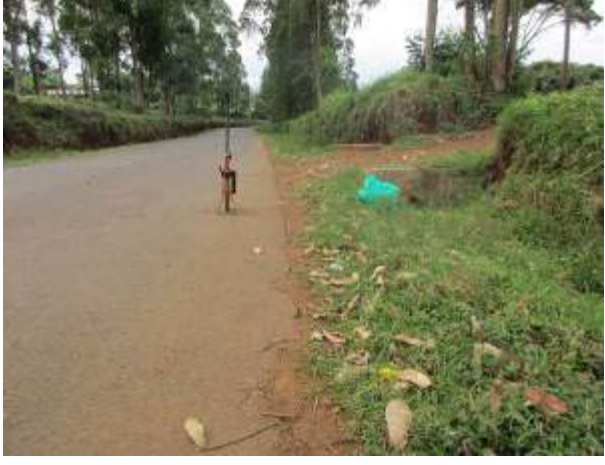
<p>Fig 3</p>	<p>Km 0+080 - 0+096 LHS main carriage way</p>	<p>-Extensive alligator cracks and deformation and depression on the outer wheel path 12m long -Silted and narrow drain hindering free flow of water along the drain</p>

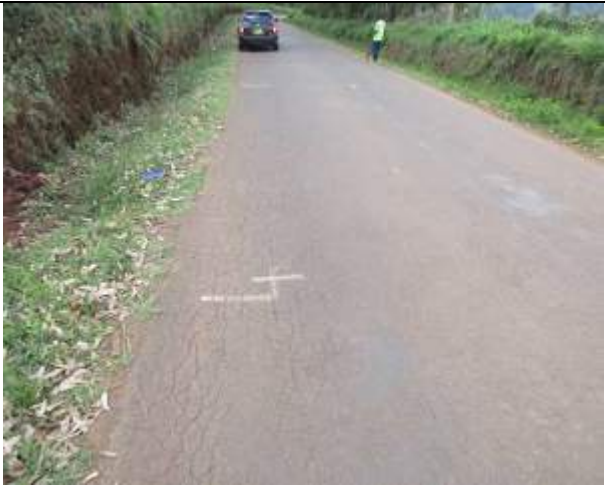
<p>Fig 4</p>	<p>Km 0+094 – 0+100 RHS</p>	<p>-Extensive alligator cracks on the outer wheel path -Deformation and depression on the outer wheel path of about -Area - 4m by 6m (24m²)</p>

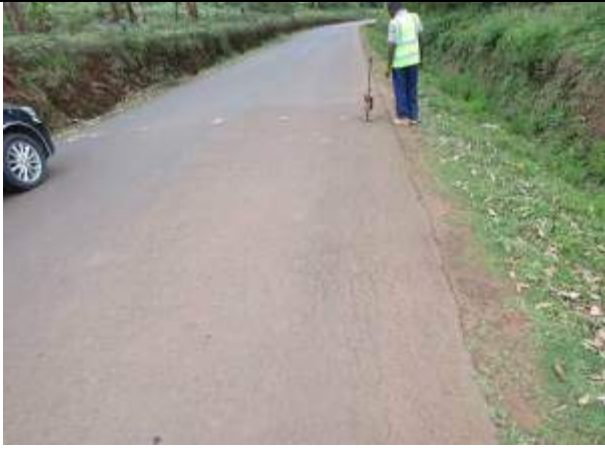
<p>Fig 5</p>	<p>Km 0+060 – 0+175 RHS main carriage way</p>	<p>-Bleeding on the inner wheel path on the RHS lane</p>

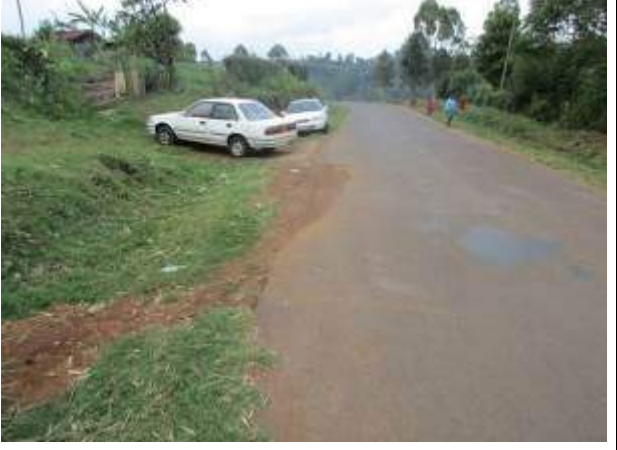
<p>Fig 7</p>	<p>Km 0+270 – 0+300 RHS</p>	<p>-Extensive alligator cracks on the outer wheel path causing deformation and alligator cracks at the edge -silted side drain</p>

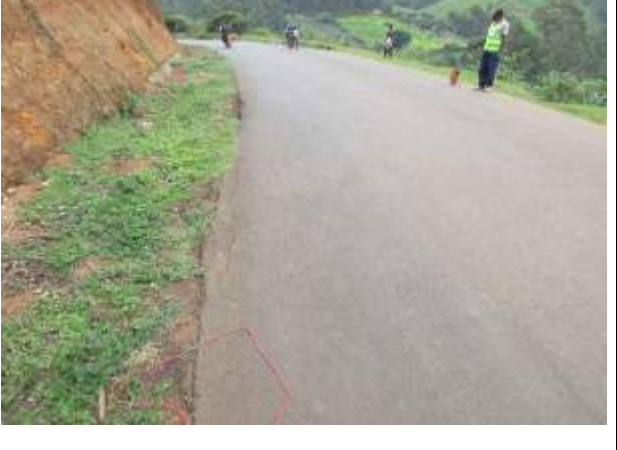
<p>Fig 8</p>	<p>Km 0+030 - 0+320LHS</p>	<p>-Extensive alligator cracks on the outer wheel path causing deformation and alligator cracks at the edge</p> <p>-Silted side drain hindering free flow of water along the drain and enhancing accumulation of deposits</p>

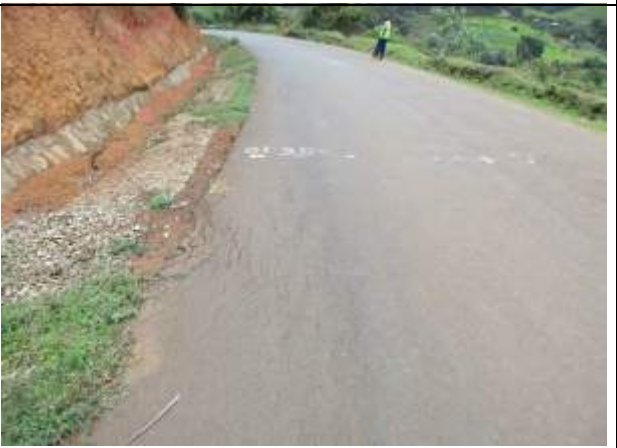
<p>Fig 10</p>	<p>Km 0+320 – 0+440 LHS main carriage way</p>	<p>-Edge deformation, subsidence breaking and cracking way</p> <p>-Too thin ac layer</p>

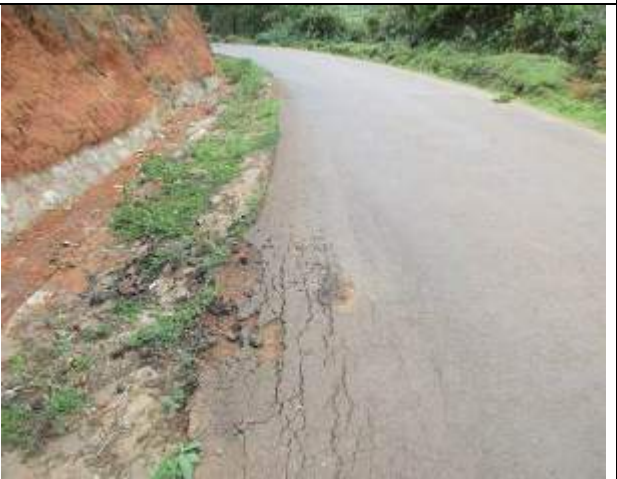
<p>Fig 11</p>	<p>Km 0+533 – 0+600 both sides</p>	<p>-Blocked and silted with waste debris side drain</p>

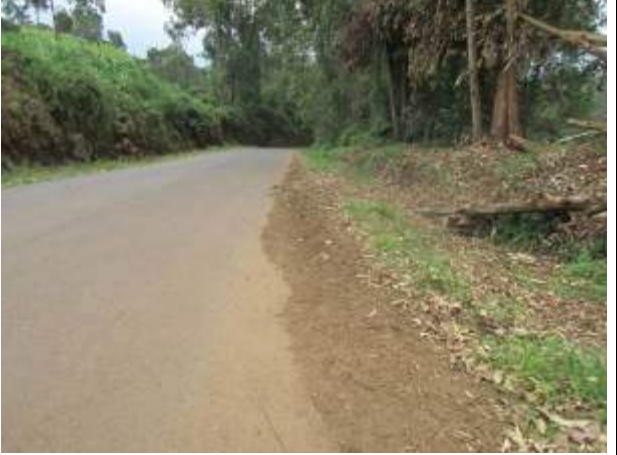
<p>Fig 14</p>	<p>Km 0+590- 0+650LHS</p>	<p>-Edge subsidence, deformation, alligator cracks and outer wheel path failure</p> <p>-Blocked with erosion deposits</p>
