SEACAP 24

CASE STUDY OF DAK LAK RRST PAVEMENT AND SURFACE DETERIORATION

SEACAP 24 is concerned primarily with research into the premature failure of two RRST-II trial roads in Dak Lak province – Boun Ho and Ea Soup.

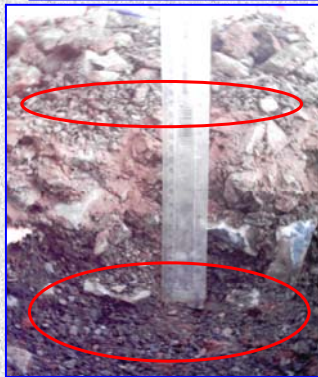
Poor grading and segregation in macadam

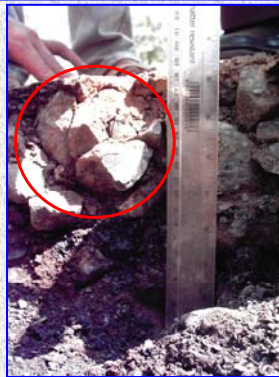
1. Oversize and poor grading macadam

Large oversize in macadam

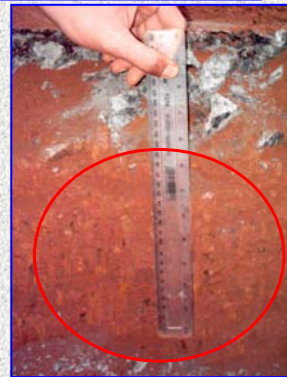
2. Poor quality natural gravel – low soaked CBR – out of specification grading and plasticity in key areas

Poor gravel in placed in 1 layer? (specified 2)

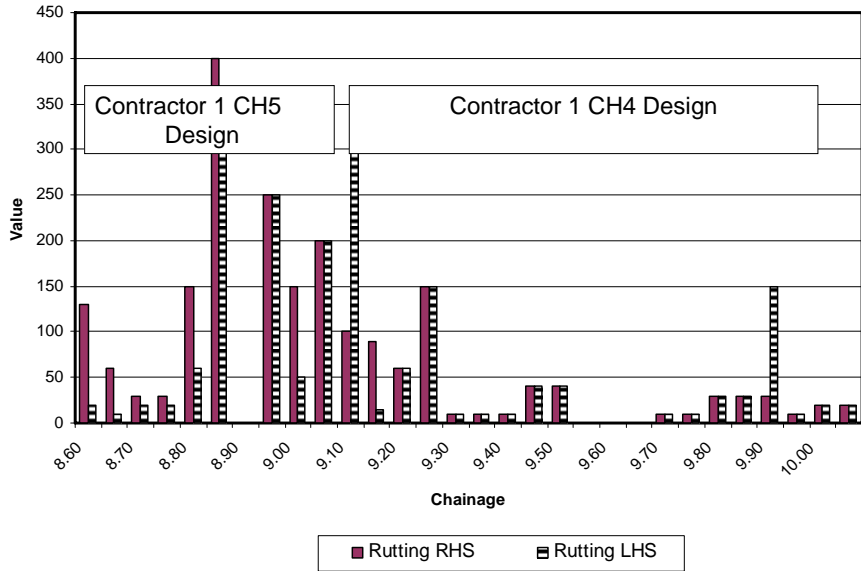
Rut Depths

Comparison of Package II and Package III would support the view that construction procedure, quality control and/or construction materials may be a contributing factor in the rate of deterioration.

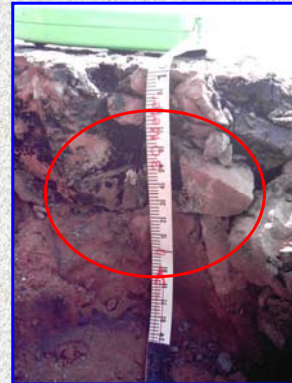
Despite the original test results showing a satisfactory material for approval there were indications that, with Buon Ho, some areas at least were constructed with out-of-specification materials

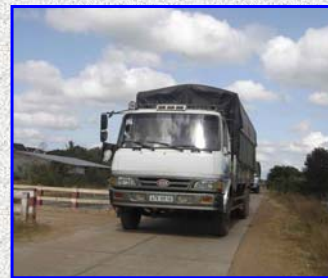
There were also indications of the road being used by vehicles exceeding the 6 Tonne limit.

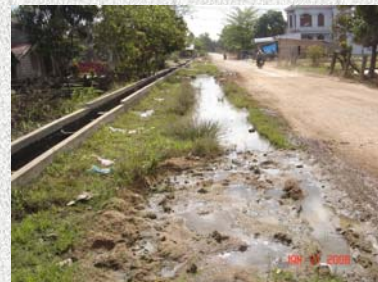
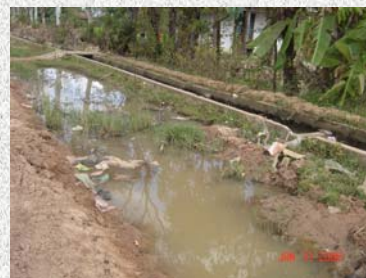
Irrigation Ditch

An irrigation ditch had been heightened very shortly after the construction of the Trial road, so that the water in this channel was above road level in the crucial section. No provision had been made for drainage of water leaking from this channel – hence water was able to soak the sub-grade and flood the macadam sub-base

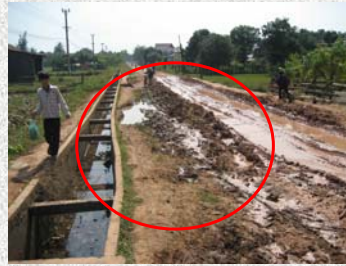
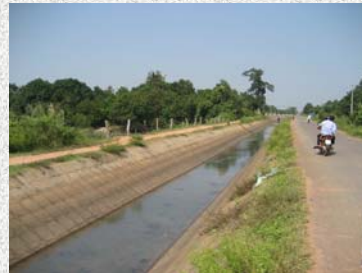
It is our opinion that the primary cause of the failure of the section of Ea Soup road was the weakening of the sub-base and sub-grade due to soaking by a high water table resulting from leakage from a recently constructed irrigation channel.

It is notable that apart from some isolated spots the road with similar design and the same contractor is in fair condition elsewhere
