SEACAP 24/001

A CASE STUDY OF THE PREMATURE FAILURE OF A TRIAL ROAD IN DAK LAK PROVINCE, VIETNAM

Dr Jasper Cook, OtB Engineering Ltd, UK

Dr John Rolt, TRL Ltd, UK

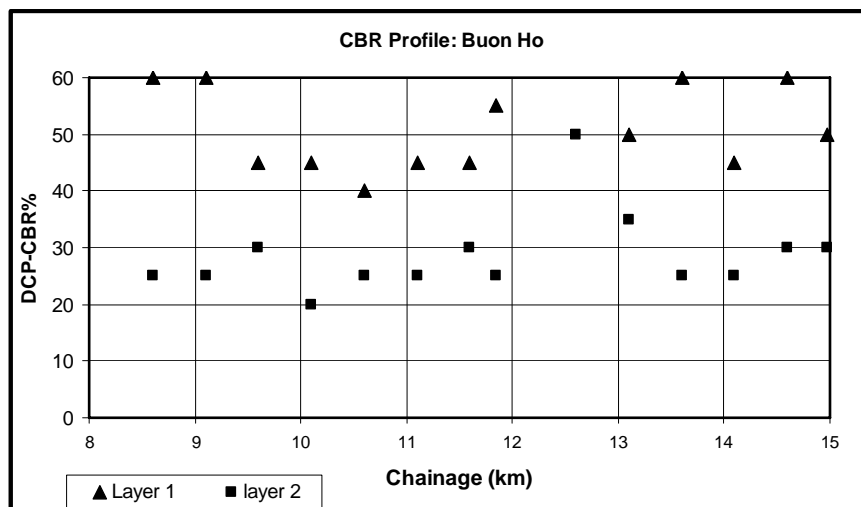
Figure 2 In Situ Strength of Existing Pre-Trial Road

Prior to the trials programme the Buon Ho road was primarily of unsealed gravel construction with some sections of Penetration Macadam. The existing surface was in poor condition and composed of sub-standard quality gravely silty clay, Figure 2.

The original designs are shown in Table 2. Estimates of the likely ‘subgrade’ strength were made by using DCP measurements in the original old road (Figure 2). Analysing the available data using the AASHTO design method it is apparent that even if the road had been constructed as designed, none of the sections would have survived for more than a year or two with the traffic that was being carried after construction (Table 8). However, this conclusion depends on the actual subgrade strength that may differ from the value assumed in the design.

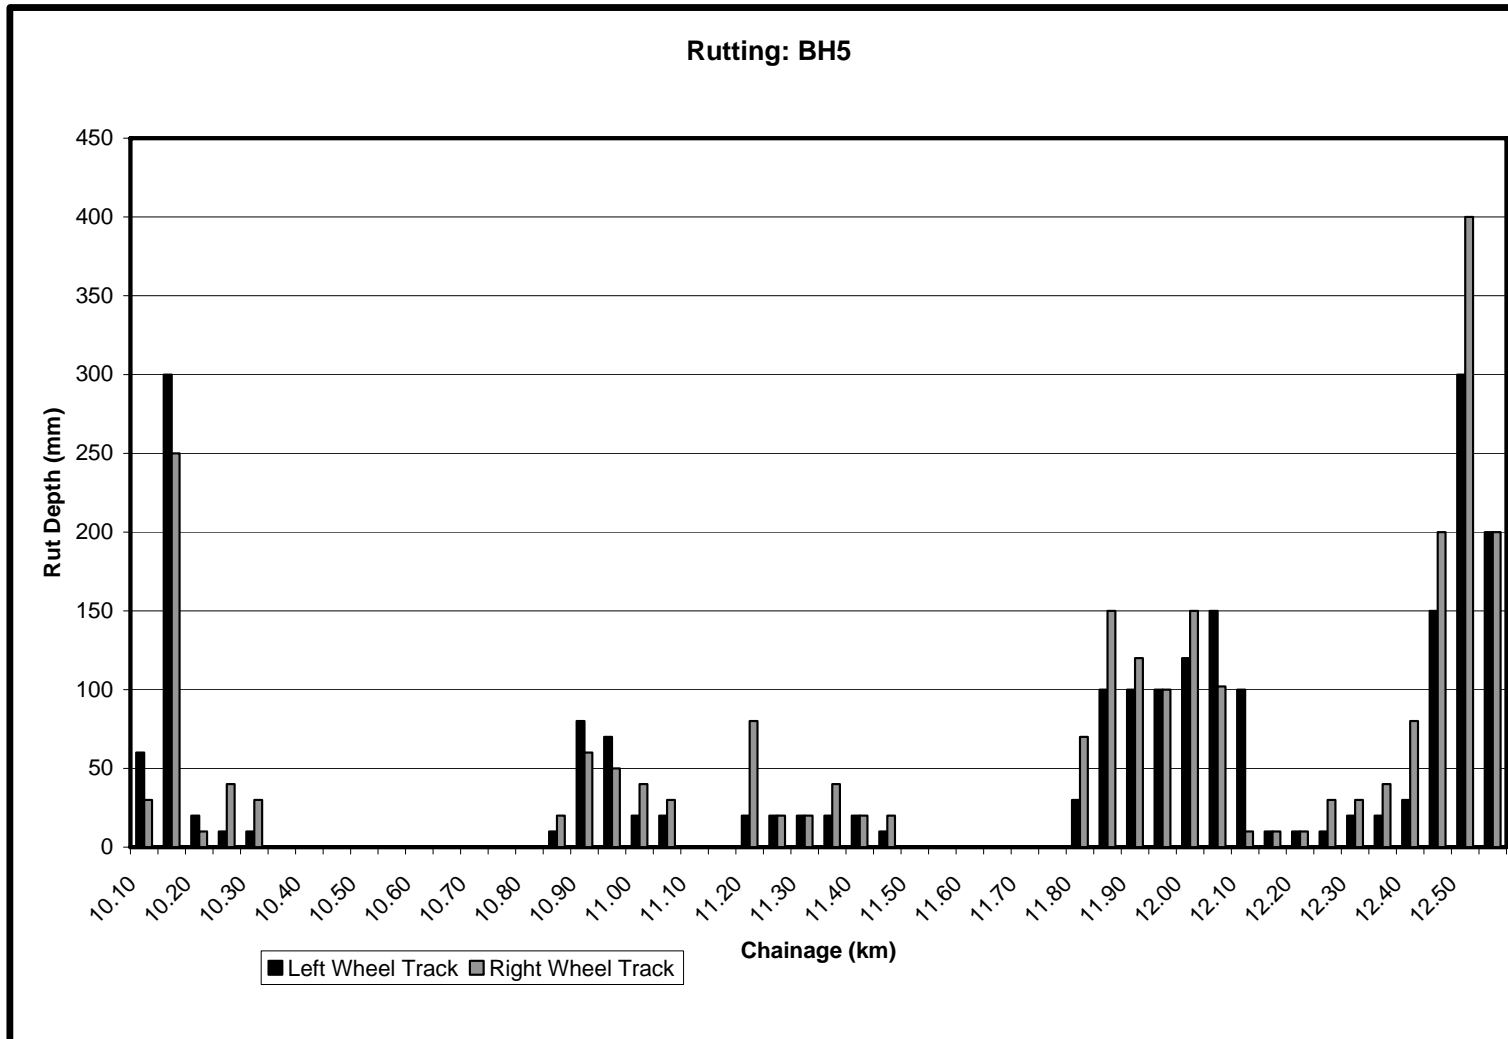
Figure 3. Rut Depths for Section BH 5

A visual condition survey was undertaken of the whole of the Buon Ho trial road using an assessment 'block' length 25m. Figure 3 presents a typical wheel-track rut depths plot measured as part of the visual survey procedure. Visual descriptions were grouped into 5 general levels of condition as defined below and presented in Figure 4, which also includes test pit locations, pavement design references and contractor boundaries.

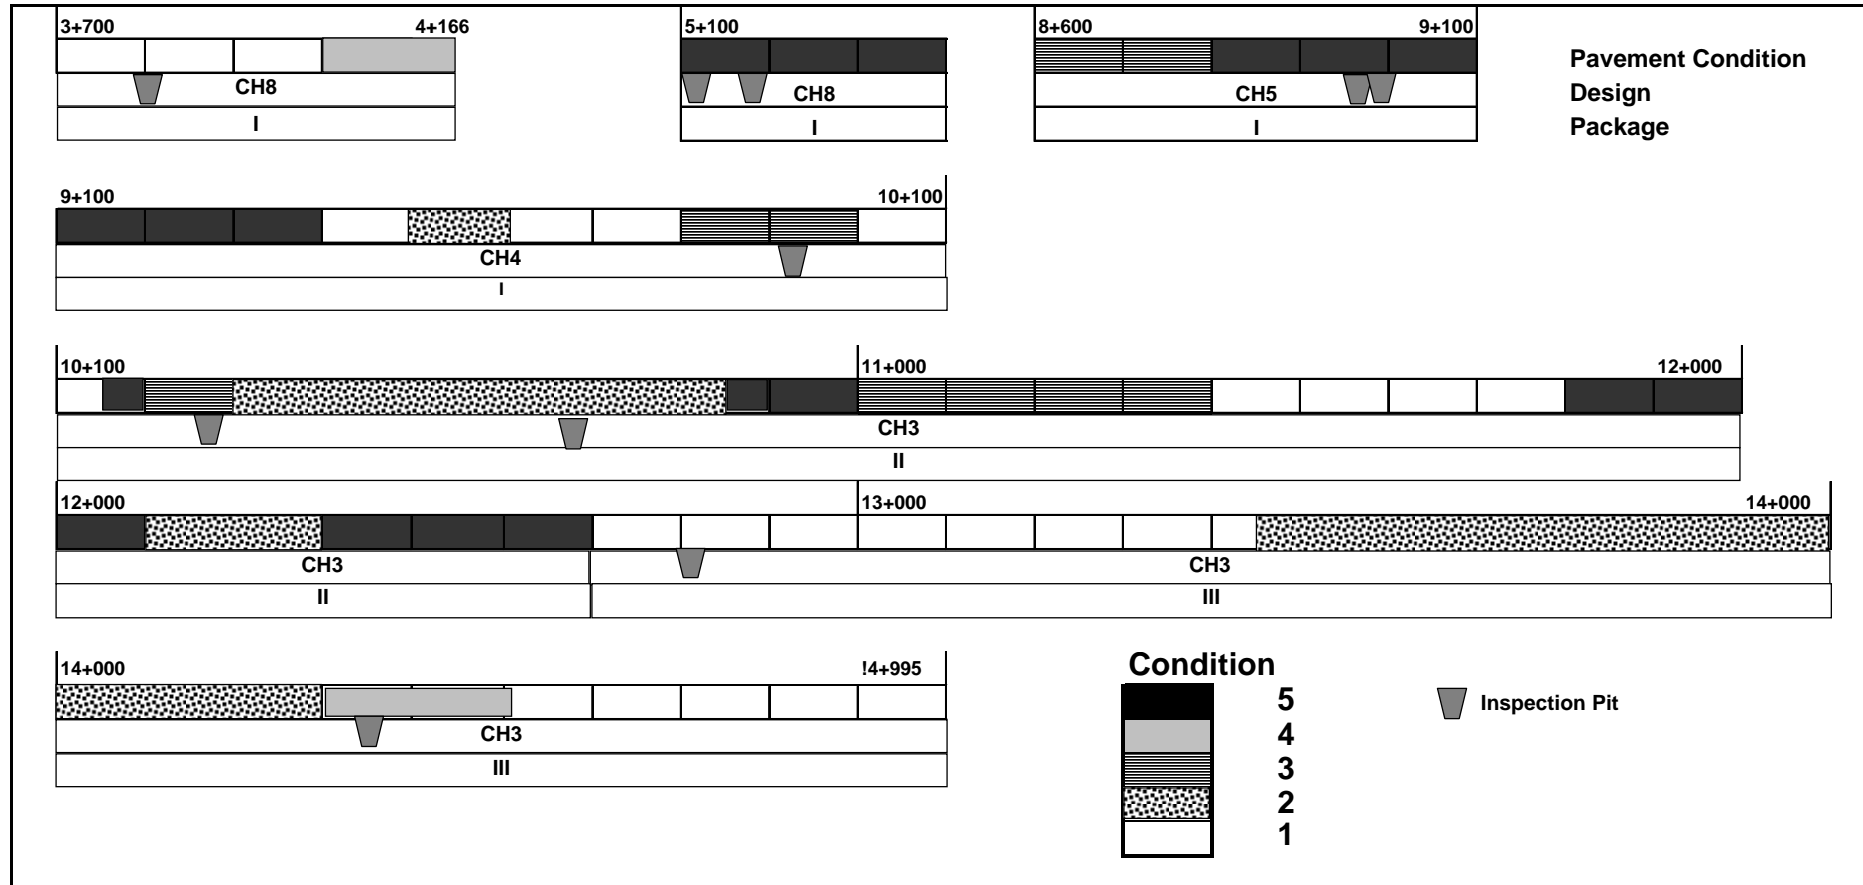
Figure 4. Buon Ho Pavement Condition Summary

1. Pavement in **good** condition, with only occasional isolated cracking and occasional minor ruts <20mm
2. Pavement in **fair** condition, with some slight stripping of seals leading to occasional shallow potholes; occasional rutting up to 20mm, occasional interconnected or crocodile cracking
3. Pavement in **moderately poor** condition, with significant crocodile cracking and scattered potholes, rutting may be up to 70-80mm
4. Pavement in **bad** condition, extensive crocodile cracking and potholes with rutting up to 200mm
5. Pavement in **very bad** condition – essentially pavement has lost seal and lost integrity with severe ruts and loosening of base material.
