PERFORMANCE OF MECHANICALLY STABILISED SAND ROAD BASES IN MOZAMBIQUE.

Authors Cumbane, Carlos Rodrigues

Dzimba, Moises

Abstract -In Mozambique only 20% of the classified road network is paved. Locally available materials for the base are often out of specification and the solution normally adopted for pavement layers is conventional chemical stabilization. The Agostinho-Neto to Mutamba Road in Inhambane Province was constructed under a programme of Targeted Interventions for Low Volume Roads. The objective of the programme was to find technical and economically viable options for local conditions. The road was constructed in 2015 and is 5.5 km long and 6.0m wide. The first 4.3 km section of the road comprises a base of blended sand and calcrete (50:50). The remaining 1.2 km has a base of neat red local sand armoured with crushed calcrete. The subbase is neat red sand throughout, and the road is surfaced with an Otta seal and slurry. Monitoring sections were established on each type of base to evaluate the road performance. Routine monitoring of these sections is being carried out according to a standard protocol developed for Mozambique. In general, the section with the armoured

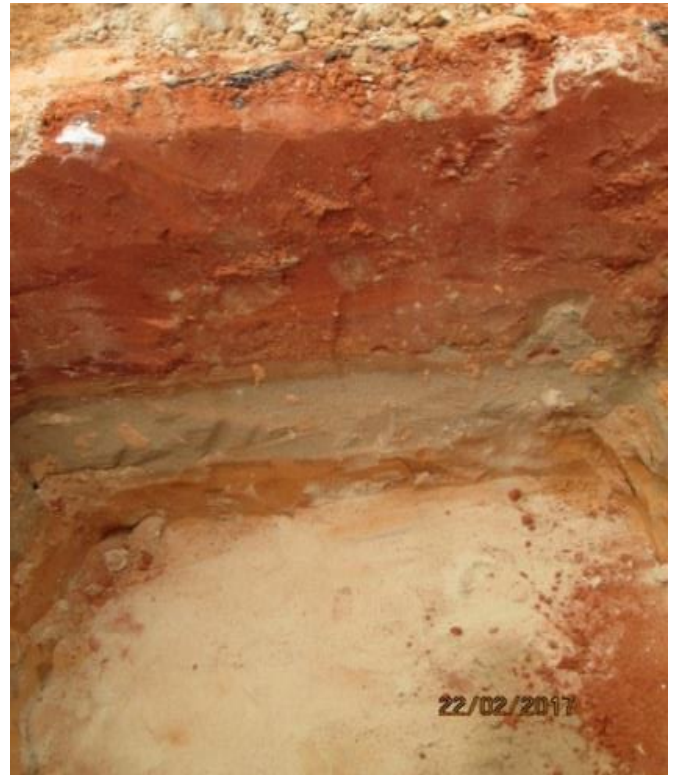
Fig. 2. Armoured base.

Armouring of the base was carried out by laying crushed calcrete with a nominal 50mm diameter on the surface and rolling it into the sand base.

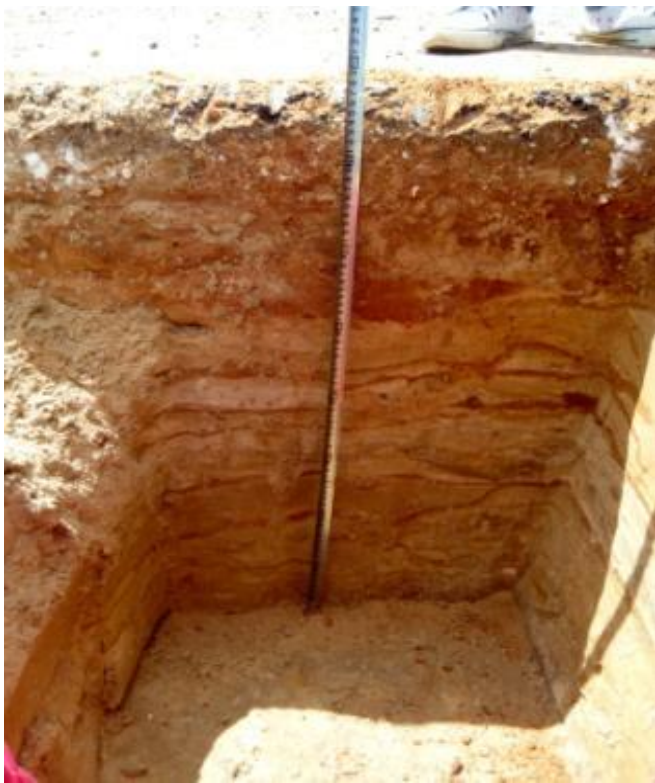
Fig. 3. :Blended base

This consists of a blend of 50% calcrete and 50% granular sand. The purpose of blending is to improve the strength of sand base material.

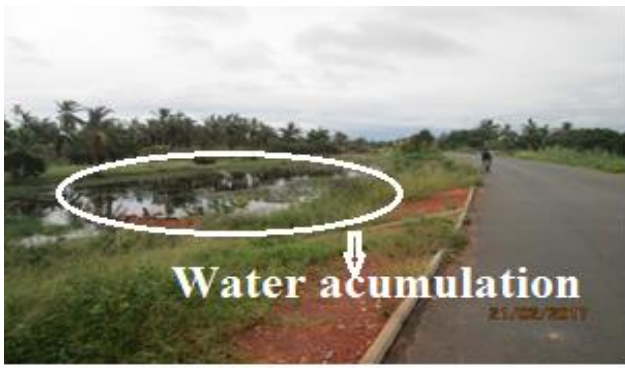
- There was visible surface cracking, bleeding, and slight deformation where the road is on an embankment.
- The shoulder is narrow on some sections, with edge drop and edge break.

Fig. 5. Armured base sections on embankment

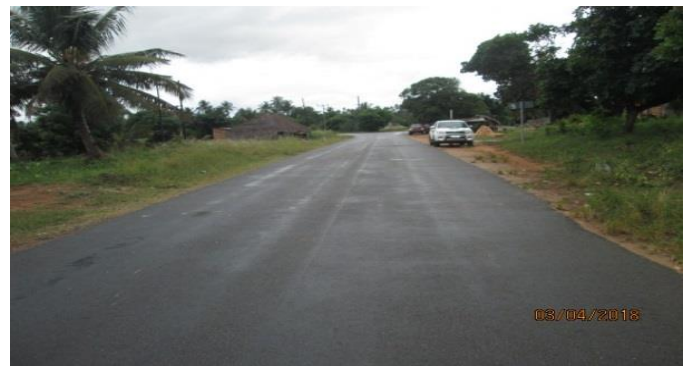
- Drainage is poor on a 250m section due to flat terrain (Fig. 6).
- On the embankment section, 170m on the right hand side of the road has asphalt kerbs and there is water accumulation alongside the road (Fig. 7).

Fig. 6. Armured base sections on flat terrain.

The research project has shown that the local sandy materials can be mechanically stabilized to provide an adequate base course without the high cost of conventional stabilization. Attention must be given to keeping the upper pavement layers dry by raising the road embankment and providing effective drainage. The performance of the blended base could be improved by reducing the fines included in the calccrete component.

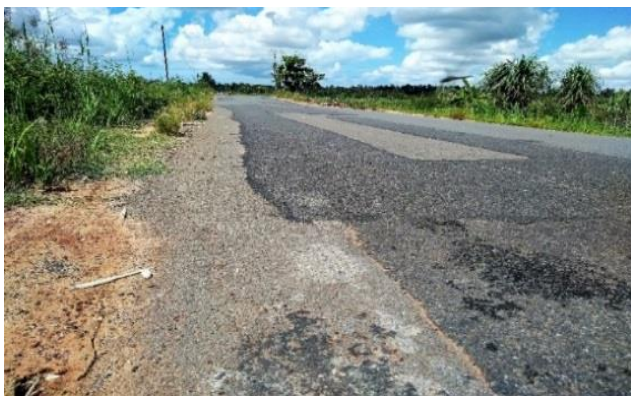
- The blended base section includes a 244 m long section on a 2 m fill (panel A) and a 264 m long section on a 3 m fill with kerbs (Fig. 8)
- The section shows cracks and deformation and has required extensive pothole repairs (Fig.7).

Fig. 7. Patches along the section

The potholes are attributed to the higher moisture content in the base.

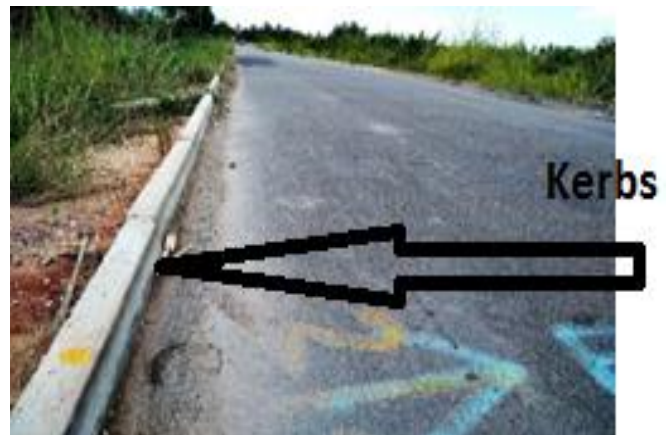
Fig. 8. Kerbs on blended base section

Based on in situ moisture results presented on Table X and XI, it seems that the part of the road protect by kerbs has lower moisture contents, probably due to the high fill and kerb protections.

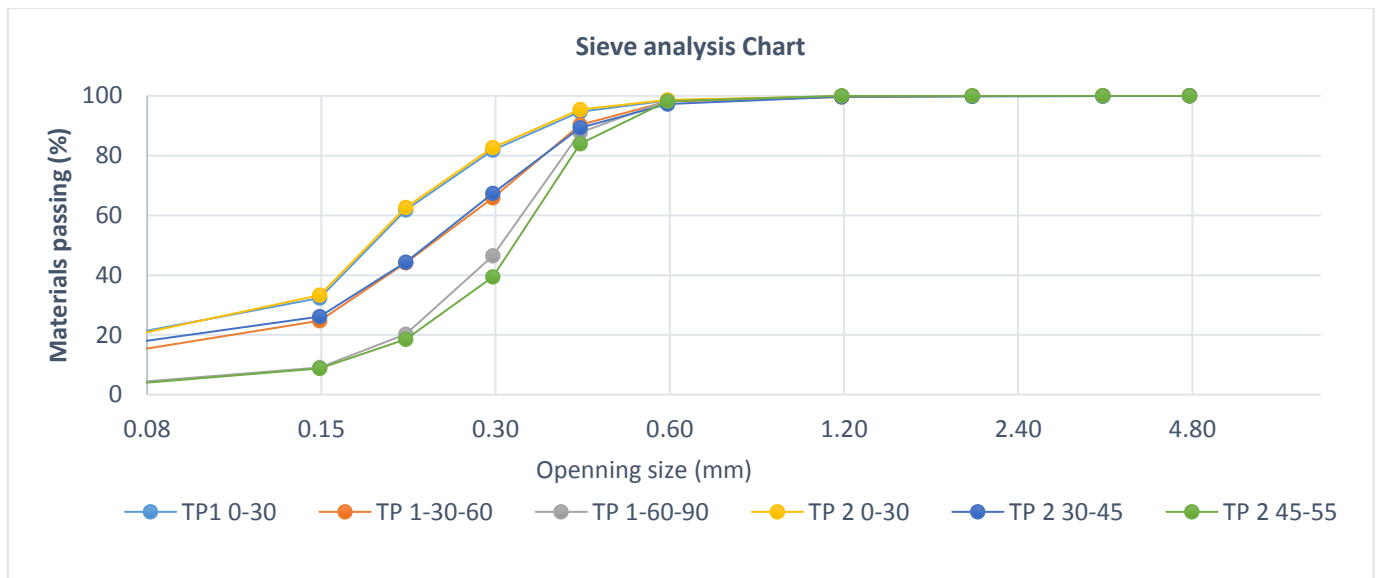
Fig. 9. : Sieve analysis graph.

From the results shown in Table- V and Fig. 9, it is concluded that the base and subbase materials have similar properties and were taken from the same borrow pit. The subgrade and fill materials are in situ and slightly coarser.

The plasticity results obtained for material passing the 0.425 mm sieve indicate that the materials used on the armoured base section have a Plasticity Index (PI) of less of 6% and the subgrade and fill are non-plastic (NP). This is within the limits recommended in the SATCC Specification [8].

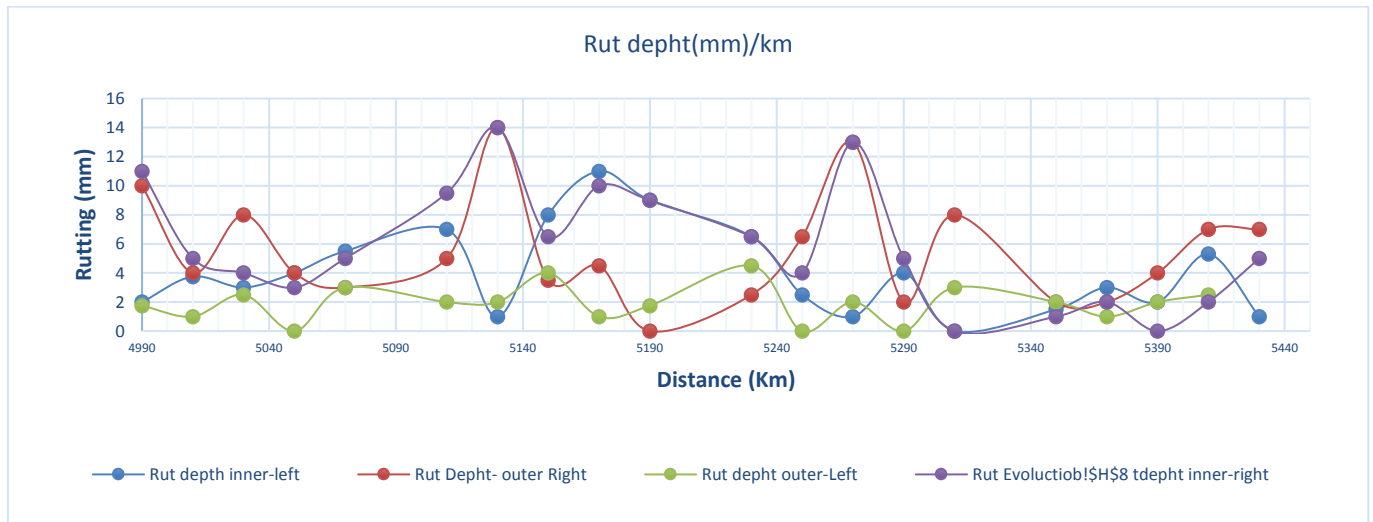
Fig. 10. Graphical representation of the rut depths

The rut depth results are presented in Fig.10 taken from each of the 20m panels (numbered 1 to 20). The highest rut depth is

14 mm at KM 5+130 on the left side and it can be attributed to settlement of the layer on the embankment

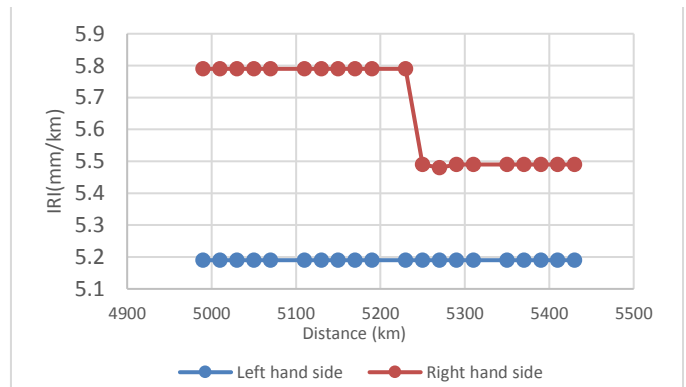
Fig. 11. : IRI results.

The results of IRI roughness measured on each 250m long section in the outer wheel path in each lane are presented in Fig.11.

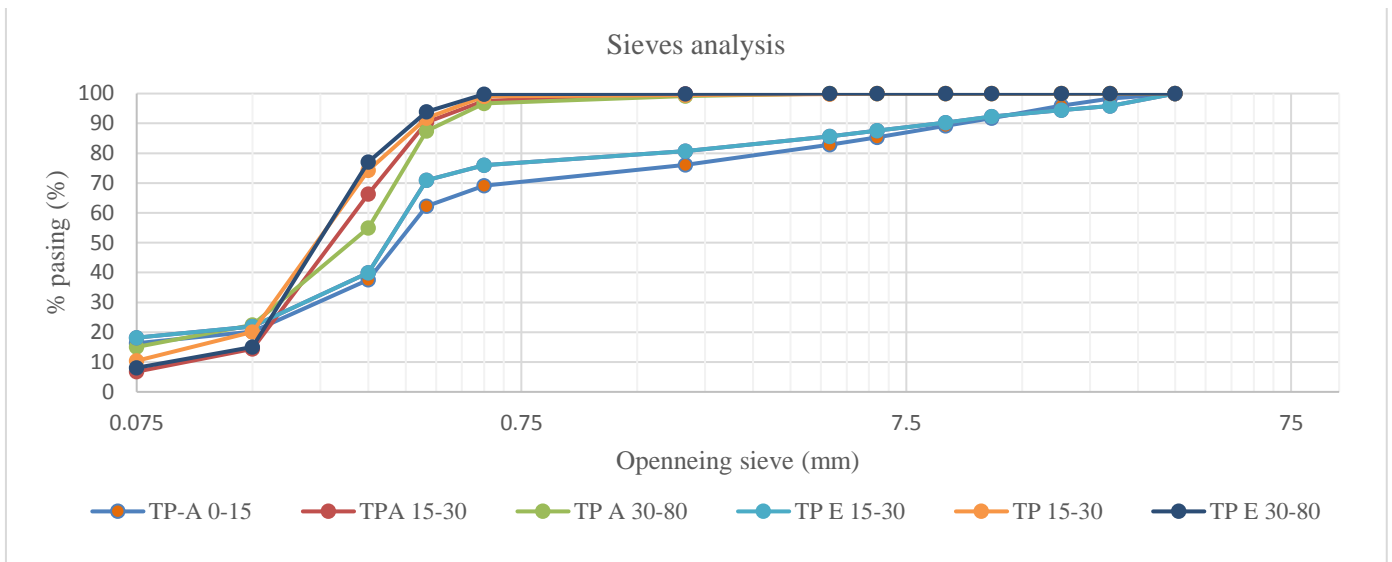
Fig. 12. Graphical Representation of the Sieve Analyses.

The sieve results show that calcrete is included in some samples of the material, taking the sample to a nominal size of 12.5mm and a maximum size of 25.4mm. However, the sieve curves (Fig.13 and Table XII) indicate that the grading of the calcrete contains more fine particles than crushed calcrete stones. Therefore, it does not contribute fully to improving the grading of blended material.

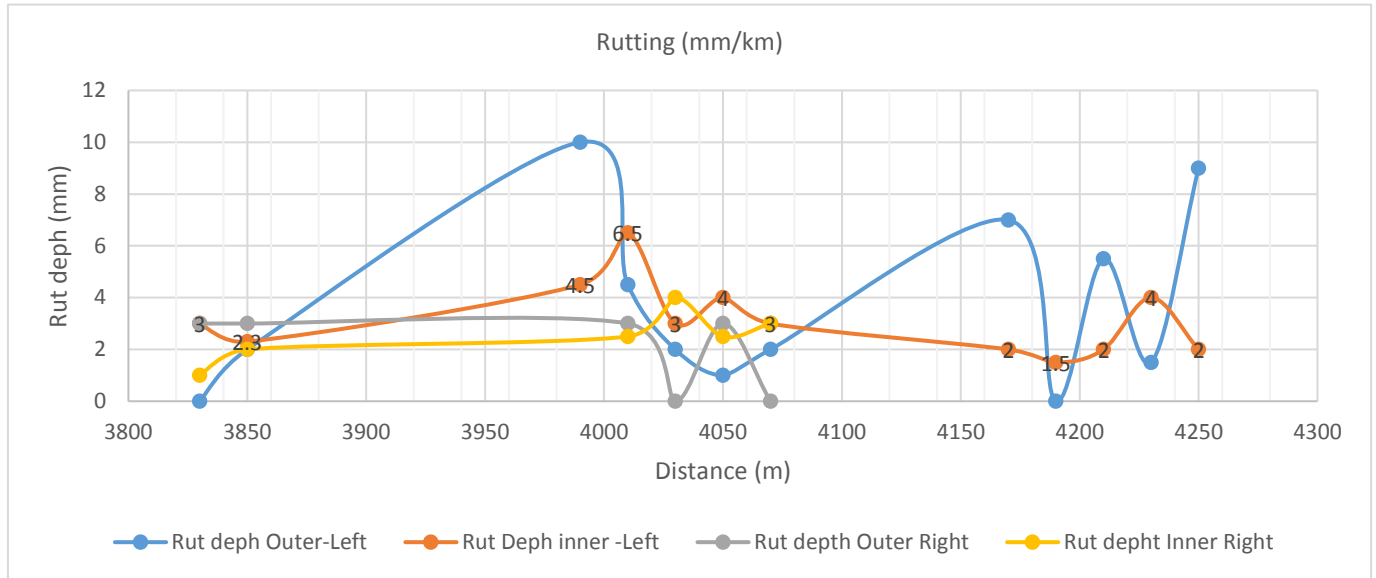
Fig. 13. Graphical representation of the rut depths

The rut depth results are taken from all 20m panels (numbered 1 to 20). The greatest rut depth is 11 mm at kmKM 4+190. However, it is less than 20mm (terminal condition), and can be attributed to the base deformations as results of poor compaction and high moisture in the base layer.
