Agricultural Sector Wide Approach Support Project (ASWAP-SP)

Mid-term Technical Audit Report

D387 Nsangwe-Dolo – Chikwawa District

S135 Mwanza-Kunenekude – Mwanza District

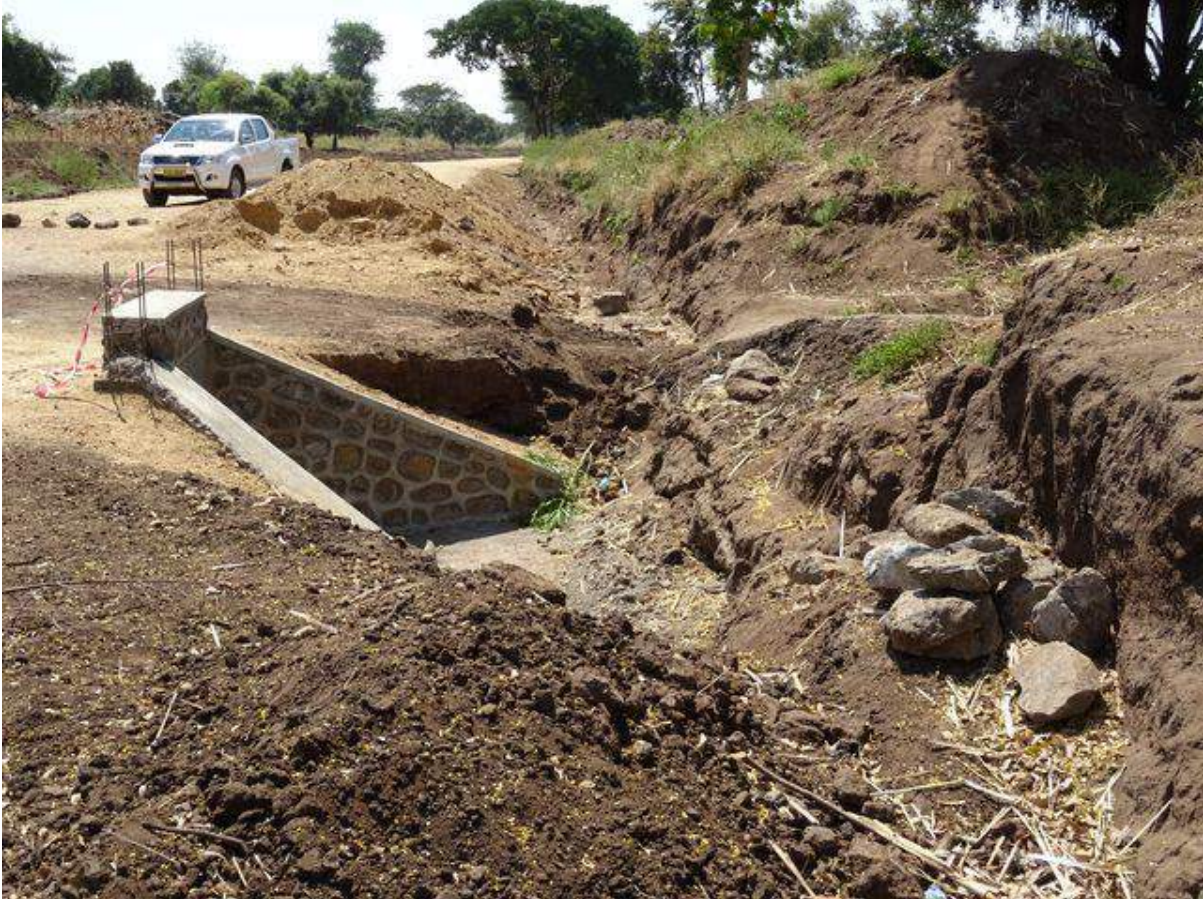
The first 3 km was characterized by the road having a sunken profile and serving as a drainage channel for water shedding off the surrounding land as well as serious erosion in the natural water courses.

Figure 4: S134 Kasinje – Kandeu. New culvert with invert well below side drain invert. Road level well below surrounding ground.

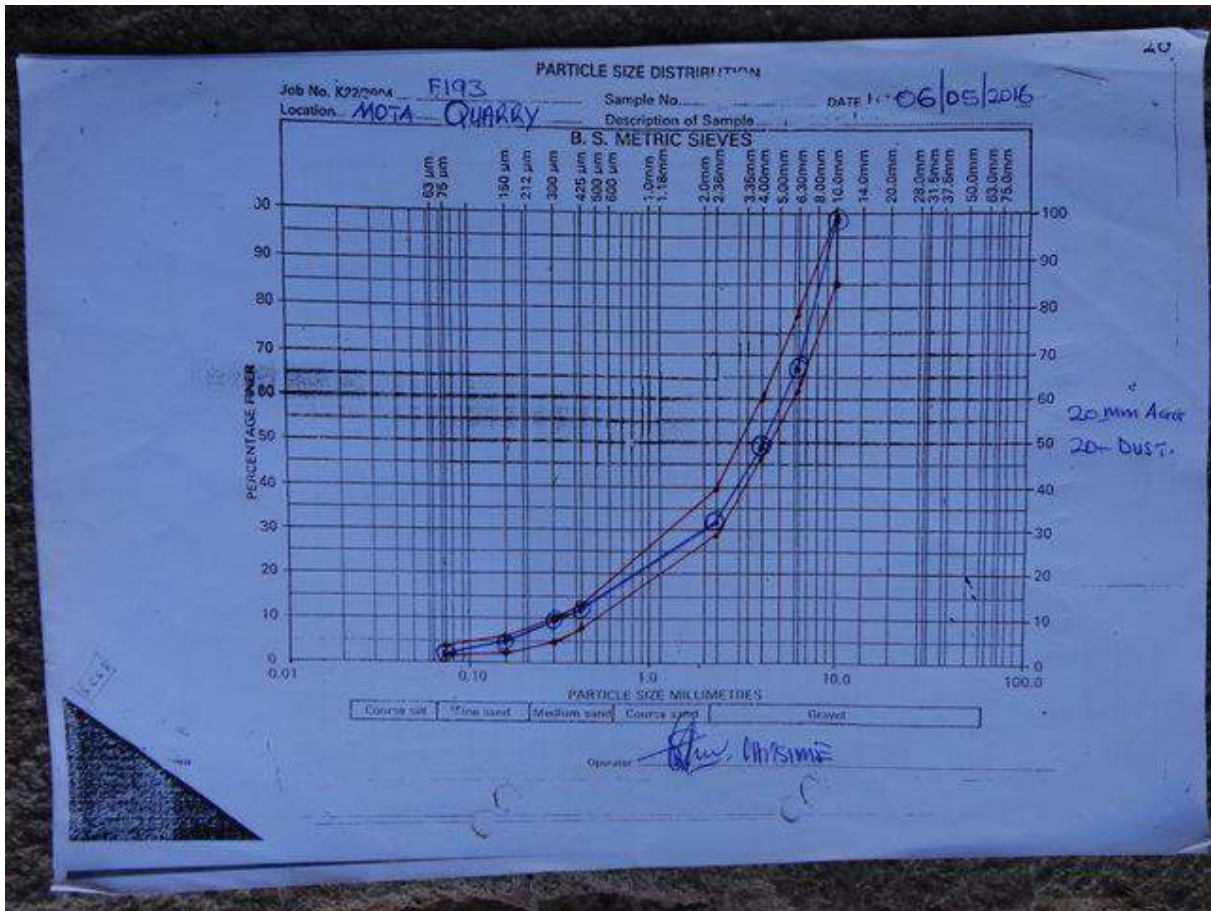
The quality and durability of the CMA require the aggregates to be within a fairly narrow grading envelope. This has now been achieved by sourcing 0-6 mm crusher dust from a crushing plant that when mixed 50-50 with the 6-10 mm stone the grading conforms to the specifications.

Figure 5: Grading analysis of CMA aggregates.

Close supervision and follow-up from the trainer is still required to ensure that the quality standards are upheld at all times, both as regards the aggregate grading and the application of the CMA on the road. **Significant Concern - Priority 3.**

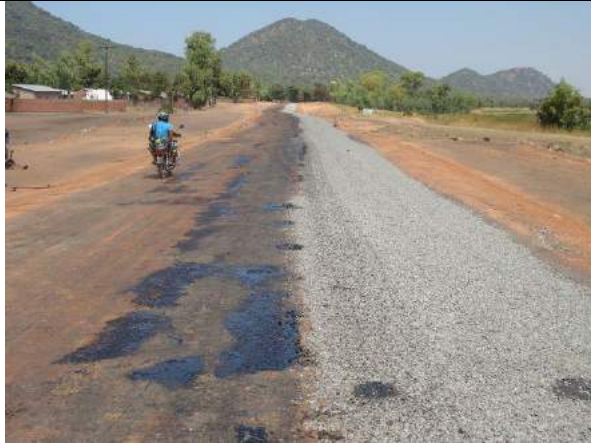
These deficiencies have resulted in a sub-standard Cape Seal, although the slurry effectively covers most of the problems with the underlying chip seal.

Figure 6: Patchy work and irregular lines

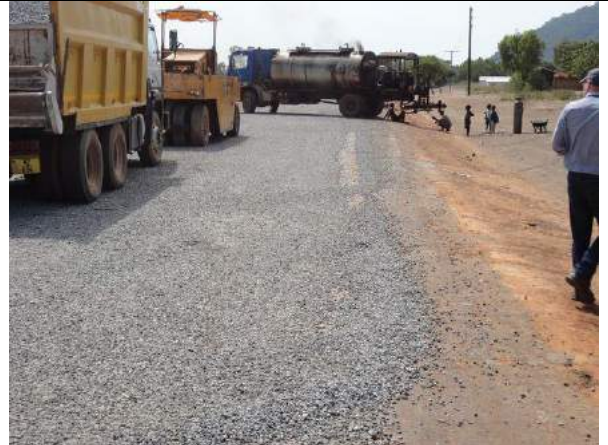
Figure 7: Patch not covered with bitumen, loss of aggregates

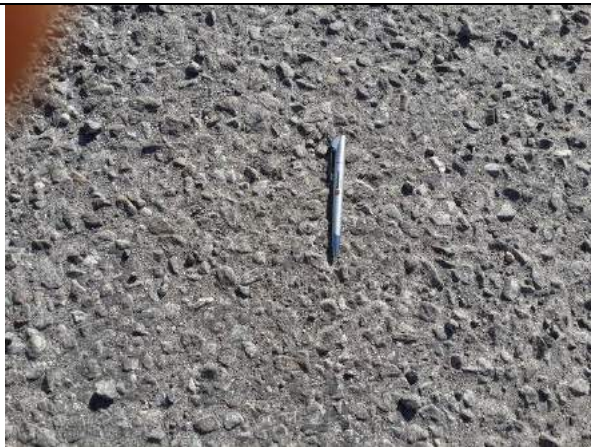
- Mechanical broom or manual brooming not able to remove all excess chippings and dust accumulating in the voids between the chippings
 - Compressor needed for blowing out dust and dirt, but compressor broken down

- First layer of slurry filling up the voids between chippings. Second layer therefore lying on top and will be worn off quickly under traffic.

Figure 8: Surface texture before application of slurry

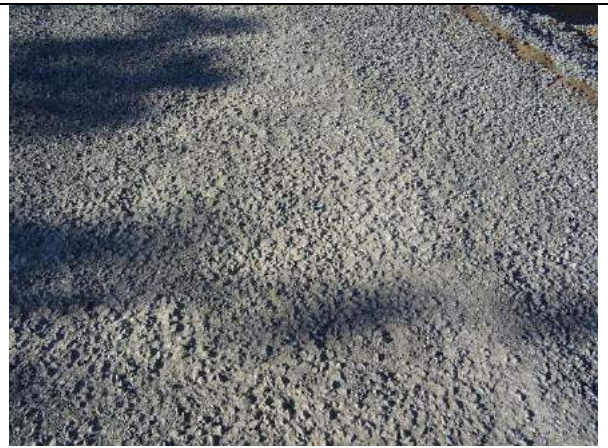
- The contractor's bitumen distributor is old and causes a lot of problems during the spraying of bitumen resulting in:
 - Uneven application rate (calibration and "bakkie test" not carried out)

Figure 9: Uneven surface due to irregular bitumen spray rate

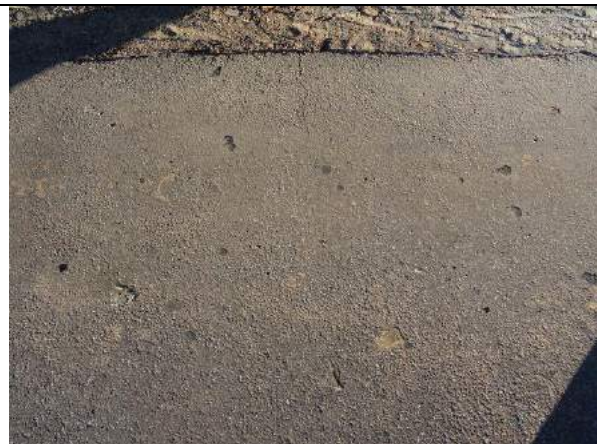
Several small defects were observed that need to be rectified. It was also observed that the shoulders on some sections had not been sufficiently compacted resulting in longitudinal cracks about 0.5 m from the edge and transverse cracks from the edge to about 0.5 m from the edge. One short section also had a deep wheel track on it close to the edge further confirming the inadequate compaction of the shoulders.

Figure 10: Small defects in CMA

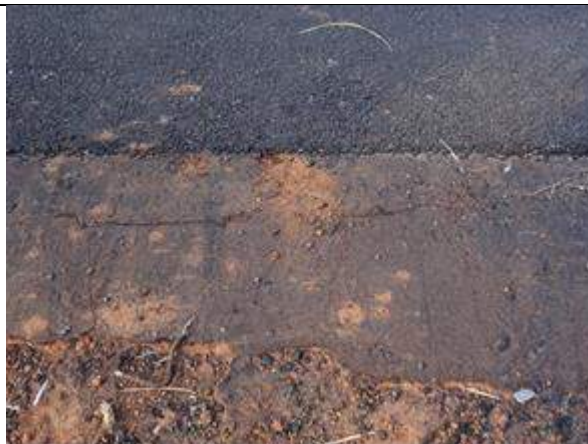
It was noted that after the training, the construction teams resorted to construction in two wide strips on each half instead of three strips of about 1 m width each as they had been taught. Going wider than 1.2 m makes the spreading and screeding more difficult and may result in a substandard surfacing (uneven thickness, segregation of aggregates etc.).

Figure 11: Edge of CMA too thin

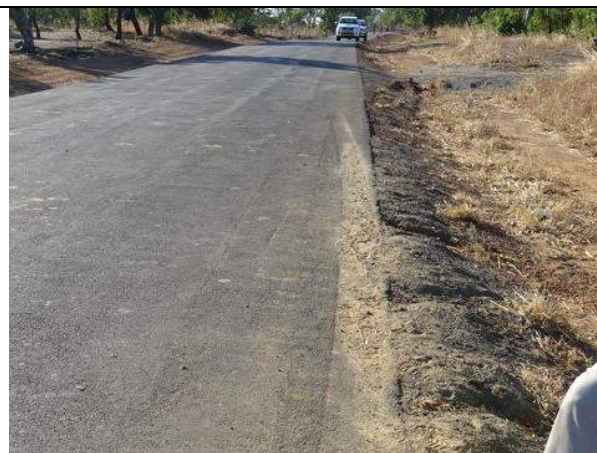
Figure 12: Wheel track on loose shoulder

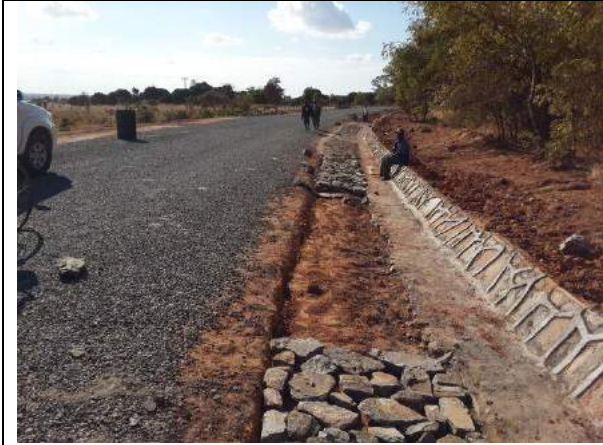
Long sections of lined drains are being constructed. However, the drain cross section is not consistent, sometimes with a relatively flat in-slope which will encourage vehicles to drive onto it and sometimes with steep in-slopes and backslopes, for no apparent reason.

The drain lining is also not following the line of the road, sometimes the edge of the lining is at or close to the edge of the surfacing, other times there's a wide gap. This makes for a very untidy appearance. The gap will have to be covered, probably with concrete, to prevent ingress of water and erosion.

Figure 14: Gap between drain lining and surfacing.
Wide, shallow drain

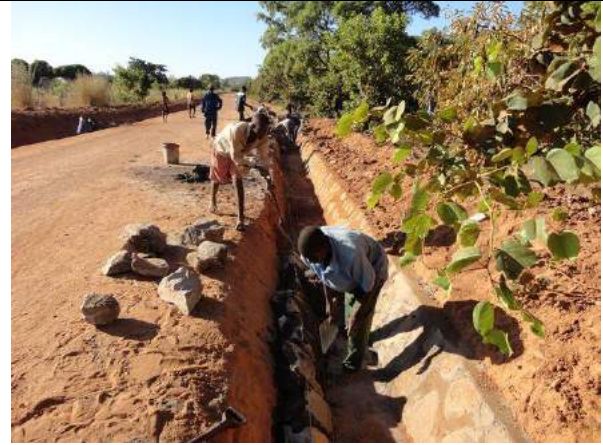
Figure 15: Narrow drain with steep sides
