Training-of-Trainers Programme for participants from Ghana, Sierra Leone and Liberia in the use of the DCP-DN Pavement Design Method

Construction Report 2

AFCAP Project Reference: GHA2100A

March 2018

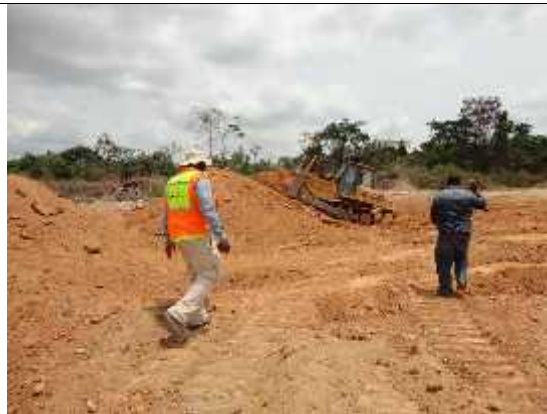
On the AfCAP Consultants' arrival in Koforidua on 5 March, the borrow pit was badly organised and had only a small stockpile of material which were to be used on another section of the road.

Figure 6: Stockpiling in process

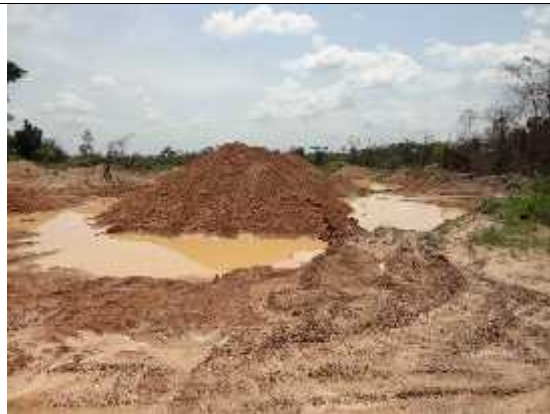
The Site Activities were severely hampered by constant delays due to, among other things, lack of fuel for the construction plant. Frequent rain showers also complicated the works with flooding of the borrow pit and soaking of the base material.

Figure 7: Flooding of the borrow pit

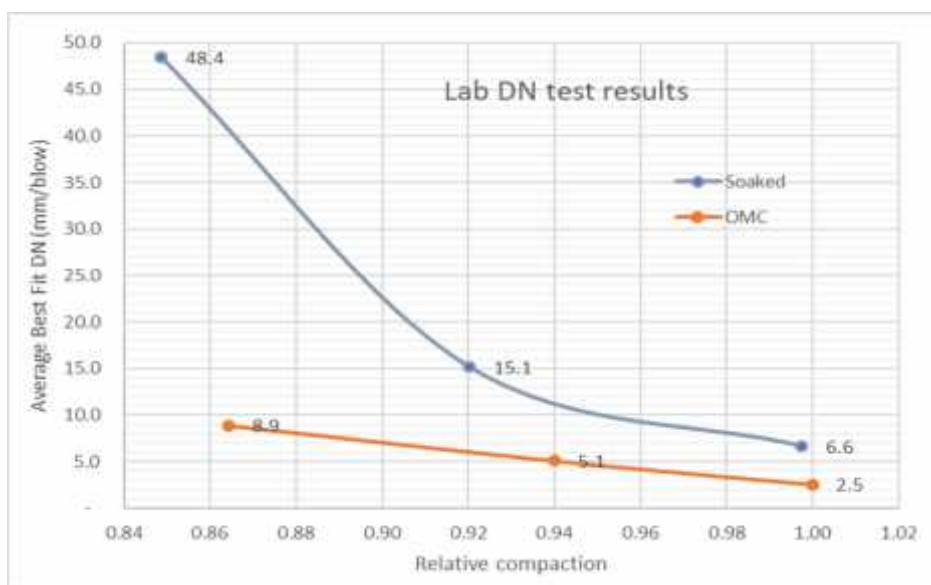
Figure 8: Lab DN test results

The Lab DN test results are close to the results obtained from testing carried out on material from the same borrow pit in April 2017 and are deemed to give a good representation of the strength of the material. The borrow pit material is thus deemed to satisfy the requirement for TLC 0.3 with DN ≤ 3.2 mm/blow.

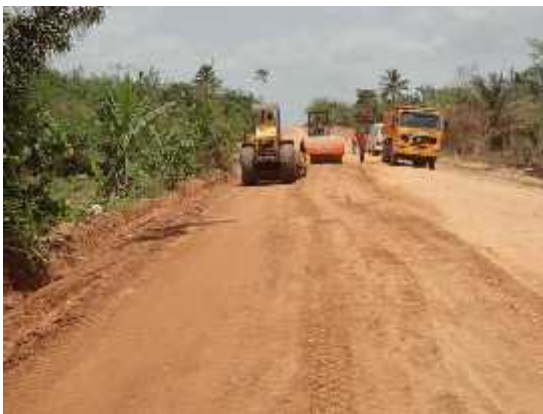
Figure 12: Correcting the camber to +/- 3%

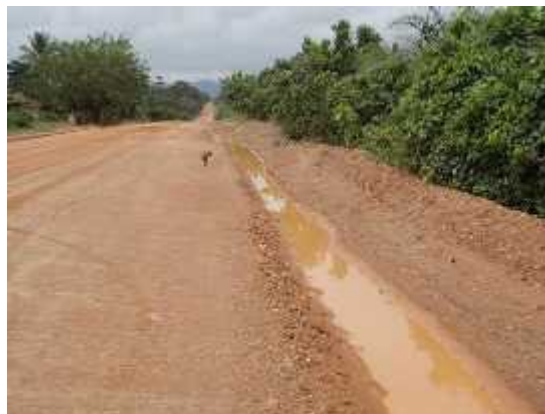
Figure 13: Windrows on backslope to be removed

- Ensure proper drainage by:
 - removal of windrows outside the drains,
 - provision of sheet drainage on the embankment (no side drains needed),
 - replacement of the access culvert at km 8+700 RHS,

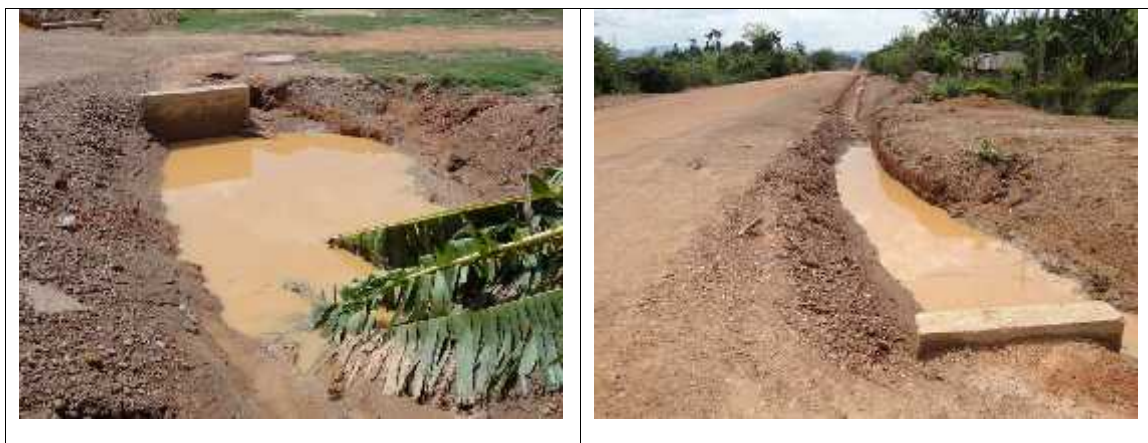
Construction of five concrete box culverts at property accesses are complete. However, the invert level of one access culvert at approx. km 8+700 RHS is too low and prevents draining out standing water in the side drain. It must be demolished and replaced, either by a new culvert or a concrete dish drain, which will be cheaper to construct and easier to maintain.

Figure 14: Access culvert at km 8+700 LHS must be replaced with new culvert or dish drain at correct invert level

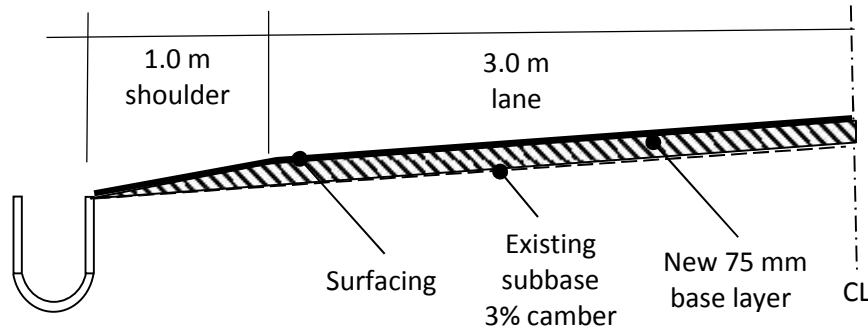
On the first approximately 100m of the Trial Section, the new pavement must be constructed to tie in with the top of the concrete U-drains on the left-hand side over that section. The existing subbase already has +/- 3% camber from the centre line to the top of the U-drain. A full 150 mm base layer would therefore make the tie-in over the width of the 1.0 m wide shoulder too steep and awkward for pedestrians and bicyclists using the shoulder. It is therefore proposed to reduce the pavement thickness over this section and only augment the existing subbase with 75 mm of new base material as illustrated in Figure 15.

Figure 15: Reduced base layer on concrete U-drain section km 8+400 - 8+500

- Other issues:
 - On section 9+200 to 9+400 both subbase and base shall be constructed as a transition to the Control Section;
 - On the section 8+400 to approximately 8+500 along the LHS concrete U-drain, a thinner base of 75 mm is recommended to facilitate a tie-in with the top of the U-drain;
