**PERFORMANCE MONITORING
OF
THE NEC-ADB PACKAGE I
TRIAL AND GRAVEL ROADS**

SEACAP 17.02

**FINAL REPORT
JUNE 2009**

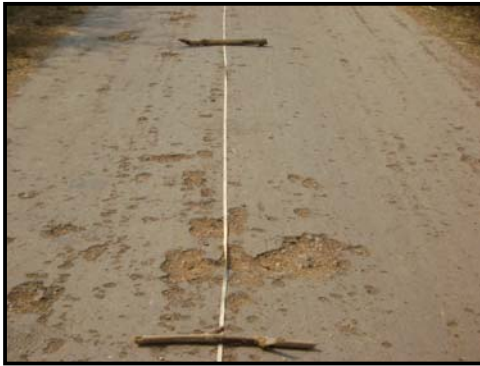
1. The principal deterioration mode in the Otta seals is minor widespread rutting (<20mm).
2. There was some evident localised damage to the surface of the Otta seals. It is not clear however whether this is construction defect. Figure 4.1
3. The significant decrease in roughness for the Otta Seals can be logically accounted for by the “bedding –in” of the sealing aggregate with use. Some of the aggregate appeared significantly oversize which also enhance initial roughness.
4. The principal deterioration on the sand seal sections is the occurrence of shallow potholes associated with localise stripping of the seal (CDI 40-50%). Figure 4.2
5. Secondary deterioration forms are minor rutting (CDI<10%) and seal cracking (CDI<30%).
6. The defects for this group are a consequence of surface deterioration rather than structural problems.

Figure 4.1 Seal erosion and shallow potholes. Road 1032.01

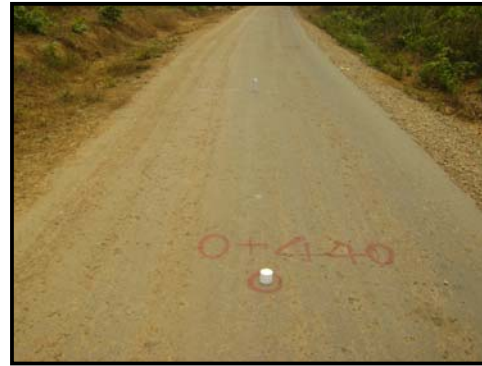
Figure 4.1 Defects in Otta Seal – possibly construction related

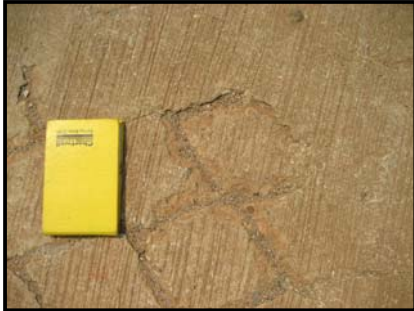
1. These options were in generally good condition and the high DEI figure is largely a reflection of the widespread deterioration of the thin surface screed. It is likely that in future analyses the importance of this factor will be down-graded.
2. There is some possible evidence of deterioration at the concrete-membrane joints (DCI 20-30%). It is unclear yet whether this is significant issue or not. Figure 4.5
3. There was no evidence of structural cracking through cells. Figure 4.6

Figure 4.5 Erosion adjacent to cell boundaries

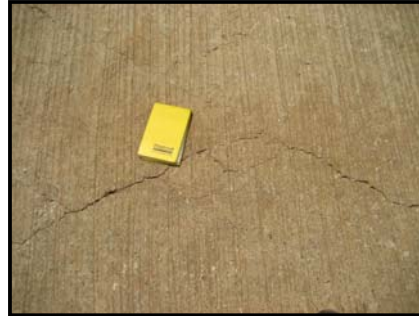
Figure 4.6 Cracks in surface screed following cell boundaries

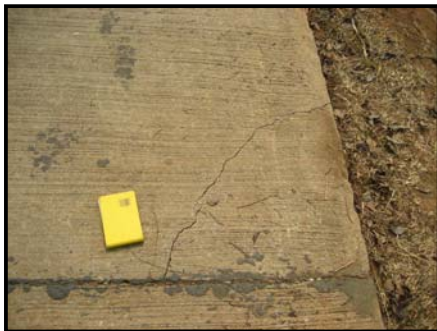
1. The pavement blocks are performing satisfactorily with only isolated cracks – typically at the edge of blocks. Experience from elsewhere indicates that erosion or soaking of the gravel sub-base can sometimes lead to cracking under load. Figure 4.8
2. The inter-block seal condition is shown separately as a significant deterioration factor that should be dealt with easily by routine maintenance.

Figure 4.8 Typical corner edge crack in concrete slab

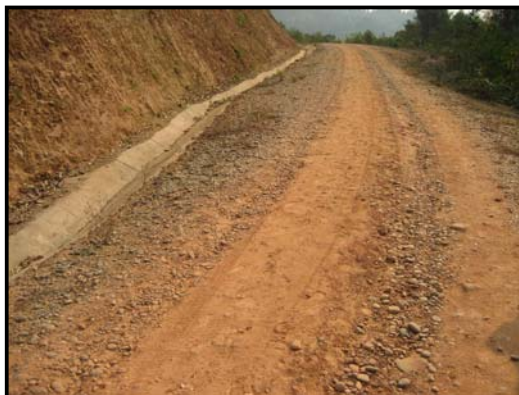
1. On the assumption that the roads were constructed to the specified 6-7% camber, then after just under 2 years all road sections are now below the required shape requirements.
2. On high gradients 30% of the NEC roads are significantly below shape, Figure 5.3
3. 75% of the non-NEC road sites were recorded as having a cross sectional shape incapable of effectively shedding surface water. The implication is that there is no effective maintenance procedure in place to maintain shape

Figure 5.3 Eroded gravel on steep section of NEC package II road 201. Shape prevents run-off into well constructed drain
