Development of Guidelines and Specifications for Low Volume Sealed Roads through Back Analysis

Phase 3 Fieldwork Report

ReCAP Reference Number: RAF2069A

September 2019

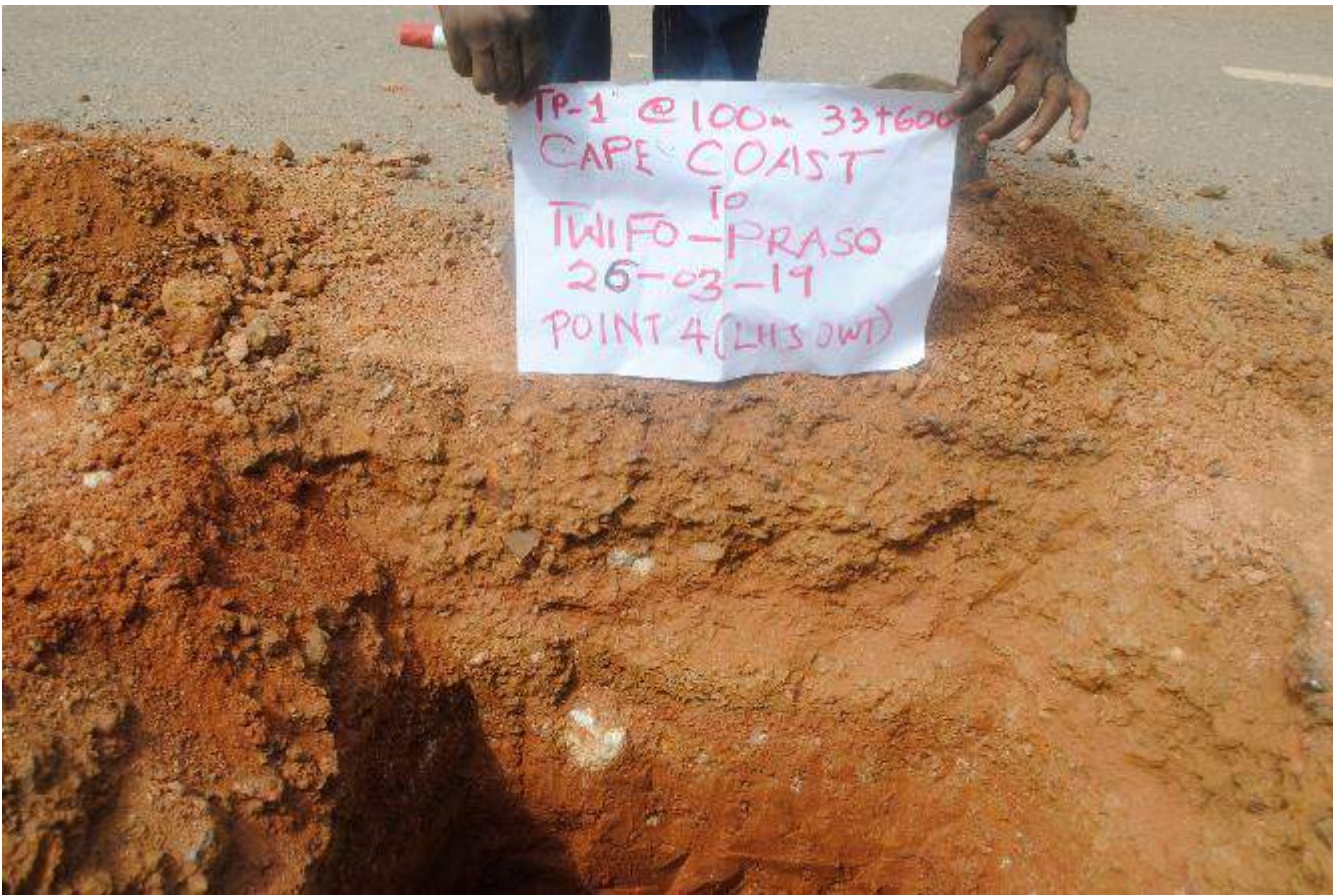
Figure 1 Test Pit 1 Section 1 Cape Coast – Twifo Praso

TEST PIT LOGGING FORM					
Project Title:	ReCAP Back Analysis Project			Survey Number:	TP-1
Province:	Central		Road Name:	Cape Coast - Twifo Praso	
Section:	Fair (33+500 - 33+850)		Date:	26/03/2019	
Length (m):	350		Chainage	33+600	Test Position: 4 (OWT)
Lane:	1 LHS (Cape Coast bound)		Surveyors:	LM, EB, JM, EA	
Surface Condition at point of test:			Ravelled		
Layer	Depth Reading (mm)	Thickness (mm)	Layer/Material Description/Defect	Sampled for:	
Surfacing	Top	0	Bituminous seal	Binder extraction, aggregate testing	
	Bottom	19			
Base	Top	19	Brown gravelly material	Full characterisation	
	Bottom	149			
Sub-base	Top	149	Reddish clayey gravel	Full characterisation	
	Bottom	259			
Capping	Top	259	Brown gravelly material	Not sampled	
	Bottom	279			
Subgrade	Top	279	Reddish brown clayey silt	Full characterisation	
	Bottom	1019			
Total Thickness		1019			
Other Notes:

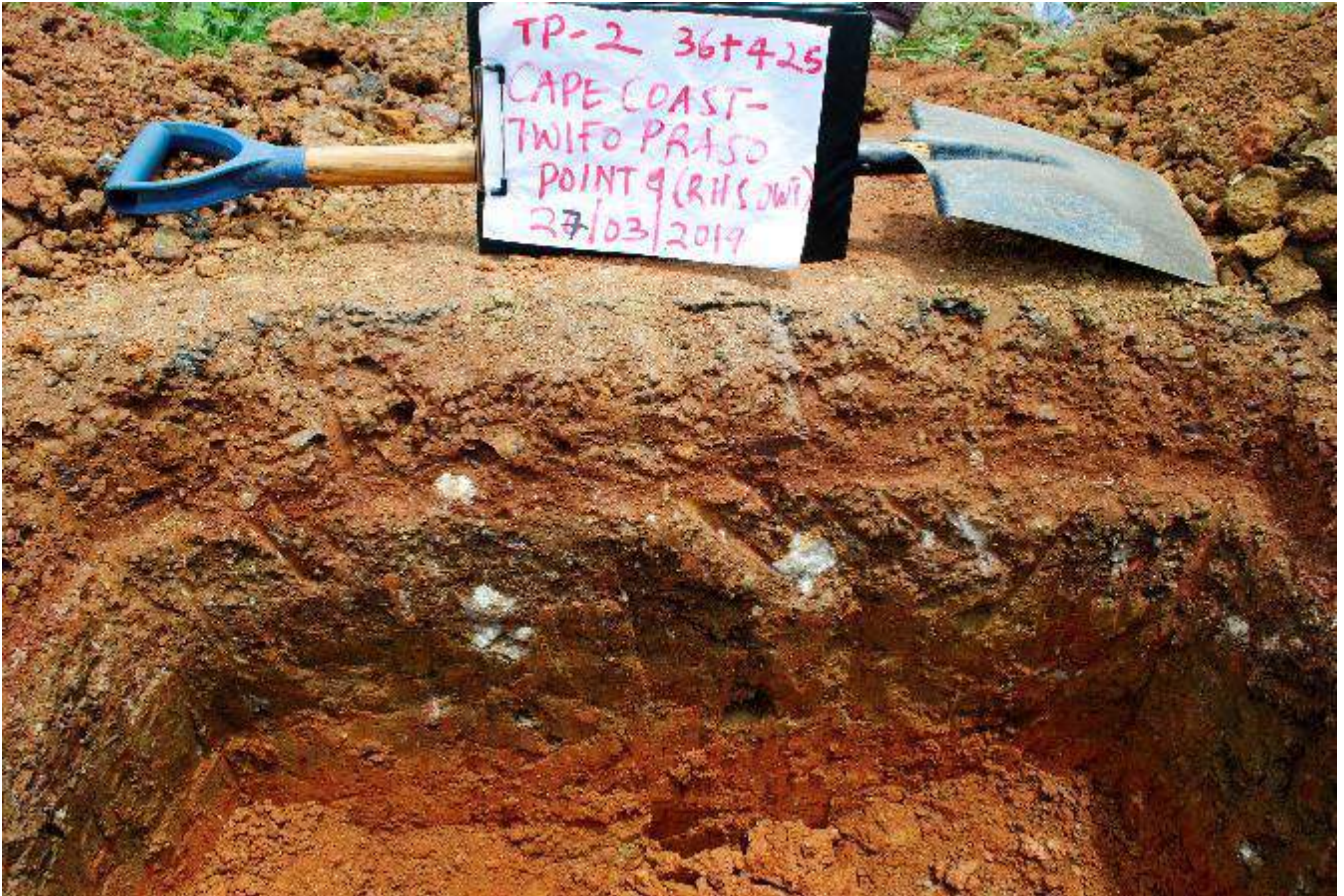
Figure 2 Test Pit 2 Cape Coast Twifo - Praso

TEST PIT LOGGING FORM					
Project Title:	ReCAP Back Analysis Project			Survey Number:	TP-2
Province:	Central		Road Name:	Cape Coast - Twifo Praso	
Section:	Fair (36+300 - 36+475)		Date:	27/03/2019	
Length (m):	175		Chainage	36+425	Test Position: 9 (OWT)
Lane:	2 RHS (Twifo Praso bound)		Surveyors:	LM, EB, JM, EA	
Surface Condition at point of test:			Crocodile cracks of medium intensity; longitudinal crack		
Layer	Depth Reading (mm)	Thickness (mm)	Layer/Material Description/Defect	Sampled for:	
Surfacing	Top	0	Bituminous seal	Binder extraction, aggregate testing	
	Bottom	20			
Base	Top	20	Brown gravel	Full characterisation	
	Bottom	120			
Intermediate	Top	120	Reddish brown silty material	Full characterisation	
	Bottom	140			
Sub-base	Top	140	Brown clayey gravel	Full characterisation	
	Bottom	480			
Subgrade	Top	480	Reddish brown clayey silt	Full characterisation	
	Bottom	740			
Total Thickness		740			
<p>Other Notes: It appears that the lower pavement layers have higher moisture content. 2 sub-base layers (with a split of 140 mm and 200 mm totalling up to the 340 mm represented in the test pit log above) were encountered. Although the materials composition of both layers was the same, the two layers appeared different due to the difference in moisture content. They will be dried separately to ascertain the similarity in material. For the sake of this logging, they have been represented as one layer</p>

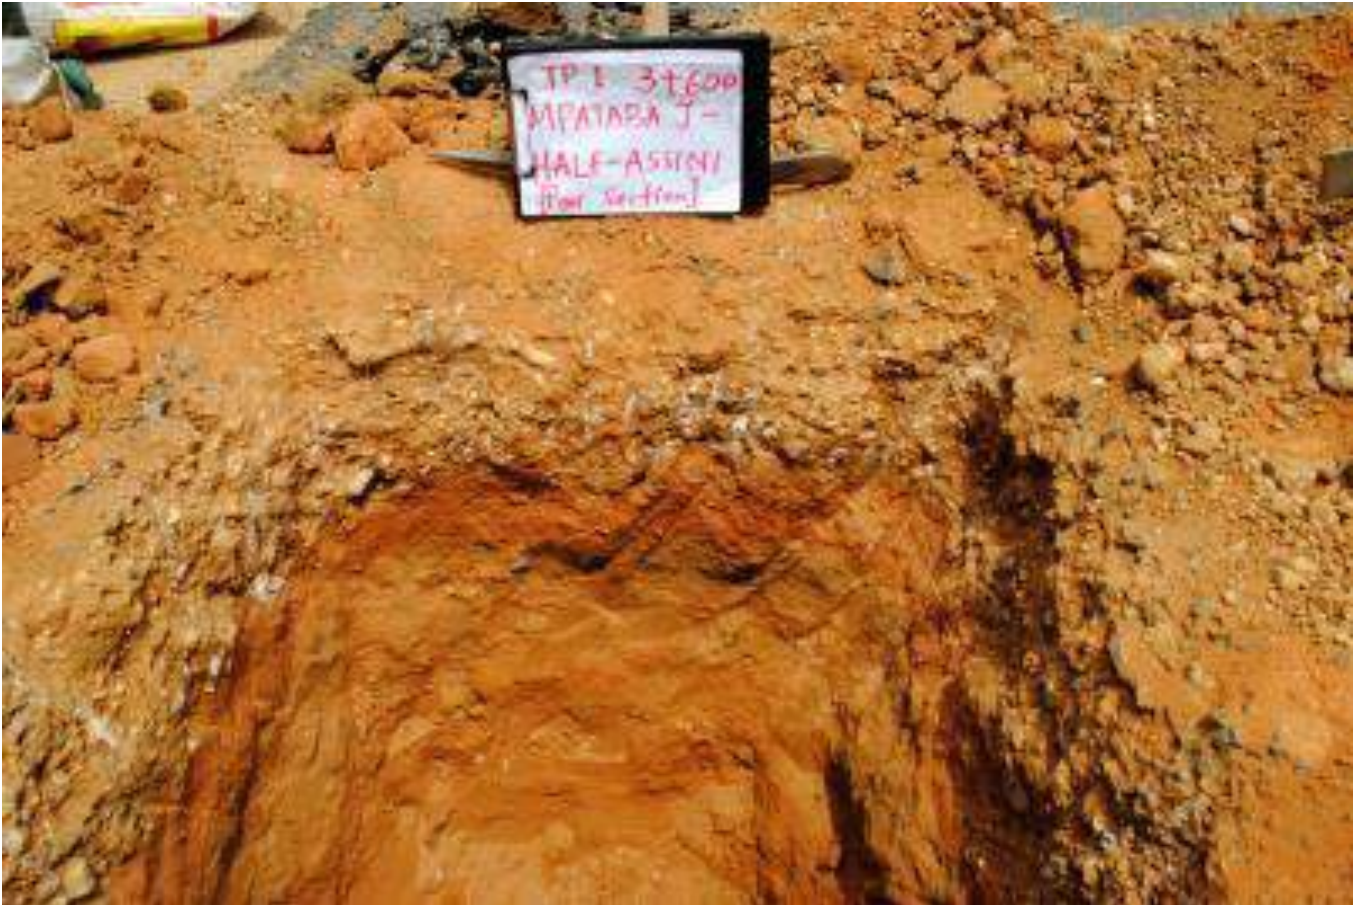
Figure 3 Test Pit on Section 1 Mpataba Junction – Half Assini

One test pit was excavated on each of the study sections. The logs are shown in Table 11 and Table 12 and photographs of the pits are shown in Figure 3 and Figure 4. It is noted that the materials are generally silty and clayey even in the good section and yet the road has performed satisfactorily for several years. Conversely, the poor section, despite having a thick layer of crushed stone material, has performed poorly with several potholes and patching as indicated in Table 11.

TEST PIT LOGGING FORM					
Project Title:	ReCAP Back Analysis Project			Survey Number:	1
Province:	Western		Road Name:	Mpataba Junction - Half Assini	
Section:	Poor section (3+500 - 3+800)		Date:	21/03/2019	
Length (m):	300		Chainage	3+600	Test Position: 8
Lane:	RHS (OWT)		Surveyors:	LM	
Surface Condition at point of test:			Heavily ravelled, crocodile cracks, distinct depression (almost a sign of break-away) from the rest of the pavement		
Layer	Depth Reading (mm)		Thickness (mm)	Layer/Material Description/Defect	Sampled for:
Surfacing	Top	0	19	Bituminous seal, defective	Binder extraction, aggregate testing
	Bottom	19			
Base	Top	19	300	Gravelly with crushed stone material	Full Characterisation
	Bottom	319			
Sub-base	Top	319	100	Reddish brown silty material	Full Characterisation
	Bottom	419			
Sub-base	Top	419	180	Dark brown clayey silt material	Full Characterisation
	Bottom	599			
Subgrade	Top	599	280	Reddish brown silty material	Subgrade Characterisation

Bottom	879			
Total Thickness			879		
Other Notes: Material just below the surfacing wet, sign of water ingress from the surfacing

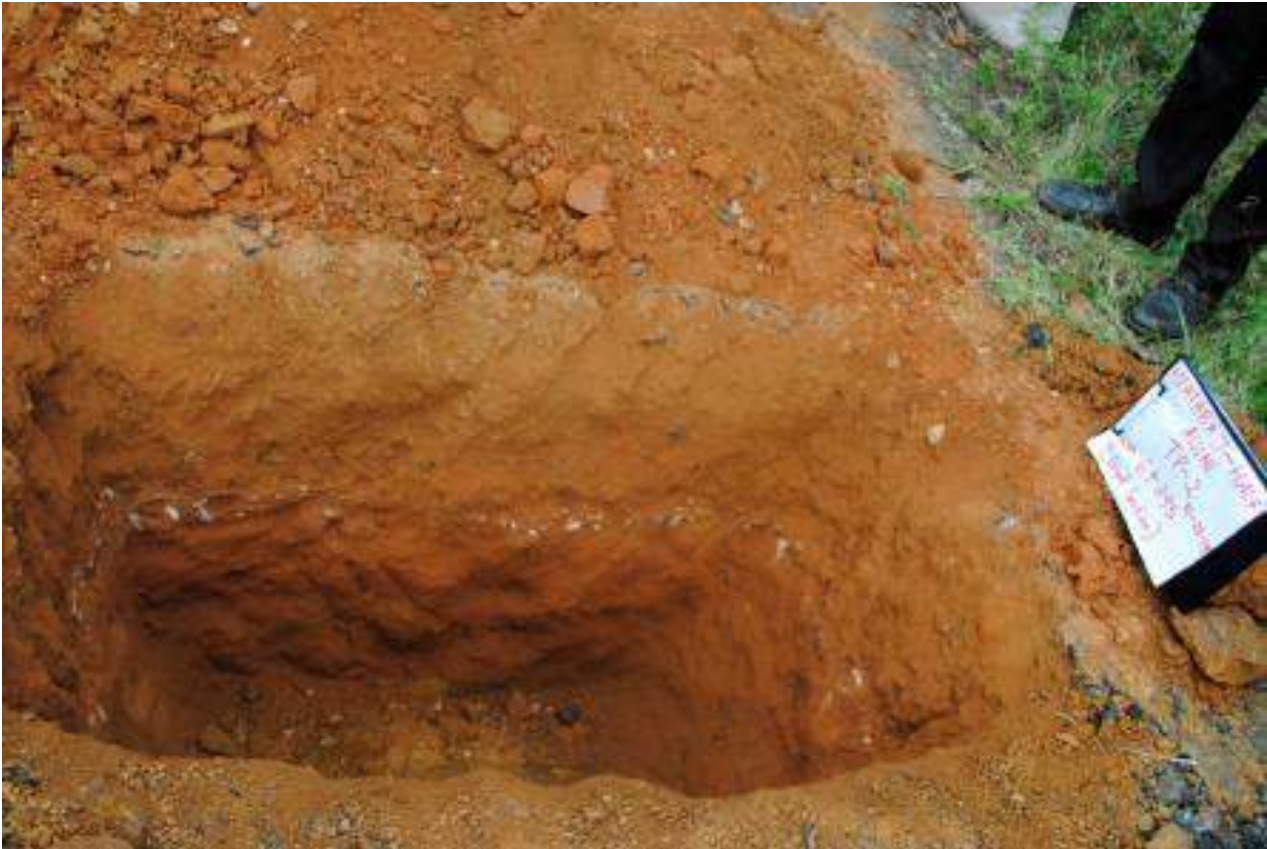
Figure 4 Test Pit on Section 2 Mpataba Junction – Half Assini

Project Title:	ReCAP Back Analysis Project		Survey Number:	2		
Province:	Western		Road Name:	Mpataba Junction - Half Assini		
Section:	Poor section (6+200 - 6+600)		Date:	21/03/2019		
Length (m):	400		Chainage	6+395	Test Position:	6
Lane:	LHS (OWT)		Surveyors:	LM		
Surface Condition at point of test:			Ravelling			
Layer	Depth Reading (mm)	Thickness (mm)	Layer/Material Description/Defect		Sampled for:	
Surfacing	Top	0	19	Bituminous seal	Binder extraction, aggregate testing	
	Bottom	19				
Base	Top	19	400	Brown natural gravel	Full Characterisation	
	Bottom	419				
Intermediate	Top	419	50	Gravelly stoney layer	Not sampled	
	Bottom	469				
Sub-base	Top	469	470	Reddish brown silty material	Full Characterisation	
	Bottom	939				
Subgrade	Top	939	70	Yellowish brown clayey gravel	Not sampled	
	Bottom	1009				
Total Thickness		1009				
Other Notes: 50 mm stoney layer between base and sub-base

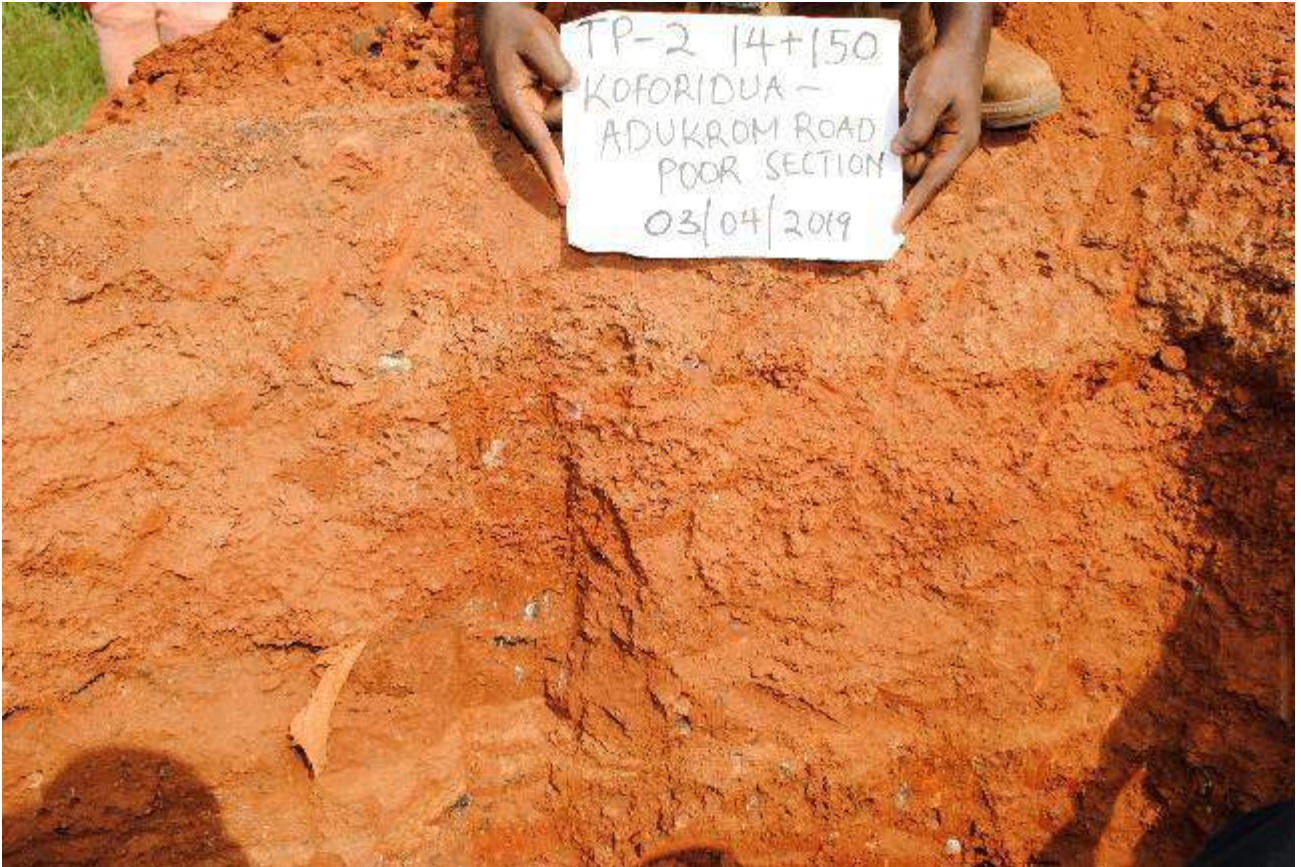
Figure 5 Test Pit on Section 1 Koforidua - Adukrom

TEST PIT LOGGING FORM					
Project Title:	ReCAP Back Analysis Project			Survey Number:	TP-2
Province:	Eastern		Road Name:	Koforidua - Adukrom	
Section:	Poor (14+100 - 14+200)		Date:	03/04/2019	
Length (m):	100		Chainage:	14+150	Test Position: LHS OWT
Lane:	1 LHS (Koforidua bound)		Surveyors:	LM, EB, JM, EA	
Surface Condition at point of test:			Crocodile cracking of medium intensity		
Layer	Depth Reading (mm)	Thickness (mm)	Layer/Material Description/Defect	Sampled for:	
Surfacing	Top	0	Bituminous surfacing	Binder extraction, aggregate testing	
	Bottom	20			
Base	Top	20	Brown gravel	Full characterisation	
	Bottom	215			
Sub-base	Top	215	Reddish brown gravel	Full characterisation	
	Bottom	415			
Subgrade-1	Top	415	Reddish brown clayey gravel	Full characterisation	
	Bottom	515			
Subgrade-2	Top	515	Reddish brown gravel with fragments of bitumen	Full characterisation	
	Bottom	745			
Total Thickness		745			
Other Notes: Old bituminous pavement encountered beneath the subgrade

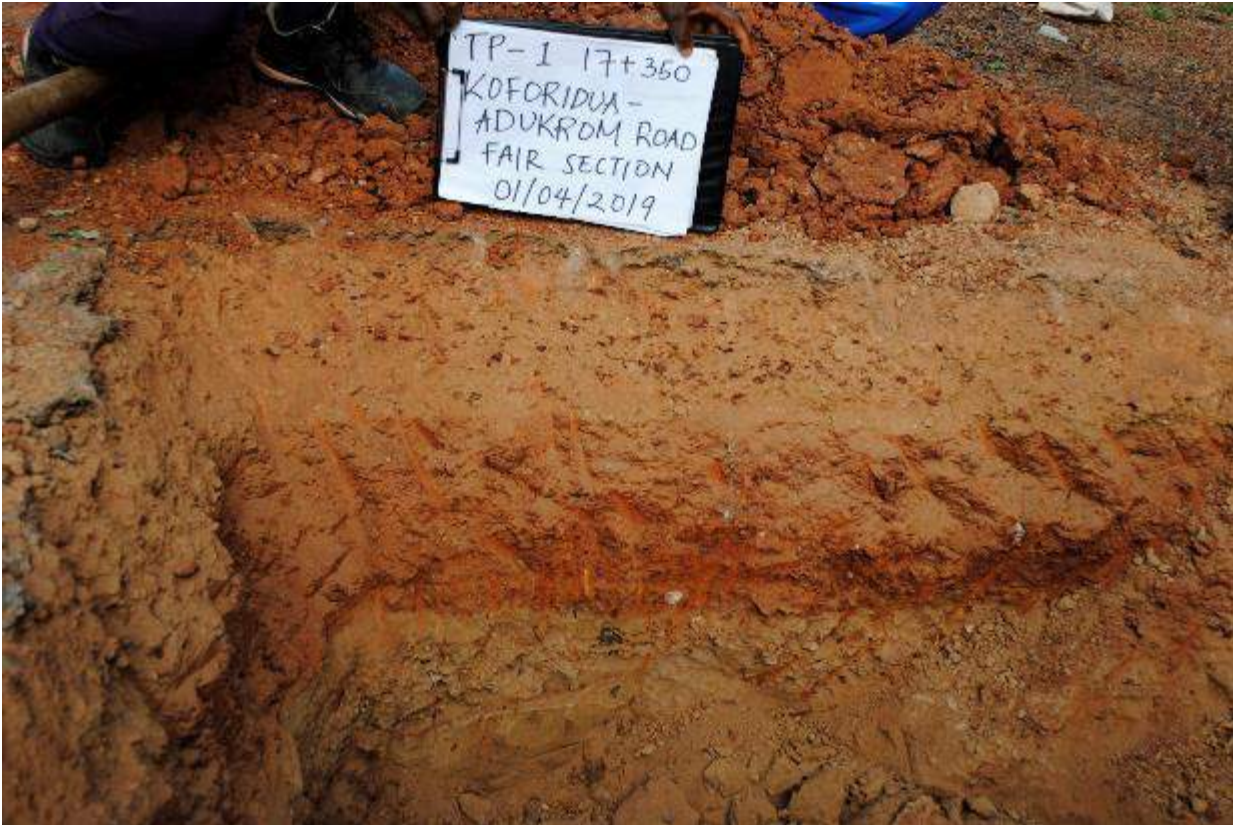
Figure 6 Test Pit on Section 2 Koforidua - Adukrom

TEST PIT LOGGING FORM						
Project Title:	ReCAP Back Analysis Project			Survey Number:	TP-1	
Province:	Eastern		Road Name:	Koforidua - Adukrom		
Section:	Fair (17+300 - 17+550)		Date:	02/04/2019		
Length (m):	250		Chainage	17+350	Test Position:	6 (OWT)
Lane:	2 RHS (Adukrom bound)		Surveyors:	LM, EB, JM, EA		
Surface Condition at point of test:			Good			
Layer	Depth Reading (mm)	Thickness (mm)	Layer/Material Description/Defect		Sampled for:	
Surfacing	Top	0	35	Bituminous surfacing	Binder extraction, aggregate testing	
	Bottom	35				
Base	Top	35	200	Brown gravel	Full characterisation	
	Bottom	235				
Sub-base	Top	235	250	Reddish brown clayey gravel	Full characterisation	
	Bottom	485				
Subgrade-1	Top	485	150	Brown silty gravel	Full characterisation	
	Bottom	635				
Subgrade-2	Top	635	180	Brown silt	Full characterisation	
	Bottom	815				
Total Thickness		815				
Other Notes: Old pavement exists at the bottom of the test pit as evidenced from the bituminous material encountered

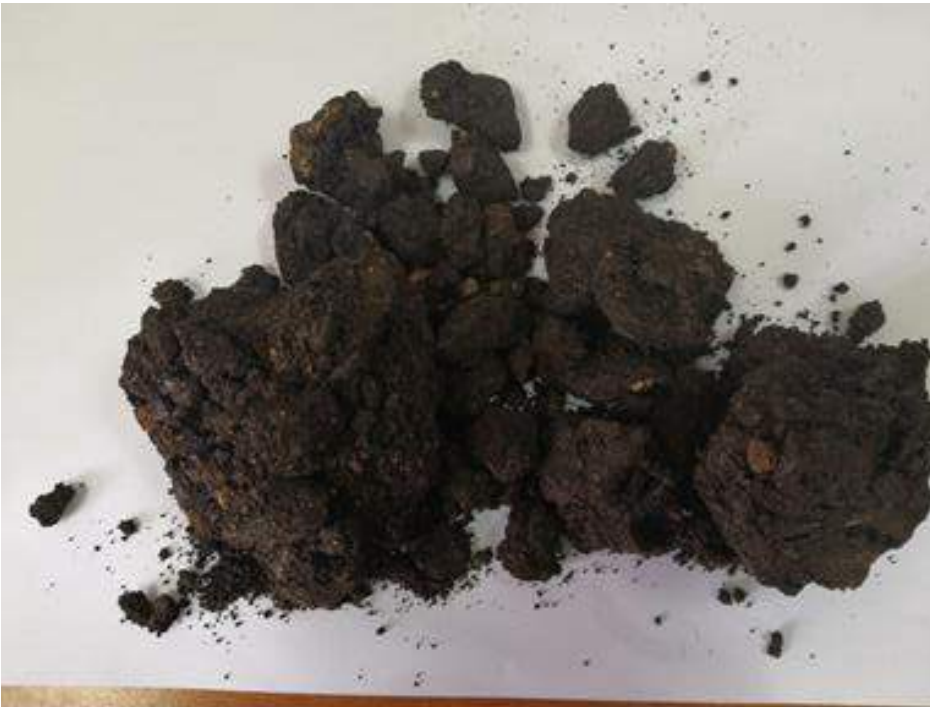
Subbase	Top		280	Ryolite gravel, brown in clour with angular aggregate. Most likely extracted using hard excavation methods or it could be crusher-run. There is high content of very coarse aggregate and boulders	Grading, Mod. Proctor (MDD, OMC), field moisture, field density, soaked CBR, swell, triaxial, etc. (some of these tests may not be possible due to the high content of boulders)
	Bottom				
Subgrade	Top			Fine black plastic soils, typical of black cotton soil. High in-situ moisture and it is untreated.	Grading, Mod. Proctor (MDD, OMC), field moisture, field density, CBR (soaked, at OMC and 0.75OMC), swell, triaxial, etc. (some of these tests may not be possible due to the high content of boulders)
	Bottom				
	Top				
	Bottom				
Total Thickness					
Other Notes: A total of depth of 600mm was excavated.

Figure 7 Clayey subgrade (possibly black-cotton soil) observed on Boane – Namaacha Section 1

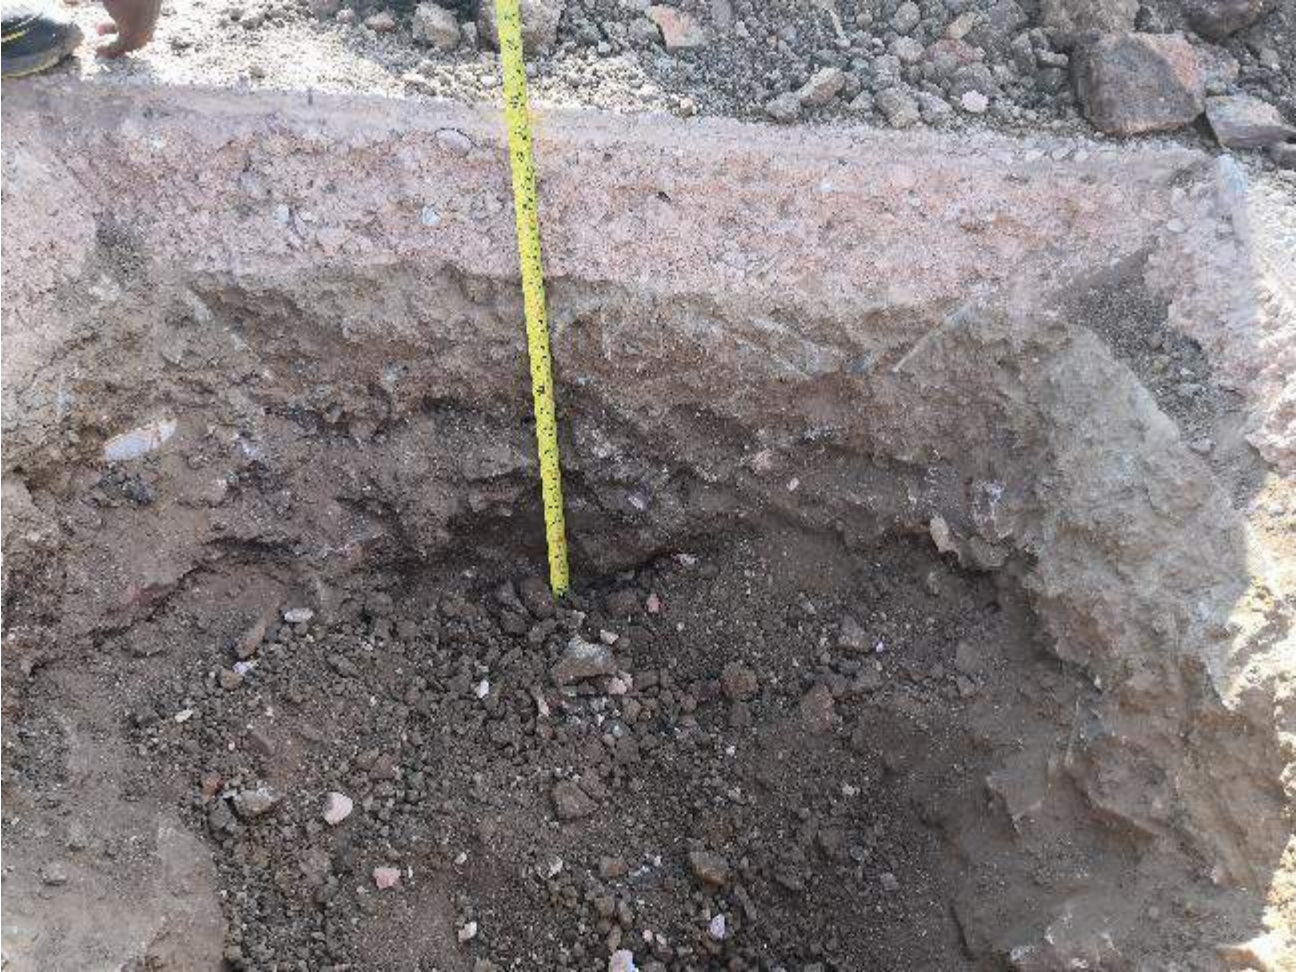
Figure 8 Test pit Section 2 Boane - Namaacha

Bottom				
Subbase	Top		100	Ryolite gravel, brown in colour with angular aggregate. Most likely extracted using hard excavation methods or it could be crusher-run. There is high content of very coarse aggregate and boulders. The subbase is part of the fill.	Grading, Mod. Proctor (MDD, OMC), field moisture, field density, soaked CBR, swell, triaxial, etc. (some of these tests may not be possible due to the high content of boulders)
	Bottom				
Subgrade	Top			The subgrade could not be reached due to the high embankment (> 2 m) but it is black cotton soil	
	Bottom				
	Top				
	Bottom				
Total Thickness					
Other Notes: Fill section with boulders used for fill. Fill could not be penetrated.

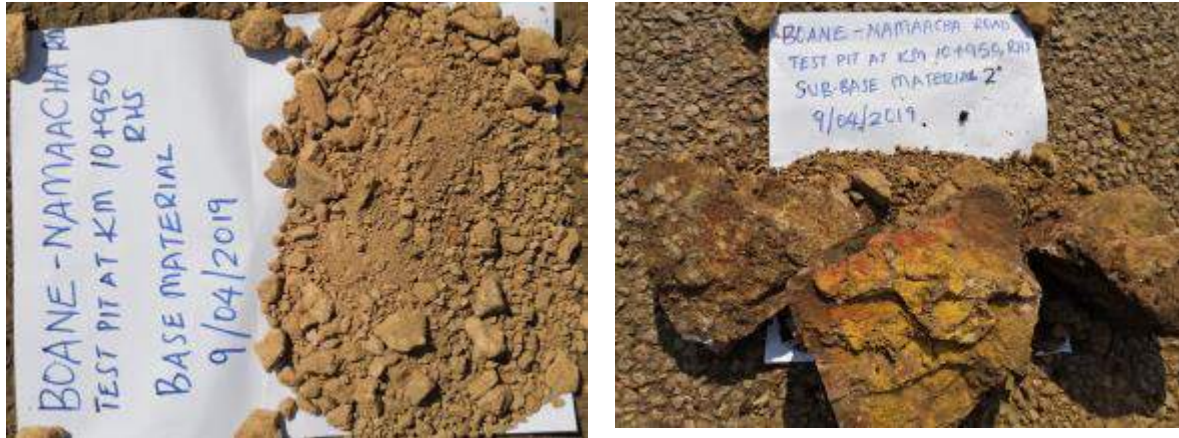
Bottom				
Total Thickness					
Other Notes: Section has 5 pavement layers.

Figure 9 Base course material and cobbles for sub-base observed on Section 3 of Boane – Namaacha road

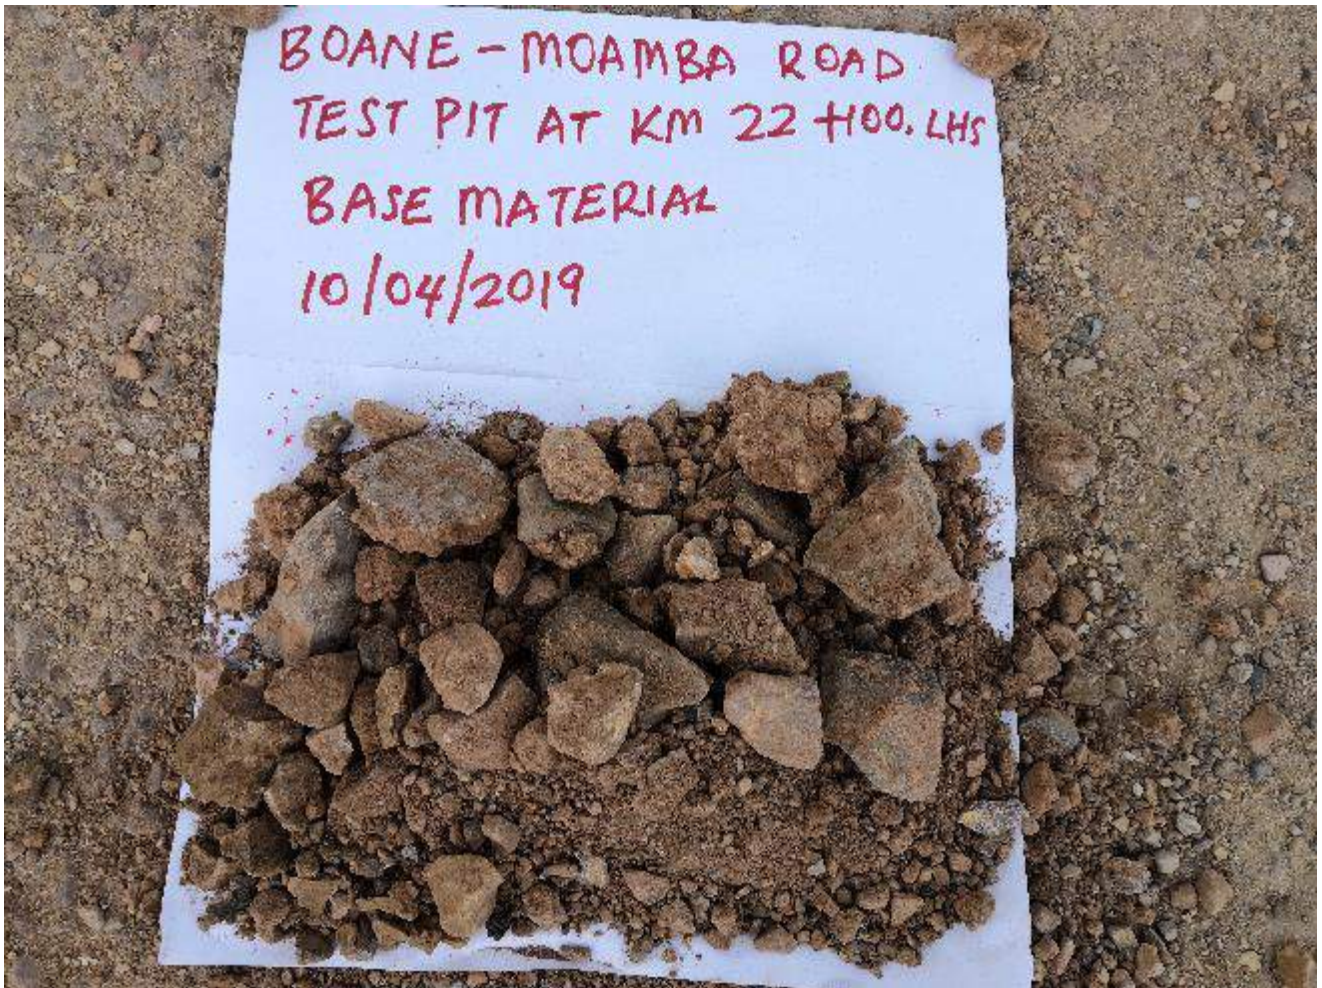
Figure 10 Base Course Boane – Moamba Section 1

Bottom				
Subbase	Top		>200	The subbase was made up of a layer of boulders which could not be excavated using hand tools.	No sample was collected
	Bottom				
Subgrade	Top			Surround subgrade material is poorly graded ryolite with boulders but the subgrade below the pavement could not be reached for sampling because the subbase was too hard to excavate.	No sample was collected
	Bottom				
	Top				
	Bottom				
Total Thickness					
<u>Other Notes:</u>

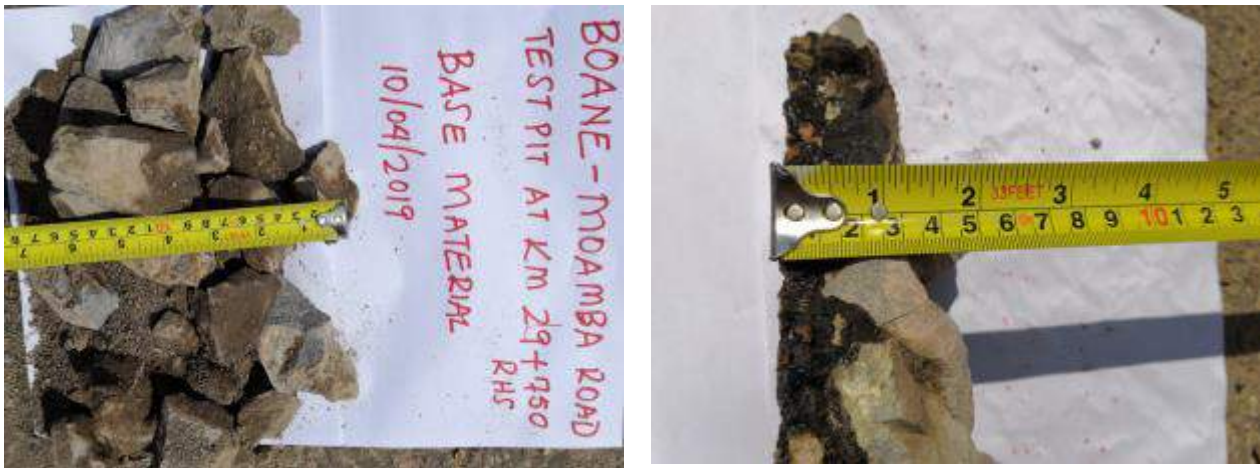
Bottom				
Subbase/Fill	Top			Brown gravel with high content of boulders	Grading, Mod. Proctor (MDD, OMC), field moisture, field density, soaked CBR, swell, triaxial, etc.
	Bottom				
Subgrade	Top			Surround subgrade material is black cotton soil but could not be reached. The Subgrade below the pavement could not be reached for sampling due to the high fill	No sample was collected
	Bottom				
Total Thickness					
<u>Other Notes:</u>

Figure 11 Coarse base materials and a well-bonded surfacing on Section 2 Boane - Moamba

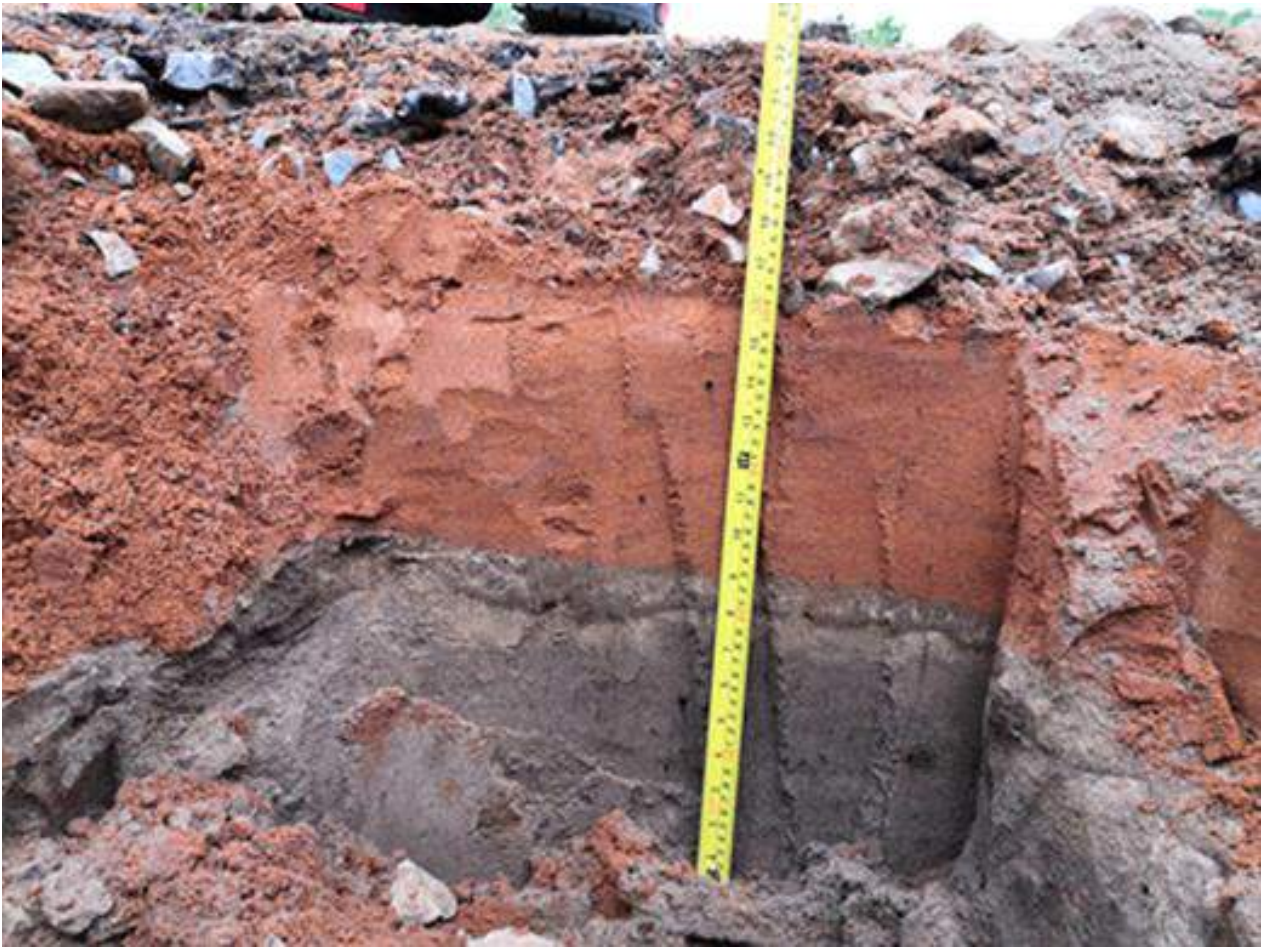
Bottom				
Subgrade	Top			Untreated grey sand	Grading, Mod. Proctor (MDD, OMC), field moisture, field density, CBR (soaked, OMC and 0.75OMC), swell, etc.
	Bottom				
	Top				
	Bottom				
Total Thickness					
<u>Other Notes:</u>

Figure 12 Test pit on Section 1 Macia – Chokwe with probable neat sand sub-base

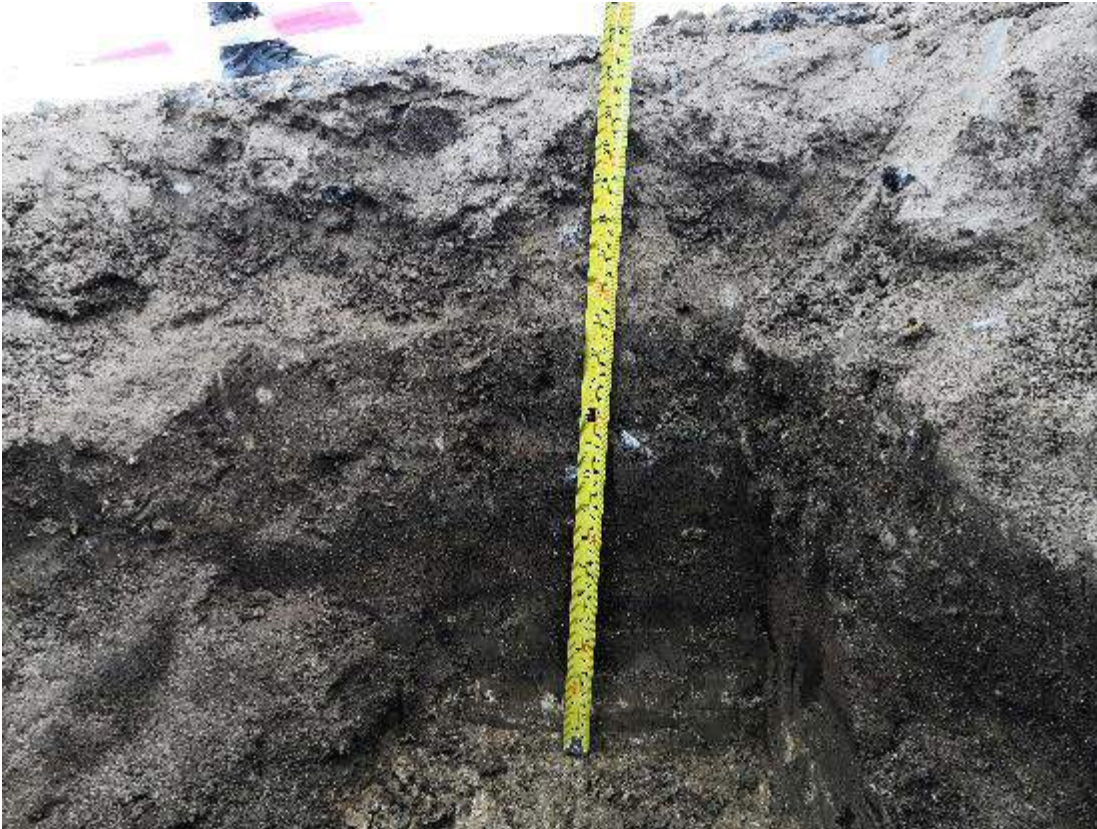
Figure 13 Test Pit on Section 2 Macia - Chokwe

Bottom				
Subgrade	Top			Yellowish, orange grey clay. The clay had high moisture content	Grading, hydrometer test, Mod. Proctor (MDD, OMC), field moisture, field density, CBR (soaked, OMC and 0.75OMC), swell, etc.
	Bottom				
	Top				
	Bottom				
Total Thickness					
<u>Other Notes:</u>

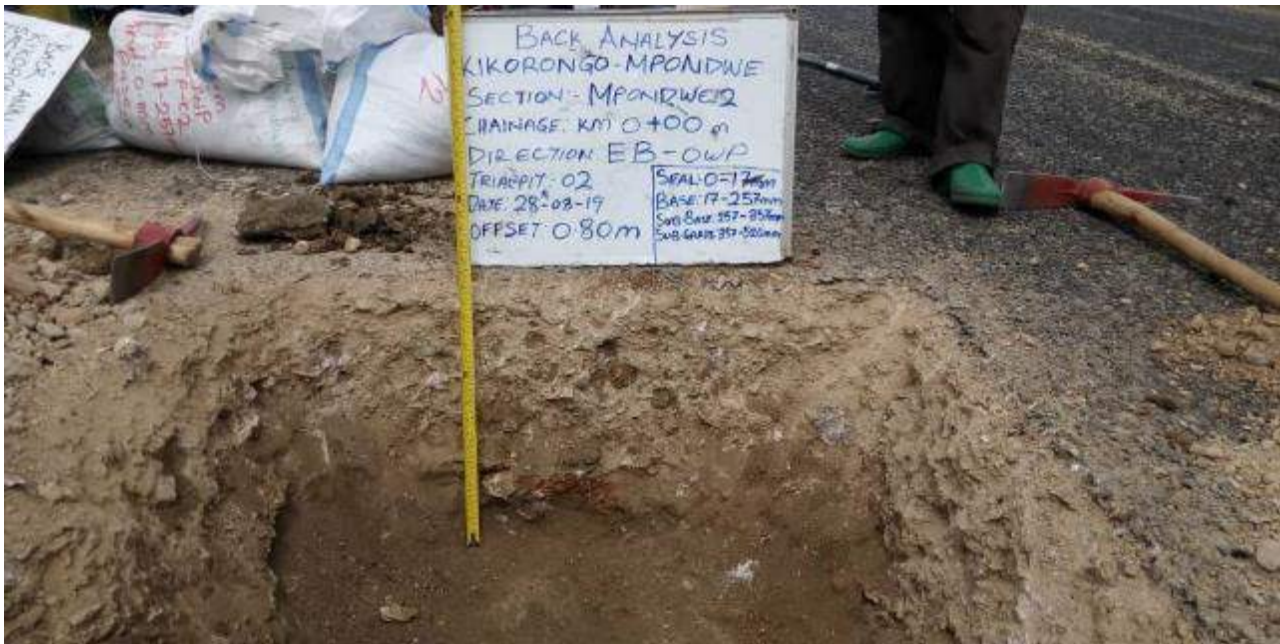
Figure 16 Test pit on Section 2 Kikorongo – Mpondwe

TEST PIT LOGGING FORM					
Project Title:	AFCAP BACK ANALYSIS			Survey Number:	1
Province:	KASESE	Road Name:	KIKORONGO - MPONDWE		
Section:	2	Date:	29/03/2019		
Length (m):	300	Chainage	0+000	Test Position:	OWP
Lane:	WB	Surveyors:	DOMINIC		
Surface Condition at point of test:		No visible defects			
Layer	Depth Reading (mm)		Thickness (mm)	Layer/Material Description/Defect	Sampled for:
Surfacing	Top	0	17	Bituminous surfacing dressing	Bitumen Recovery, PSD
	Bottom	17			
Base	Top	17	240	Slightly moist greyish light brown medium dense intact crushed aggregates CRS of maximum sinze ranging to 50mm) imported base material.	Full Characterisation
	Bottom	257			
Subbase	Top	257	100	slightly reddish grey moist medium dense intact crushed rocks, CRS imported sub base.	Full Characterisation
	Bottom	357			
Subgrade	Top	357	163	Slightly moist light brown medium dense intact silty clays with presence of cobbles in subgrade masterial	Subgrade Characteristation

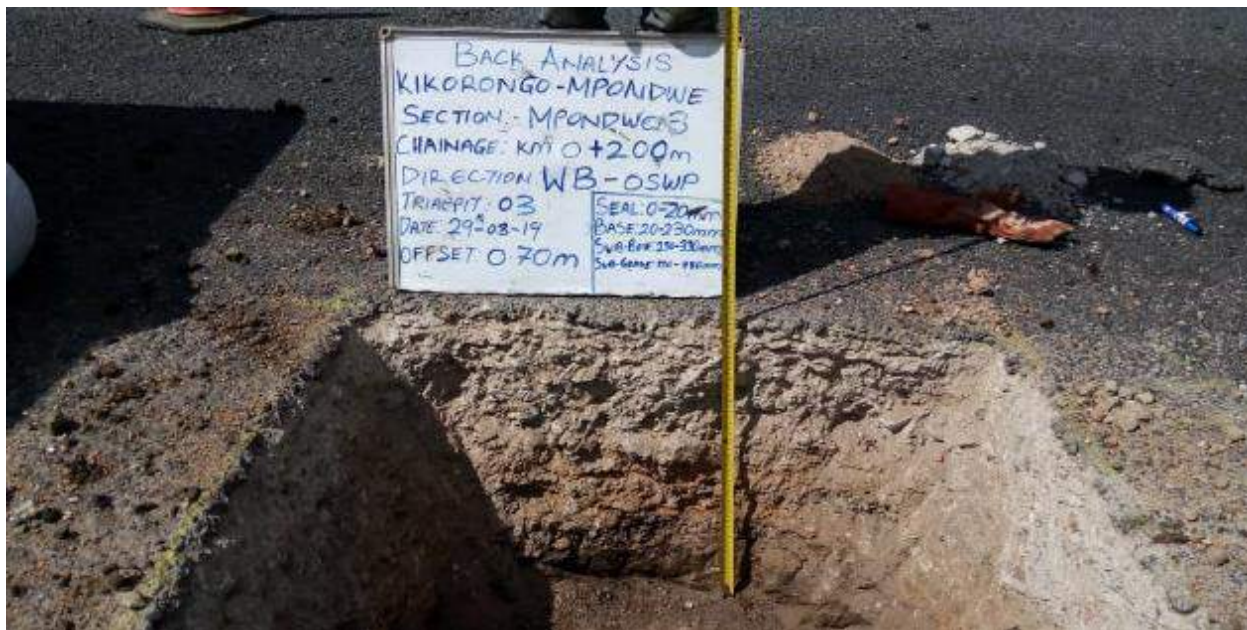
Figure 17 Test pit on Section 3 Kikorongo – Mpondwe

TEST PIT LOGGING FORM					
Project Title:	AFCAP BACK ANALYSIS			Survey Number:	1
Province:	KASESE	Road Name:	KIKORONGO - MPONDWE		
Section:	3	Date:	29/03/2019		
Length (m):		Chainage	0+200	Test Position:	OWP
Lane:	WB	Surveyors:	DOMINIC		
Surface Condition at point of test:		No visible defects			
Layer	Depth Reading (mm)	Thickness (mm)	Layer/Material Description/Defect	Sampled for:	
Surfacing	Top	0	Bituminous surfacing dressing	Bitumen Recovery, PSD	
	Bottom	20			
Base	Top	20	Slightly moist greyish brown dense intact crushed stone with cobbles imported base material	Full Characterisation	
	Bottom	230			
Subbase	Top	230	Slightly moist reddish grey dense intact silty gravel with aggregates of average size, 20mm, and traces of cobbles imported sub-base material.	Full Characterisation	
	Bottom	330			
Subgrade	Top	330	Slightly moist blackish dark brown medium dense silty clays existing sub-grade material, not imported	Subgrade Characterisation

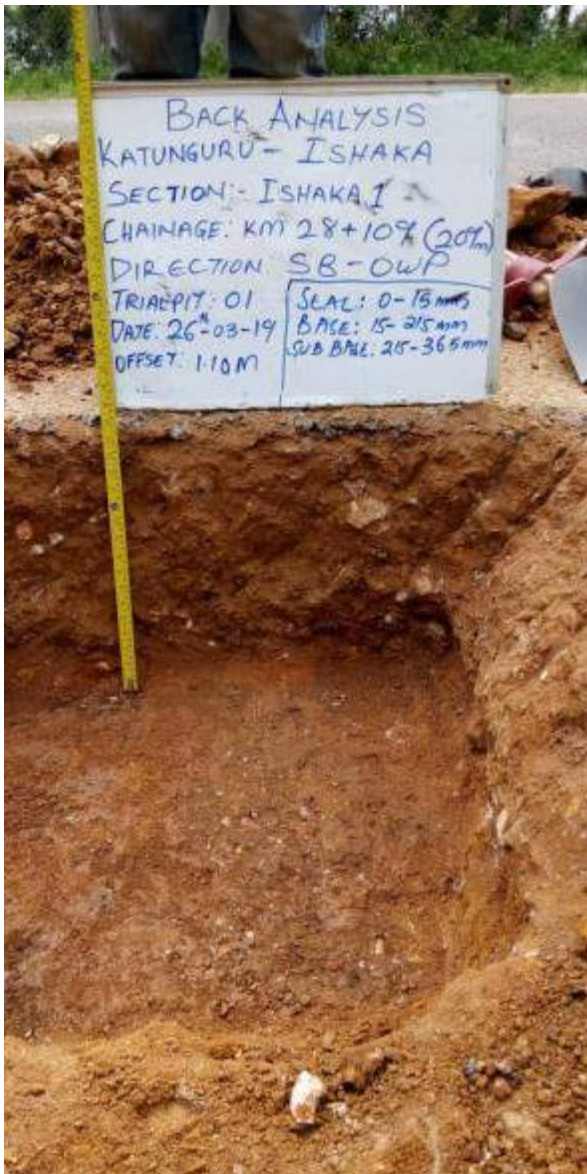
Figure 18 Test Pit on Section 1 Ishaka – Katunguru road

The in-situ average DCP-CBR test results for Section 1 (Table 56) show that the base is of lower strength compared to the sub-base – thus an inverted pavement structure. The laboratory characteristics show that the good-performing section has materials generally inferior to the fair-performing section.

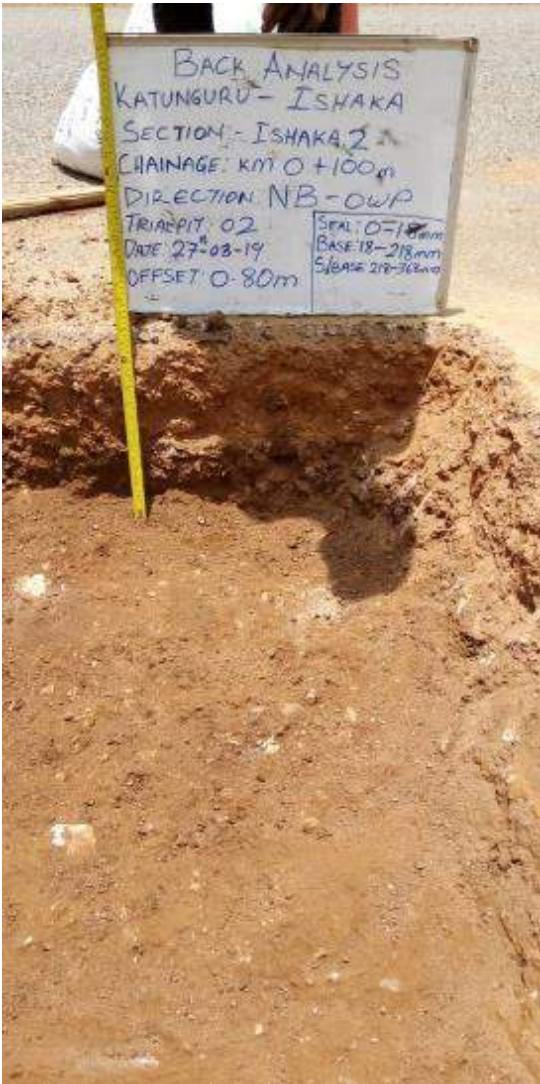
Figure 19 Test Pit on Section 2 Ishaka – Katunguru

TEST PIT LOGGING FORM					
Project Title:	AFCAP BACK ANALYSIS			Survey Number:	1
Province:	KASESE		Road Name:	KATUNGURU - ISHAKA	
Section:	2		Date:	27/03/2019	
Length (m):	200		Chainage	0+100	Test Position: OWP
Lane:	NB		Surveyors:	DOMINIC	
Surface Condition at point of test:			No visible defects		
Layer	Depth Reading (mm)		Thickness (mm)	Layer/Material Description/Defect	Sampled for:
Surfacing	Top	0	18	Bituminous surfacing dressing	Bitumen Recovery, PSD
	Bottom	18			
Base	Top	18	200	Moist reddish brown silty clay gravelly material with cobbles	Full Characterisation
	Bottom	218			
Subbase	Top	218	150	Slightly moist yellowish brown silty clayey gravel with cobbles	Full Characterisation
	Bottom	368			
Subgrade	Top	368	150	Slightly moist dark brown clay material	Subgrade Characterisation
	Bottom	518			
	Top				
	Bottom				
Total Thickness					
Other Notes:					
Rut = 6 mm, vegetation in vicinity of the drainage

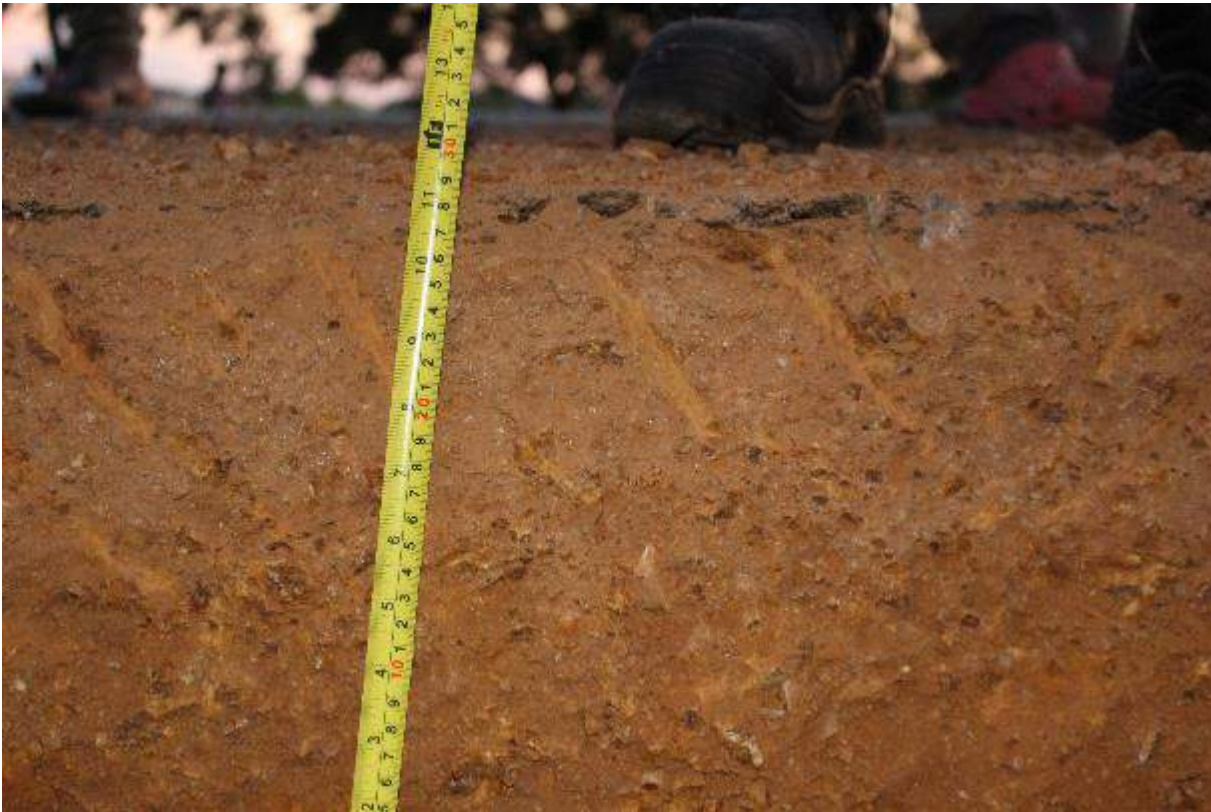
Figure 22 Test Pit on Section 2 Samfya – Musaila

TEST PIT LOGGING FORM				
Project Title:	AFCAP BACK ANALYSIS		Survey Number:	1
Province:	LUAPULA	Road Name:	SAMFYA - MUSAILA D94	
Section:	2 (Good)	Date:	22/03/2019	
Length (m):	200	Chainage	7+400	Test Position: OWP
Lane:	RHS	Surveyors:	Andrew (RDA)	
Surface Condition at point of test:		No visible defects		
Layer	Depth Reading (mm)	Thickness (mm)	Layer/Material Description/Defect	Sampled for:
Surfacing	Top	10	Bituminous surfacing dressing seemingly a Cape Seal	Bitumen Recovery, PSD
	Bottom			
Base	Top	160	Tough lateritic gravelly layer (Probably stabilised)	Full Characterisation
	Bottom			
Fill	Top	140	Lateritic gravel	Full Characterisation
	Bottom			
	Top	-		
	Bottom			
	Top			
	Bottom			
Total Thickness				
Other Notes:				
Section is on an a shallow embankment. Crown height measurements to verify. Rut = 13 mm

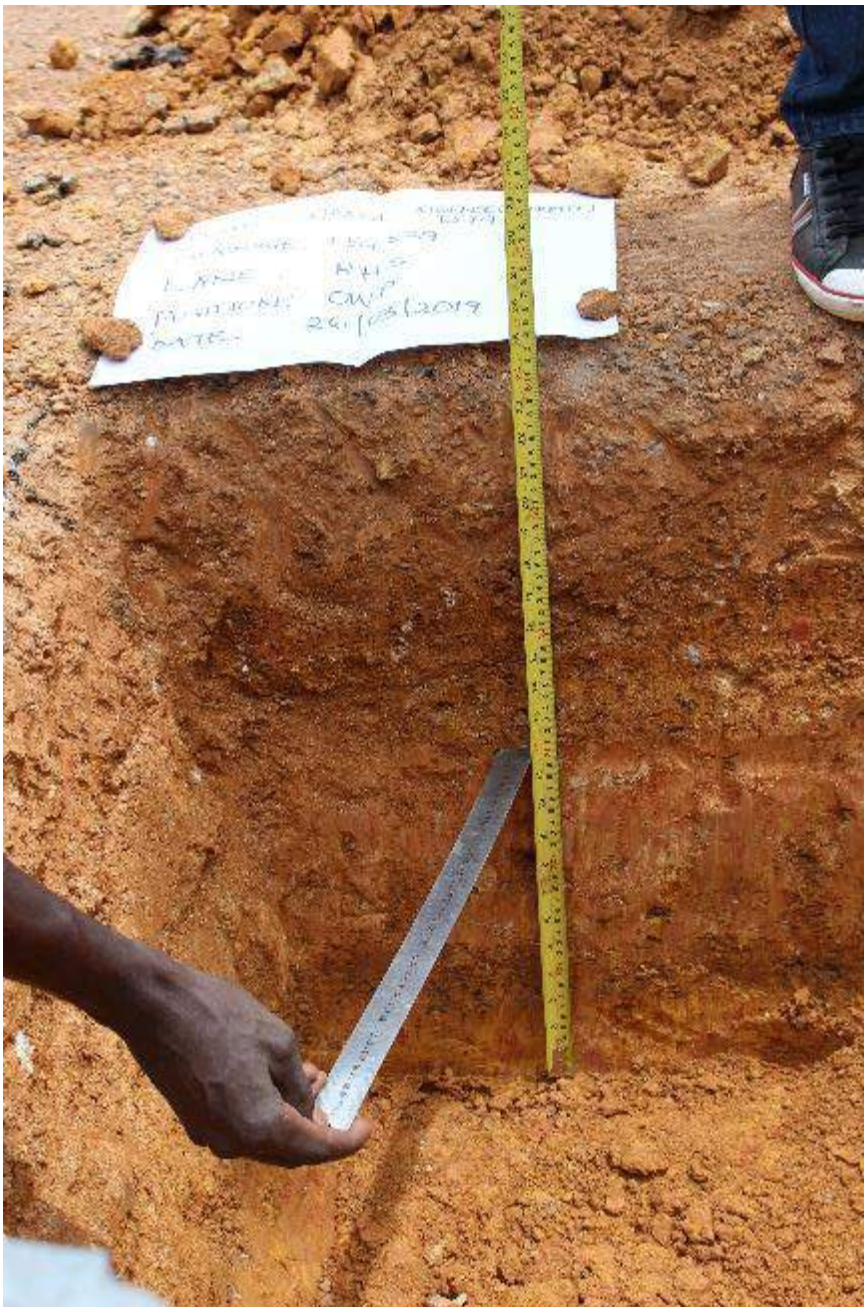
Figure 23 Test Pit on Section 1 Mansa - Bahati

The in-situ DCP-CBR values measured in Section 1 are significantly lower than those in Section 2 (Table 81). Observations on site showed poor surface drainage on Section 1. Moreover Section 1 is in a shallow cut and the water table appears to be high in the area (there is a domestic water dam nearby). The laboratory CBRs were used only for comparison purposes since the previously cemented materials were broken down before laboratory testing. Plasticity indices are above common specification values.
