Development of Guidelines and Specifications for Low Volume Sealed Roads through Back Analysis

Phase 3 Fieldwork Report

ReCAP Reference Number: RAF2069A

September 2019

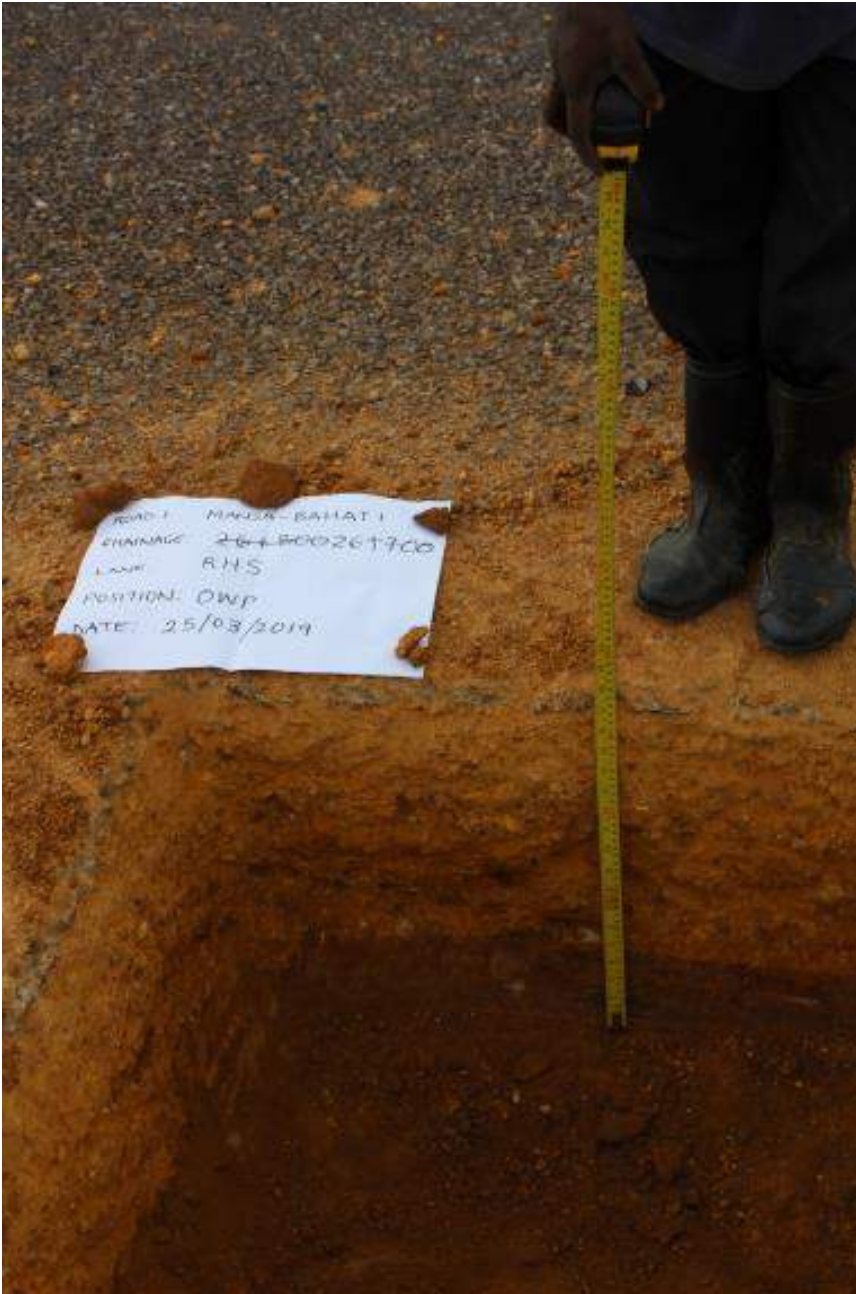
Figure 24 Test Pit on Section 2 Mansa - Bahati road

TEST PIT LOGGING FORM					
Project Title:	AFCAP BACK ANALYSIS			Survey Number:	1
Province:	LUAPULA	Road Name:	MANSA - MWENSE/BAHATI D79		
Section:	2 (Good)	Date:	23/03/2019		
Length (m):	300	Chainage	26+700	Test Position:	OWP
Lane:	RHS	Surveyors:	Andrew (RDA)		
Surface Condition at point of test:		No visible defects			
Layer	Depth Reading (mm)		Thickness (mm)	Layer/Material Description/Defect	Sampled for:
Surfacing	Top		20	Bituminous surfacing dressing seemingly a Double Surface Dressing	Bitumen Recovery, PSD
	Bottom				
Base	Top		150	Tough lumpy lateritic layer (Probably stabilised)	Full Characterisation
	Bottom				
Subbase	Top		150	Lateritic gravel, highly weathered/plastic	Full Characterisation
	Bottom				
Subgrade	Top		-	Brown clayey-sand	Subgrade Characterisation
	Bottom				
	Top				
	Bottom				
Total Thickness					
Other Notes:					
Section is on part cut (LHS) and part fill (RHS). Rut = 13 mm

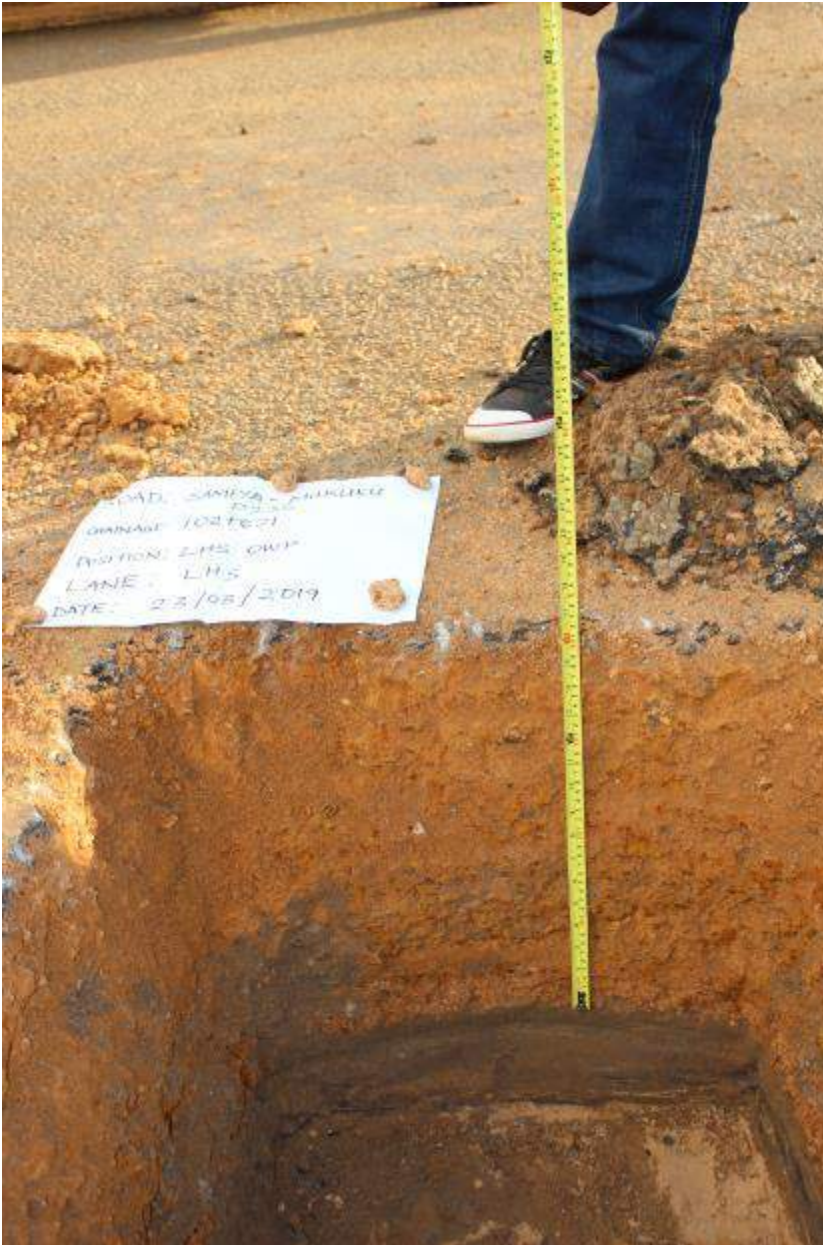
Figure 26 Test Pit on Section 2 Samfya – Mukuku Bridge road

TEST PIT LOGGING FORM				
Project Title:	AFCAP BACK ANALYSIS		Survey Number:	1
Province:	LUAPULA	Road Name:	SAMFYA - MUKUKU BRIDGE D235	
Section:	2 (Poor)	Date:	23/03/2019	
Length (m):	300	Chainage	102+621	Test Position: OWP
Lane:	LHS	Surveyors:	Andrew (RDA)	
Surface Condition at point of test:		No visible defects		
Layer	Depth Reading (mm)	Thickness (mm)	Layer/Material Description/Defect	Sampled for:
Surfacing	Top	25	Bituminous surfacing dressing seemingly a triple seal	Bitumen Recovery, PSD
	Bottom			
Base	Top	200	Tough lumpy lateritic layer (Probably stabilised)	Full Characterisation
	Bottom			
Subbase	Top	200	Lateritic gravel	Full Characterisation
	Bottom			
Subgrade	Top	-	Grey to black clayey-sand (Probably a blend of clay and sand)	Subgrade Characterisation
	Bottom			
	Top			
	Bottom			
Total Thickness				
Other Notes:				
Section is on an embankment in a swamp. A large body of seemingly deep water is standing on both sides of the embankment within 5-10 m of the edge of the seal. The top of the water seems to be within 1 m of the crown. No protective berm either side of the embankment. Rut = 5 mm
