**MID TERM PAVEMENT CONDITION MONITORING
OF THE RURAL ROAD SURFACES RESEARCH**

Technical Paper 1

**Visual Condition Assessment of RRSR Trial Road
Options**

SEACAP 27

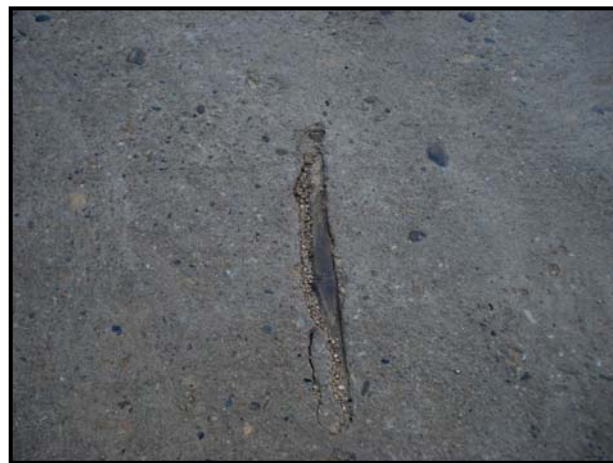
Figure 3.6 TQ(1)-2. Indication of poor construction technique – reinforcement exposed.

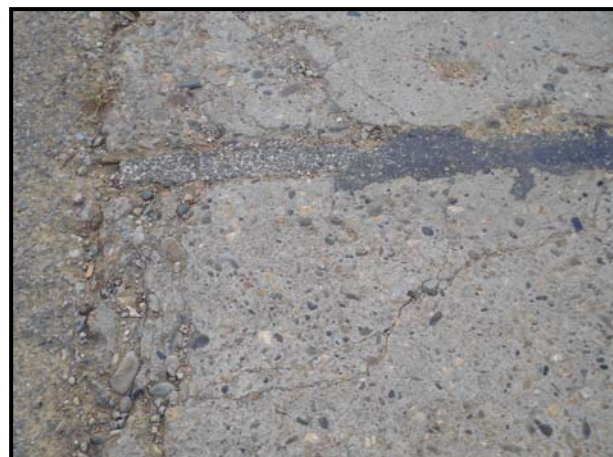
Figure 3.7 TQ(1)-2. Indication of disintegrating poor quality concrete with rounded aggregate. .

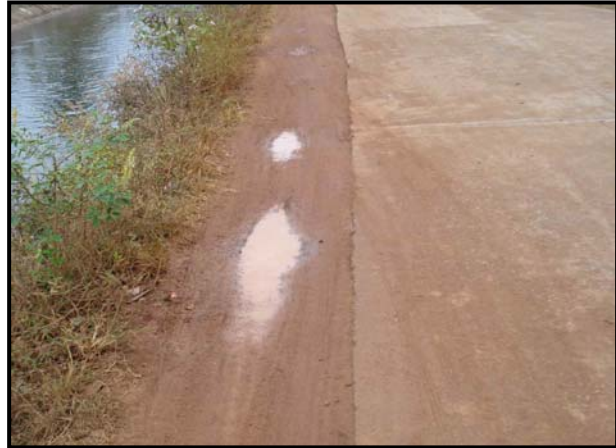
Figure 3.8 DL(3)-1. Saturated plastic shoulder gravel in contact with sub-base of same material. .

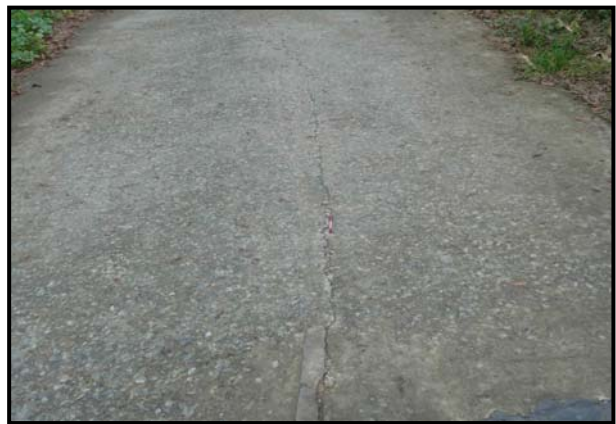
Figure 3.9 TG2-. Single crack running along centre-line of slabs . .

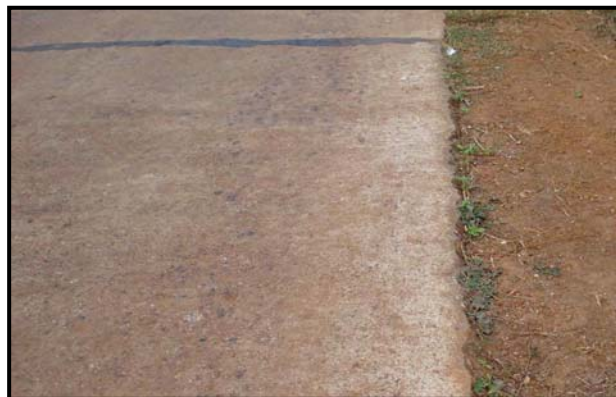
Figure 3.10 GL(2)-3 .Shoulder erosion cracking between shoulder and slab

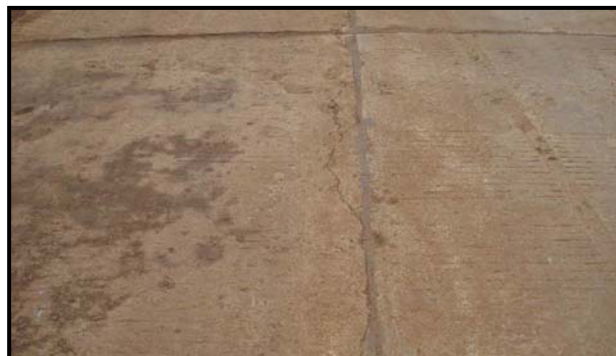
Figure 3.11 DN(1)-5 .Cracking adjacent to central joints

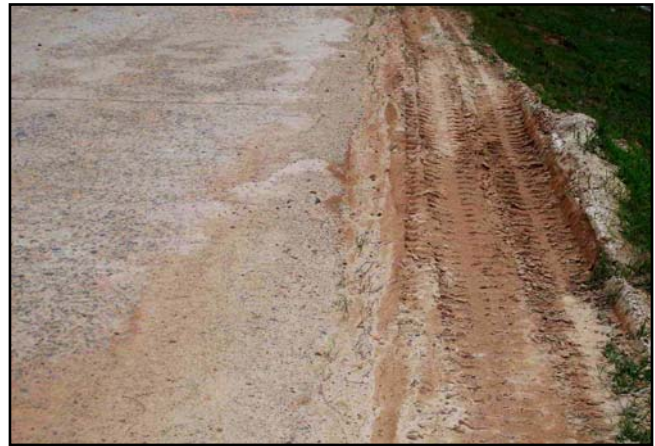
QB2-2	20	Probable heavy truck usage allied to shoulder erosion, Figure 3.12
TG09	18	Cracking mainly between blocks 23 and 33. Possible sub-base erosion in a flood-prone section.
HT2-2	15	Poor quality concrete suspected. The PDoT was given a formal note on the perceived poor construction techniques being employed.

Figure 3.12 DN(1)-5 .Evidence of heavy vehicle erosion of shoulder leading to edge cracking

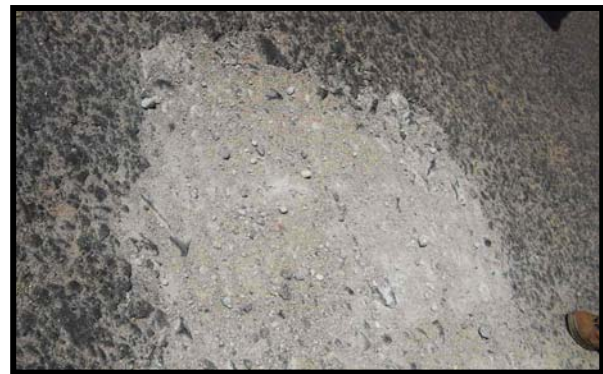
Figure 4.1 .Pothole in PenMac in Ea Soup road DL(3)-2

In this study the field teams have usually described the deterioration as 'potholes' and hence the number of potholes on such roads appears excessive and could be mistakenly interpreted as a very advanced stage of deterioration. In reality, the deterioration is usually not so serious and describing it as 'ravelling' would convey a more accurate picture. This problem is not unique to this study, similar problems have occurred on other projects and in other countries. For example, in Indonesia it was concluded that the primary mode of deterioration of penetration macadam roads is actually a form of ravelling affecting those areas of the surfacing that are deficient in bitumen.

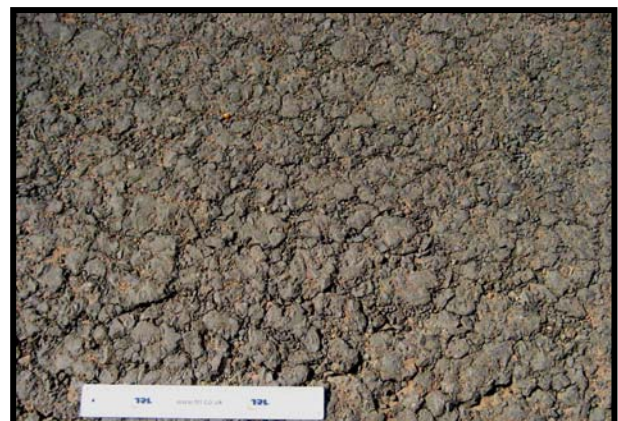
The type of cracking which commonly occurs on penetration macadam roads is also rather different from other bitumen sealed options. Since the voids in the material are high, cracks tend to be anything but uniform in their individual characteristics. Although crocodile cracking is probably the best description, it sometimes appears to be a type of reflection cracking, possibly mirroring the position of the very large stones that form the first layer of many of the roads, Figures 4.2. Deciding on the width of cracks and whether the cracks are structural in nature (i.e. caused directly by traffic loading), the result of hardening of the bitumen at the surface, or movement of the underlying stones has proved difficult.

Figure 4.2 .Cracking in PenMac in Ea Soup road DL(3)-2

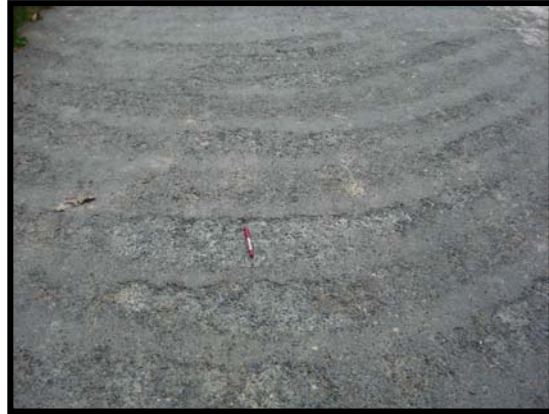
Figure 4.3 .D05. Deterioration of emulsion sand seal which may be related to labour based construction techniques

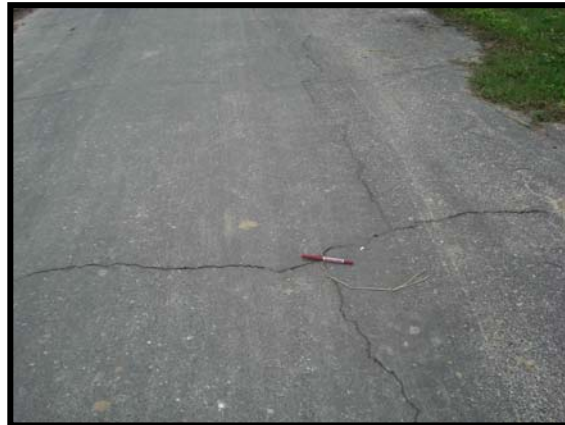
Figure 4.4 .DaN03. Large scale cracking related to cracking in underlying cement stabilised sand

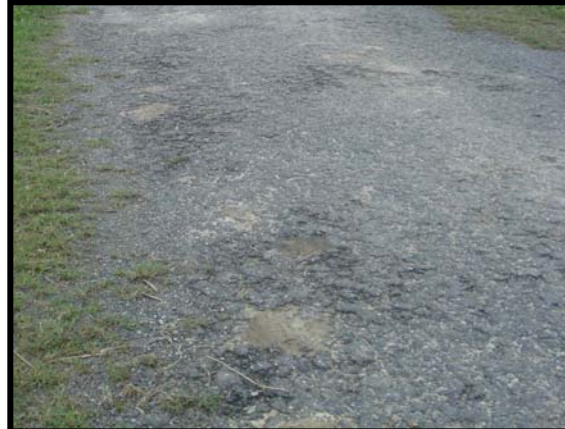
Figure 4.5 .DaN05. Rapid deterioration of surface seal following a number of tropical storms and associated flooding

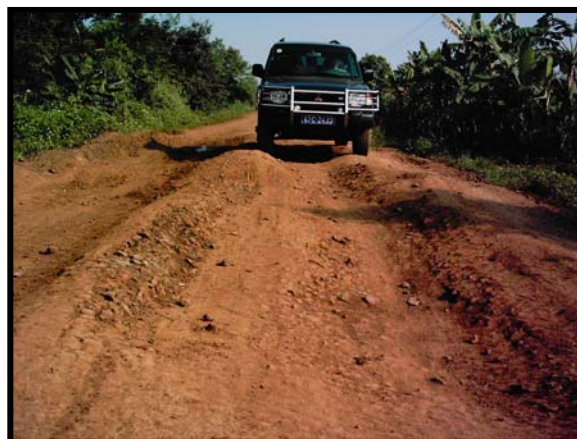
Figure 4.6 .DL(2)-2. Pavement failure caused by excessive traffic overloading

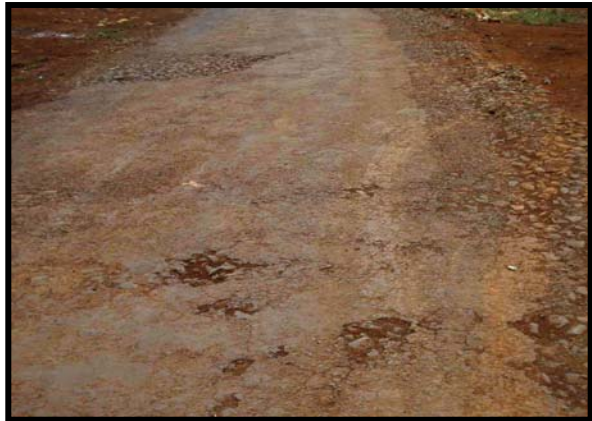
Figure 4.7 .DL(1)-4. Deterioration of initially very poor quality seal

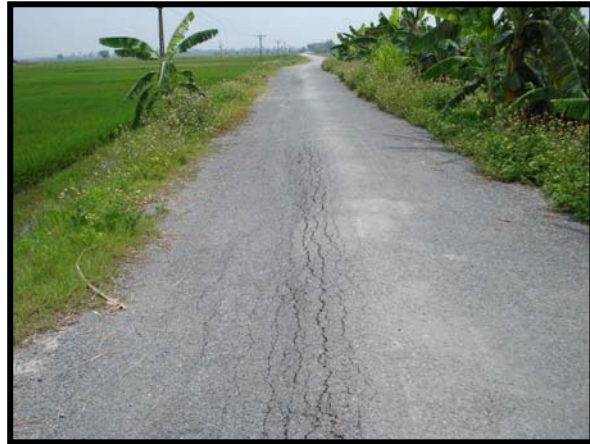
Figure 4.8 .HY(2)-4. Longitudinal cracking associated with probable sub-grade movement

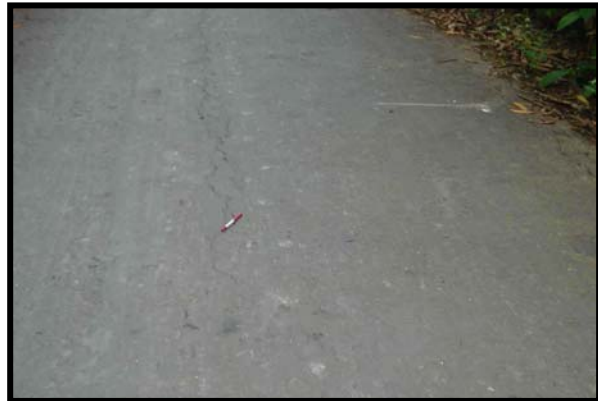
Figure 4.9 .TG05. Centre line longitudinal cracking

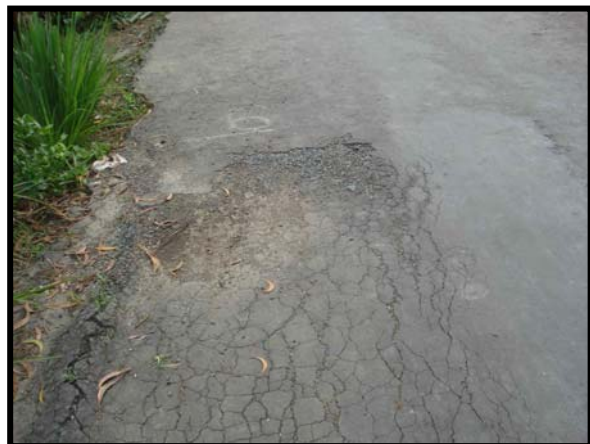
Figure 4.10 .TG05. Potholing probably related to localised strength deterioration in stabilised base

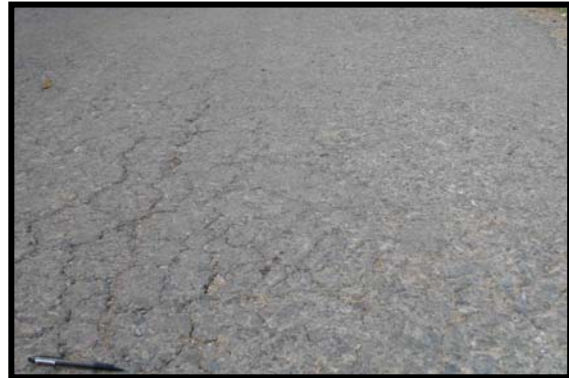
Figure 4.11 .TQ(2)-1. Cracking probably related to recorded weakness in sub-base and sub-grade.

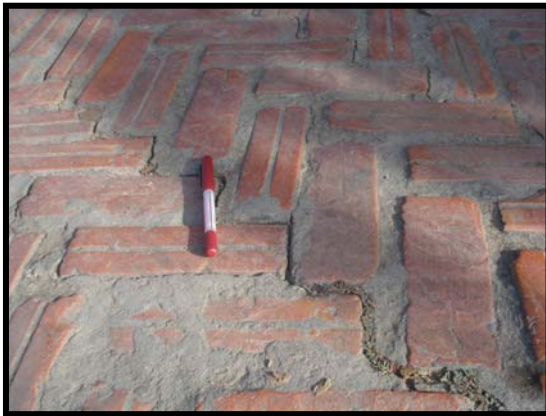
Figure 5.5 Cracks in mortared joints with intact clay bricks (D10)

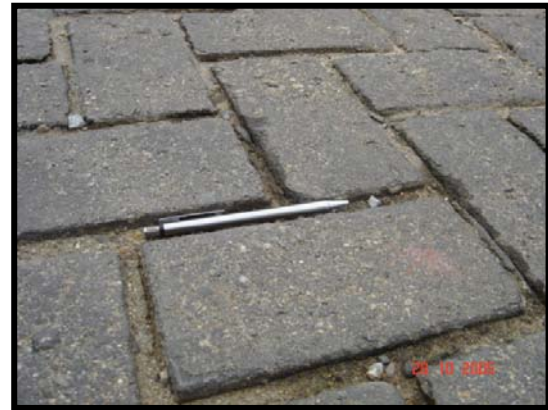
Figure 5.6 Eroded sand joints with intact concrete bricks (H07)

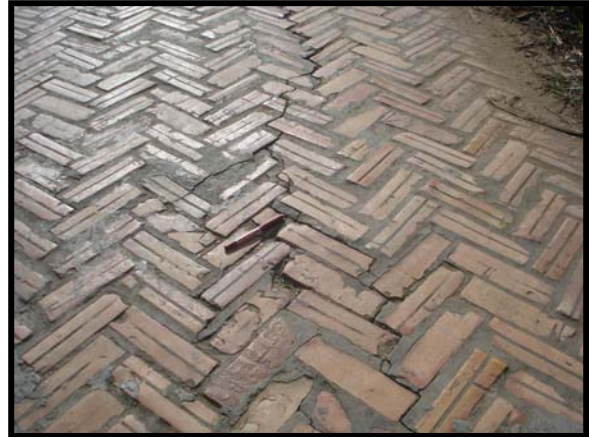
Figure 5.8 Mortared clay brick pavement (D10) exhibiting extended cracking similar to that in adjacent concrete sections (cf Figure 3.9)

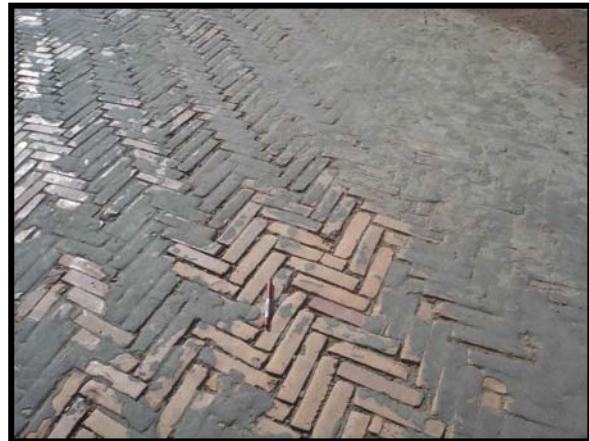
Figure 5.9 Sand joint clay brick pavement (D11) exhibiting significant seal loss after more than 3 years of service

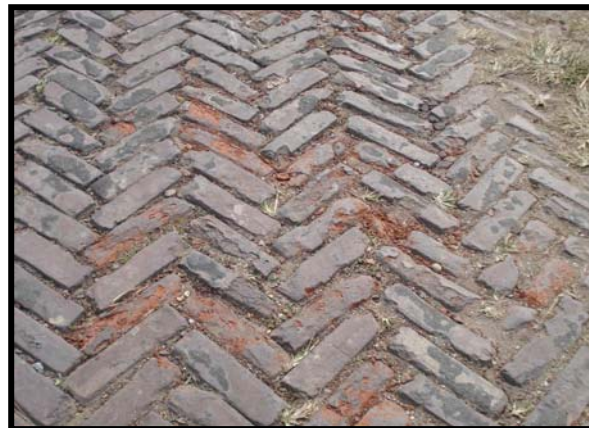
Figure 5.10 Sand joint clay brick pavement HY(2)-2 exhibiting significant seal loss and brick deterioration after 2 years of service

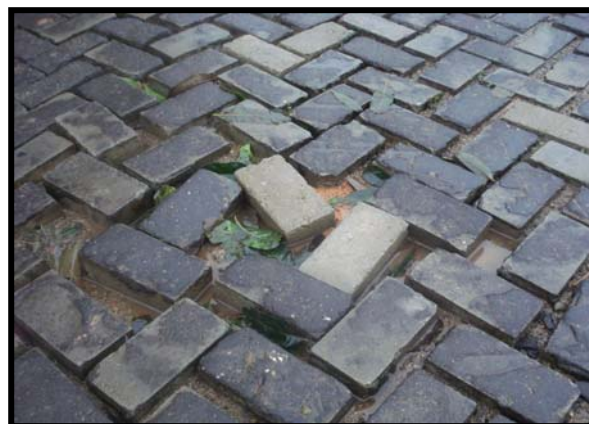
Figure 5.11 Sand joint concrete brick pavement (H07) exhibiting total seal and joint deterioration with consequent loss of pavement integrity. January 2009, following rainy season with intense tropical storms

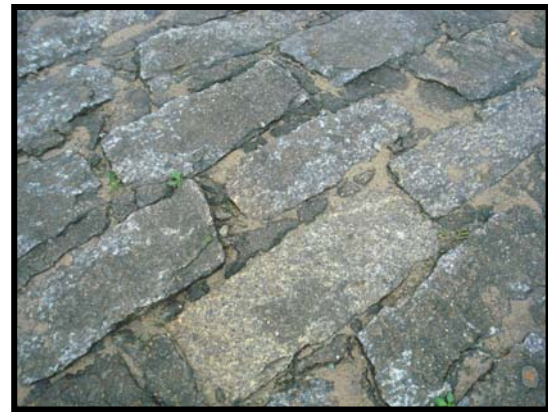
Figure 5.12 Dressed stone pavement (H11) in fair condition with cracked mortared joints

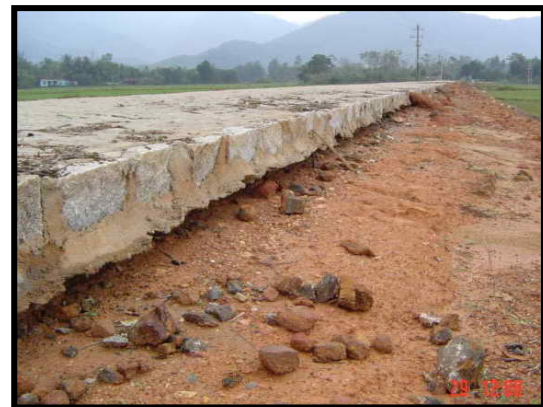
Figure 5.13 Dressed stone pavement (H11) maintained integrity despite severe erosion of shoulder and edge of sand bed layer following tropical storm floods after 1 year of service.

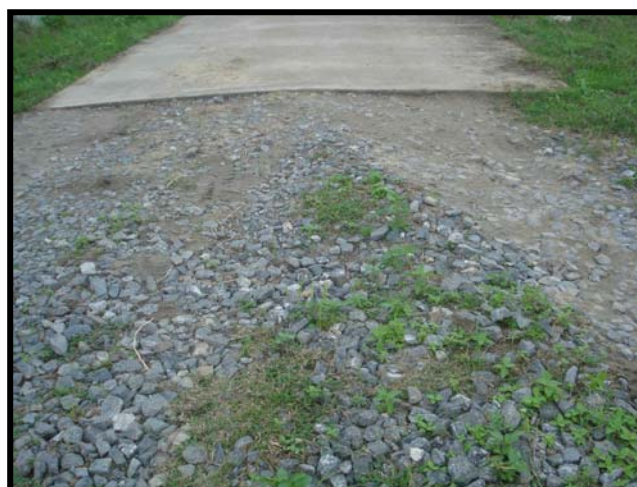
Figure 6.1 Trial DaN06 showing loose eroded surface. Vegetation indicates the low level of traffic.

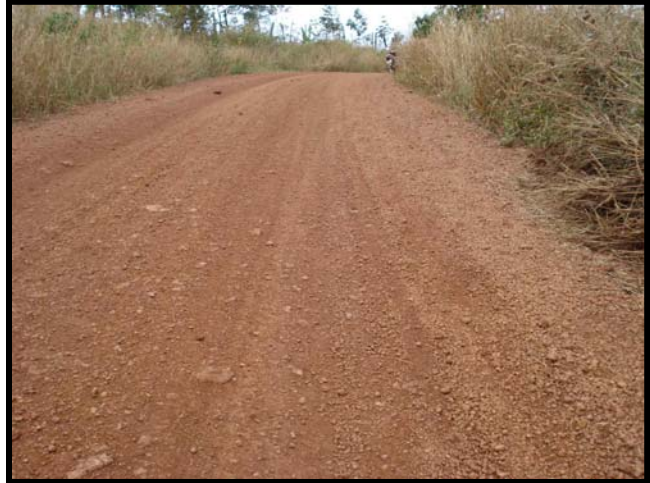
Figure 6.2 Trial DN(2)-5 showing eroded surface and out-specification grading.. No effective side drainage

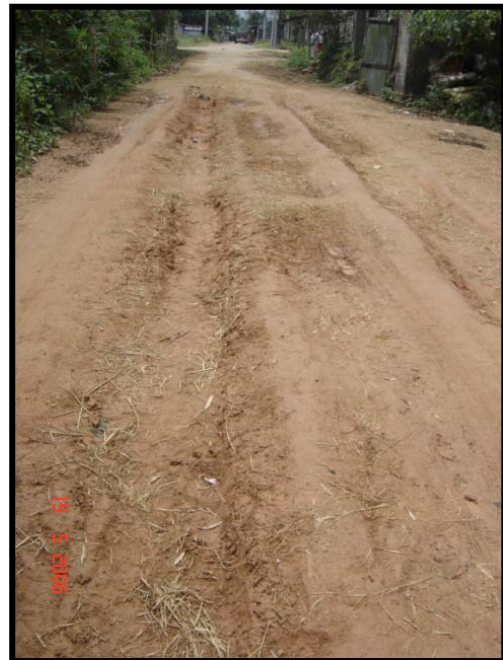
Hue	H03	This gravel in this section has suffered from rapid shape deterioration and consequent soaking and deformation within the first six months, despite very light traffic. Major cause of deterioration has been high rainfall (including a number of tropical storms) allied to poor drainage and complete lack of maintenance on carriageway shape), Figure 6.5.
Tien Giang	TG10	Following significant deterioration in the first 15 months this section of gravel was rehabilitated and sealed as per the agreement with the district authorities
Tien Giang	TG08	Following significant deterioration in the first 15 months this section of WBM was rehabilitated and sealed as per the agreement with the district authorities.

Figure 6.5 Trial H03 1 year and 1 rainy season after construction.
