TAN008

Design, Construction and Monitoring of Demonstration Sites for District Road Improvement in Tanzania to the Prime Minister's Office – Regional Administration and Local Government (PMO-RALG) under the African Community Access Programme (AFCAP)

## Workshop Report

**REPORT TITLE: BAGAMOYO WORKSHOP**

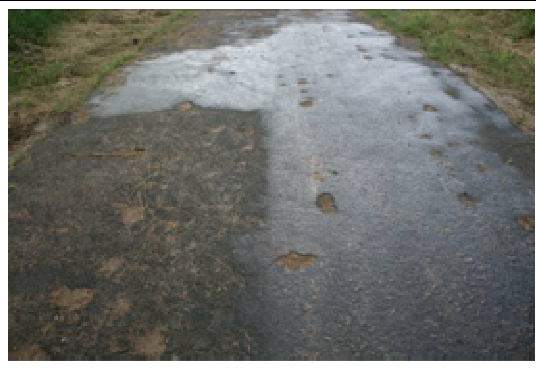
<p>Slurry Seal: Left side is Lime Slurry, the Right side is Cement Slurry. Latter performing better, but neither performing well. Does not appear to be appropriate solution, possibly due to lack of construction</p>

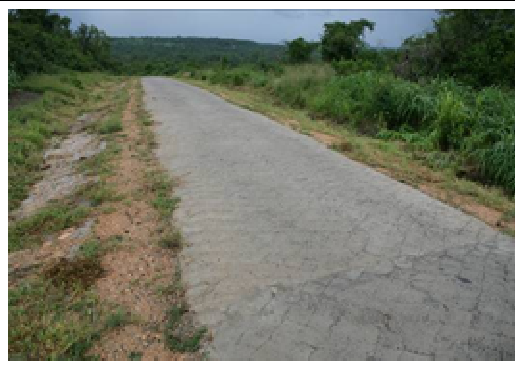
<p>Geocells: some minor cracks and spalling, but overall performance is good</p>

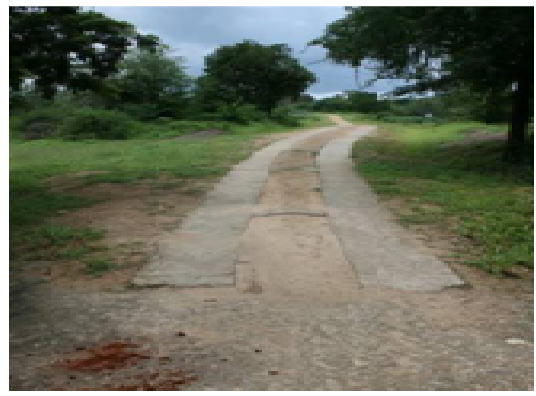
<p>Concrete Strips with concrete intermittent ribs. The gravel shoulders are performing well</p>

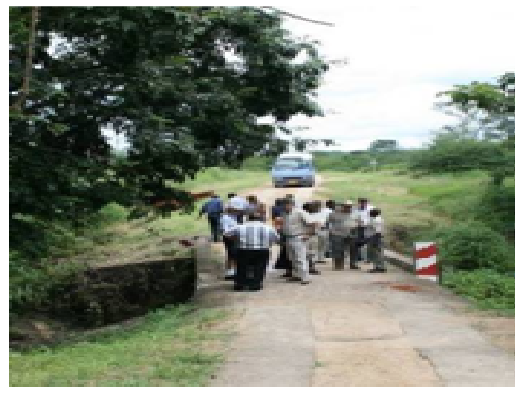
Not constructed under AFCAP. It was noticed that the reinforced concrete hazard bollard had been hit. It suggests that the bridge is too narrow. It was also noted that warnings indicating the bridge could be made more prominent for motorists. Eg. introducing rumble strips on bridge approaches. There were no warning signs present.

<p>Narrow section due to bridge – note safety reinforced concrete bollards. This could be too narrow</p>

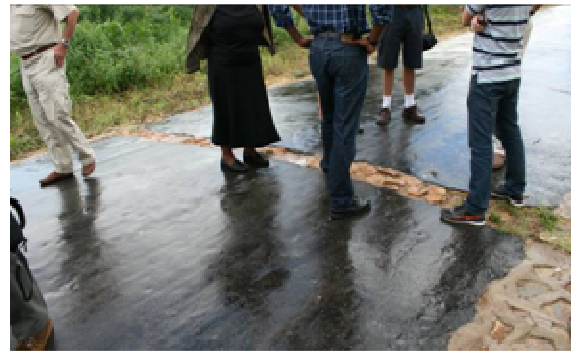
Sand Seal well-constructed (and measures taken by Villagers to reduce speed) Softening at high temperatures was the feedback from the community

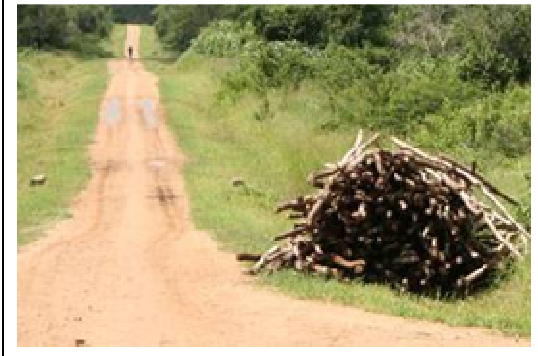
Significant lengths of Unpaved Road Gravel is performing well (but some maintenance is required as can be seen)

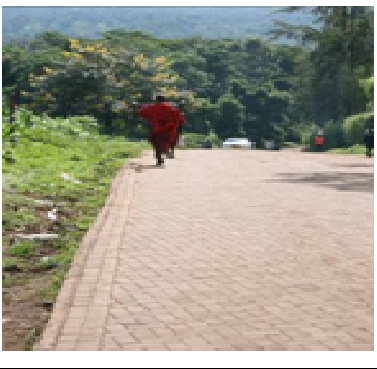
<p>Block Paving – Good Condition</p>

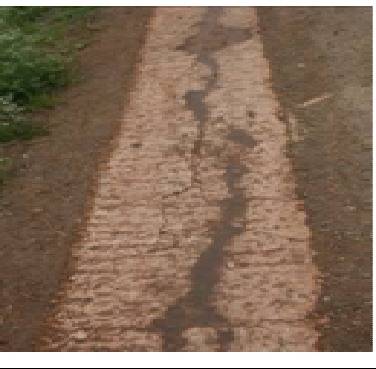
Some cracks were observed on the concrete sections, both slab and strip. Various reasons for this were suggested and it was recommended that Roughton try to establish this before their contract ends:

- Poor quality of concrete
- Inadequate thickness. This could be caused by a poorly shaped sub-base underneath which could easily lead to thin concrete especially on sections that have high and variable camber and especially at the outside edges. Concrete could easily have been forced towards the centre line to ensure good camber leaving the edges too thin.
- Heavy vehicles using the road too soon, before the concrete has gained sufficient strength

<p>Concrete Strips – sealed crack</p>

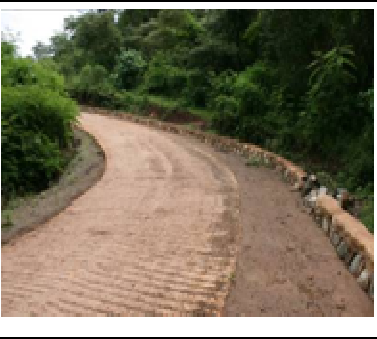
<p>Concrete slab – Note drainage channel can be used as overrun</p>

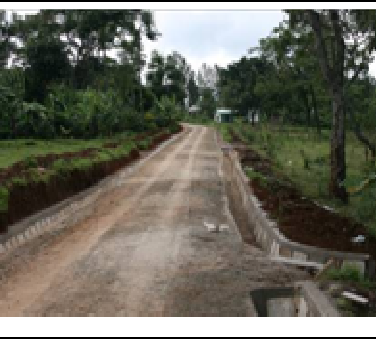
In many areas the necessary drainage ditches were missing or inadequate but it was reported that the contractor was still building ditches. In one location the drainage was both over-designed, incorrectly designed and potentially dangerous to road users.

<p>Drainage both sides – nowhere for pedestrians to go</p>

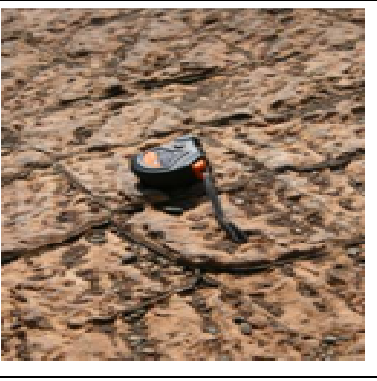
<p>Concrete Geocells – Rough Texture</p>

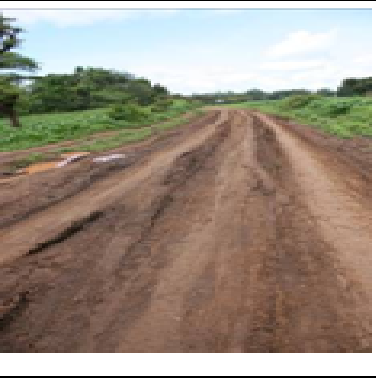
<p>Soft ground – Potential for future spot improvement</p>

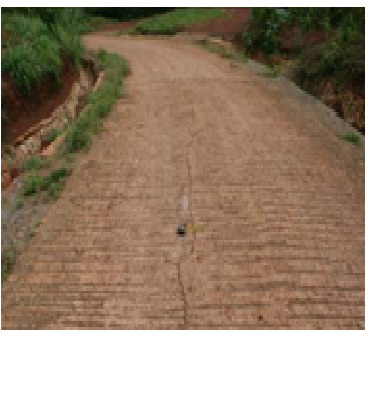
<p>Concrete Slab – longitudinal crack</p>

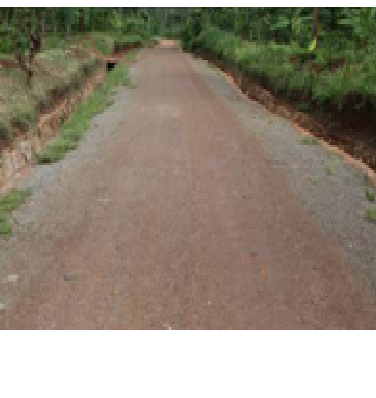
<p>Penetration Macadam – Good Condition</p>
