MPWT - SEACAP 21 - DFID

DF 68: SEACAP PRACTITIONER MEETING (SPM)
STUDY TOUR TO THE SEACAP 21 TRIALS
5-7 NOVEMBER 2008

STUDY TOUR REPORT

SEACAP 21 Slope Stabilisation Trials

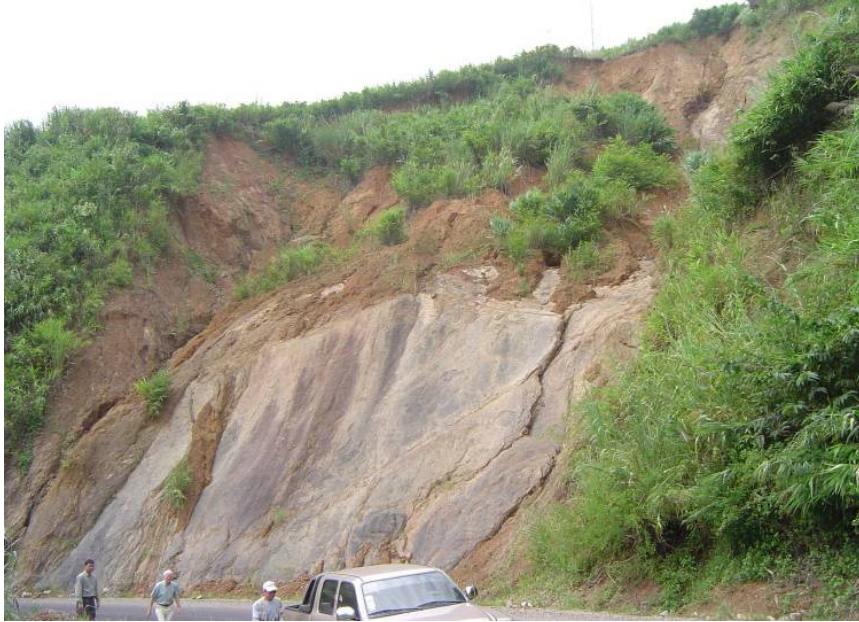
Road: 13N **Location:** Km 238.0

Above Road: Extensive active shallow slope failure 25m wide and roughly 40m high with crest of failure approaching base of high tension electricity pylon (now since relocated), overlying 10m high phyllite outcrop Weathering Grade (WG) II-III.

Below Road: Actively failing 30 deg loose slip debris slope 40m down to watercourse, but gradually re-vegetating naturally.

Above Road: Not known, but possibly associated with land use/natural drainage beyond crest of failure.

Below Road: Surface runoff from road onto unstable loose slip debris slope creating further instability.

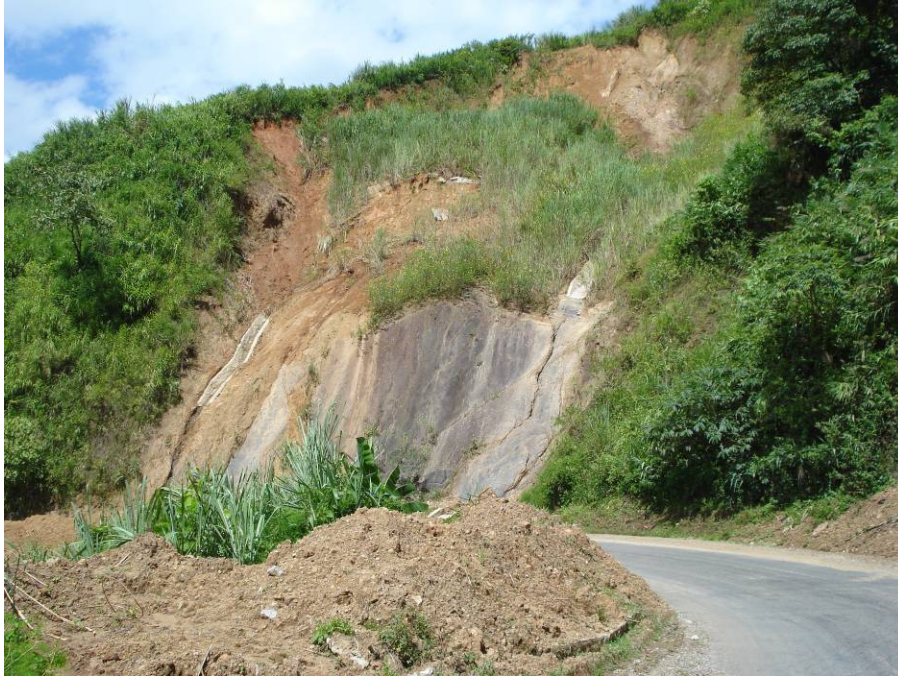
Road: 13N Location: Km 238.0

Above Road: Satisfactory up to July 2008 when extended periods of heavy rainfall caused the upper portion of the above-road slope to slump and some masonry lined slope drainage channels to be destroyed.

Below Road: Satisfactory up to July 2008 when material which had slipped onto the road from the above-road slope was cleared and dumped on top of the below-road fill slope, destroying the bio-engineering measures and creating further instability.

Above Road: Back scar trimmed and loose slope debris removed. Exposed surface re-profiled and compacted. Stone-lined slope drains constructed. Gabion check dam constructed on slope. Shrub seeding in rock areas as required. Diagonal grass lines planted. (Work carried out in June 2007)

Below Road: Fill slope debris trimmed to a rounded profile. Remaining debris smoothed and compacted. Live check dams installed in gullies on fill slope. Grass strips planted on slopes less than 35 deg and brush layers on slopes greater than 35 deg.

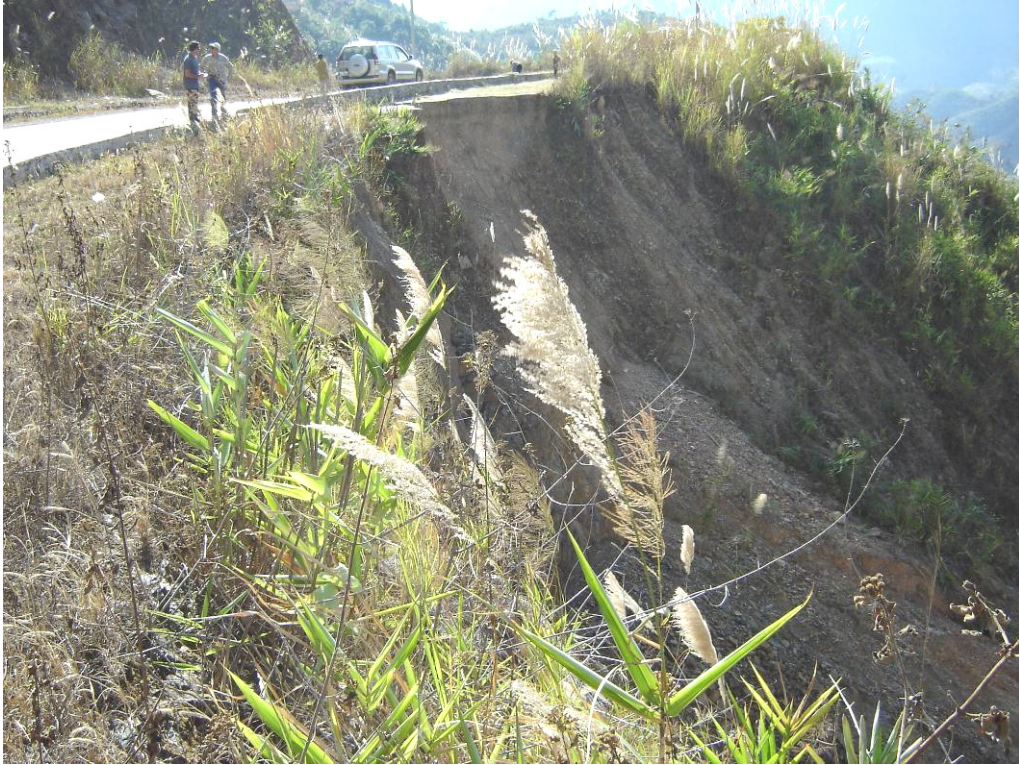
Road: 13N Location: Km 242.6

Below Road: Large 80m width by 70m length erosion scar active below road. Original road lost and new road on alignment shifted by half road width, but failure has progressed to masonry edge wall. Exposed surface comprises slate/phyllite that varies from competent rock of Weathering Grade (WG) II-III to more highly weathered material. Quartz veins are present on the north eastern side of the backscar. Further slate outcrops are present lower in the base of the landslide scar. Two major joint sets were identified.

Below Road: Cause of original failure not known but erosion is continuing due to presence of surface runoff down steep crest profile in un-vegetated WG IV-V material.

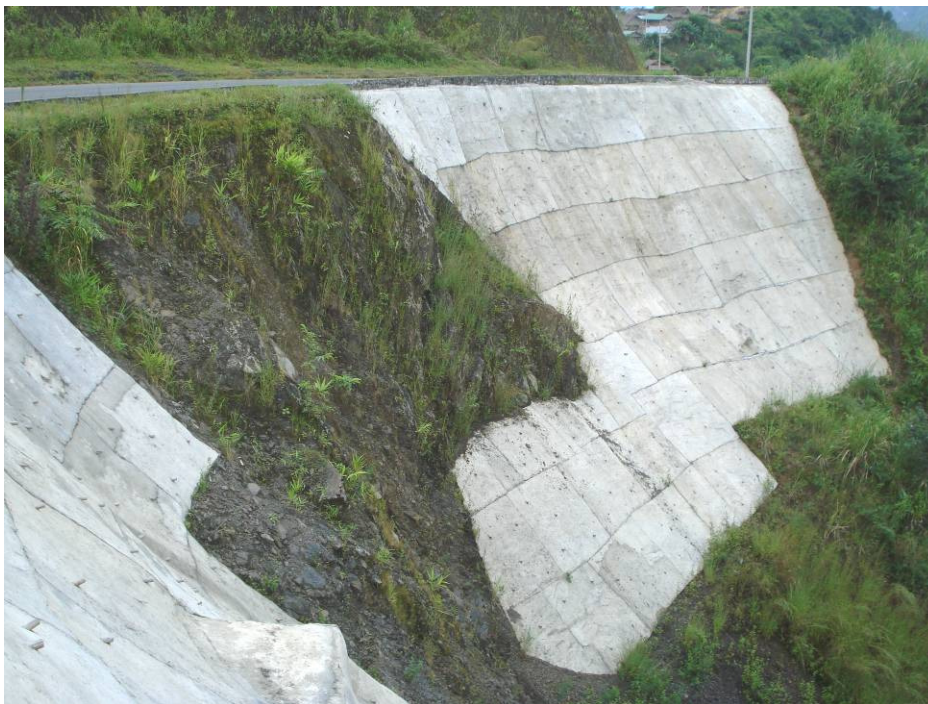
Road: 13N Location: Km 242.6

Below Road: Good

Below Road: Upper 5m edge of backscar re-reprofiled. Original intention was to protect backscar with reinforced shotcrete, but due to the absence of specialist equipment/contractor, this was substituted with cast in-situ hand-applied 75mm thick continuously reinforced concrete.

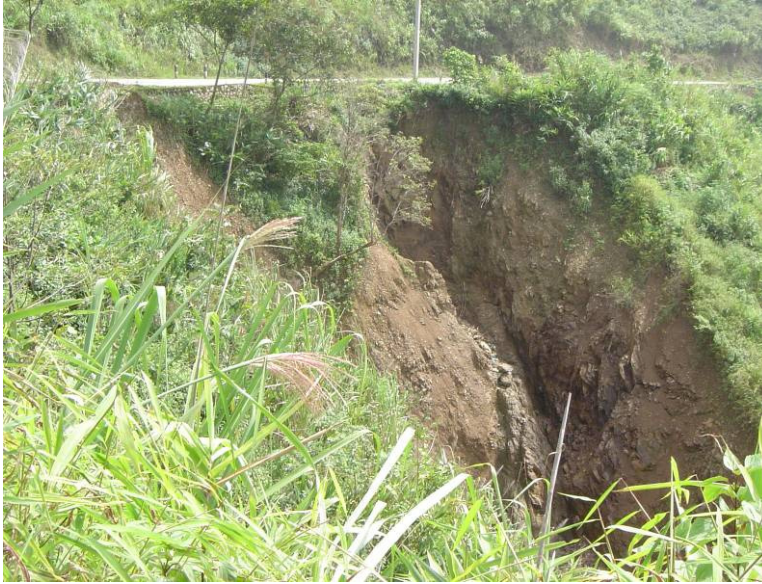
Road: 13N Location: Km 254.0

Below Road: Culvert head/retaining wall undercut due to outlet scour. Left Hand Side (LHS) of gully also scoured in highly disturbed rock mass with adverse jointing. Masonry edge wall 1.5m deep also failed due to scour of foundation at up-chainage end. Total affected area 30m wide by 50m downslope. Large deep slide on down-chainage end undergoing active movement.

Below Road: Failure apparently occurred during the 2004 wet season, the deep gully erosion from the culvert outlet triggering the up-chainage slide. It would appear likely that the original gully erosion had been occurring unnoticed for some time prior to the 2004 wet season.

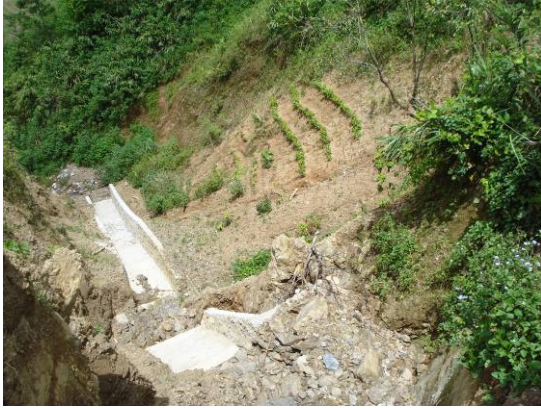
Mortared masonry channel

Below Road: Satisfactory although ongoing gradual movement of slope on down-chainage side close to culvert outlet structure will need regular inspection with the possibility of further stabilisation works in the future.

Below Road: 35m x 6m high mortared masonry retaining wall constructed, although original design length of 50m was reduced to save money. 3m wide mortared masonry drainage channel constructed in existing gully. Grass slips planted and brush layers installed. Live check dams planted in gullies.

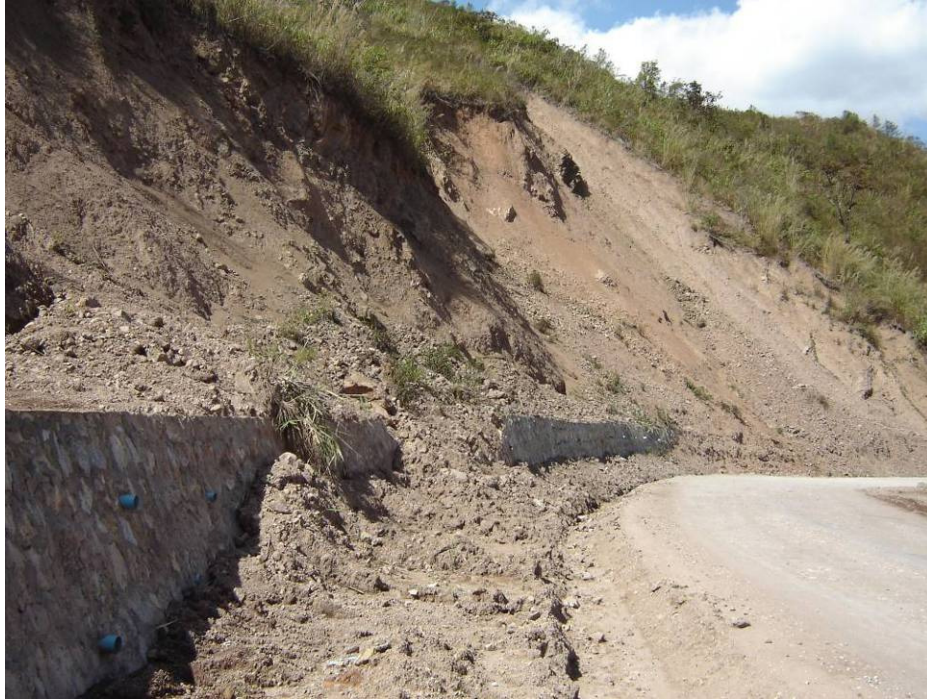
Road: 13N Location: Km 260.3

Above Road: Major failure affecting the entire road bench over a 150m length of road. Tension cracks associated with the main failure extend more than 100m upslope. 2m high toe wall installed in 2004 by the Department of Public Works and Transport already exhibiting significant movement and cracking. Side drain and cross culvert inlet totally blocked. Exposures in failed cut slopes from Ch 260+360 comprise some highly fractured argillaceous rock (WG III). More weathered siltstone/mudstone (WG IV-V) with some Phyllitic texture (Metasiltstone exposed higher in backscar of main failure).

Below Road: Area used for spoil dumping. Significant gully erosion taking place at original cross culvert outlet location, although inlet completely blocked with slope debris. One limestone exposure is visible. Hillside continues down to a valley base/stream course where further limestone outcrops are present.

Above Road: Possible reactivation of larger, relict failure. Relevance of geologic boundary between argillaceous rock and limestone is uncertain.

Below Road: Gully erosion in loose fill from road and cut slope run-off due to adverse road cross fall.

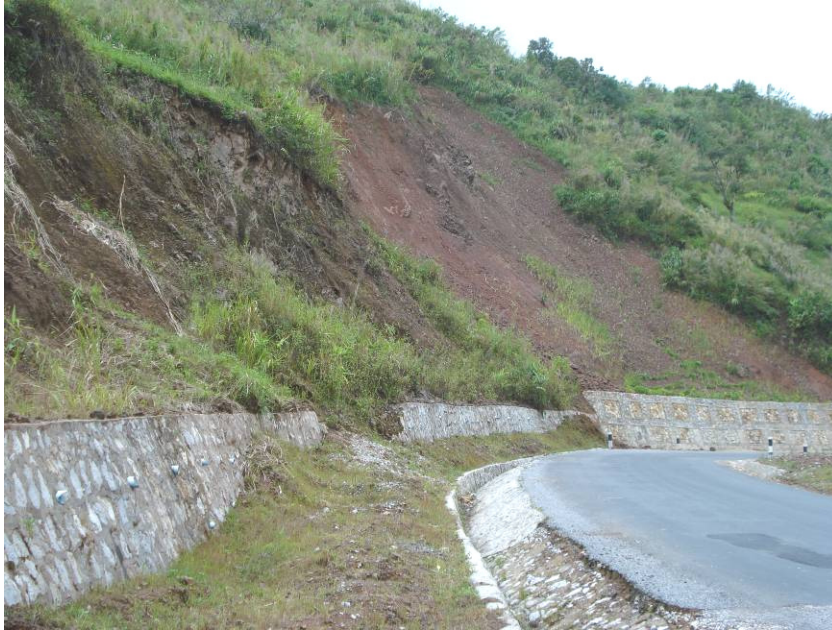
Road: 13N **Location:** Km 260.3

Above Road: Given the wider extent of ground movements taking place, the slope improvement measures constructed are performing satisfactorily.

Below Road: Satisfactory but additional gabion check dams necessary to prevent further gullying below existing culvert outlet.

Given the large extent of the existing instability which is also known to extend beneath the road, the stabilising measures have been designed only to address the current situation on a temporary basis, since a permanent solution will be very expensive and could involve a complete relocation of the road.

Above Road: Mortared masonry roadside drain reconstructed throughout length of failure area. Later decision to extend the existing mortared masonry retaining wall with a new 35m long by 3m high composite masonry retaining wall. Grass slip planting and brush layering on slope above the retaining wall

Below Road: Existing cross culvert cleared and new gabion outlet structure constructed.

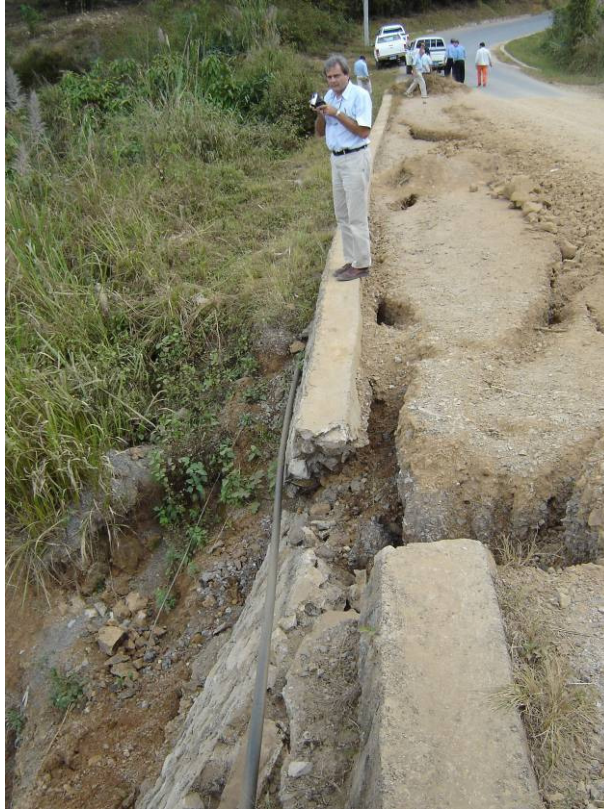
Location: Km 3.3

Below Road: Major failure affecting part of LHS road surface and fill slope/natural ground below masonry edge wall on 1.5m high gabion (culvert location?). Additional deep scouring down-chainage adjacent to road exposing black clay (shale). Road located on embankment on vertical sag curve (saddle). On RHS, evidence of movement of cracked masonry upstand at crest of 6m fill slope. Total affected area roughly 60m wide by 30m downslope.

Below Road: A cross road culvert is located in the low point/saddle of the road. The culvert drains artificial ponds to the north of the road to an incised gully on the south. The ponds are artificial and have modified the hydrology of the area. Incision and erosion by surface water has removed support from the toe of the slope and this has probably triggered failure. The stream flow rate has been artificially increased by pond and culvert construction. In addition, high runoff towards base of sag curve and lack of roadside drainage may have also created erosion conditions in weak fill.

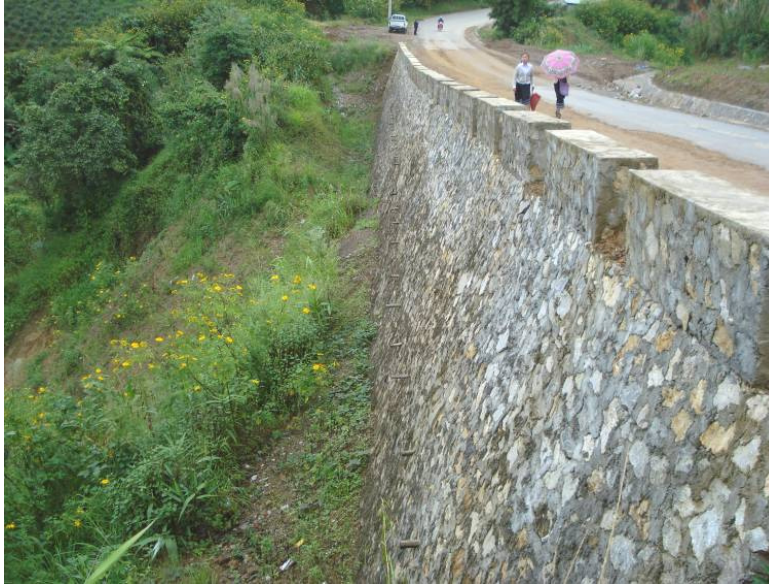
Location: Km 3.3

Below Road: Good, but new roadside channel necessary on LHS up-chainage of retaining wall to ensure road runoff is directed into roadside outlet away from wall structure.

Below Road: 75m long mortared masonry retaining wall constructed on LHS, 6m high. New masonry roadside drain with outlet to RHS. Existing culvert cleared and new gabion headwall and outlet structure constructed on LHS. Gabion check dam constructed in existing drainage course to reduce erosion and scour. Grass slips planted on re-graded ground below new retaining wall and above culvert inlet and outlet structures.
