Interactions between improved rural access infrastructure and transport services provision

Report of Tanzania Surveys

ReCAP GEN2136A

June 2020

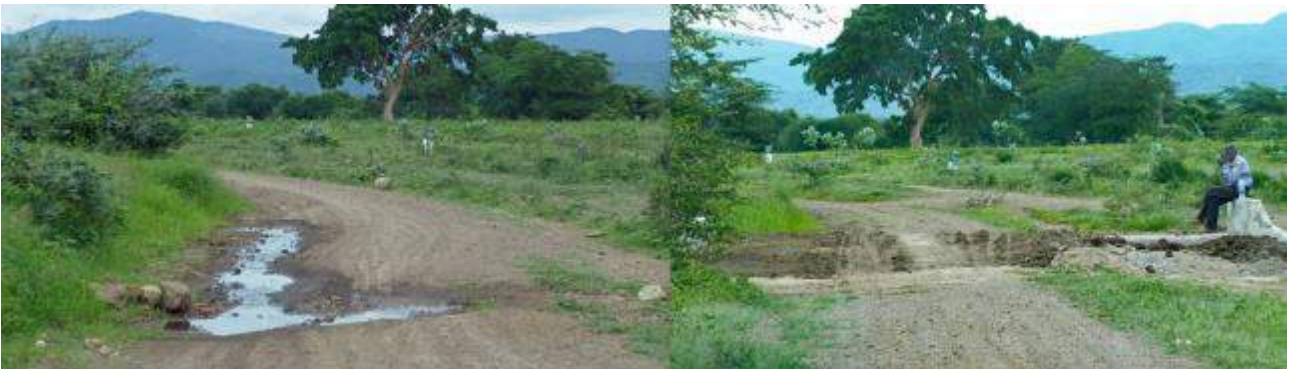
Figure 16 Road within Kaway showing a failed culvert (June 2019, left) and the new culvert (Nov 2019)

As one of the failed culverts on this section was replaced in 2019 by a wider culvert (see Figure 16). This suggests that not only are some TARURA maintenance tasks taking place on this poor section of the road, but that further upgrading investments are envisaged in the future.

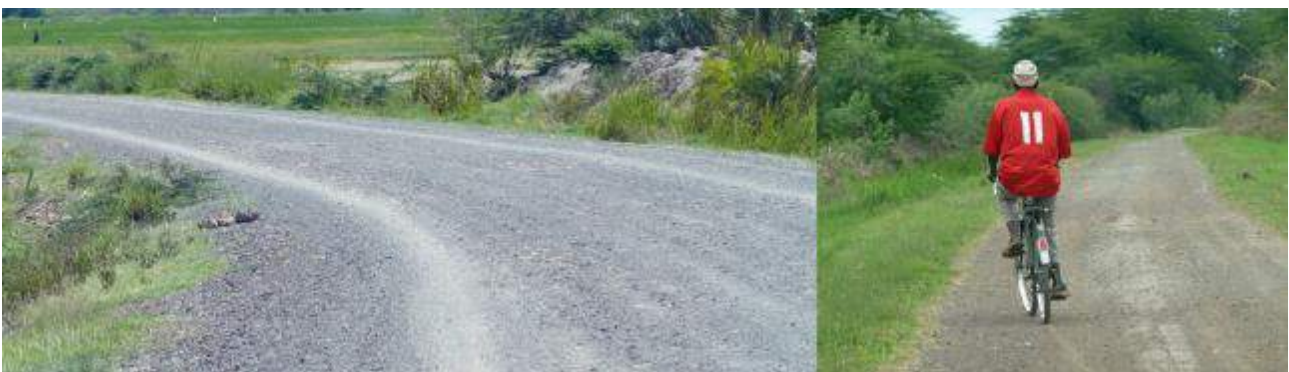
This road is shown as being in good condition in 2019/20 on the DROMAS2 database. The surface on the rehabilitated section is gravel that has been sourced locally from within a few kilometres of the road. The width is approximately 6 m, with some areas being slightly wider, up to 7 m. In general, there is a reasonable camber on the rehabilitated carriageway in most areas. The surface is relatively smooth, although motorcycles follow the even smoother trajectories they have created through repeated use, as shown in Figure 20 and Figure 21.

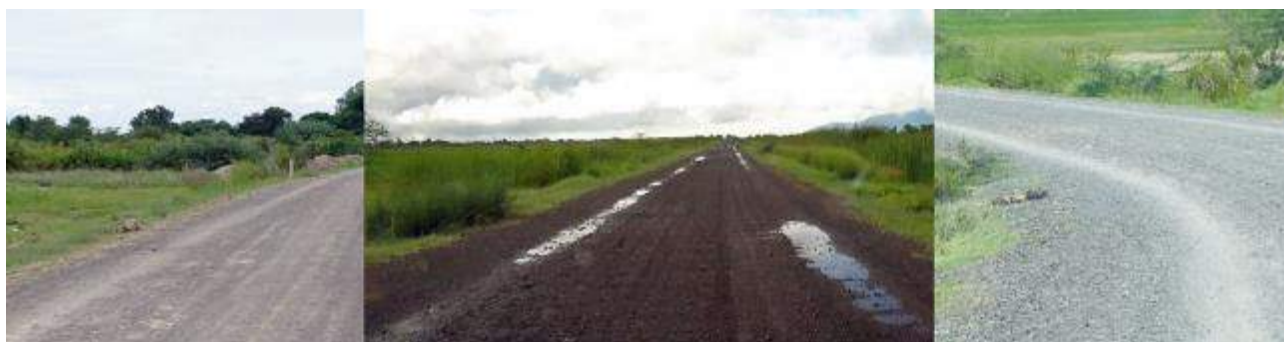
Figure 21 Gravel road surface showing puddles (centre) and smooth tracks worn by motorcycles (left and right)

The rehabilitated section has lost much of its camber along the embankment and standing water is more prevalent after rain. Small areas of standing water can be seen where the surface has rutted slightly, as shown in Figure 21, although there were no soft spots at the time of the survey. Corrugations are starting to appear in some areas, but this is not yet a problem. As the rehabilitated section progresses towards Kawaya it narrows, down to 4 or 5 m in places.

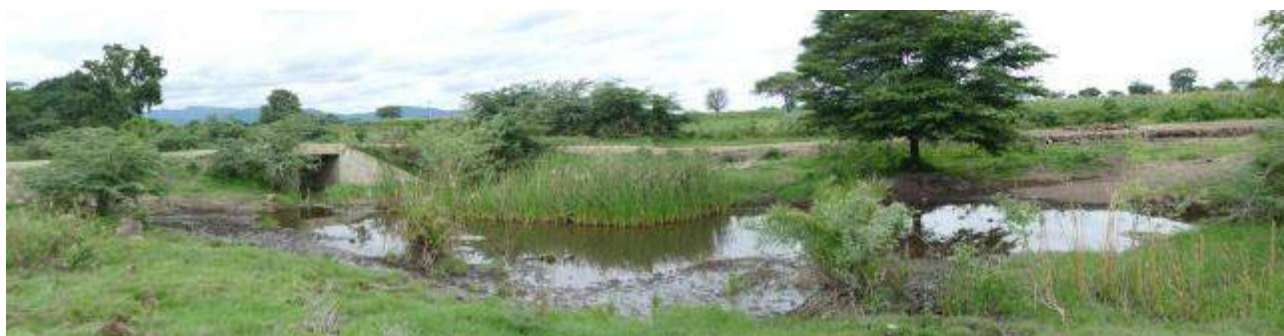
Figure 23 Culvert around 4.7 km showing eroded embankment caused by high water levels after heavy rains

Drainage is quite effective, and the condition of the side drains is good, although they are quite overgrown and there are few culverts. There is no obvious structural damage to the new road structure through water ingress. The output of a culvert at 4.7 km has not drained away quickly enough when the waterway is in spate and this has allowed water to erode a section of the embankment, as shown Figure 23.

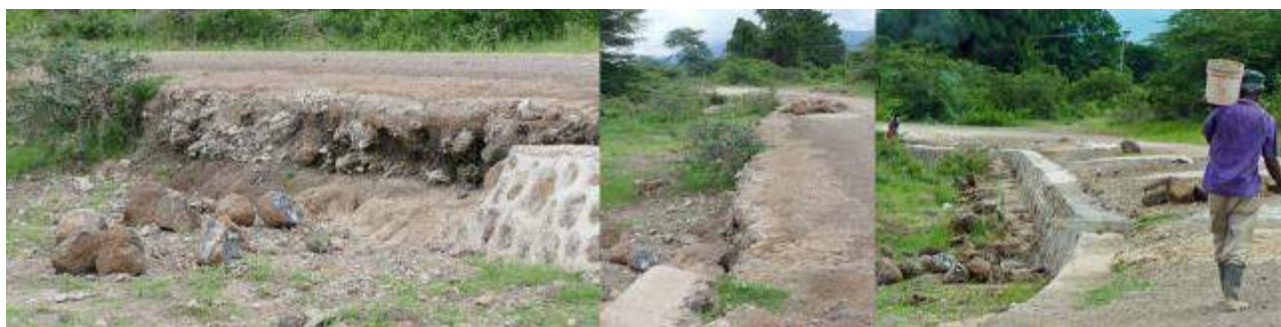
Figure 24 Road embankment near 4.7 km and the final culvert showing water erosion and repair

There appears no visual evidence of regular maintenance on the rehabilitated section of the road, although the area at 4.7 km has recently had repairs as water associated with the final culvert had eroded the embankment, as show in Figure 23 and Figure 24.

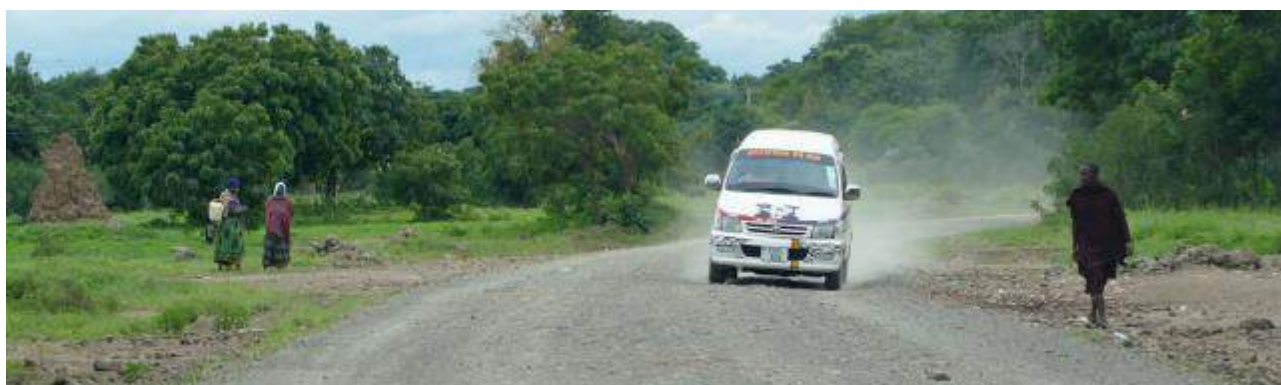
Figure 26 Road from Boma Ng'ombe to Rundugai, showing a drift and a problem water crossing

Apart from some poor earth roads to the hot springs, agricultural areas and the back of Rundugai, the only access to this road is from the Boma Ng'ombe-Rundugai-Chekimaji-Longoi-Kikavu road (DROMAS Road 35001), and therefore the condition and transport services along this road largely determine how traffic patterns on the rehabilitated road section evolve. The road from Boma Ng'ombe to Rundugai is very rough, with one water-crossing that can be difficult after heavy rains. This is illustrated in Figure 25 and Figure 26.

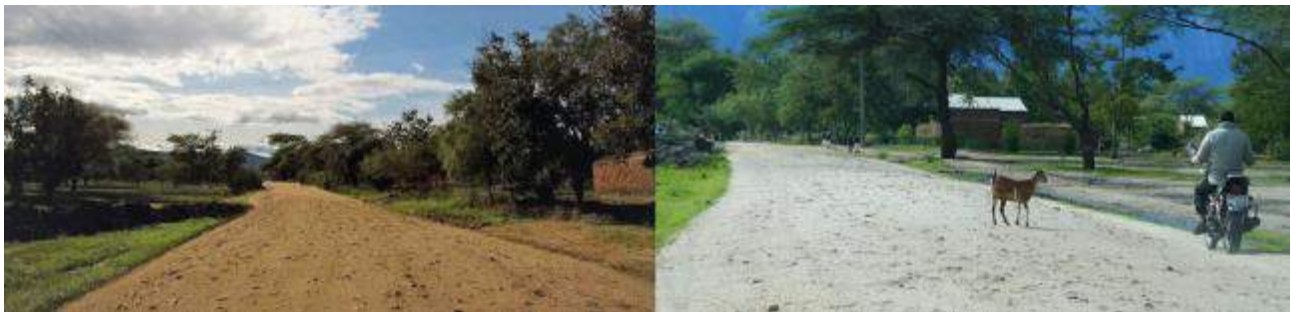
The road is in fair to poor condition in the agricultural area up to the junction at 6.6 km. Culverts are raised above road level because of the low-lying surrounding land, and some culverts are in poor repair, as shown in Figure 36.

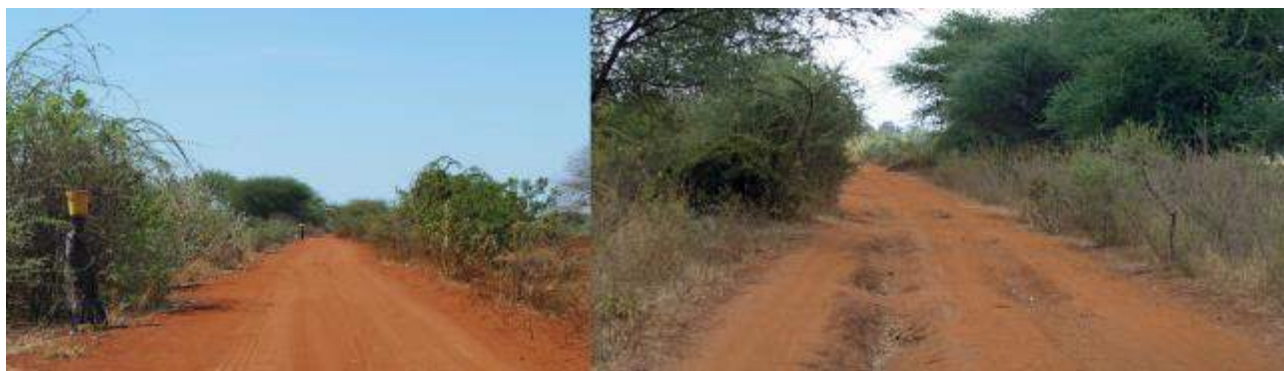
The road is between 6 m and 7 m wide. This is a low rainfall area and no soft spots or muddy areas were noticed, but the road surface is quite sandy in places, as shown in Figure 56.

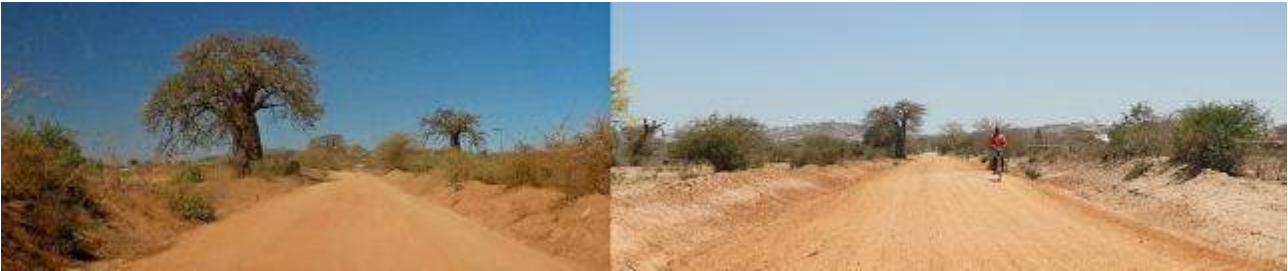
The road is not raised and in places is lower than the surrounding land, with little drainage apart from side drains. This is possible in a dry area but can still pose problems during heavy rains. Some large side drains have been constructed to the south side of parts of the road, and appear to be designed to capture surface water running off from the gently sloping land during a rain storm, and direct this run-off to culverts passing under the road, as shown in Figure 58.

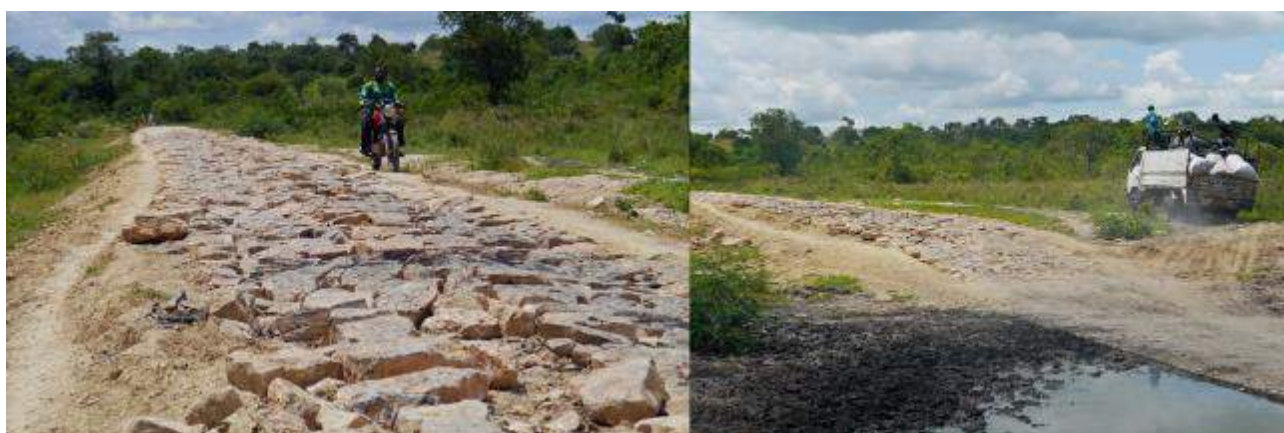
From 2012, all vehicles using this short section had problems. Motorcycles developed smooth side trails along the shoulder, while other vehicles including light trucks started to use side trails alongside the road to avoid this very rough and uneven surface, as shown in Figure 103.

The failed section had to be repaired, and this time high kerbs were installed to retain the surface. Gaps were left in the kerbs every 5 m to facilitate drainage into side drains, which are wide and flat alongside the road (see Figure 104). This system has survived for several years, although the surface is uneven, mainly due to the nature of the materials and the way the stone was dressed. It is still in good condition with little sign of recent deterioration. However, there is vegetation growing between the stones in the non-trafficked areas, and if left to grow this will eventually damage the surface.

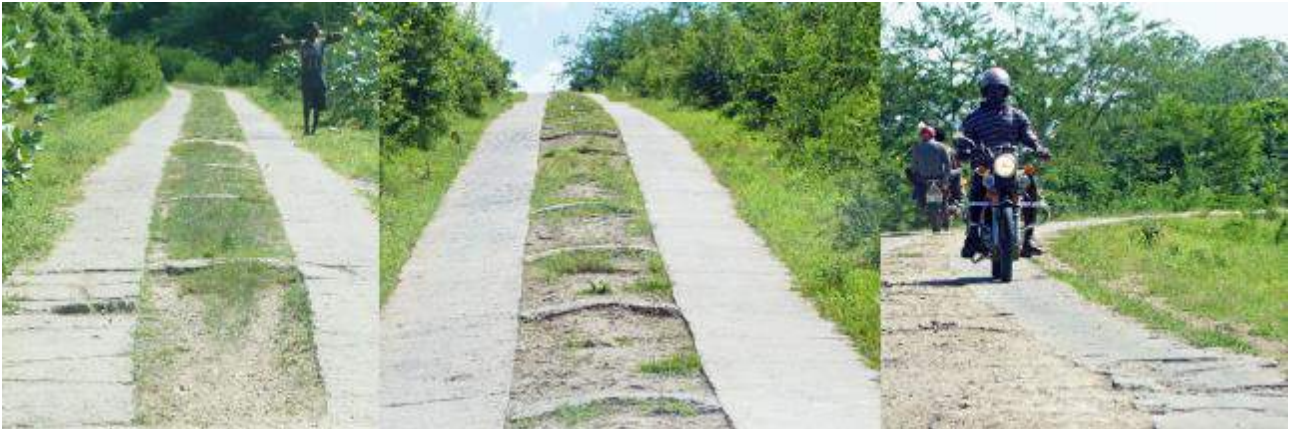
Since their construction, the connectors between the parallel strips have been proud of the surrounding gravel, with vertical edges at right angles to the road (creating small kerbs to be crossed by traffic using the centre of the road). This would pose particular problems to three-wheelers since their front wheels would repeatedly have to climb these kerbs. There is also some vegetation growing on the gravel base between and alongside the strips. While there was a construction difference between the reinforced and non-reinforced sections, in 2019 there was no obvious visible difference between the sections that could be attributed to the reinforcement. There was some breakup of both construction types, as can be seen in Figure 106 where the left photo is of the reinforced section and the right photo is of the unreinforced section.
