**TARGETED INTERVENTIONS UNDER THE  
RURAL ROAD INVESTMENT PROGRAMME IN  
MOZAMBIQUE (PHASE 1)**

**Construction/Progress Report**

**CLIENT PROJECT REPORT CPR 470**

**by K Mukura, S Done and Dr J Rolt**

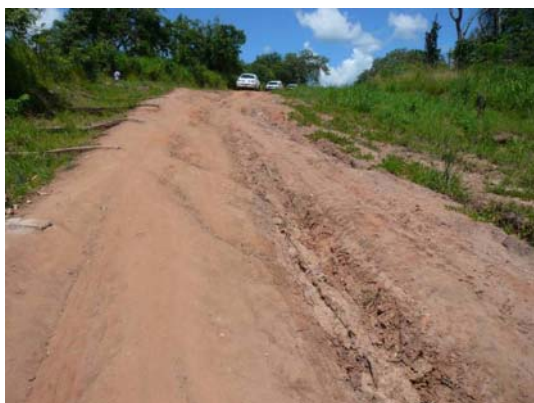
Eroded section of road prior to the main ramp

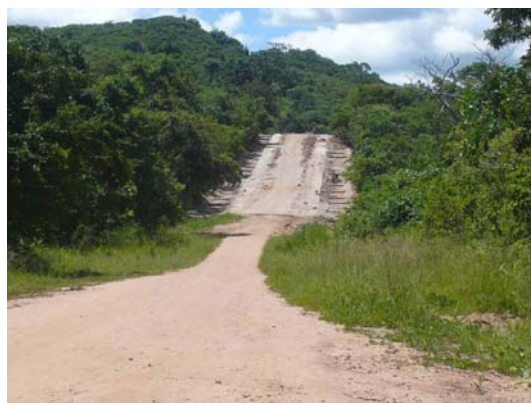
Toe of the concrete surface on the main ramp

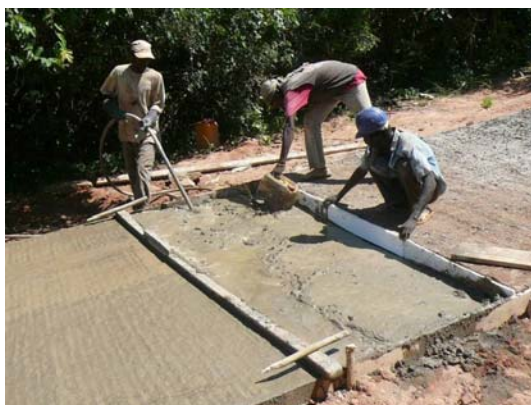
1. Concrete construction was variable, with potentially inaccurate batching by volume and with a high slump. High slump concrete can leave voids when hydrating and can also deform when being compacted on a steep gradient. It is not clear whether the concrete slabs are being kept moist for long enough to allow curing to complete.

Concreting a slab

6. The curing process must be carefully monitored and lengthened to 14 days because rapid loss of moisture on the surface could lead to weak concrete on the surface of the slabs which would not be resistant to abrasion and crushing under traffic.

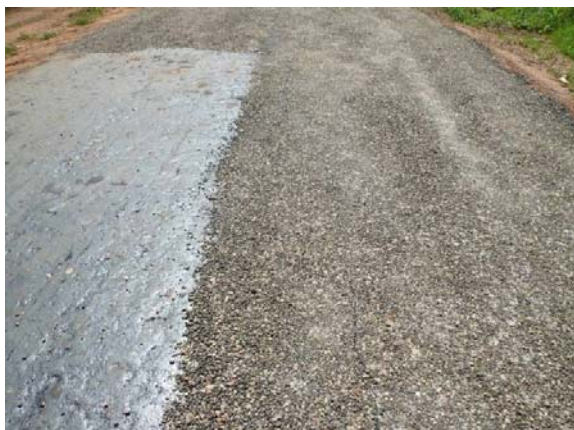
Section of prime (L) and Cape seal (R)

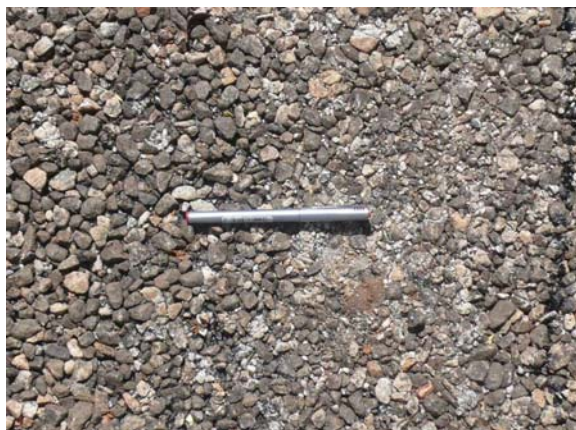
Crushing of Cape seal chippings

7. Pneumatic-tyred rollers should be used for compaction. Steel-wheeled rollers tend to crush and crack the aggregate and are not so good at orientating the stones into a tight mosaic. If pneumatic-tyred rollers are not available, only relatively light steel-wheeled rollers should be used (<8 tonnes) and then only if the aggregate is strong enough.

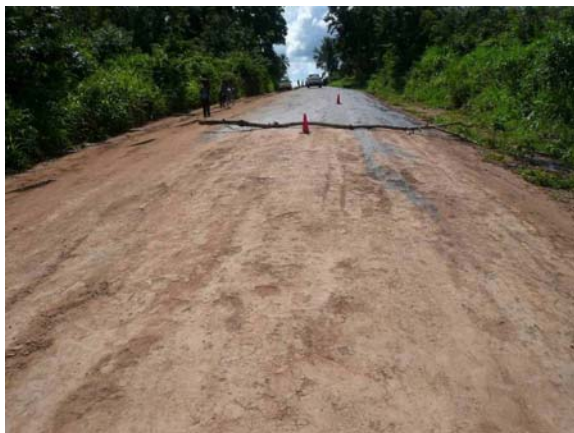
1. The preparation of base course made out of cement stabilised red sand had a very rough and uneven surface. This is not good for surface dressing because the bitumen will flow from the bumps to the depressions during application causing uneven distribution of the binder and this will, in turn, affect the performance of the surfacing. This could have been caused by over application of compaction water. Strict controls should be applied to construction of this nature.

Non-uniform base prior to applying the surfacing

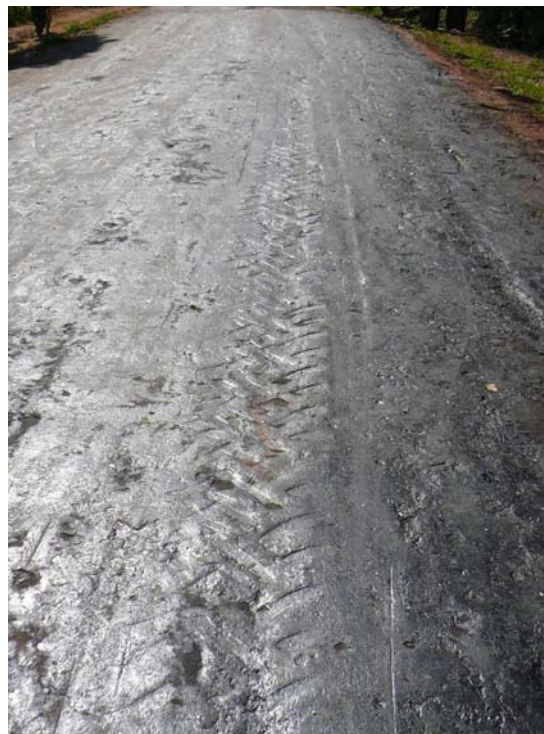
3. The road foundation on which the slabs were constructed was not properly compacted and was evident when it rained. The compacted foundation softened so badly that it was not possible to walk on it.

Tractor tyre indentations in the poorly compacted base

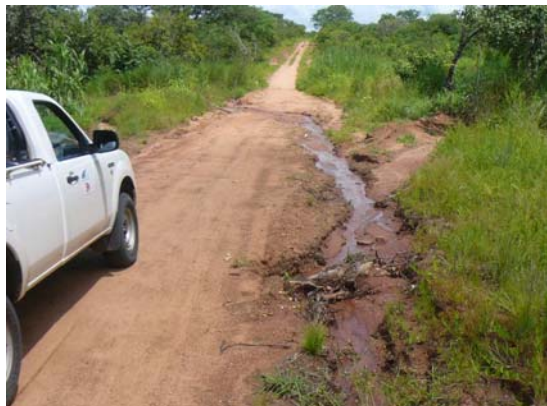
1. Most of the road is in poor condition with many areas of eroded and degraded formation, loss of gravel and some collapsed structures. Re-gravelling has begun in some places.

Section of road in need of repair and a new structure

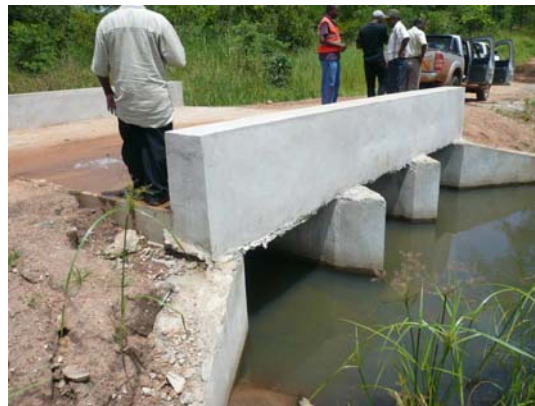
3. The wing walls of the recently constructed culverts were observed to be low, connecting to the headwalls at the level of the underside of the culvert slab rather than at the level of the top of the gravel surface. This low level is likely to lead to rapid erosion of the gravel.

Low wing walls which lead to the erosion of surfacing materials

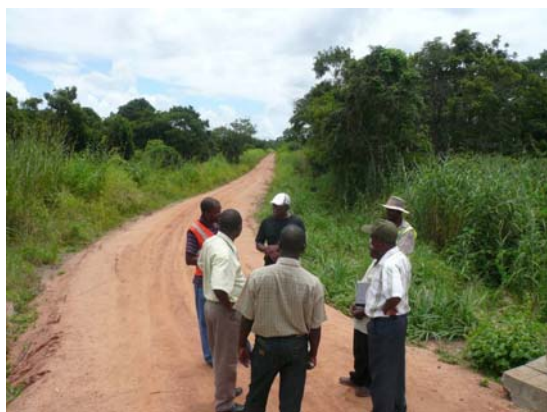
Section, beyond Mecuburi bridge, which is said to overtop

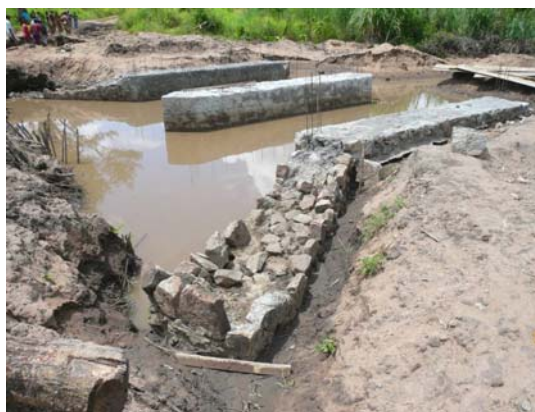
4. The estimated cost of a large culvert approximately 19 kilometres from Gracio is higher than would be expected for such a structure. Reasons for this high cost are unknown. It also appeared that the required cross-drainage capacity of the culvert has been estimated without supporting information concerning likely peak flows and therefore the culvert is at risk of being overtopped with subsequent damage to the road and to the culvert itself. It seems that, typically, culverts which overtop are replaced with larger culverts without any attempt to estimate the required size.

Culvert approximately 19 km from Gracio under construction

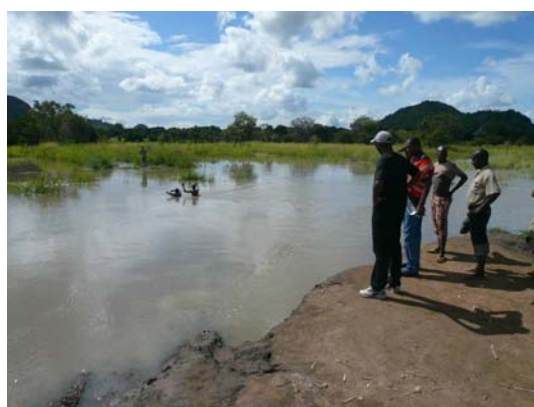
Basin at Milhana showing people wading across

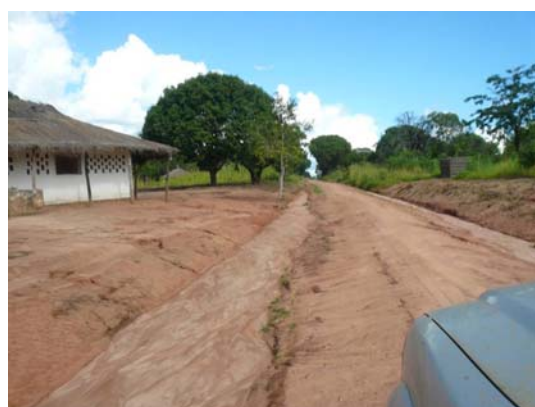
2. Unfortunately, in many places, recently constructed formation has already started to collapse and erode into the side drains and will need repair before being gravelled again.

Section of formation degrading without the protection of a gravel surface

1. It was recommended that new formation work is covered with gravel as soon as possible to prevent it being damaged by rain.
2. The basin at Milhana should be surveyed in detail to look for the most suitable place to locate the embankment crossing (a stable site, reduced volume of required fill, etc) and to determine if an outlet blockage is preventing the basin draining and thereby raising flood water levels.
3. Source of good construction materials should be identified and assessed for quality (grading, Atterberg and CBR tests) and quantity.
4. Alternative designs for the Milhana crossing should be considered.
5. A breakdown of concrete costs should be prepared.

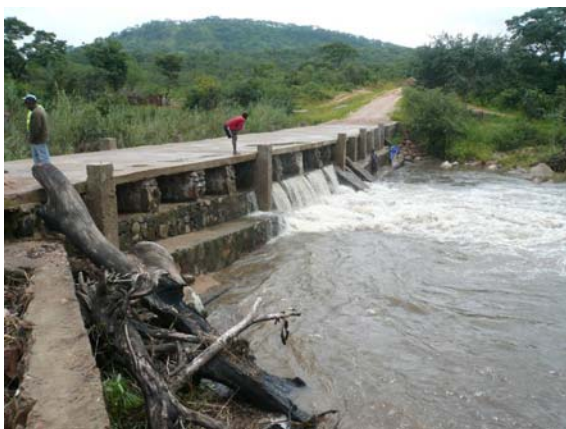
Improved structure on Rio Nhimbe with water flowing at both levels

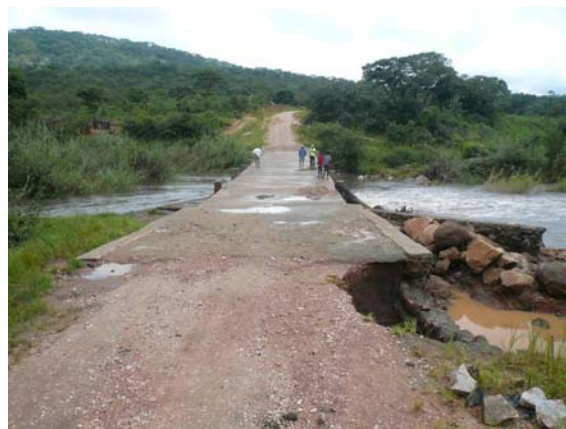
Downstream erosion of improved Rio Nhimbe structure

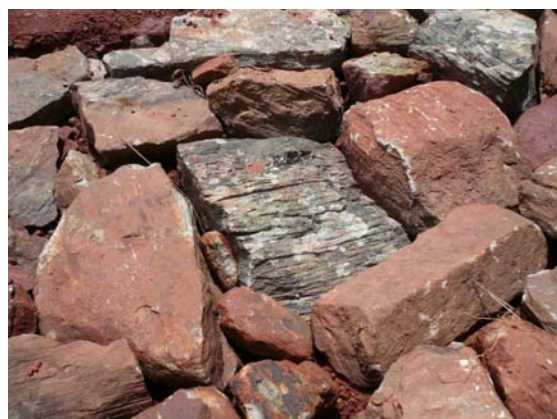
Stone placement – uncompacted soil and loose packing

1. Clear section of all debris.
2. Mark and excavate carriageway area for laying stones.
3. Compact road base.
4. Lay stone packed in stable position.
5. Pour concrete of high workability to fill the gaps.
6. Lay mesh wire or fencing net wire.
7. Prepare and place concrete screed of low workability.
8. Compact by ramming and in the process impress fine corrugations for traction.
9. When concrete has set, place a blanket of sand on top and wet it for curing for 7 days.

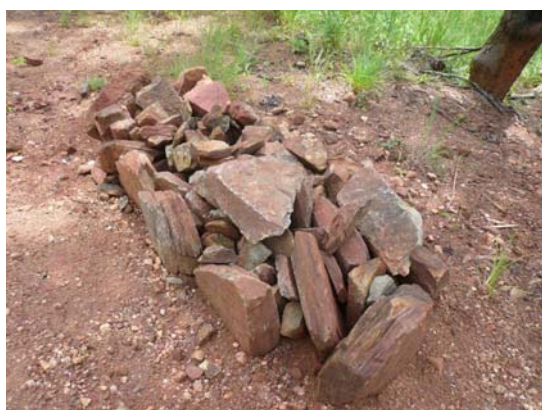
Rejected stones – some laminar, some non-laminar

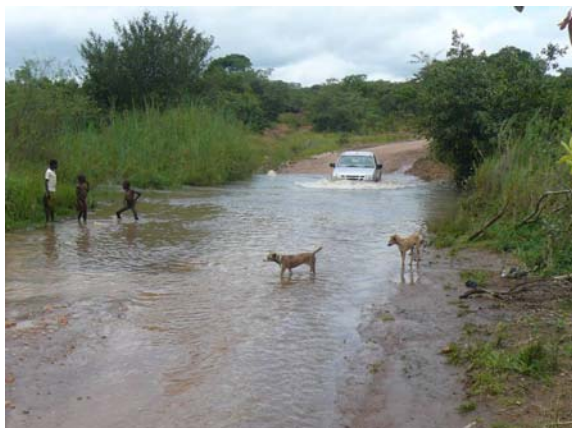
Deep drift near to Cachombo

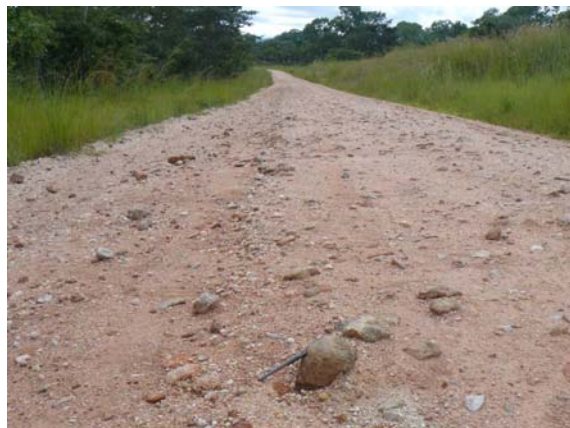
Rough road surface

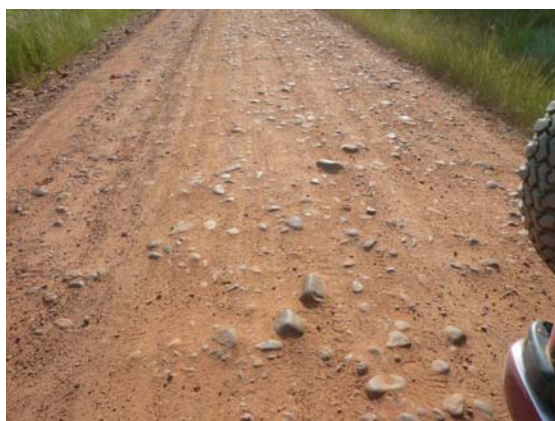
Rough surface of the original road

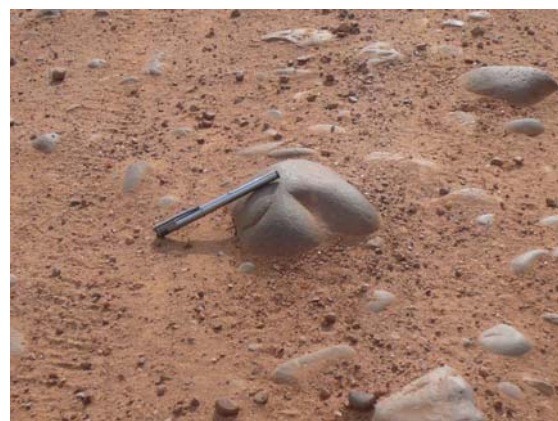
Rough surface of the original road – detail

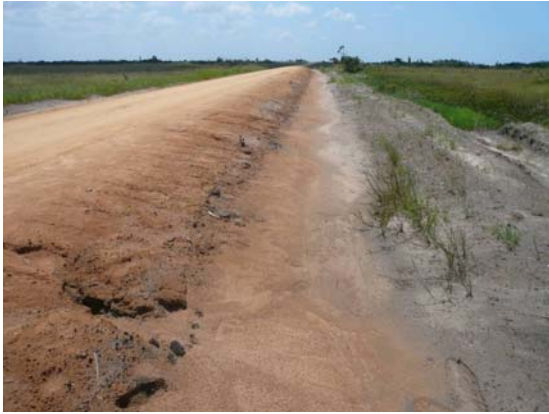
Lateral erosion of the constructed embankment

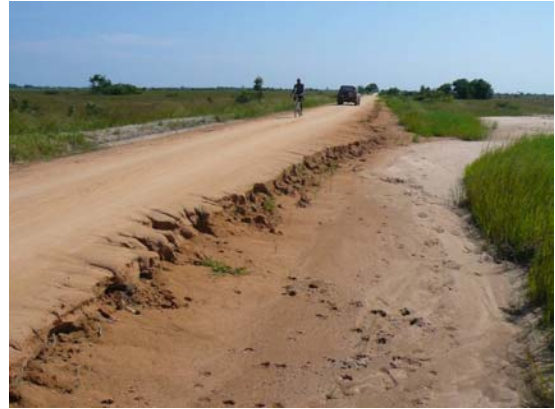
Side drain erosion of the constructed embankment

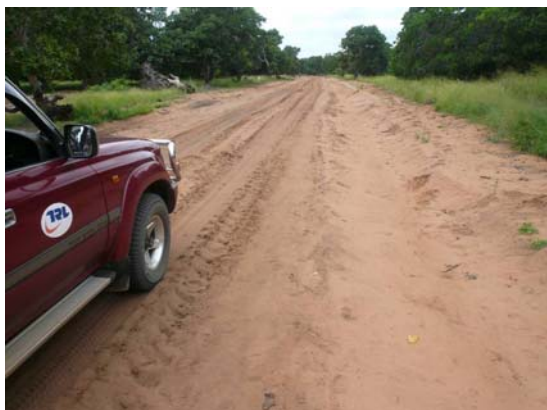
Completed formation which is rapidly collapsing

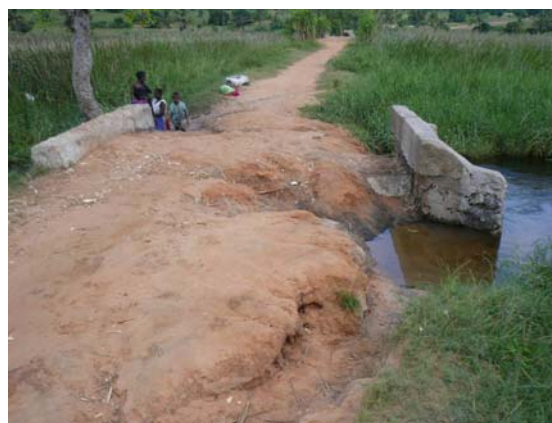
One of several original culverts to be cleaned and repaired

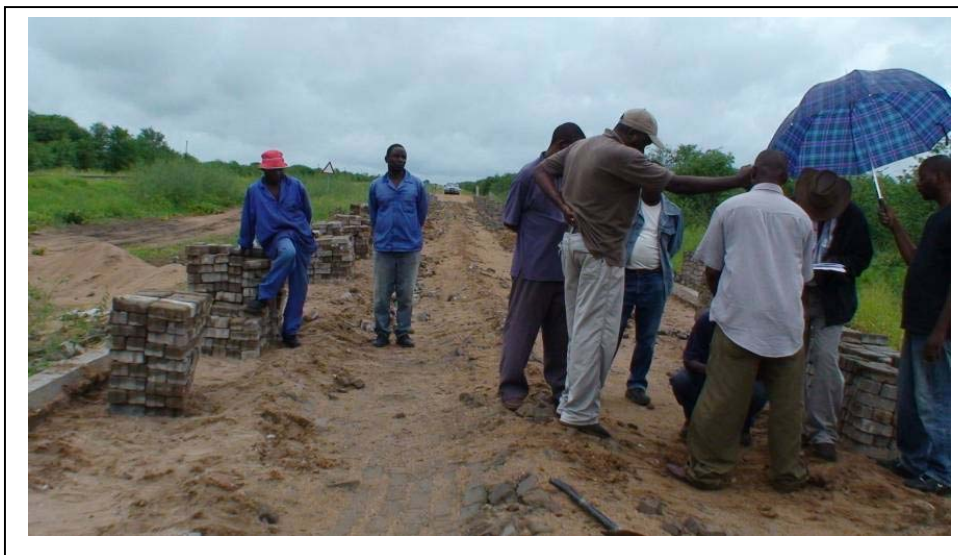
Block paving failures on Macaritane Chicualacuala Road

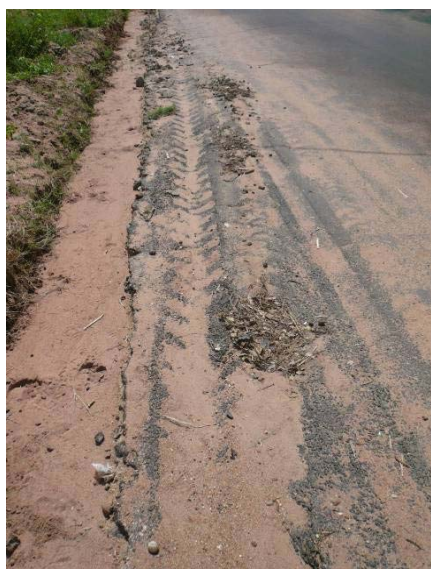
Section 3: Left hand side edge damage

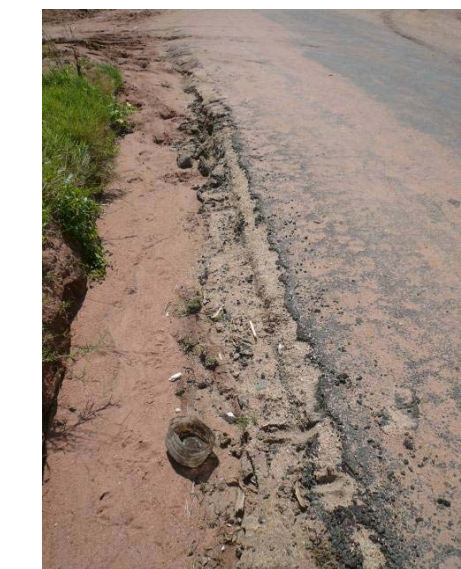
Section 3: Erosion and reduced lateral support

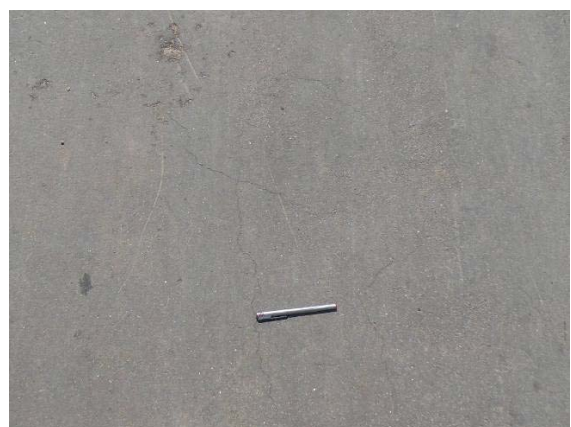
Section 5: Potholes and surface detail

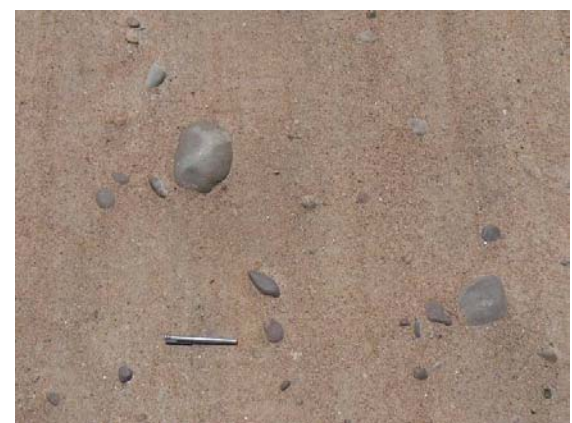
Section 6: Large stones and surface detail

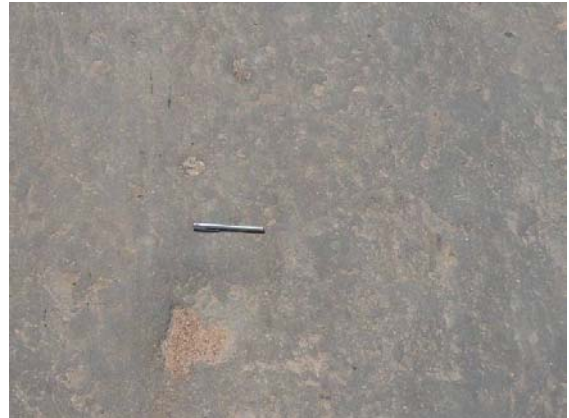
Section 7: Potholes, bleeding and surface detail
