Targeted Interventions on Low Volume Rural Roads in Mozambique

AFCAP Project Phase 2

QUARTERLY PROJECT PROGRESS REPORT NO.3

FEBRUARY 2011

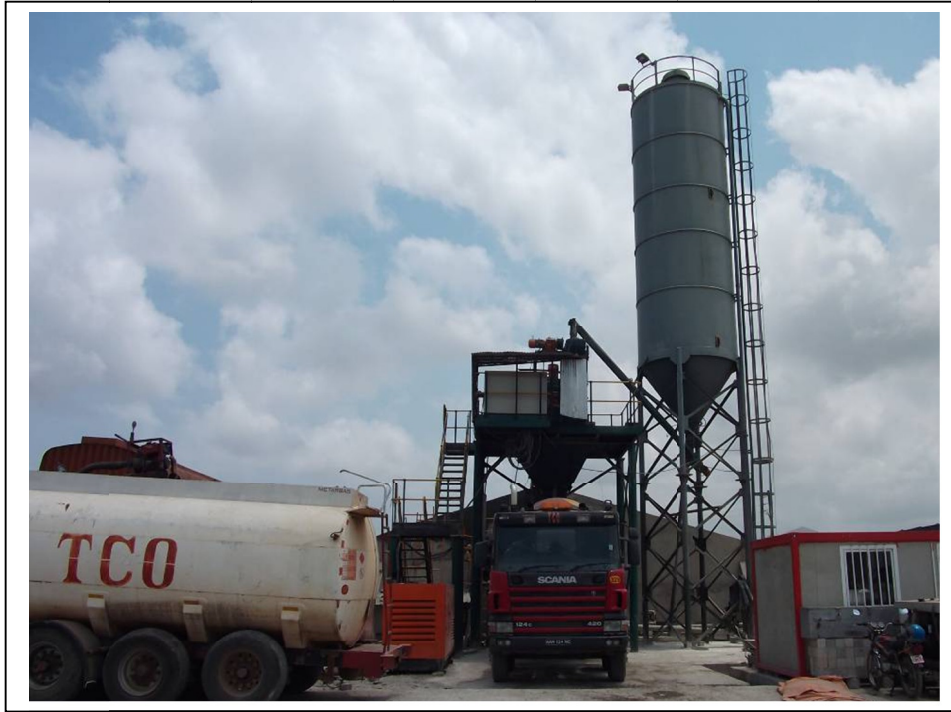
Figure 4-1 TCO's Concrete Plant for ETB Mixing

- d. The contractor had promised to use the concrete plant in Beira Town to mix the ETB, ~~Figure 4-1~~ [Figure 4-4](#). This would have been the best option because plant mixing produces better quality of ETB and productivity is usually high at about 8m³ in 20mins. However, it has come to light that the plant is now committed to other works and will not be available for the project.

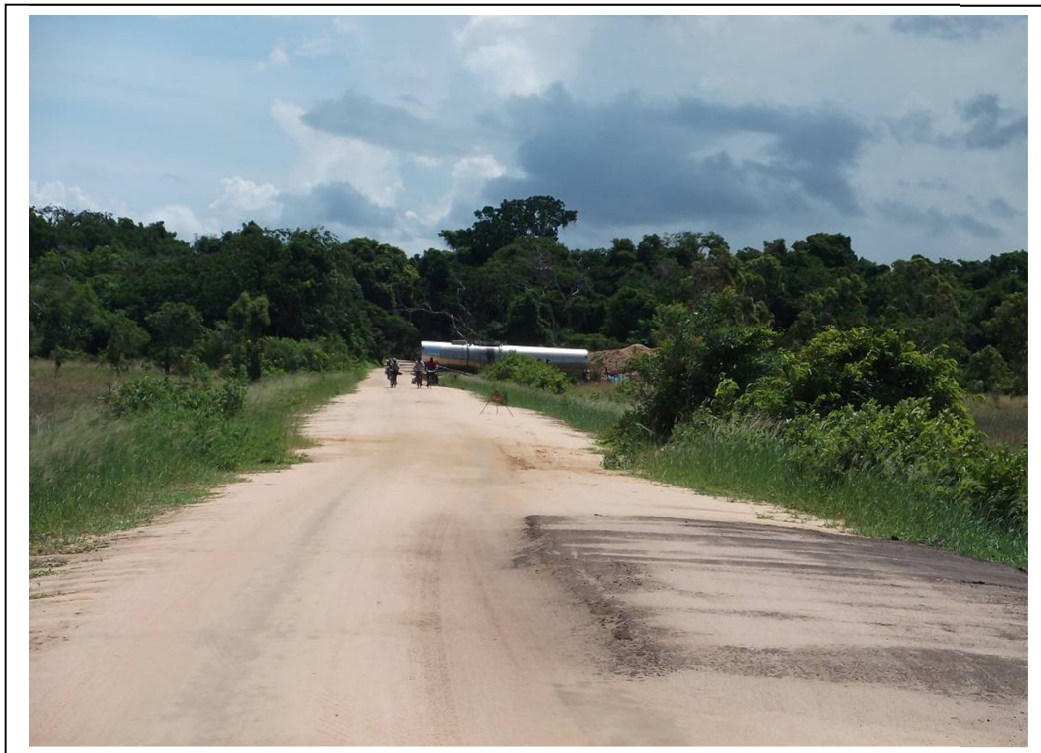
Figure 4-2 Trial section for ETB Construction

- a. The design of 4% emulsion content for the ETB was found to be satisfactory based on the ETB that was produced. This is a very positive outcome because the sand is very fine and there had been concerns as to

- b. The workmanship was poor and a lot needs to be done to improve it. The mixing was inadequate and there are portions in the ETB layer matrix with little bitumen and others portions which are rich in bitumen.

- c. The construction of the ETB was slow and cumbersome. The contractor was advised to increase the mixing capacity by either using the concrete plant in Beira city or by bringing more mixers to site, otherwise the work will take many months to complete.

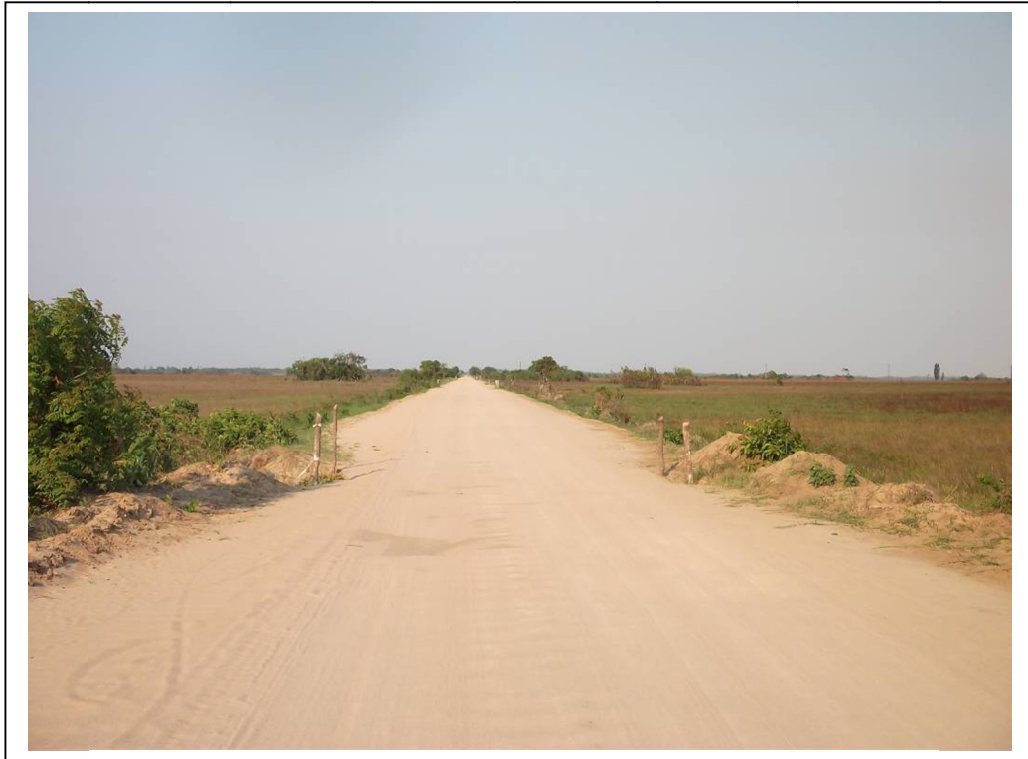
Figure 4-3 Culverts needing extension

- b. The existing culverts in both sections are about 5m in length and the carriageway was designed to be 6m wide. Since there is no budget for drainage improvements it was suggested that the carriageway be narrowed to 5m with 0.5m sealed shoulders in between the culverts. The general carriageway width for other sections built under RRIP/AFCAP project was 5m with 0.5m shoulders. The difference in design on this project of a 7m wide road was due to the high water levels during flood periods. A wide road reduces the extent of moisture ingress from the sides and this helps to keep wheel tracks at below optimum moisture content. There are 4 culverts, two on each section which are less than 4.5m long and will need to be extended, Figure 4-3.

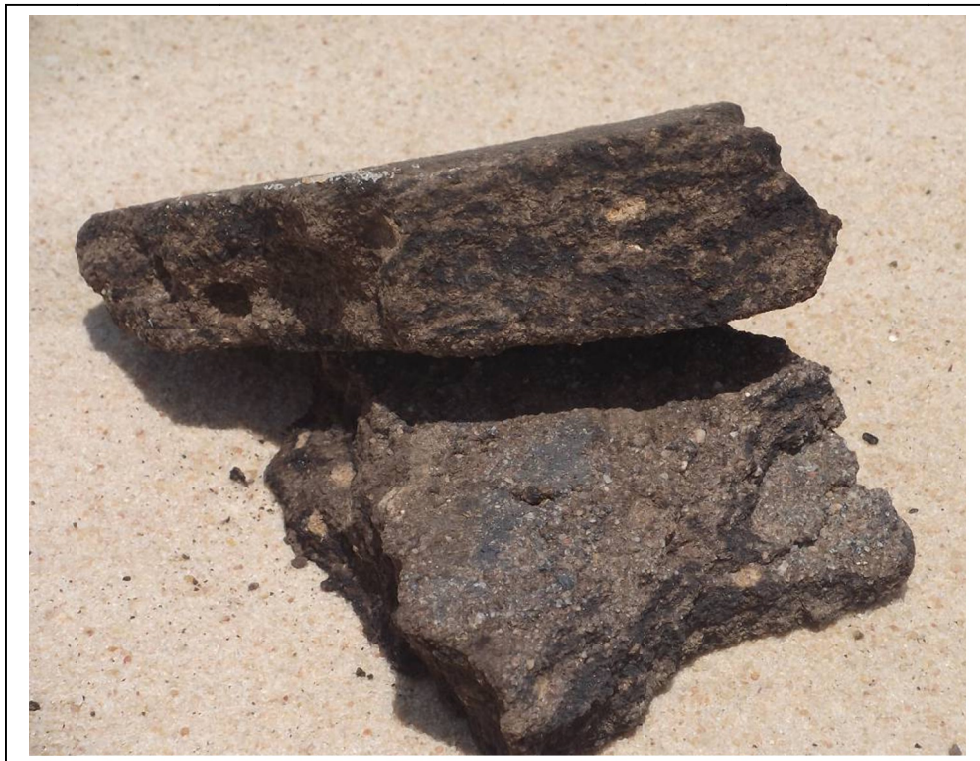
- d. The strength of the ETB as laid showed good resilience against traffic and weather elements. This is illustrated in the ETB blocks, [Figure 4-4](#), sampled from the cured trial sections. The ETB cannot be used as wearing course but the trial section has been open to traffic and weather elements for more than two months and there has been very little damage. Some of the ETB which fell on the side slopes has been submerged in water for almost two months since the flood waters rose and these have maintained much of their strength. This is a good sign.

Figure 4-4 Block of cured ETB from trial section

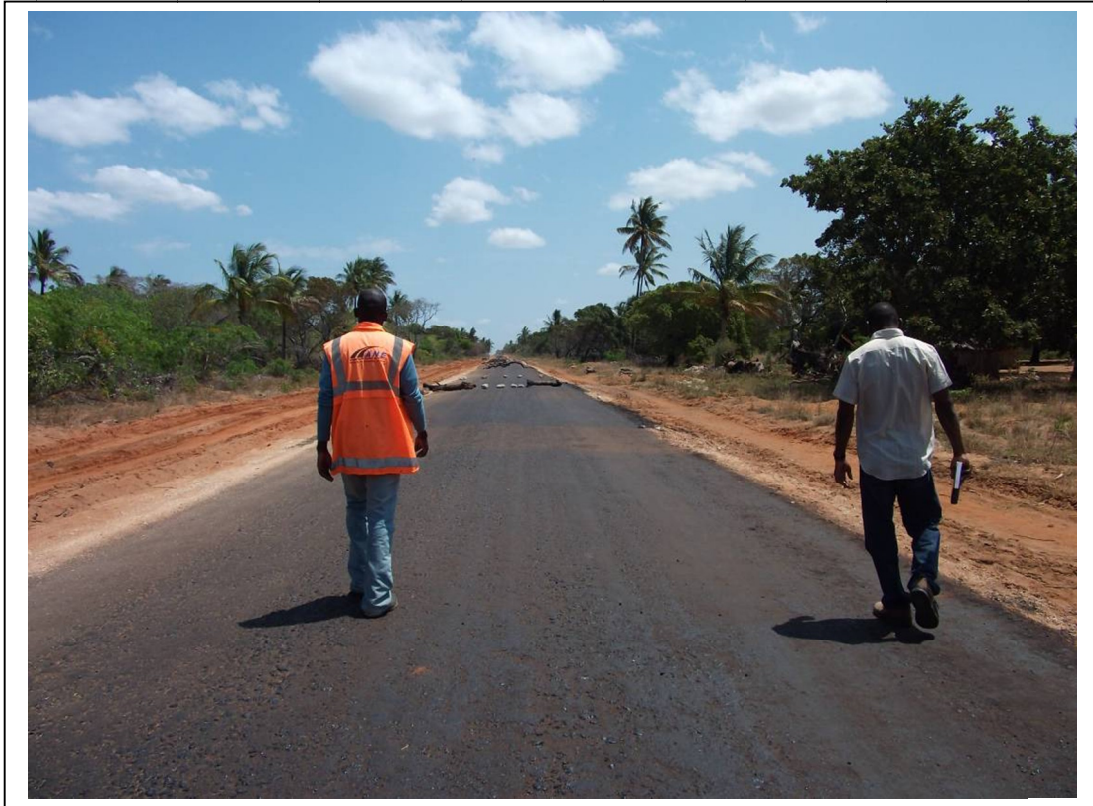
The construction of the base was completed in the previous reporting period. Unfortunately the completed base was trafficked for a long time before priming. As a result, the surface of the base became rough. Nevertheless priming was applied on the rough base. The newly-acquired binder distributor was used and it worked well, producing a prime coat that met the specifications (an application rate of 0.6L/m² of MC30 is specified for the Otta seals on trial sections under AFCAP). The prime cured properly before surfacing was applied, [Figure 4-5](#)~~Figure 4-5~~.

Figure 4-5 Primed section ready for Otta seal surfacing

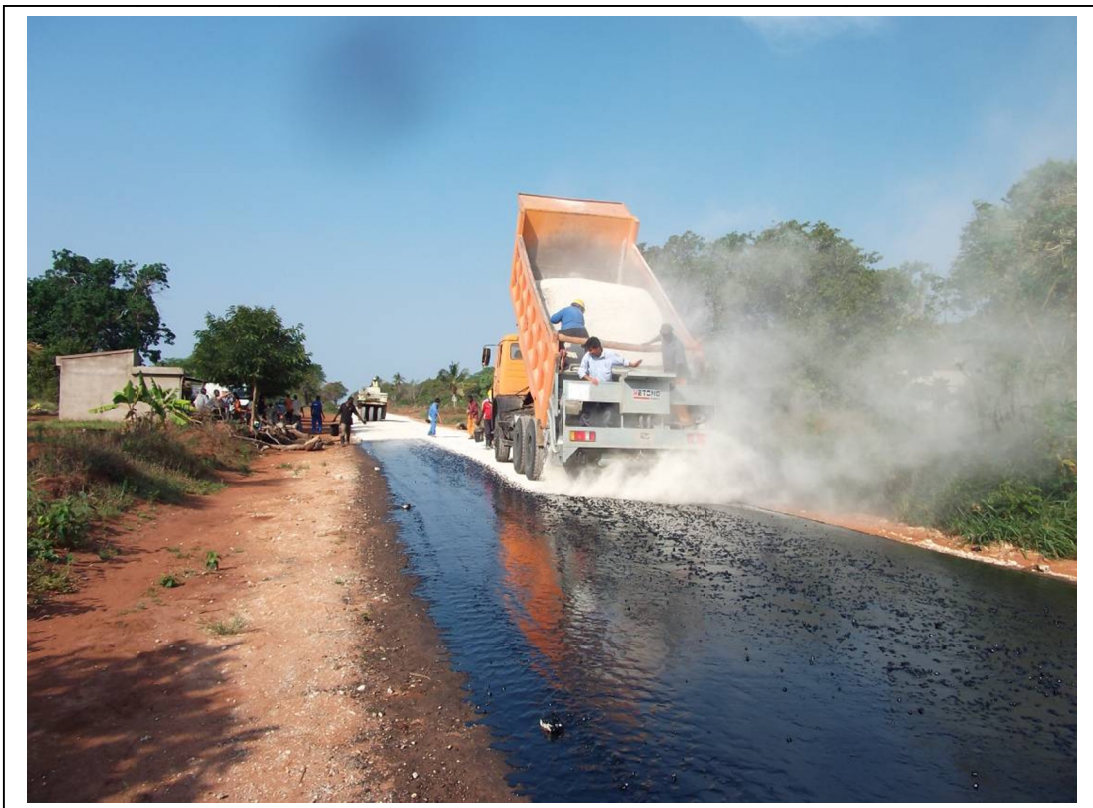
The dust in the aggregate was of major concern, ~~Figure 4-6~~ ~~Figure 4-6~~, but there was not much that could be done without escalating costs through repeated sieving. However, the nature of the dust is such that it could act as a filler because of its gritty nature. It was decided to use the aggregate as it was.

Figure 4-6 Dusty calcrete aggregate

3. *Materials*: the calcrete aggregate was too dusty and remedial measures were required to make the application work. Prolonged rolling was necessary to produce the necessary mosaic.

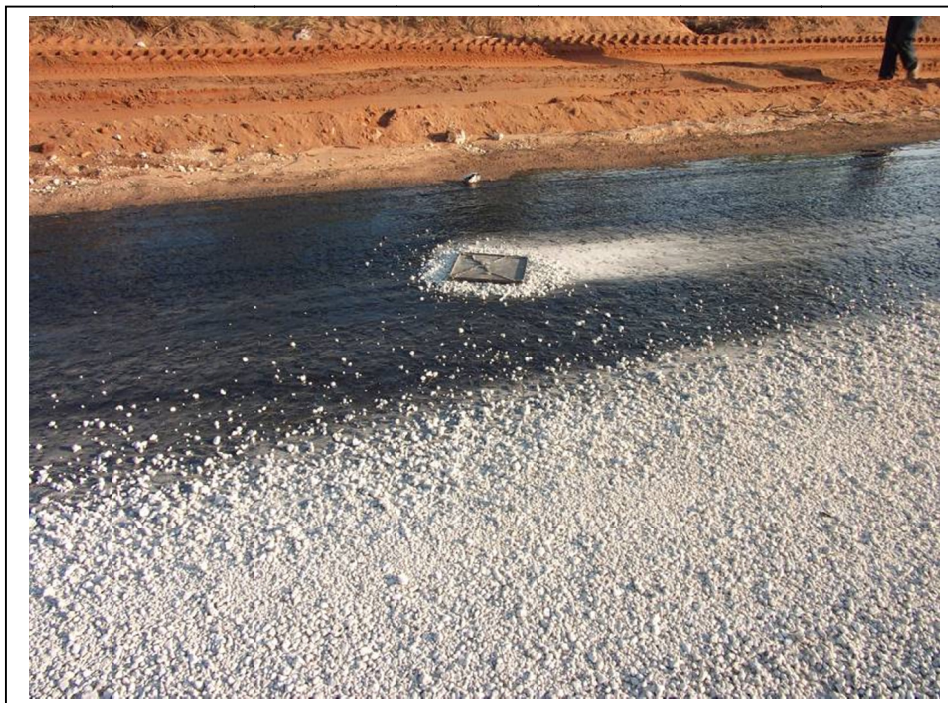
The application rates of stone were measured using the tray and balance, [Figure 4-7](#). This measurement was carried out regularly in order to control the application rates of the aggregate.

Figure 4-7 Tray test for control aggregate application rate

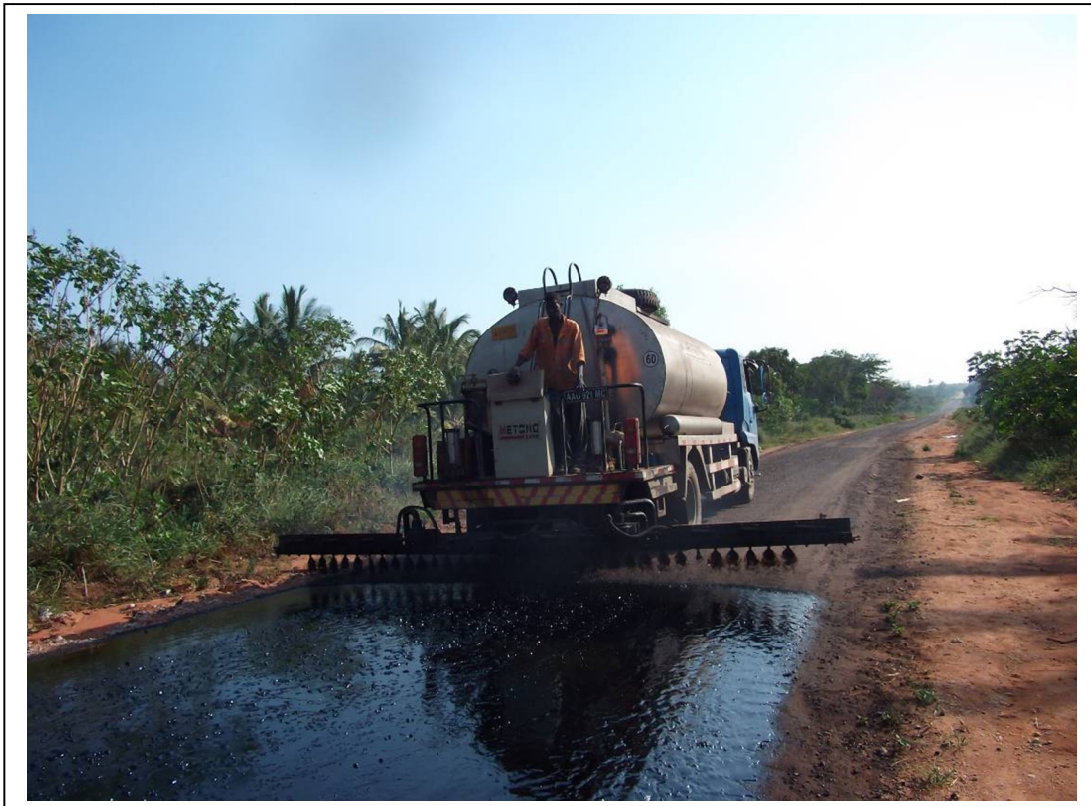
2. *Equipment.* There was a major problem with the BD. The spray bar clogged frequently and it took a long time to unblock. This is actually an inherent problem with the equipment. The spray bar had no insulation and therefore the bitumen cools down rapidly and becomes too viscous to flow properly (~~Figure 4-8~~~~Figure 4-8~~). Clogged nozzles adversely affected the even distribution of bitumen. This normally shows up as stripping in areas starved of bitumen. The contractor did not have adequate tools on site. The burner which was supposed to be used to heat and unblock the spray bar was too small and not useful at all. The BD did not have a hand lance which is used for corrective spraying. There weren't enough hard brooms. The chip spreader was also, at times, clogging up and sometimes not spreading aggregate uniformly.

Figure 4-8 Binder application and illustration of blocked nozzle
