Back Analysis of Previous Low Volume Rural Roads in Mozambique

DRAFT PROJECT INCEPTION REPORT

Report No. CPR 1410

Transport Research Laboratory

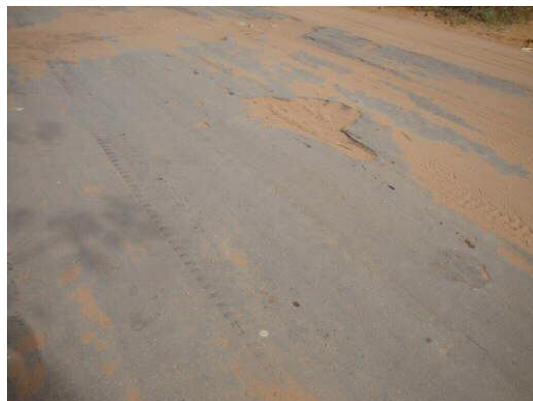
The surface condition of Section 1 is poor with several potholes and surface loss. Section 2 is better than Section 1 but most traffic tends to drive on the sandy side of the road which is smoother.

Although this road was built in 2005, it is already showing signs of significant structural and surfacing failure. The causes of the failure will be investigated during the detailed phase of this study. This could be attributed to some of the following:

1. Under design of the pavement
2. Non-compliance with the method statement during construction
3. Drainage induced failure associated with the road level being below ground level
4. Seasonal moisture variations/repeated wetting and drying.

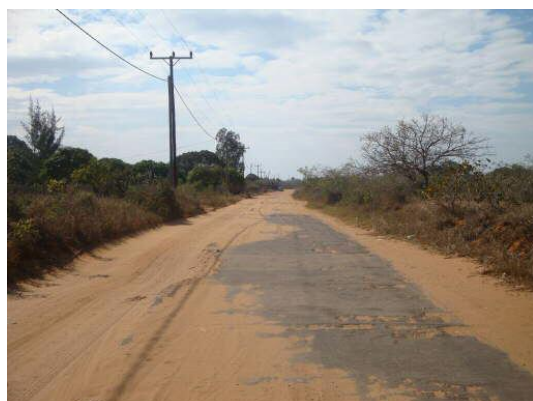
Section 3 is identical in condition to Section 1. The surface has several potholes and depressions by the side of the surfaced portion where water ponds.

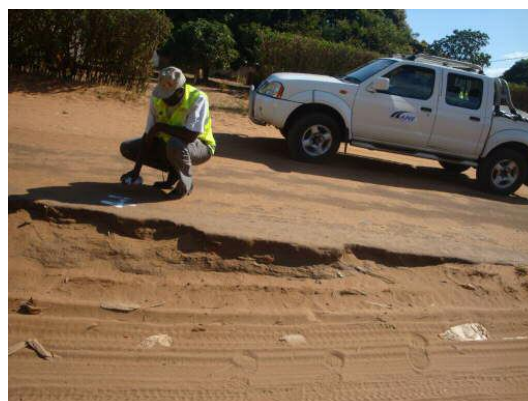
Section 4 has deeper and wider potholes and traffic generally avoids using the road section and rather uses the side of the road. It is in very poor condition.

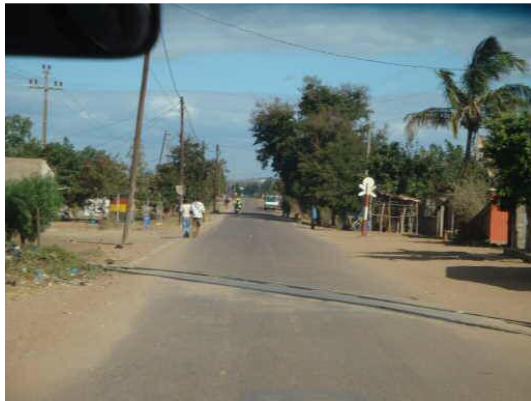
Section 1 and 2 were constructed with a crushed stone Macadam base. Section 1 is in good condition despite being predominantly flat and without side drains. Section 2 is visually in poor condition with several potholes and cracks. The geometry of this section alternates between flat and sloping. Sections 3 to 6 were built with a cement treated sand base (CTSB). Section 3 is flat and the visual condition is good. Section 4 is in fair condition with several crocodile cracks and minor potholing. Section 5 is sloping and is located in a swamp. The visual condition is good with minor rutting. Section 6 is located in a swamp but, unlike Section 5, the condition is poor with significant rutting, cracking and potholing.

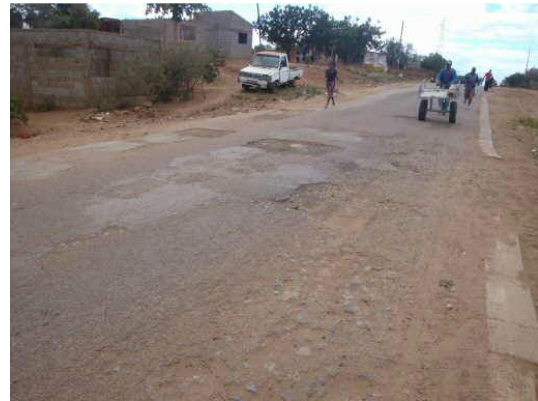
Section 2

| Section | Start Chainage | End Chainage | Section Length (km) | Surfacing Type | Base Materials | Visual Condition (Good, Fair, Poor) | Longitudinal Section Geometry (Flat, Slope, Rolling) | Cross-sectional Geometry (Trough, Crest, Flat) | Sub-surface drainage (Good, Fair, Poor) | Other Remarks |
|---|---|---|---|---|---|---|--|--|---|---|
| 2 | Km: 0+300 | 0+800 | 0.5 | Double Surface Dressing | Crushed Rock | Poor | Slope | Flat | Good | Potholes, Cracks and Patching |

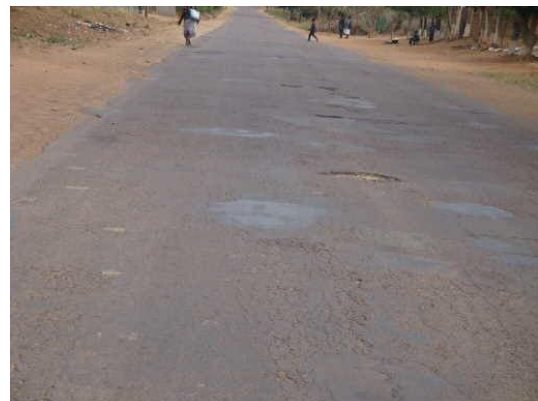
Section 4

| Section | Start Chainage | End Chainage | Section Length (km) | Surfacing Type | Base Materials | Visual Condition (Good, Fair, Poor) | Longitudinal Section Geometry (Flat, Slope, Rolling) | Cross-sectional Geometry (Trough, Crest, Flat) | Sub-surface drainage (Good, Fair, Poor) | Other Remarks |
|---|---|---|---|---|---|---|--|--|---|---|
| 4 | Km: 5+400 | 5+700 | 0.3 | Double Surface Dressing | CTSB | Fair | Flat | Flat | Good | Cracks all over but minor potholing |

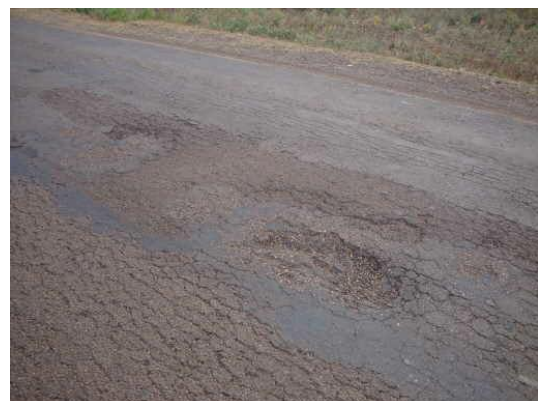
Section 6

| Section | Start Chainage | End Chainage | Section Length (km) | Surfacing Type | Base Materials | Visual Condition (Good, Fair, Poor) | Longitudinal Section Geometry (Flat, Slope, Rolling) | Cross-sectional Geometry (Trough, Crest, Flat) | Sub-surface drainage (Good, Fair, Poor) | Other Remarks |
|---|---|---|---|---|---|---|--|--|---|---|
| 6 | Km: 7+960 | 8+600 | 0.64 | Double Surface Dressing | CTSB | Poor | Flat | Crest | Poor | Rutting, Cracking and Potholes |

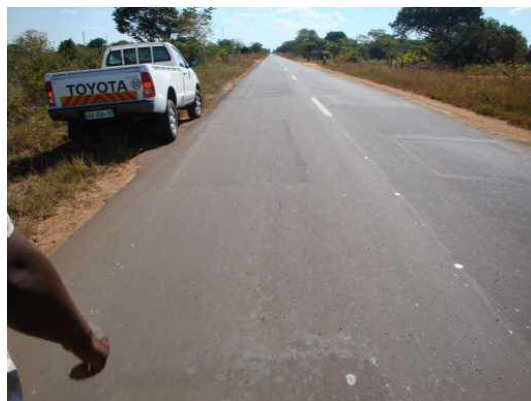
The sections have very similar characteristics but with minor differences. There is some minor pitting in Section 1; the mix on Section 3 looks leaner; Section 12 is low lying; and there are curves on Sections 13, 14 and 15.

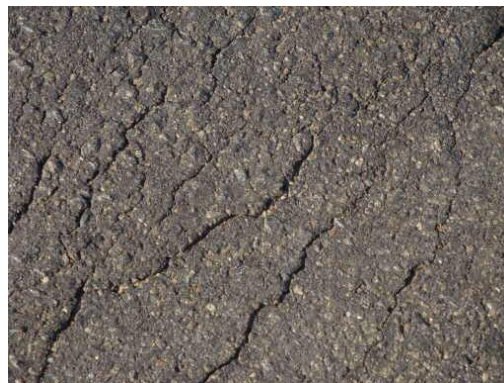
Section 5

| Section | Start Chainage | End Chainage | Section Length (km) | Surfacing Type | Base Materials | Visual Condition (Good, Fair, Poor) | Longitudinal Section Geometry (Flat, Slope, Rolling) | Cross-sectional Geometry (Trough, Crest, Flat) | Sub-surface drainage (Good, Fair, Poor) | Other Remarks |
|---|---|---|---|---|---|---|--|--|---|---|
| 5 | Km: 140+700 | 141+900 | 1.2 | Hot Sand Asphalt | Patched on CTB after milling DSD | Fair | Flat | Crest | Good | Low lying land, though well drained. Some cracks and 5 potholes |

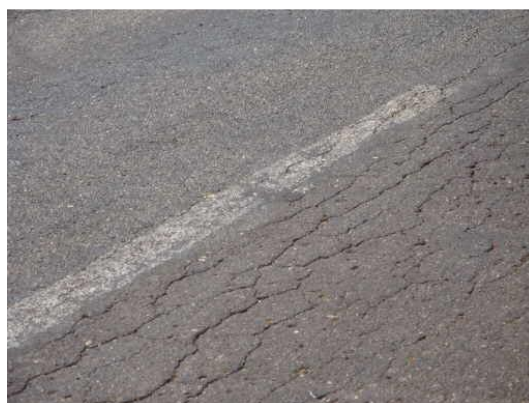
Section 6

| Section | Start Chainage | End Chainage | Section Length (km) | Surfacing Type | Base Materials | Visual Condition (Good, Fair, Poor) | Longitudinal Section Geometry (Flat, Slope, Rolling) | Cross-sectional Geometry (Trough, Crest, Flat) | Sub-surface drainage (Good, Fair, Poor) | Other Remarks |
|---|---|---|---|---|---|---|--|--|---|---|
| 6 | Km: 155+000 | 155+200 | 0.2 | Hot Sand Asphalt | Patched on CTB after milling DSD | Poor | Flat | Crest | Good | Crocodile cracks, rutting and flow. |

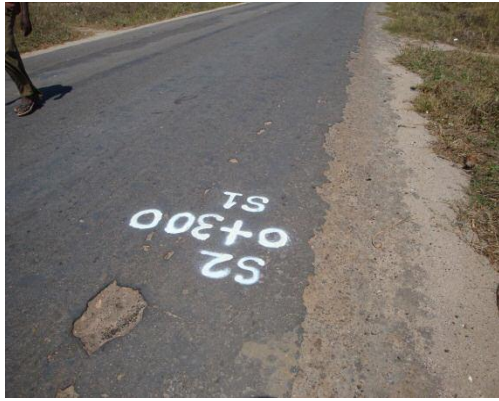
Section 1 and 2

| Section | Start Chainage | End Chainage | Section Length (km) | Surfacing Type | Base Materials | Visual Condition (Good, Fair, Poor) | Longitudinal Section Geometry (Flat, Slope, Rolling) | Cross-sectional Geometry (Trough, Crest, Flat) | Sub-surface drainage (Good, Fair, Poor) | Other Remarks |
|---|---|---|---|---|---|---|--|--|---|---|
| 1 | Km: 0+000 | 0+300 | 0.3 | Sand Seal | ETB | Fair | Flat | Crest | Good | Block cracks-(shrinkage) unsurfaced shoulders Road level above ground level |

Sections 1 and 2 are on flat terrain, the road lies above ground level and appears well drained. Section 1 is in a fair condition and most of the visible defects are block cracks.

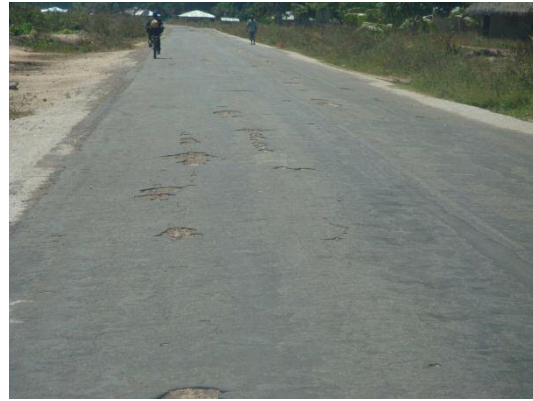
| Section | Start Chainage | End Chainage | Section Length (km) | Surfacing Type | Base Materials | Visual Condition (Good, Fair, Poor) | Longitudinal Section Geometry (Flat, Slope, Rolling) | Cross-sectional Geometry (Trough, Crest, Flat) | Sub-surface drainage (Good, Fair, Poor) | Other Remarks |
|---|---|---|---|---|---|---|--|--|---|---|
| 2 | Km: 0+300 | 0+900 | 0.6 | Sand Seal | ETB | Poor | Flat | Flat | Good | Potholes (1.5x0.5m) Transverse cracks Stripping Road level below ground level |

Section 2 is in poor condition as characterised by the stripping of the surfacing, transverse cracks and severe potholing (typically 1.4m by 0.5m), which are mainly concentrated in the Oasse-bound lane.

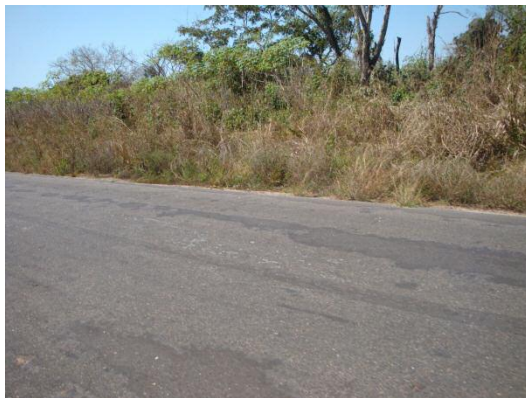
Section 4 is on a longitudinal slope. The road level is above ground level and it is in good condition. Section 5 is in rolling terrain and the cross section is in part cut and part fill. The condition of the section is very poor, most evident in the cutting on the Mocimboa-bound side of the carriageway where the road lies below the natural ground level. There is no evidence of sub-surface drainage. The typical depth of edge drops is 300mm.

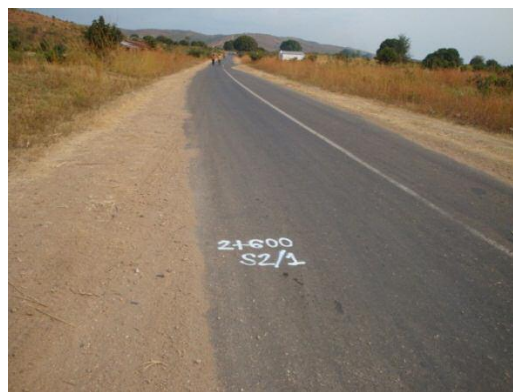
| Section | Start Chainage | End Chainage | Section Length (km) | Surfacing Type | Base Materials | Visual Condition (Good, Fair, Poor) | Longitudinal Section Geometry (Flat, Slope, Rolling) | Cross-sectional Geometry (Trough, Crest, Flat) | Sub-surface drainage (Good, Fair, Poor) | Other Remarks |
|---|---|---|---|---|---|---|--|--|---|--|
| 2 | 2+500 | 2+600 | 0.1 | Otta seal | Natural Gravel | Poor | Flat | Flat | Good | Potholes Cracking Access to petrol station |

Section 2 is 0.1km long and is located approximately 2.5 km from Metangula. The road lies below natural ground level, and there are signs of poor pavement condition and deterioration characterised by potholes, patching, runoff overtopping and severe cracking and patching.

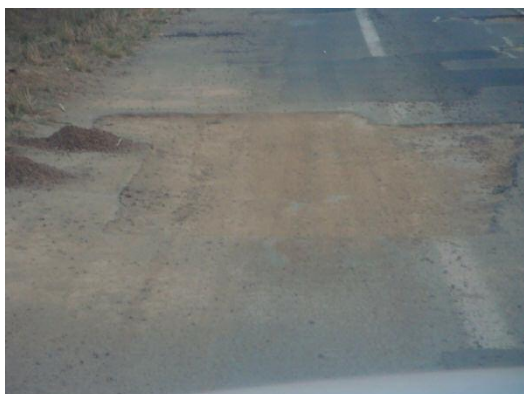
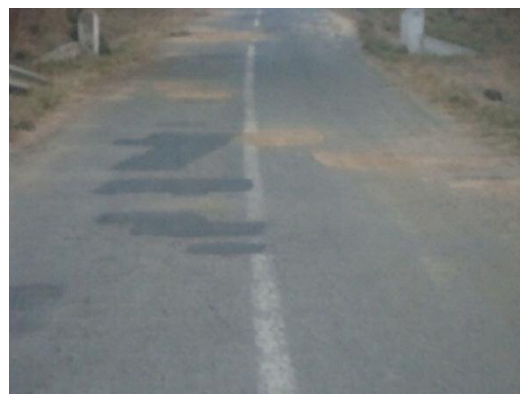
Section 6 is 3.9km long and lies within terrain that ranges from flat, low lying to mountainous. The study section is in a very poor condition and is characterised by stripping, disintegration, potholes and complete surfacing disintegration in some areas. The road along this section generally lies in areas where there are deep cuts due to the mountainous terrain. The side drains are not paved and there is no evidence of sub-surface drainage. The absence of sub-surface drainage may have contributed in part to the poor pavement condition. Some localised maintenance work is being carried out on some of the areas with the most severe pavement failures. The work includes pothole repair, drainage improvement and partial to full pavement reconstruction.

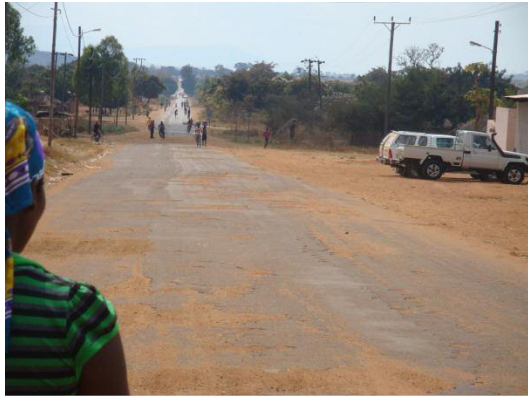
| Section | Start Chainage | End Chainage | Section Length (km) | Surfacing Type | Base Materials | Visual Condition (Good, Fair, Poor) | Longitudinal Section Geometry (Flat, Slope, Rolling) | Cross-sectional Geometry (Trough, Crest, Flat) | Sub-surface drainage (Good, Fair, Poor) | Other Remarks |
|---|---|---|---|---|---|---|--|--|---|--|
| 1 | 0+000 | 0+900 | 0.9 | Otta seal | Natural Gravel | Very Poor | Flat | Flat | Good | Potholes mainly on centre line Cracking and patching Edge drops Road level below ground level |

Section 1 is 0.9km long and lies within the urban area of Mandimba. It is in a very poor condition characterised by edge drops, cracking, patching and potholes, the latter being localised within the middle of the carriageway. The road level lies below the ground level.

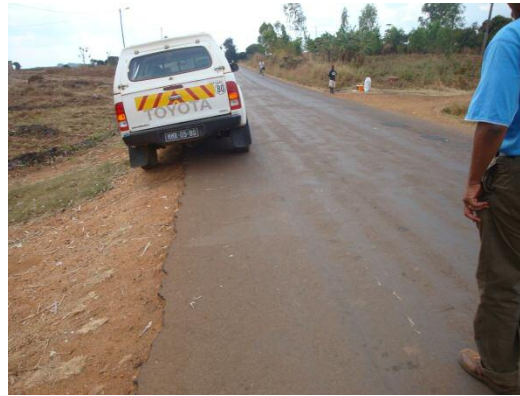
Section 2 is 1.8km long and is in a good condition. The road lies above ground level and there are some crocodile cracks on the Mandimba bound lane.
