TRAINING CONTRACTORS FOR TARGETED INTERVENTIONS ON LOW-VOLUME ROADS IN MOZAMBIQUE

MONTHLY REPORT

APRIL 2011

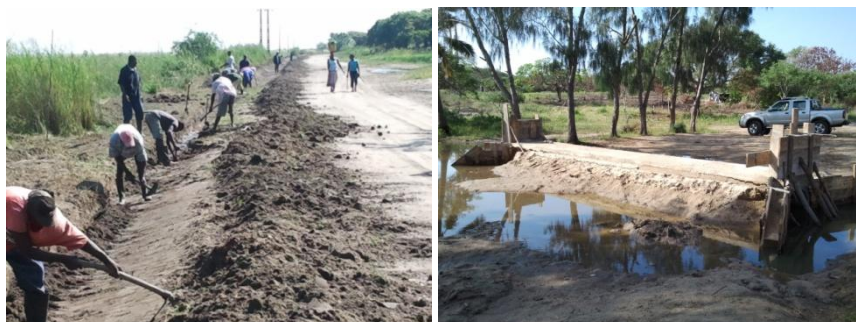
- a. Excavation and shaping of road side drains in section 5-7km:
Excavation and shaping of the right hand side drain was being done by hand in section 5-7km. The soil is soft damp sand and easy to work by hand, and the profile of the drain that was produced looked alright.
- b. Culvert construction in section 8-9km
Construction of culverts was not in progress on the day of the visit, reportedly due to shortage of cement. One culvert had just been completed near the end of the project, at about 8+700km. The set invert level was alright. However, the outlet needs to be opened up to take water away. Also, the length of this culvert was longer than necessary, being 8m in a section with a road width of 5m. Lengths of subsequent culverts will be corrected.

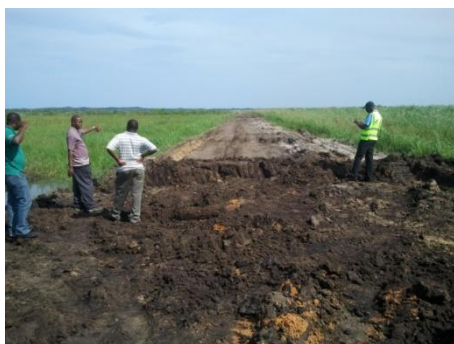
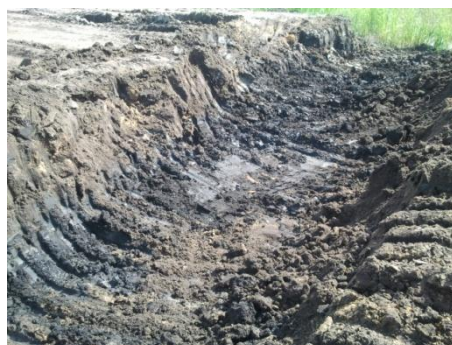
Excavation was in progress for the first of additional pipe culverts instructed by the engineer. The soils in this section are very poor and the water table is very high, making construction conditions very difficult. It was recommended to the contractor at an earlier meeting that the culvert foundations be stabilised using stones rammed into the soil similar to what is being done on other projects.

A vehicle was bogged down while trying to bypass the culvert excavation, indicating the need to make proper arrangements to accommodate traffic during construction of the culverts.

- i. There is need to make proper arrangements to accommodate traffic during construction of the culverts in section 0-2km.
- ii. Culvert foundations must be stabilised. A proposed technique is shown below.
- iii. Section 0-2km is in very bad condition and needs some grading
- iv. There is no reason why block paving at Machubo Administrative Post cannot be done. This work must resume.
- v. There is still the need to have works accelerated

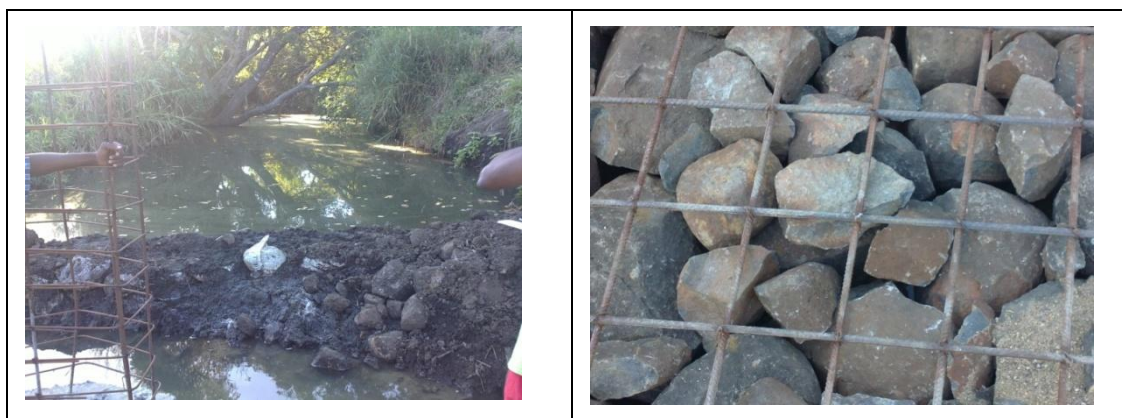
- iv. De acordo com a informação do empreiteiro, depois de construir as sapatas e parte inferior de encontros e pilare, construíram muros de ligação na jusante e montante entre quais tiraram todos solos e substituíram com saibro compactado em camadas antes de enrroncamento que se ve nom local abaixo da malha de Ø16mm afastados ao 200mm ambos os sentidos.

- v. Quando se espera betonagem da laje inferior, notamos que no inicio haverá perca de muita betão para os vazios entre as perdras, para que sugerimos que devia enche-lo com areia limpa e alizar por cima com uma betonilha fina antes de se colocar a malha e betonagem da laje.

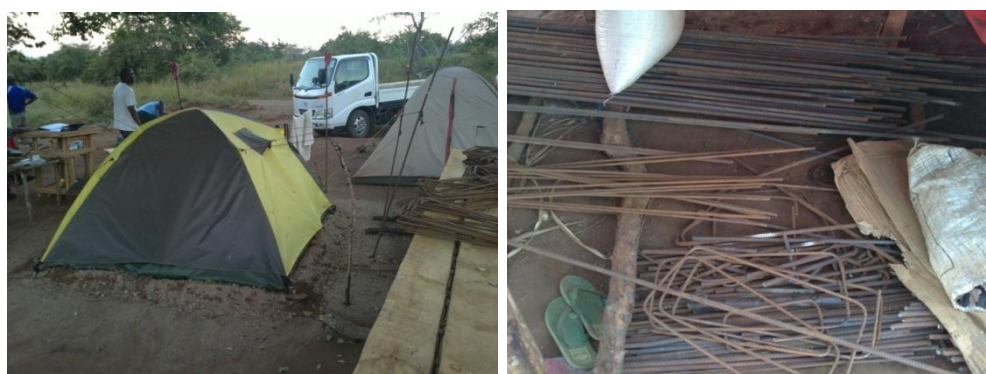
Tem estabelecido um acampamento perto do local da obra, feito de material local, tem o mínimo para funcionamento no local da obra mas notamos problema de armazenamento de material e maquinaria.

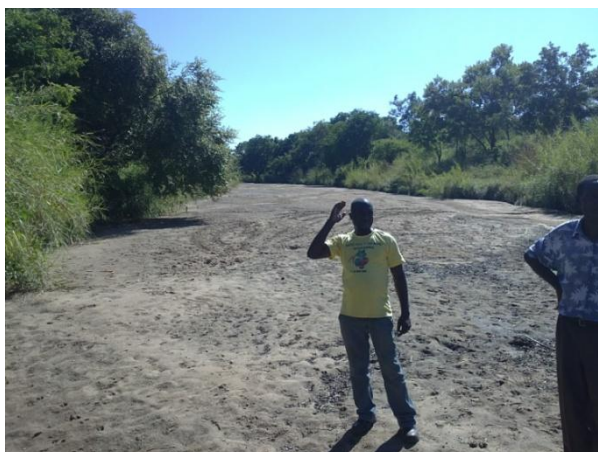
Era antes de se iniciar qualquer actividade de construção no local. Nem a limpeza do local de trabalho não tinha iniciada.

Local de trabalho sem nenhuma actividade ainda em curso

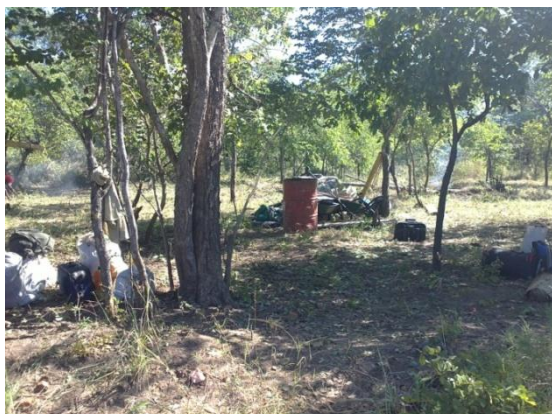
Local de acampamento ainda na fase de limpeza

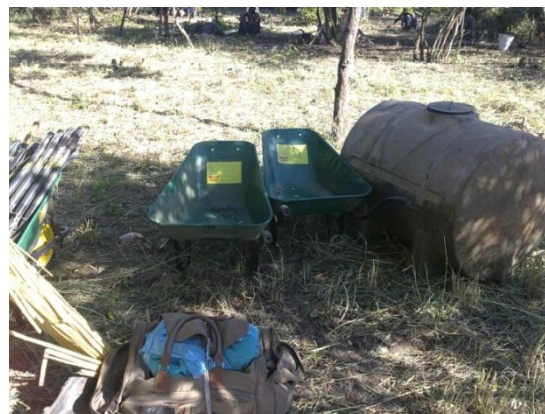
Ferramentas que o empreiteiro, parte de mobilização

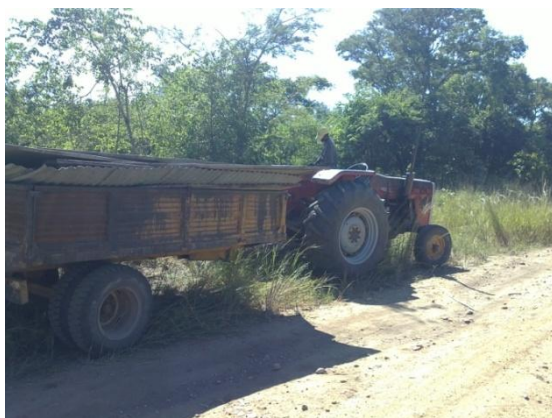
Tractor e atrelado

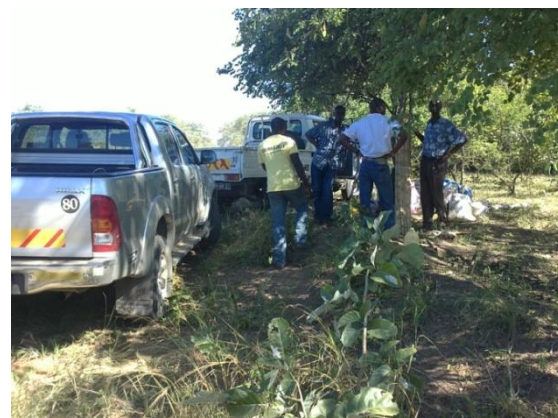
Carinha Land Cruiser 4x4
