Landslide management on the Ugandan national road network

G Hearn, Hearn Geoserve Ltd., UK, gareth@hearngeoserve.co.uk

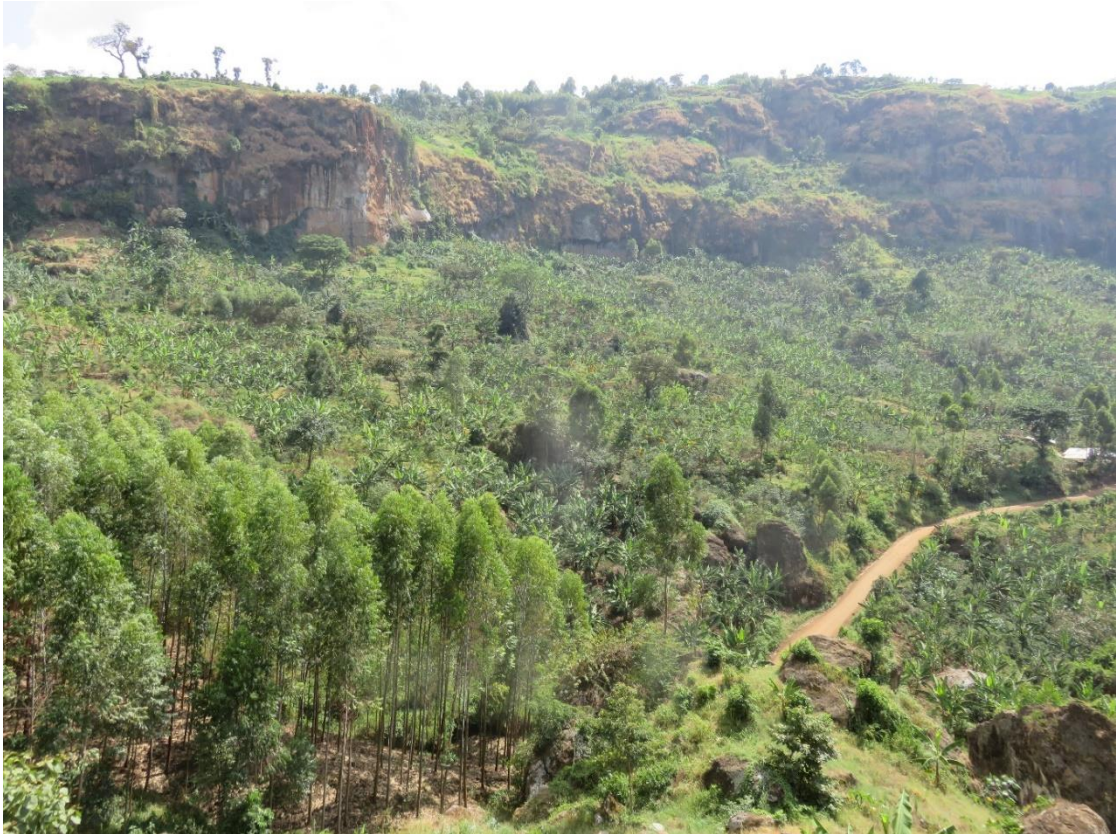
Figure 2 - Cliffs and debris slopes formed in lava and pyroclastic materials, Mount Elgon, where rock falls and toe-slope landslides are common.

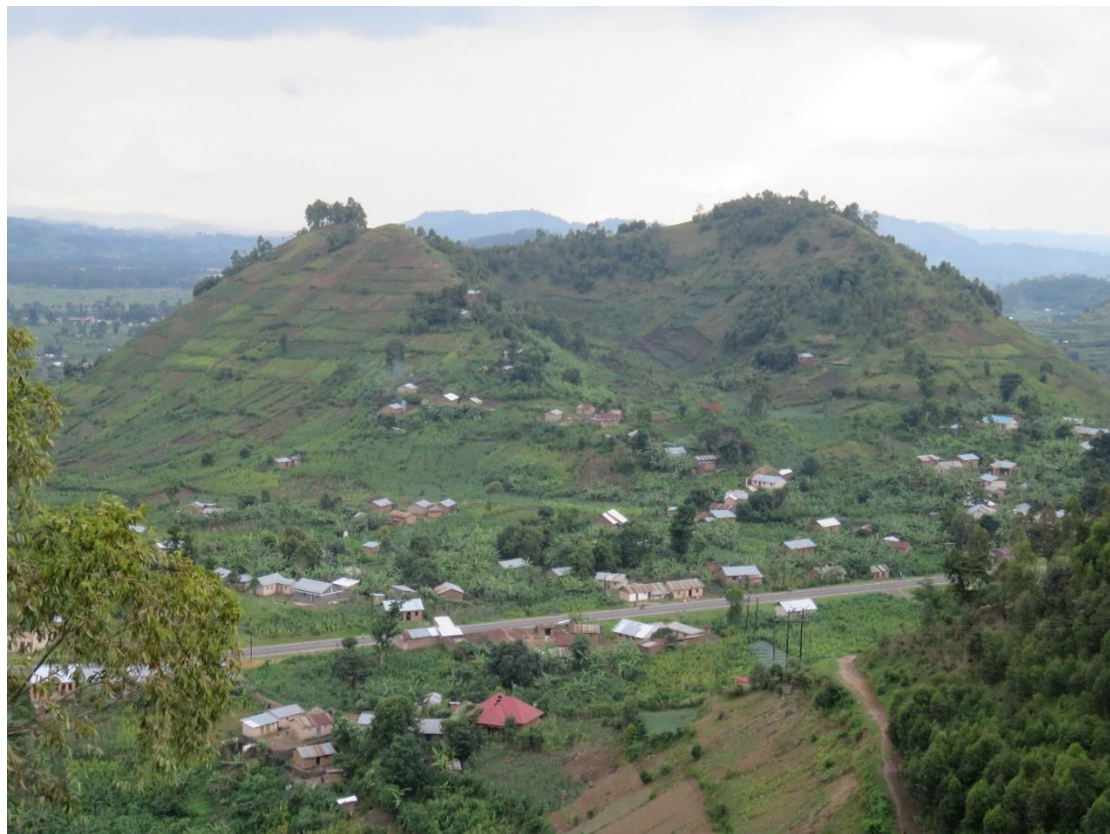
Figure 3 - Volcanic terrain around Kisoro (collapsed cones and lava flows are common)

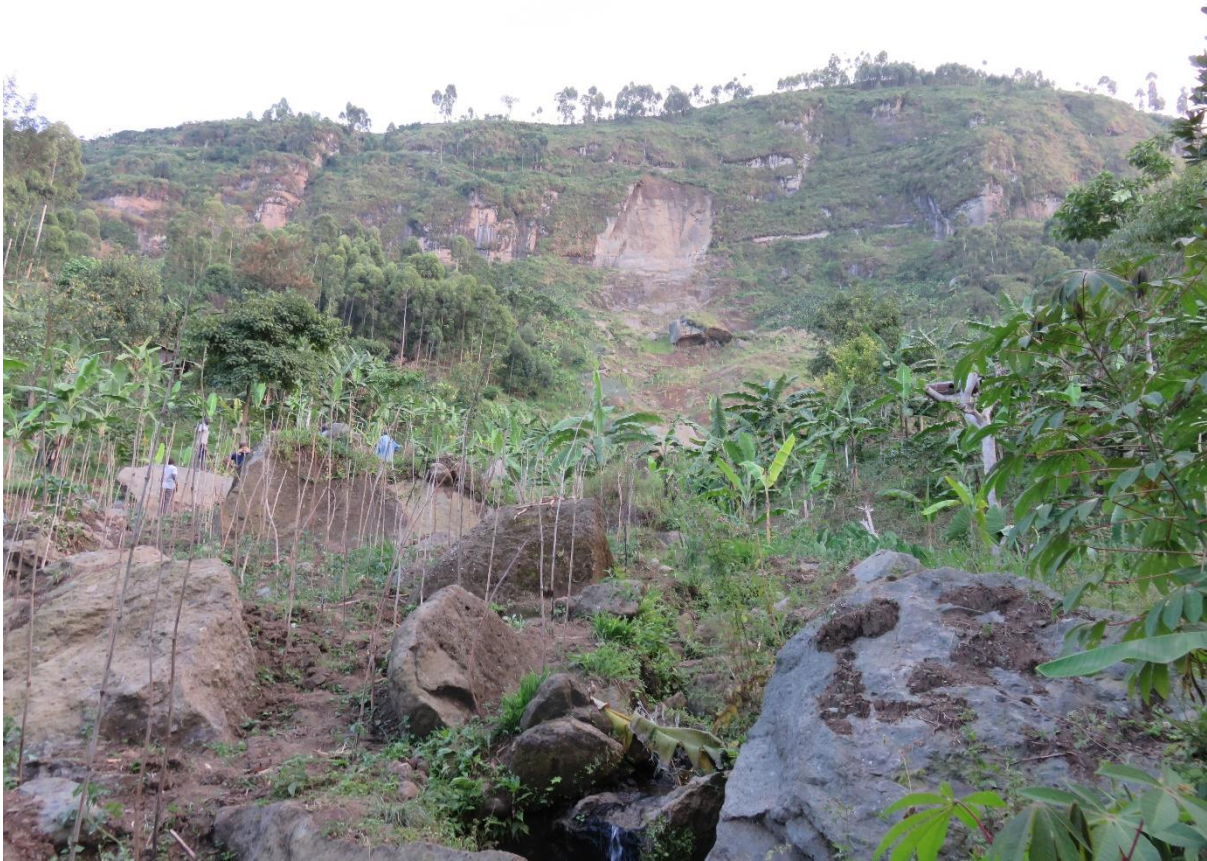
Figure 4 - Rock fall debris in foreground from slide scar in centre of background (Oct 2018)

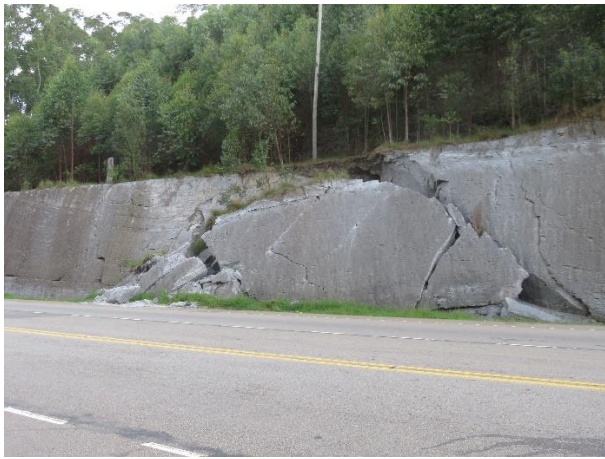
5A Rock failure along adverse joints

- Cut slope failures, often involving movement along adversely orientated rock jointing (Figure 5A)
- Fill slope failures, often involving movement along low-strength clay horizons beneath (Figure 5B)
- Earth flows from the slopes above the road reserve, often triggered by spring seepage and irrigation practices (Figure 5C)
- Rock falls from natural cliffs above the road (Figure 5D)

Figure 5 - Illustrations of earthworks failures and natural slope instability affecting parts of the Uganda road network

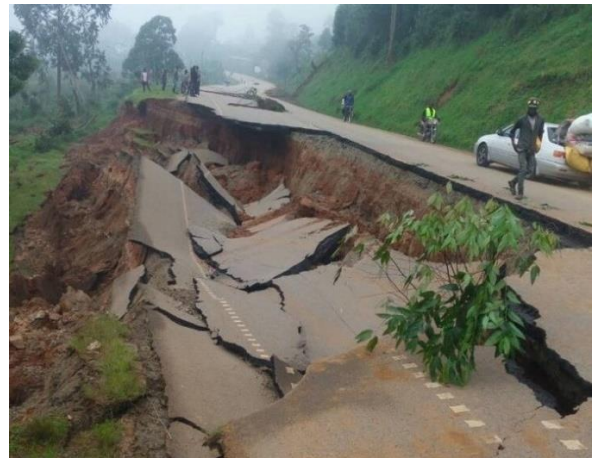
5B Fill slope failure with underlying soft clay

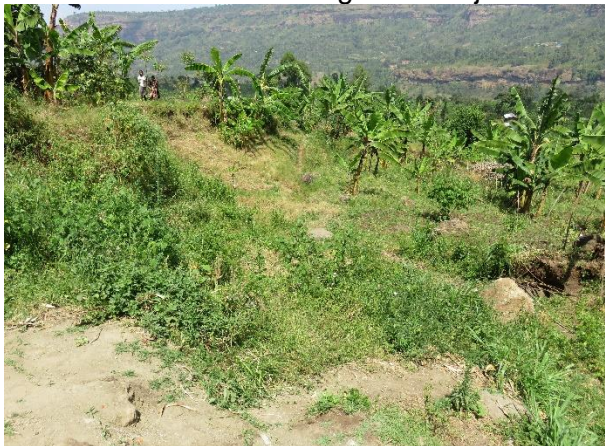
5C Slide scar of earth flow that blocked road

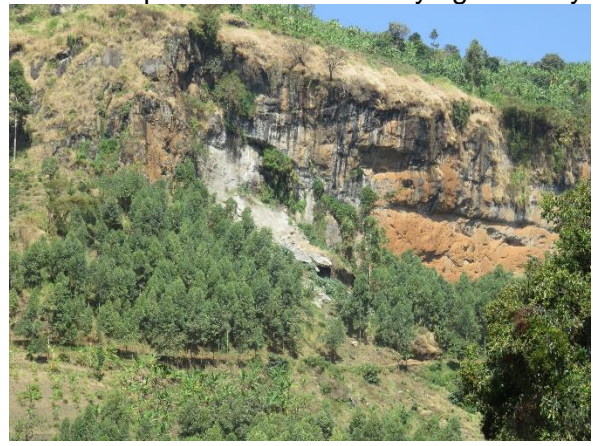
5D Rock falls from natural cliffs above road

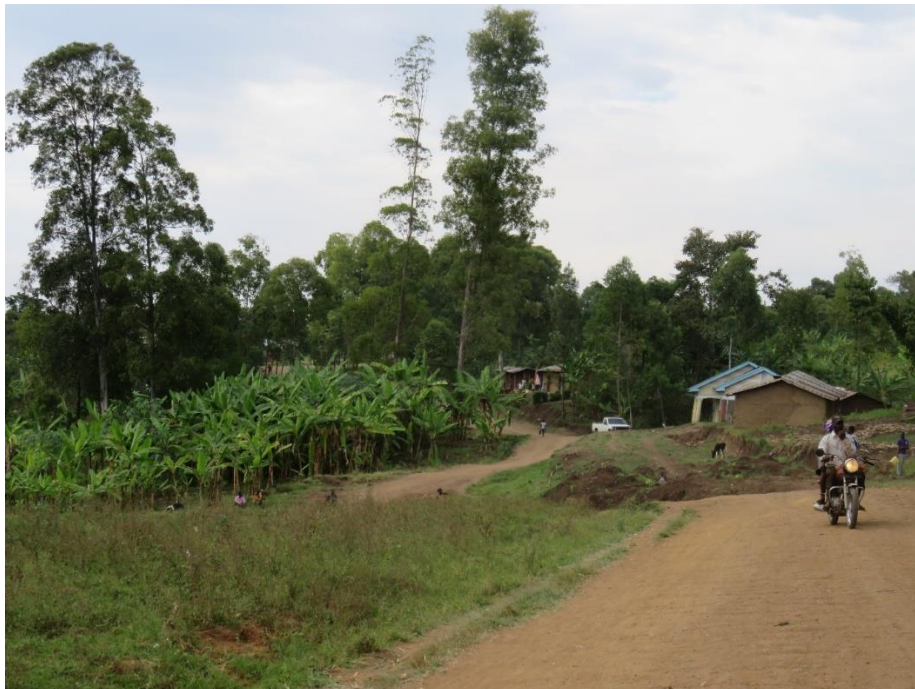
Figure 6 - Horizontal displacement to this originally straight section of road with rotation and structural damage to adjacent buildings

In addition to the above, there are cases where sections of road have been excavated across large, deep-seated, landslides that have subsequently become reactivated. In the example shown in Figure 6 more than one kilometre of alignment was constructed across such a landslide. What was originally a designed vertical and horizontal alignment has now become an erratic track that requires regular reinstatement to allow traffic to pass.

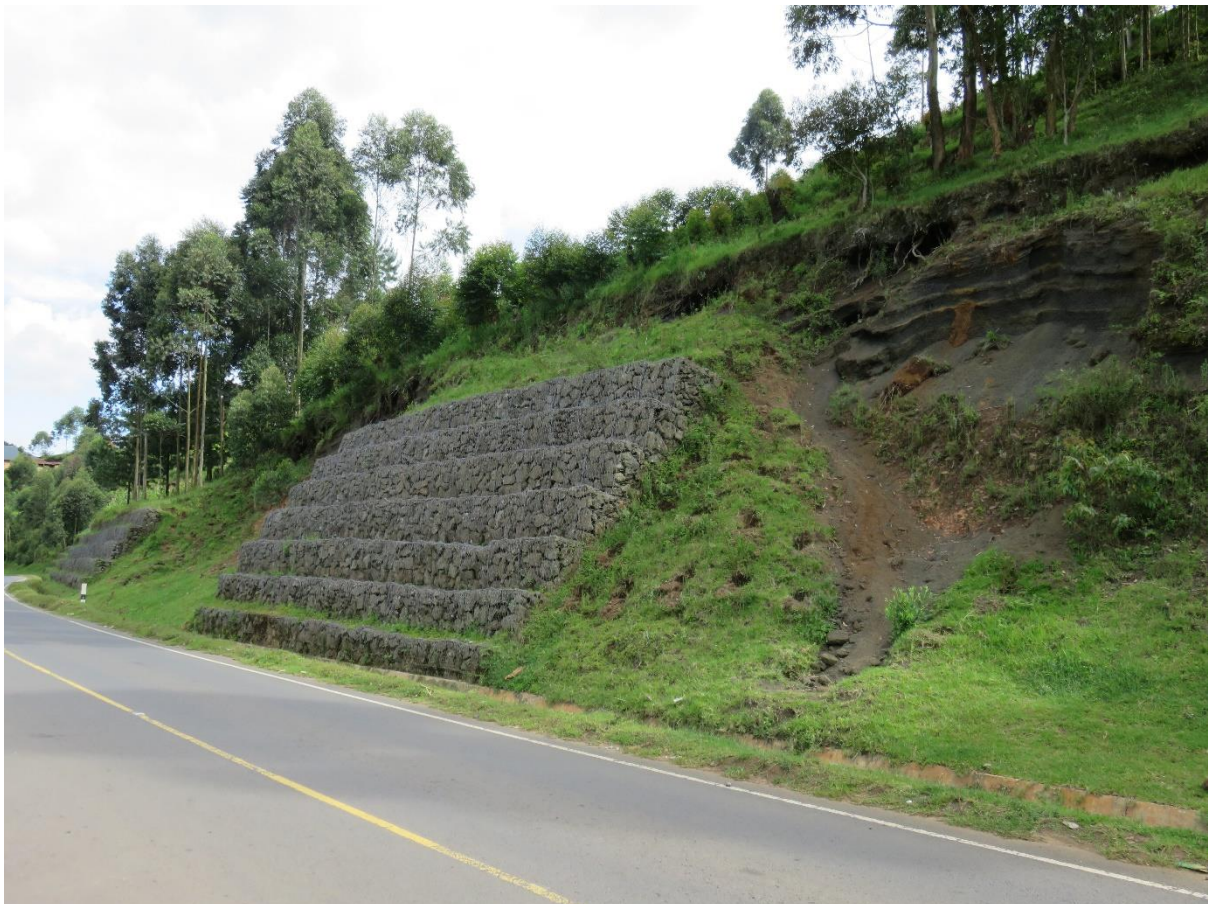
Figure 7 - Use of gabion retaining walls to support vulnerable sections of cut slope

The Road Reserve in Uganda is currently nominally 40m either side of the centre-line. In hilly and mountainous parts of the country this road reserve comprises cut slopes and fill slopes, with the occasional use of retaining walls (Figure 7). Incursion into the road reserve for commercial use is commonplace in built-up areas and along the more highly-trafficked roads, potentially leading to conflicting priorities in the need to preserve rural livelihood while at the same time maintain the stability and engineering functionality of the road reserve.

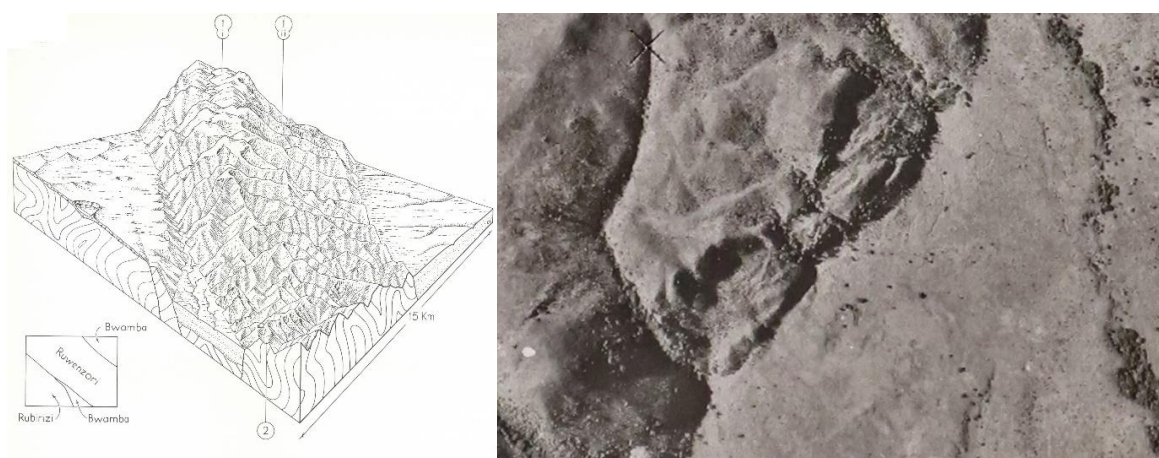
Figure 8 - Example of Northern Rwenzori Land Unit (from Ollier, 1969) and aerial photograph of large landslides at the slope-floodplain boundary

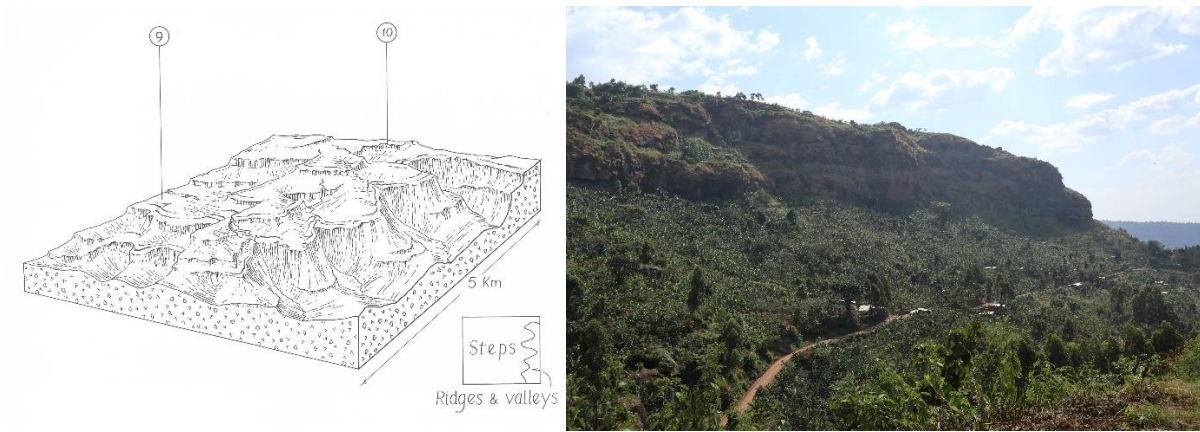
Figure 9 - Example of Elgon Steps Land Unit [16] and field photograph of terrain with rockfall and earth flow hazard to the adjacent District Road.
