Monitoring and Evaluation of Low Volume Roads Trial Sections in Kenya

Inception Report

*AFCAP Project Reference Number:
KEN2043C*

June, 2016

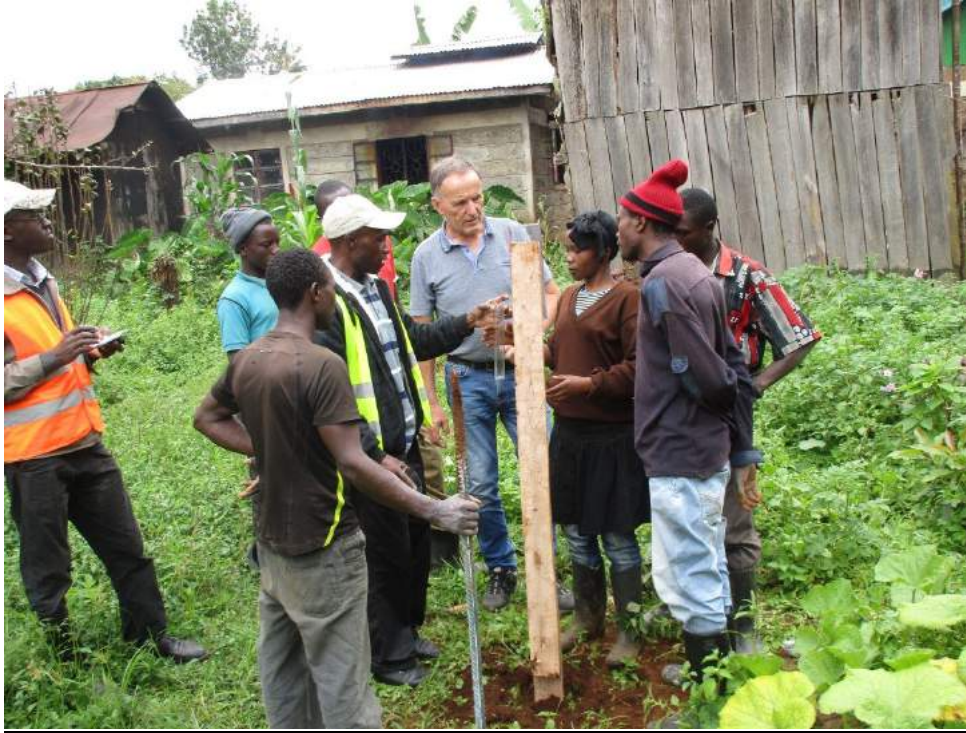
Figure 10: Across Africa team with Jon Hongve of AfCAP training a local on how to read and record daily rainfall amounts (Trial Section E511)

With the guidance of the AfCAP Consultant, this was successfully done on Friday, 13th May, 2016 for trial section E511. We located a responsible homestead right at the beginning of the site. The home owner agreed to help us collect rainfall data for the area by daily reading and recording the rainfall amounts.

The raingauge was mounted on a sturdy 5 feet high 100 by 50 mm wooden post, well seated in the ground. This was meant to make it comfortable for the person responsible for taking the readings, as well as getting it out of the reach of small children. The reader was adequately trained, ready for the job. The following is a sample of the readings recorded so far:

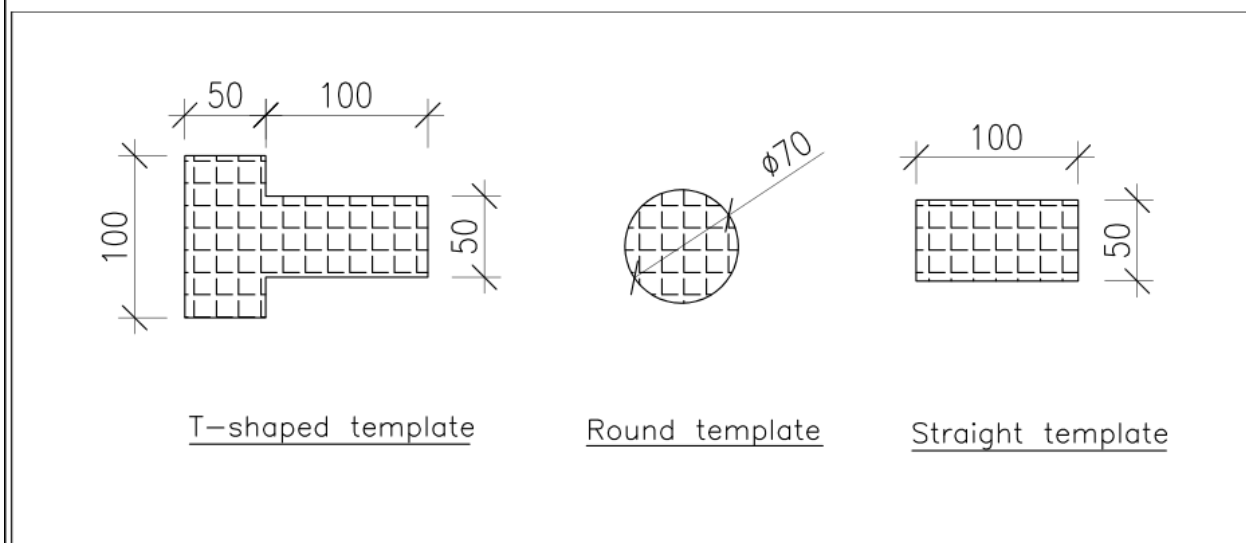
For this exercise, the consultant used 3 major road marking templates as illustrated in the figure below:

Figure 11: Dimensions of the road marking templates used (adopted from Kenya LTPP guideline)

These are better illustrated in the image below. The workers would lay down the templates flat on the pavement and paint the opening.

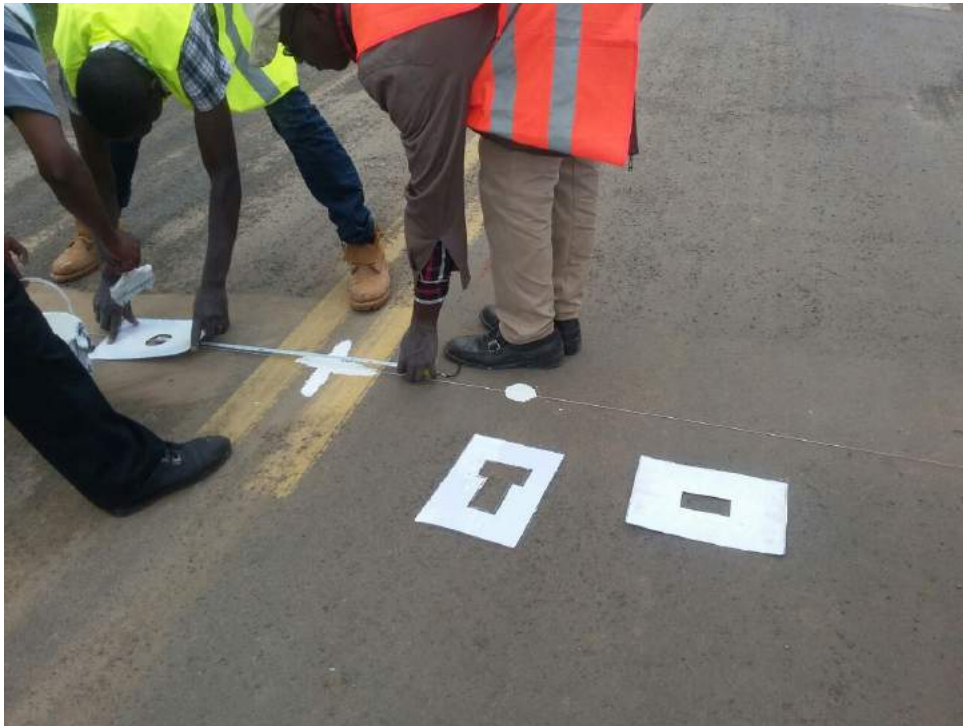
Figure 12: Across Africa team using the three road marking templates

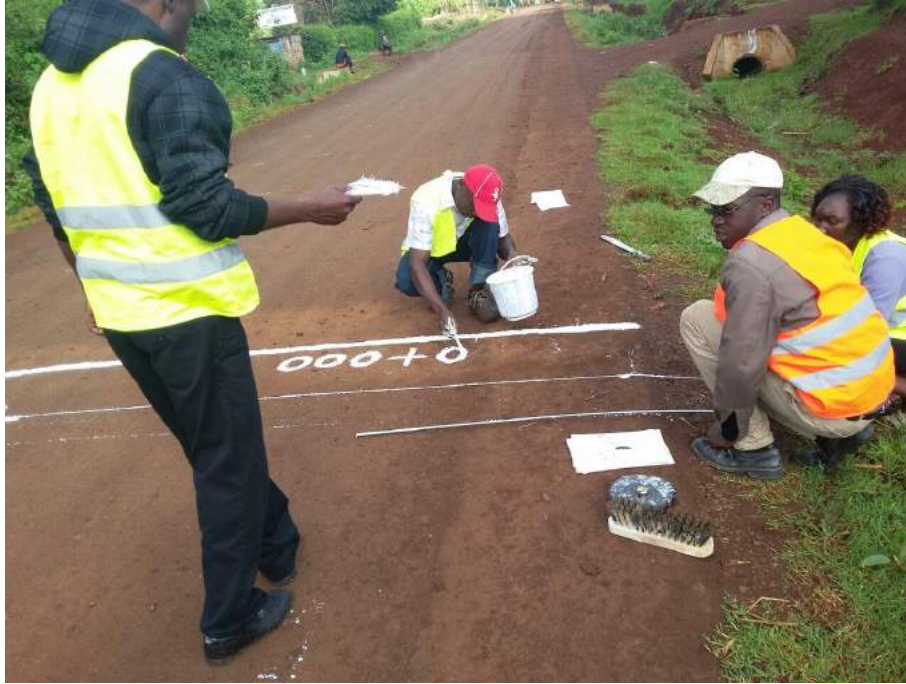
This was marked by a 50 mm wide solid line running across the whole width of the pavement. The chainage of this starting point was marked as km 0 + 000. The chainage of the ending point depends on the length of the section being monitored, but the maximum was km 1 + 000.

Figure 13: The solid line with chainage 0 + 000 marking the beginning of the section to be monitored

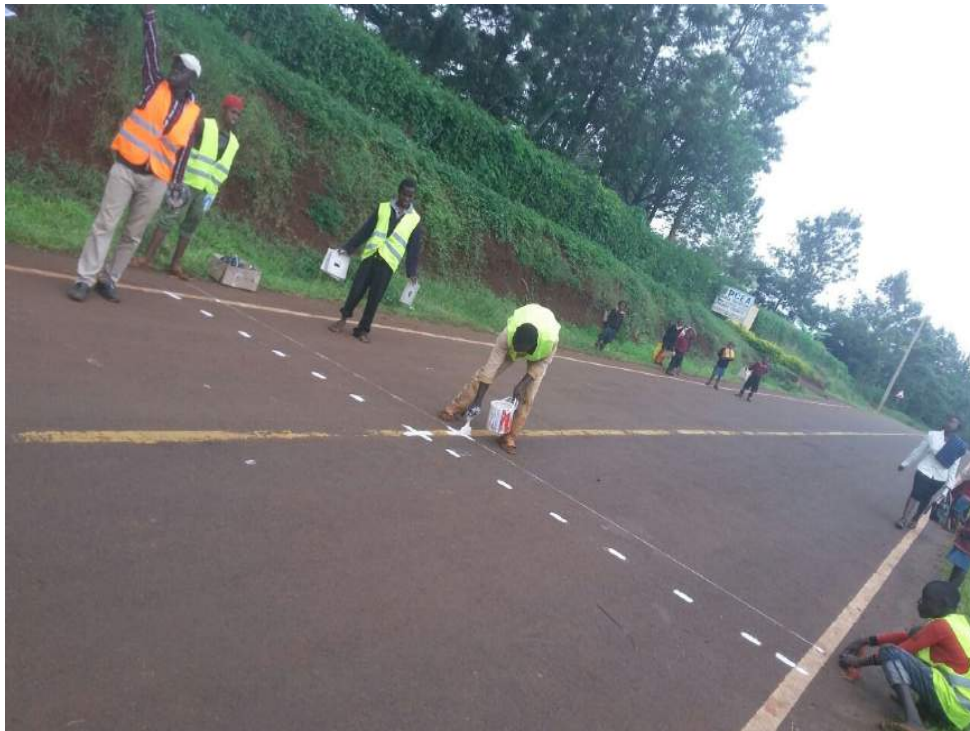
This measured 200 m long for each trial section. The edges of the destructive zones were demarcated by a dashed line as shown in the image below. The test points falling on this edge were offset 500 mm from the dashed line

Figure 14: The dashed line marking the boundary of the destructive testing panel of the LTPP section

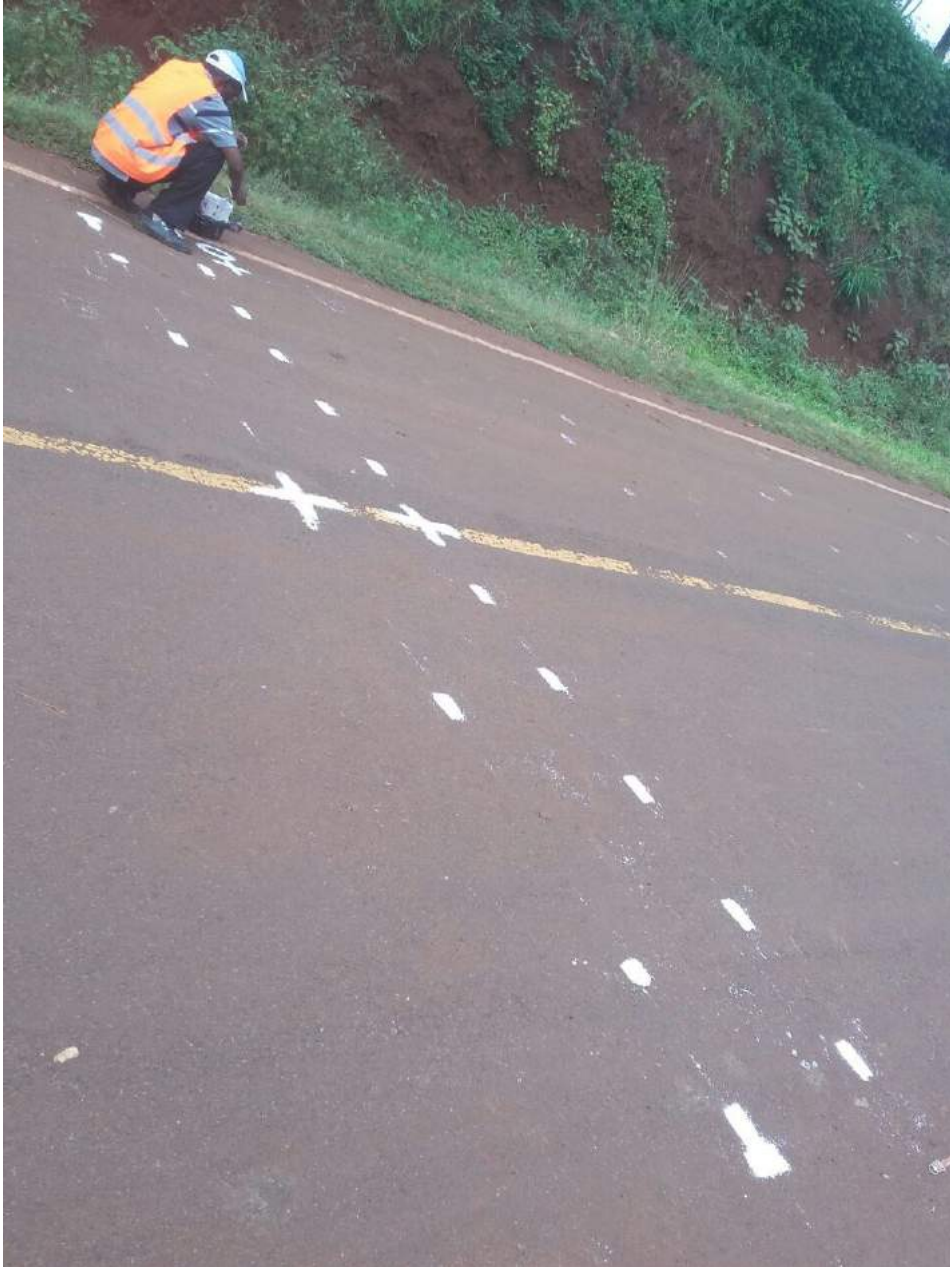
Figure 15: One profile offset 500 mm from the edge of the dashed line

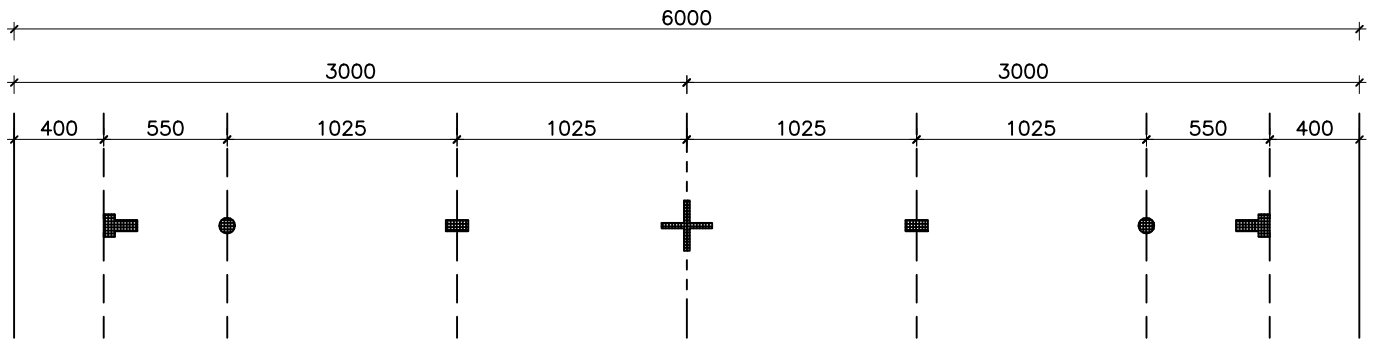
The trial sections to be monitored are either 5.4 m or 6 m wide. Others have wide shoulders whereas others lack. Therefore, the marking plan adopted depended on the width of the pavement. Typical marking plans for a 6 m wide and 5.4 m wide road are shown below:

MARKING PLAN FOR 6 M WIDE SEALED SURFACING, OUTER WHEEL PATH
(Adapted from Kenya LSPS Guideline)

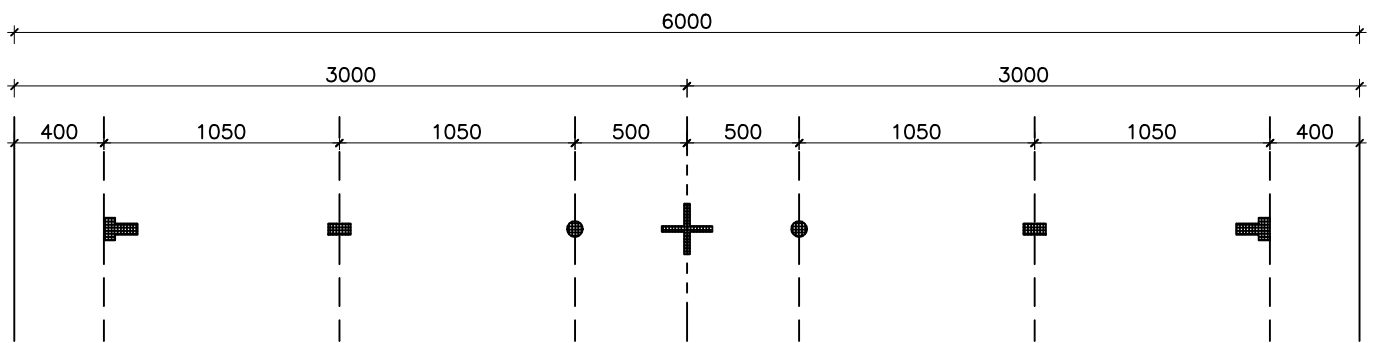
MARKING PLAN FOR 6 M WIDE SEALED SURFACING, INNER WHEEL PATH
(Adapted from Kenya LSPS Guideline)

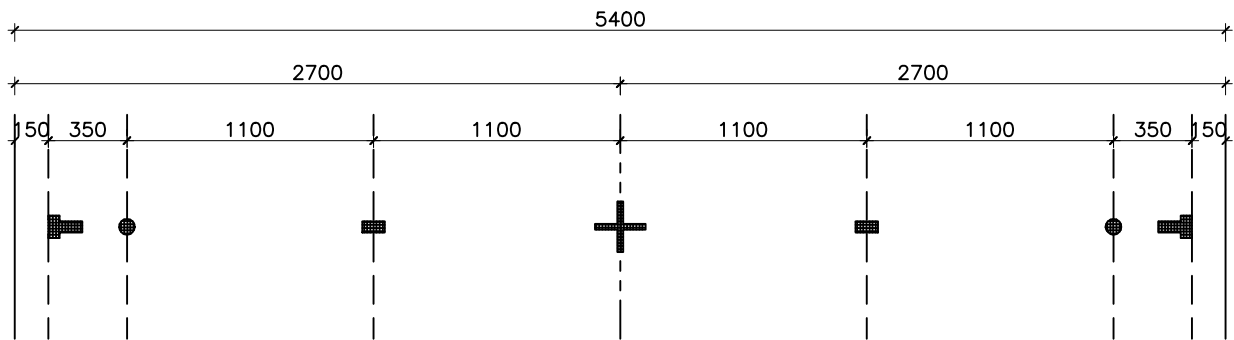
MARKING PLAN FOR 5.4 M WIDE SEALED SURFACING, OUTER WHEEL PATH
(Adapted from Kenya LSPS Guideline)

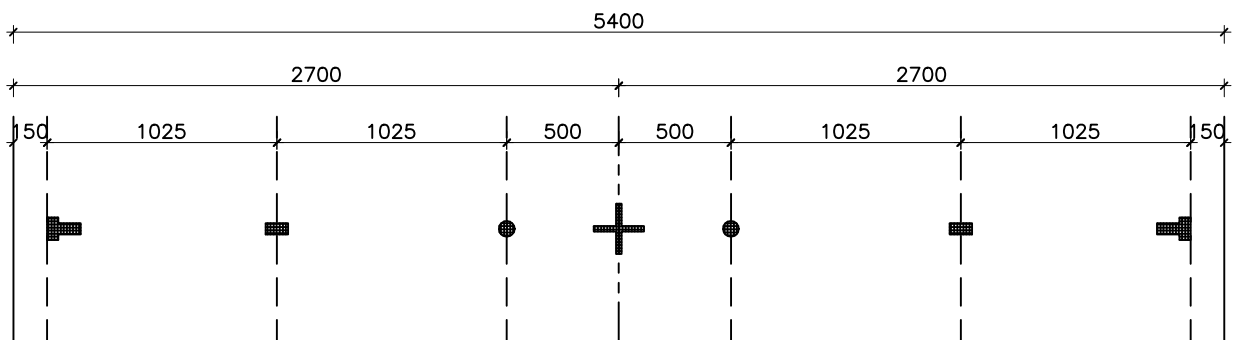
MARKING PLAN FOR 5.4 M WIDE SEALED SURFACING, INNER WHEEL PATH
(Adapted from Kenya LSPS Guideline)

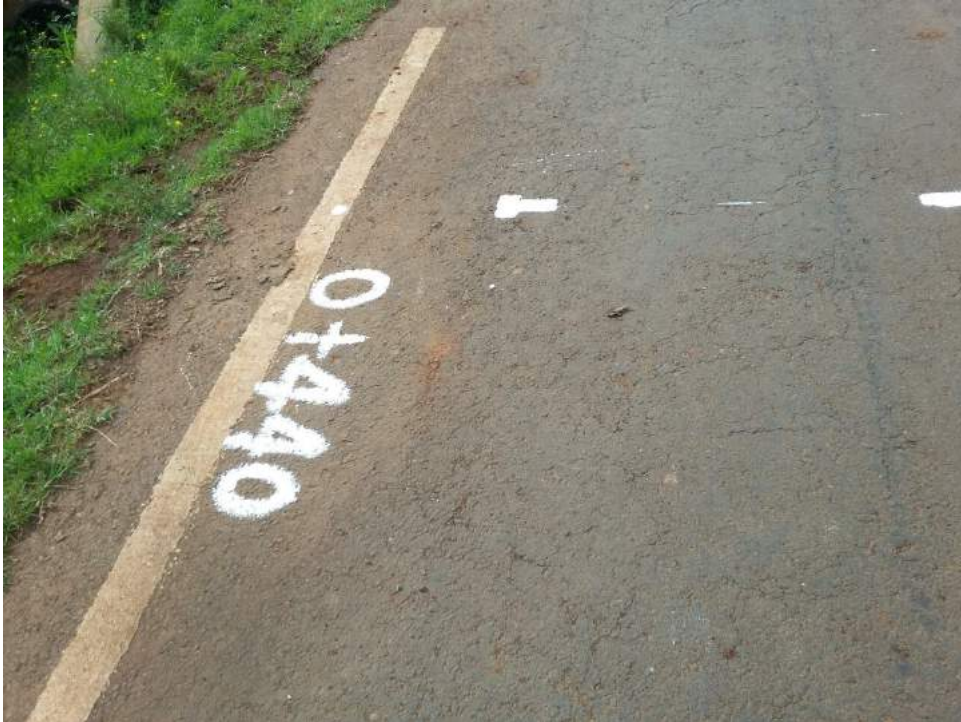
Figure 16: Typical chainage of a profile

- Writing the chainages of all the profiles
- Numbering the 10 LTPP 15 m sections
- Marking the destructive testing zones as either panel A or B

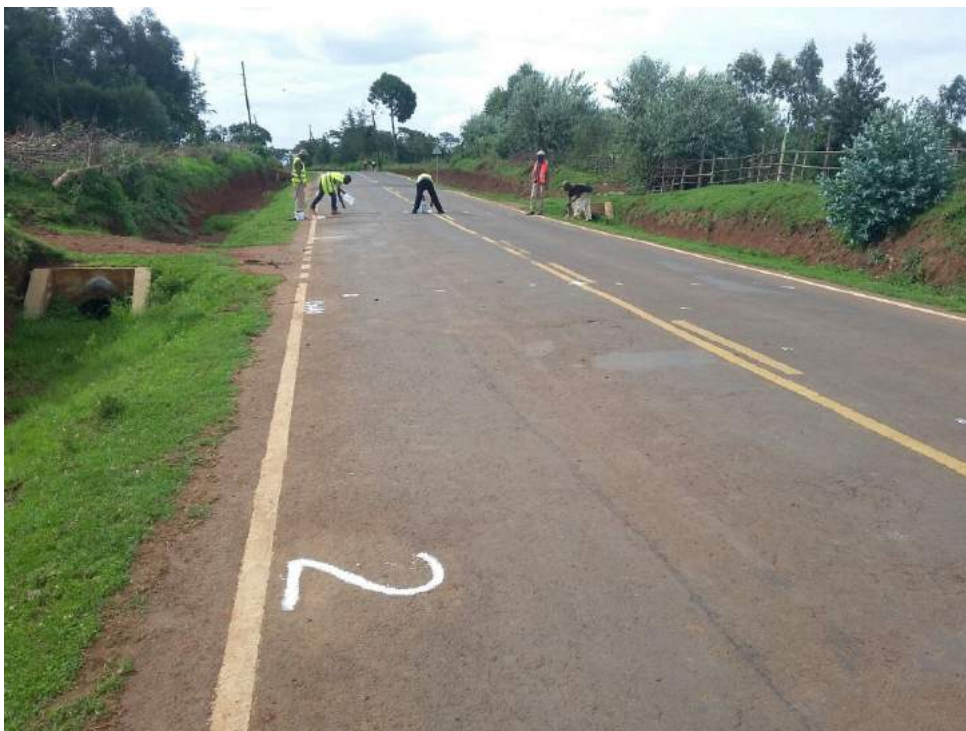
Figure 17: Typical numbering of the LTPP sections
