SEACAP 27
**MID TERM PAVEMENT
CONDITION MONITORING OF
RURAL ROAD SURFACES**

INTRODUCTION & KEY ISSUES

SEACAP 27 was concerned primarily with the collection and analysis of pavement performance data from the **Rural Road Surfacing Research (RRSR) Trial** road sections. This mid-term monitoring was seen an essential link in the ongoing analysis of rural road performance.

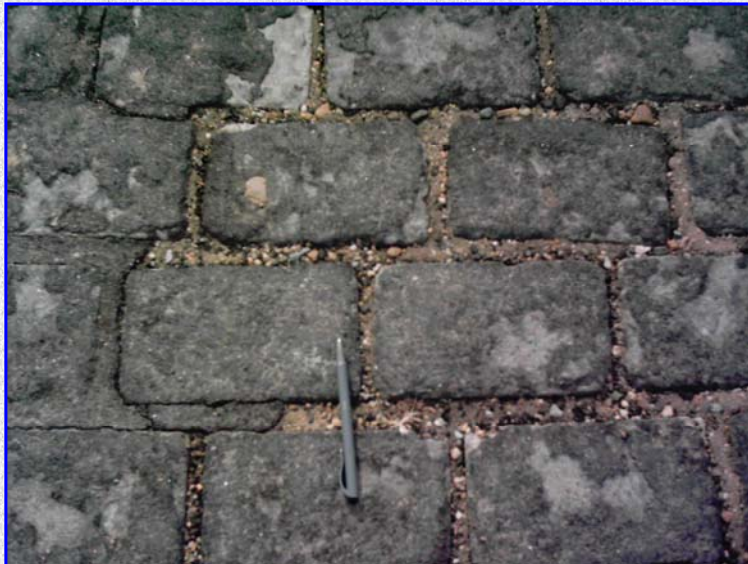
Summary of Block Pavement Performance

Performance ranking	Block condition	Joint condition	Seal condition	Overall performance
Good –	5	0	0	1
Fair –	3	0	0	3
Poor	3	7	0	4
Very poor	0	4	11	3

- The single sand seals have performed poorly.
- The minimum strength requirement of 20-25MPa for manufactured engineering quality bricks is important.

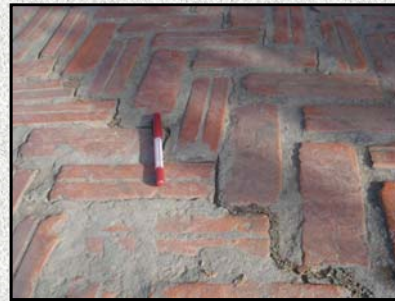
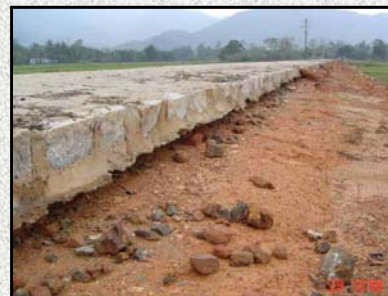
- Mortared jointed options are probably more appropriate than sand joint options.
- Stone options: robust but rough

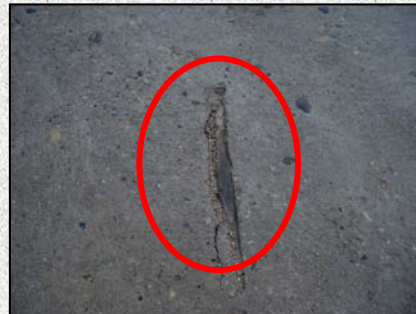
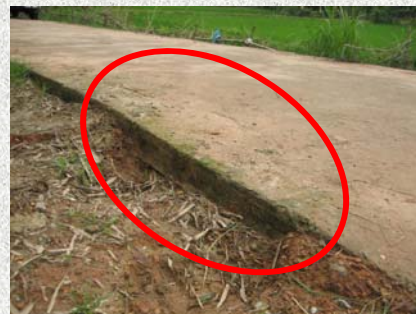
Two principal causes for poor performance stand out:

Poor quality concrete and poor support for the concrete slabs (sub-base or eroded shoulders).

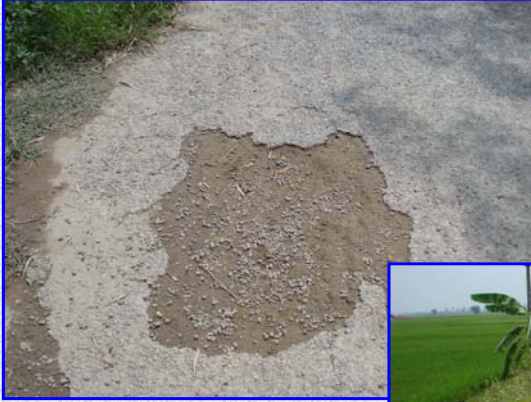
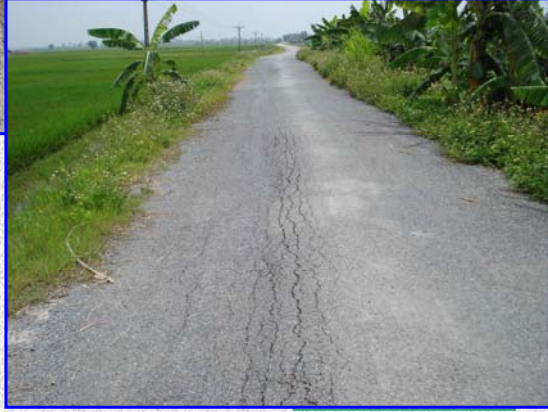
Surface Failure

Flexible Pavements

Structural Failure

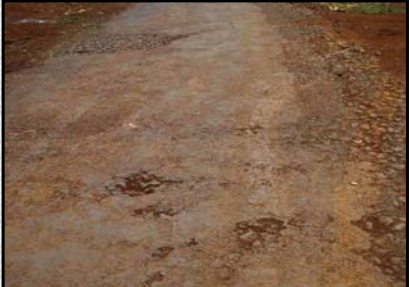
Evidence indicates that the combination of emulsion DBST over DBM is performing better than the standard option of hot DBST over WBM.

Poor construction is major issue with the flexible pavement sites, particularly with regard to the seals. Less than 50% were satisfactory as-built.

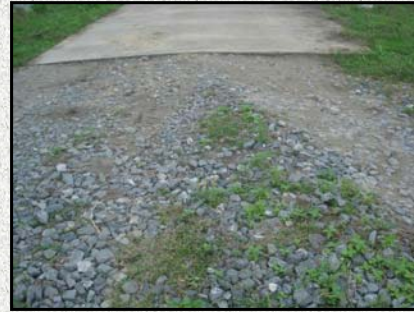
The majority of gravel control sites performed poorly- however there are clearly areas where unsealed gravel surfaces are a sustainable LVRR option provided they are constructed correctly and MAINTAINED.

Unsealed WBM is not a realistic option because of loss of cohesive fines and surface loosening.
