Capacity Building and Mentorship for the Establishment and Implementation of Monitoring & Evaluation Programmes on Experimental and Long-Term Pavement Performance (LTPP) Sections in Six African Countries and Myanmar

Meeting Report (August 2018)

Civil Design Solutions

November 2018

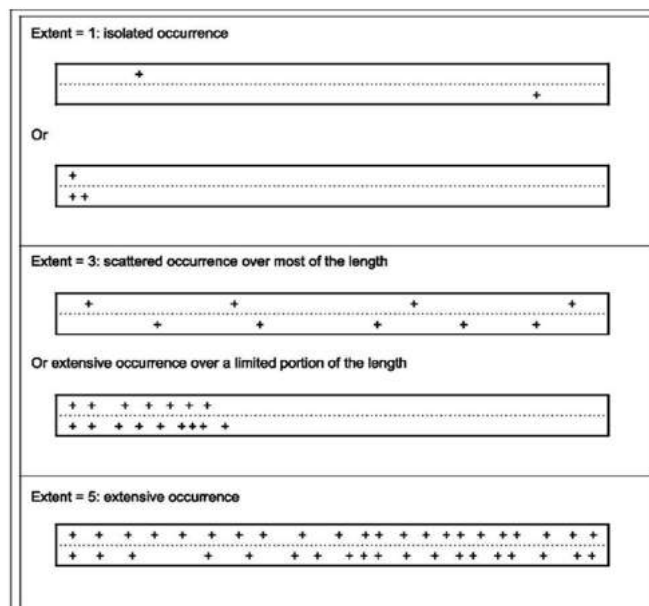
Illustration of Extent

Extent	Description	Percentage of length
1	Isolated occurrence Not representative of the segment length being evaluated	< 5
2	Occurs over parts of the segment length More than isolated	5 – 10
3	Intermittent (scattered) occurrence over most of the segment length (general), or Extensive occurrence over a limited portion of the segment length.	10 - 25
4	More frequent occurrence over a major portion of the segment length.	25 - 50
5	Extensive occurrence over the entire segment.	> 50

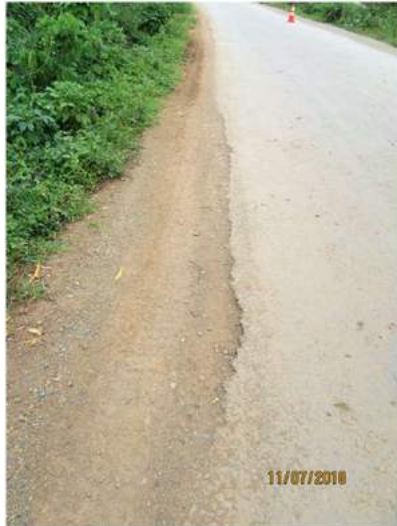
Edge Break

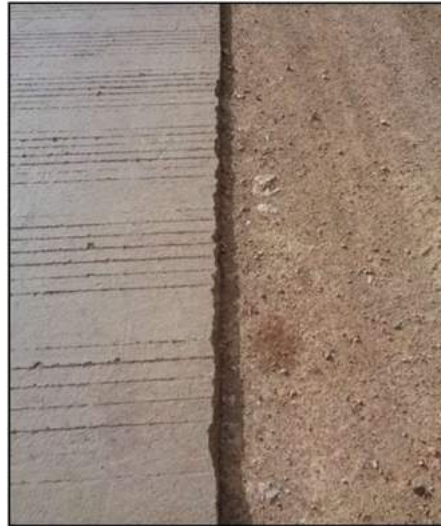
Edge Drop

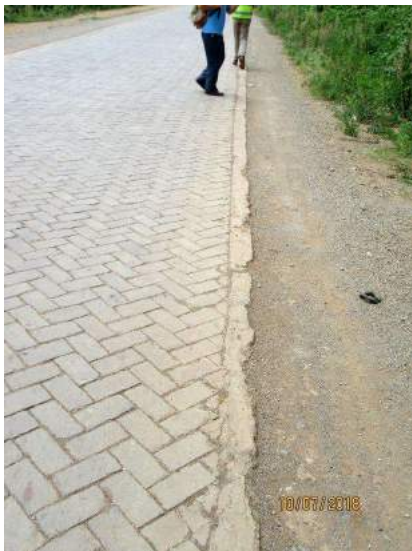
Edge Break

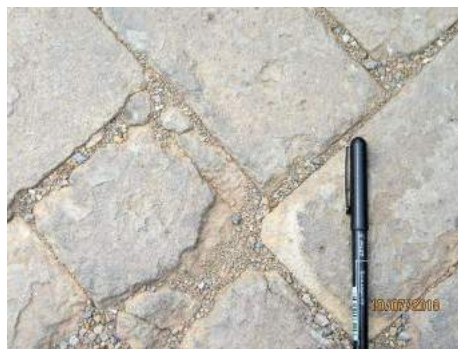
Concrete Block Breakage

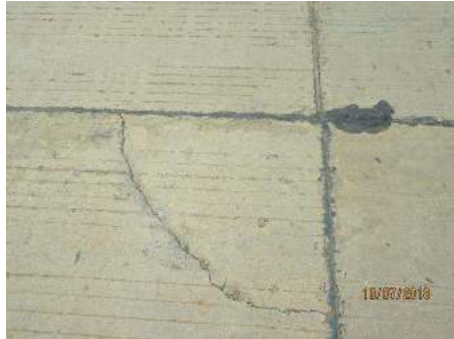
Corner crack in concrete slab

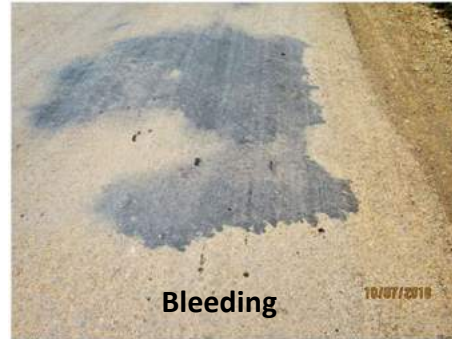
Bleeding

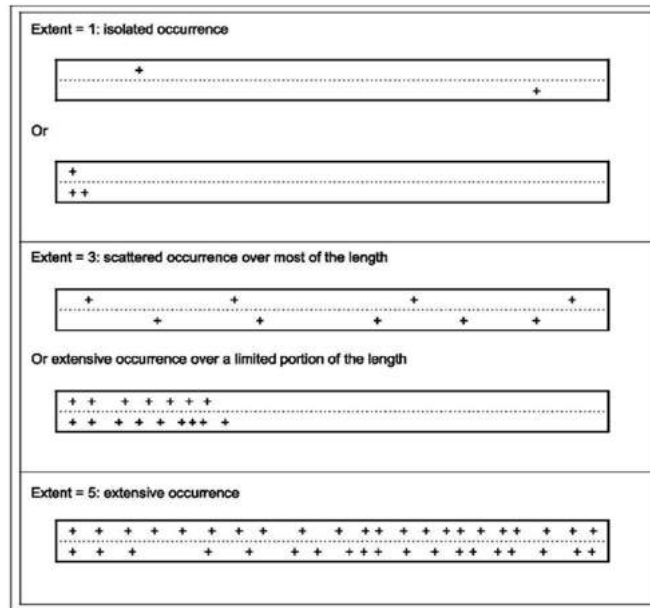
Illustration of Extent

Extent	Description	Percentage of length
1	Isolated occurrence Not representative of the segment length being evaluated	< 5
2	Occurs over parts of the segment length More than isolated	5 – 10
3	Intermittent (scattered) occurrence over most of the segment length (general), or Extensive occurrence over a limited portion of the segment length.	10 - 25
4	More frequent occurrence over a major portion of the segment length.	25 - 50
5	Extensive occurrence over the entire segment.	> 50

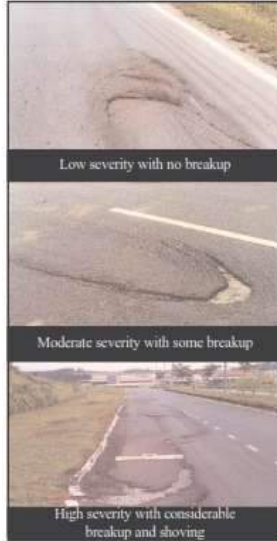
2.6. CRESCENT SHAPED CRACKS

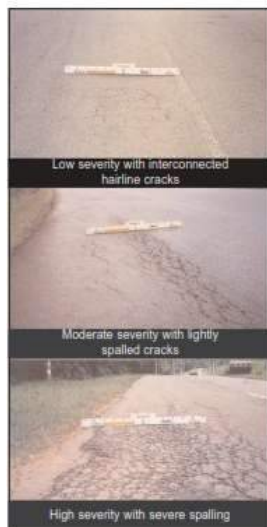
2.1. CROCODILE CRACKS

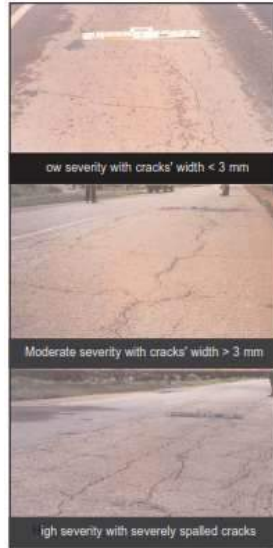
2.2. BLOCK CRACKS

Ladder cracks.

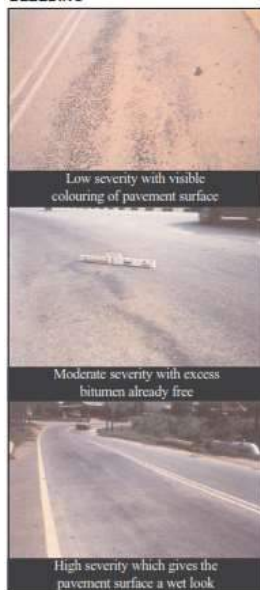
4.1. BLEEDING

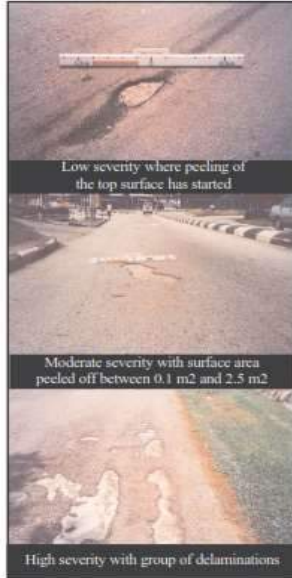
4.4. DELAMINATION

- thickness of layer(s) peeled off.
- area of individual delaminations.
- number of delaminations.

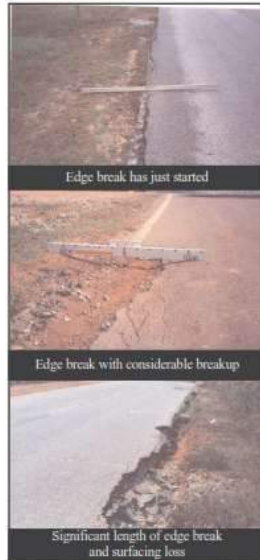
EDGE BREAKS

7.0. EDGE DEFECTS

Edge defects occur along the interface of flexible pavement and the shoulder, and are most significant where the shoulder is unsealed. The detrimental effects of edge defects include :

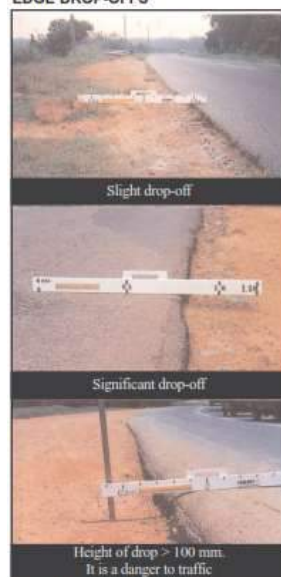
7.2. EDGE DROP-OFFS

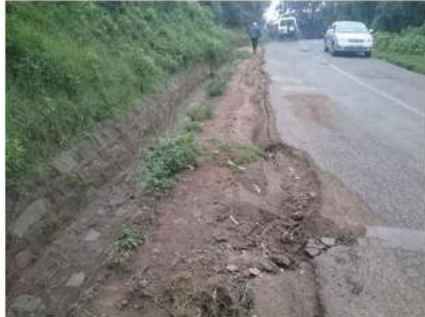
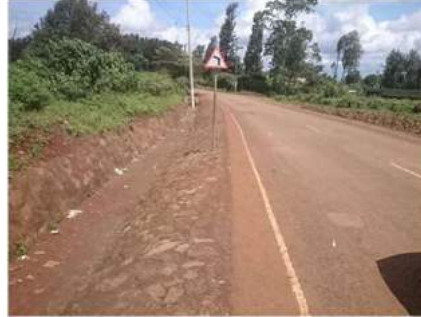
Influence of shoulder drainage on pavement performance

- Most influential factor affecting performance of a LVR
- Without an adequate, well-functioning drainage system, the pavement is likely to exhibit distress due to moisture ingress,
- Important to assess functionality of the drainage system in an objective manner during the performance monitoring of the road.
- The drainage system consists of:
 - Side drains and access culverts
 - Mitre drains
 - Cross culverts
- Need to measure Drainage Factor

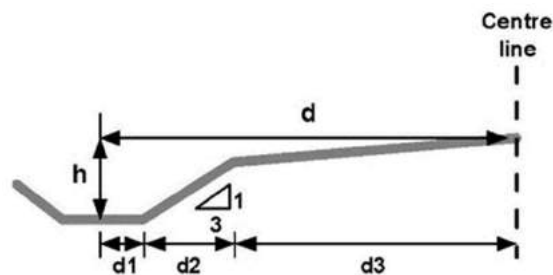
Drainage Factor $DF = d \times h$	Classification
$DF \geq 6.00$ or free draining	Very good
$4.5 \leq DF < 6$ or $H \geq 0.75$	Good
$3.5 \leq DF < 4.5$ or $H \geq 0.60$	Moderate
$2.5 \leq DF < 3.5$ or $H \geq 0.40$	Poor
$DF \leq 2.5$	Very poor

Notes: Classification can be moved up one class if:
 - gradient $\geq 1\%$ and/or
 - Lined drains where lining connects to edge of surfacing

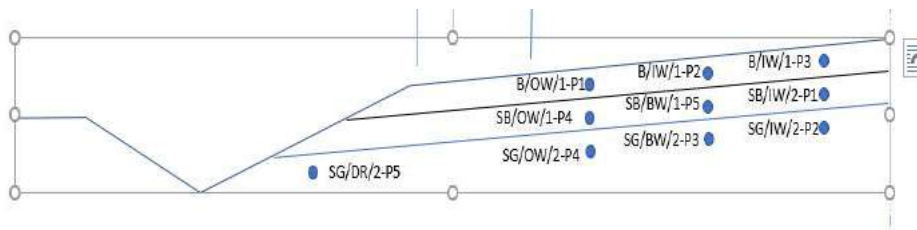
Use of Moisture Sensors

Cost? Approx. USD 3000.00/set of 10 sensors
