## **Development of Pavement Design Standards for Low Volume Roads in Ethiopia**

RPN 2975

Overview of four research projects carried out by the Research and Development Directorate of Ethiopian Roads Authority

April 2014

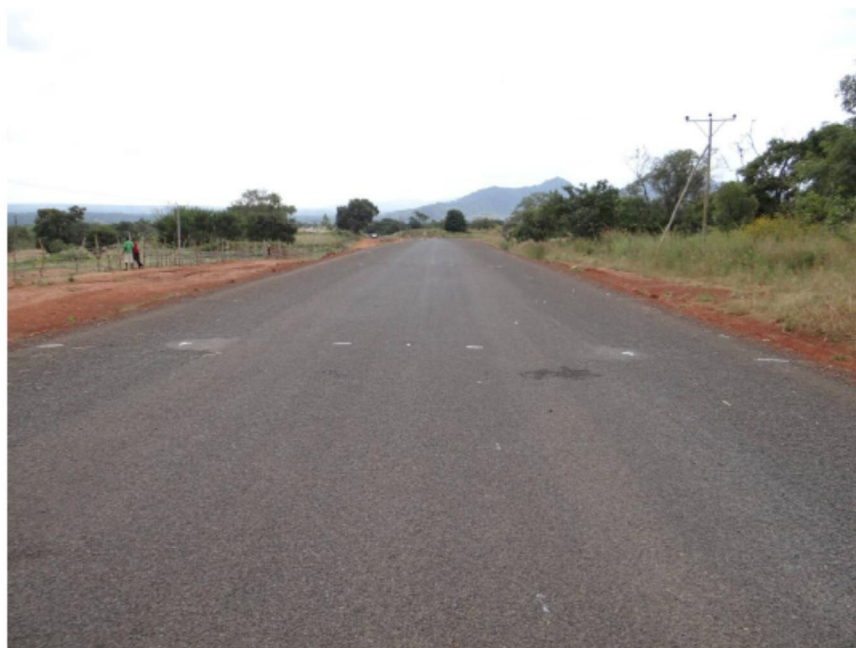
**Figure 4-2** Example of one of the trial sections

It is recognised that the Research Directorate has limited resources to undertake monitoring of the trials. However, if the research objectives are to be achieved and benefits of the investment in the research realised, then it is recommended that ERA seek external support for the timely collection of data until such time as they have sufficient skilled resources to undertake the timely monitoring of the trials unaided. A completed section of the trials is shown in **Figure 4-2**.

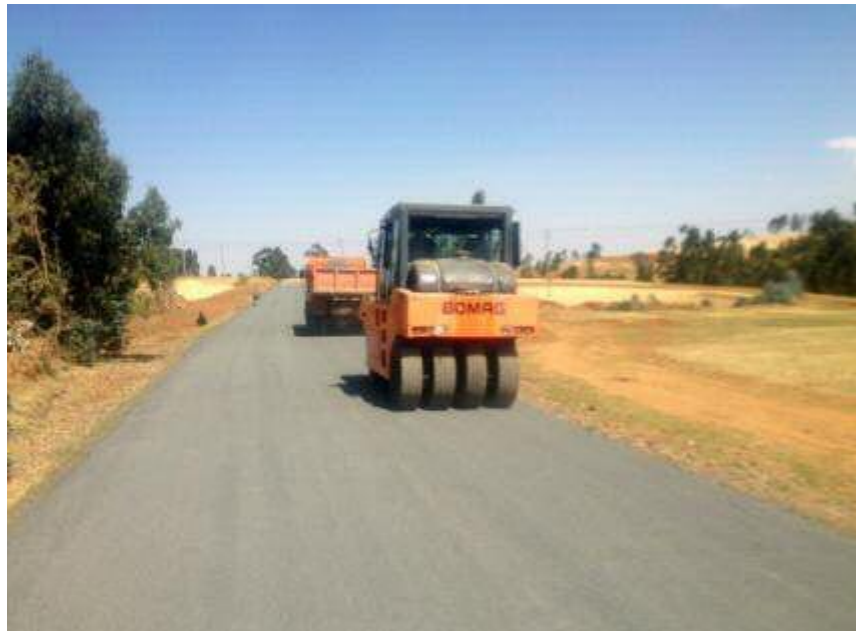
**Figure 5-2 A completed section of the Combel trial**

The cinder gravel used for one of the sections failed to perform well and a different source of cinder gravel (stronger and non-plastic) was used in the second seal. Unfortunately, some of this material was used on the existing failed section (against TRL advice) and this section should now be considered as a single seal due to the amount of aggregate loss from the 1<sup>st</sup> seal. The remainder on this cinder was used for the 2<sup>nd</sup> seal on the final section of the trials on top of the well-performing seal of crushed rock. A completed section of the trials is shown in **Figure 5-2**.

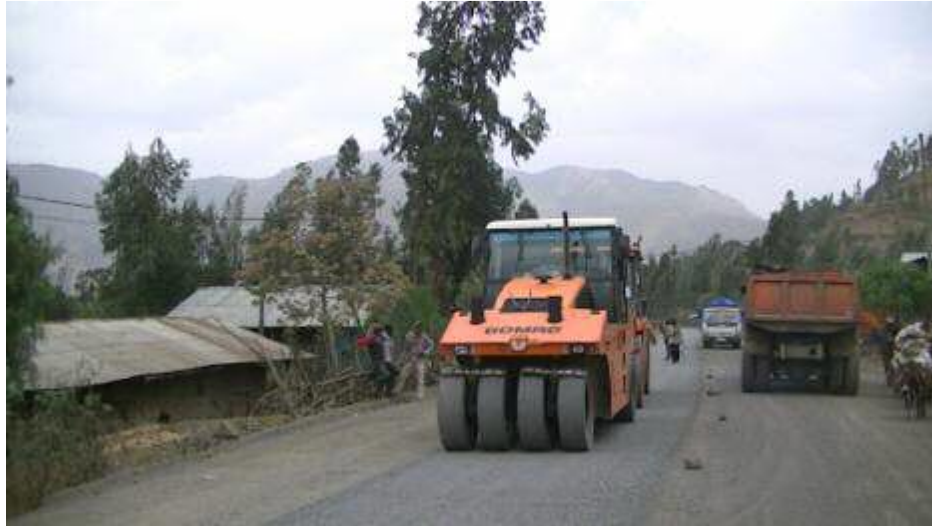
**Figure 6-2 Rolling with pneumatic roller and tipper truck**

After completion of the 2<sup>nd</sup> sealing operations, the entire section received three days of rolling at slow speed (less than 10km/hr) by the pneumatic roller. The steel roller also stayed on site to roll and flatten out the longitudinal joints.

The rolling during construction and afterwards was carried out using a 24-tonne pneumatic roller followed closely behind by a 10-tonne steel roller in non-vibratory mode, as shown in Figure 6-2. The rolling was carefully supervised so that the entire width of the surfacing and all sections received adequate rolling.

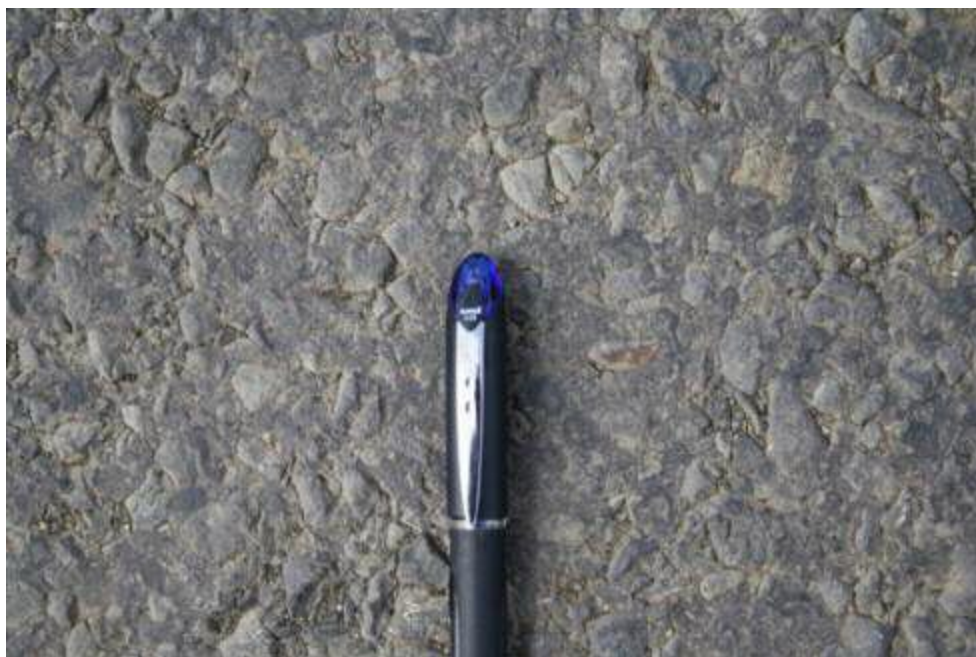
**Figure 6-3 Close-up of the broomed surfacing applying the 2<sup>nd</sup> seal**

The whole trial section was cleaned with a power broom to remove dust and detritus before applying the seal (Figure 6-3). The layout of the trials is shown in Appendix C.

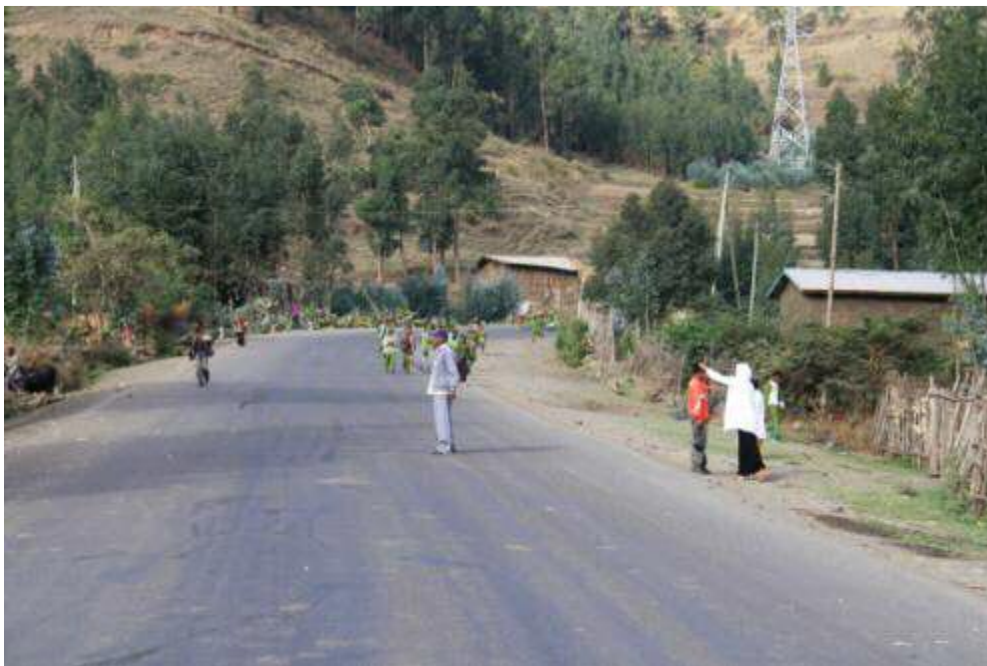
**Figure 6-4 Completed Otta seal surfacing near the school**

A section of road at the beginning of the trial near the school is shown in Figure 6-4.

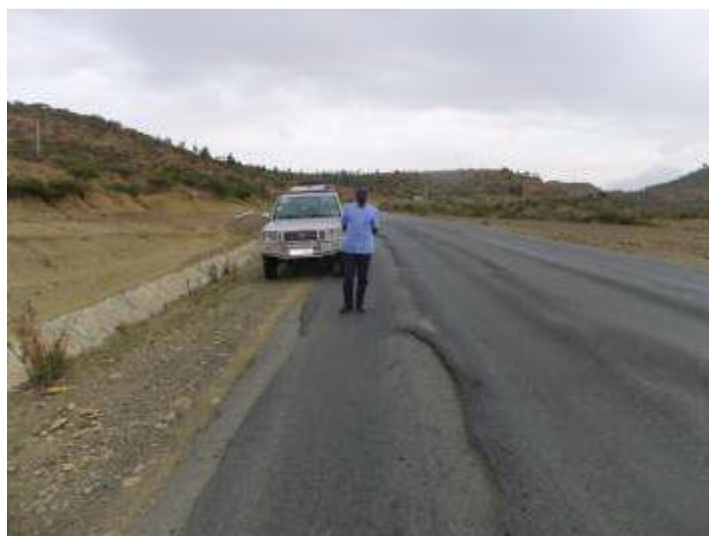
Figure 7-1 Deformation of the AC surfacing on the Mekelle - Combolcha road

Of major concern is plastic deformation which occurs on many Asphaltic Concrete roads in Ethiopia. The problem is particularly evident on steep sections of road manifested as deep ruts in the wheel paths and at junction approaches as “ripples”. The slow heavy vehicle speeds in these areas means that the surfacing materials are loaded for longer and hence are more likely to deform. Plastic deformation in HMAC surfacing is the most serious form of failure because the affected material must be removed before the road can be rehabilitated.

The problem is more pronounced in areas of high ambient temperature (such as Afar Region and parts of Tigray Region) or areas that experience high temperatures for significant periods of the year. (see Figure 7-1 and **Figure 7-2**).

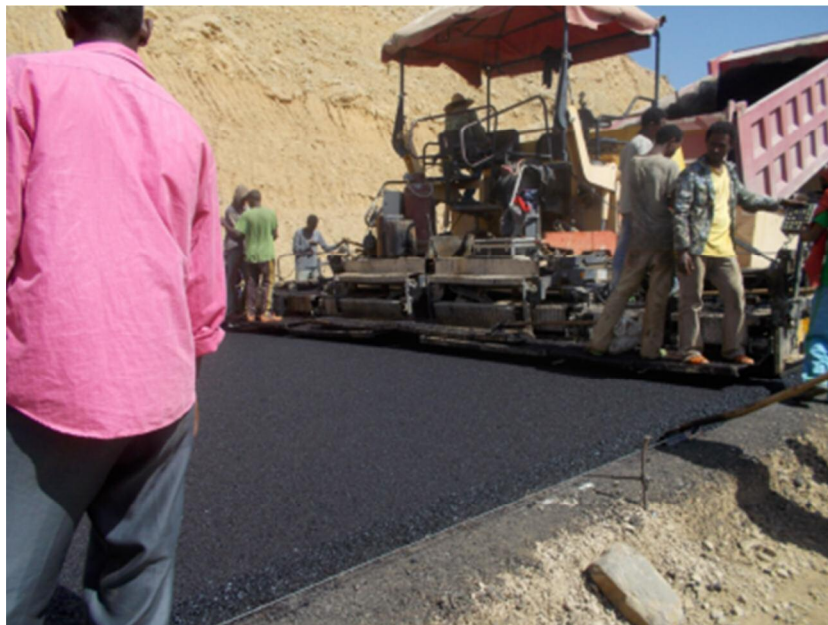
**Figure 7-3** Laying of the asphalt layer by paver

A paver was used to lay the AC mat and produced a 50mm thick by 7m wide layer after compaction as shown in **Figure 7-3**. Compaction was carried out by one Tandem Roller plus two PTRs as shown in **Figure 7-4**. After completion of construction, cores were taken out of the AC surfacing to check that the quantity of asphalt and aggregate grading were within tolerance limits. The cores were then subjected to bitumen extraction test and the quantity of bitumen and the grading of the aggregate component were determined.
