**SOUTH EAST ASIA COMMUNITY ACCESS  
PROGRAMME**

**DEVELOPMENT OF LOCAL RESOURCE BASED  
STANDARDS**

### STUDY OF ROAD EMBANKMENT EROSION AND PROTECTION

By J Howell (Living Resources)

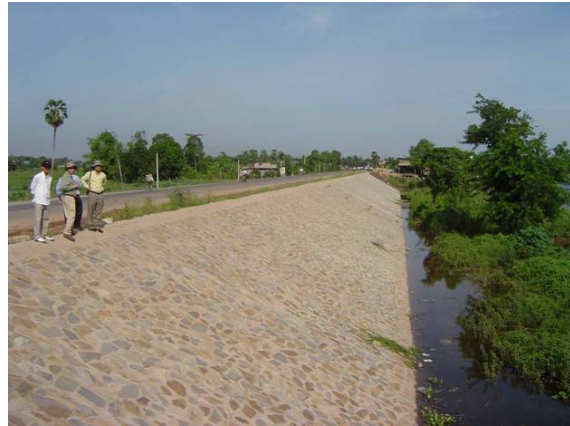
### *Km 19*

On the river side (NE) of the road there is recently built mortared masonry embankment protection. The embankment is about 4 metres high, and though the river bank is about 400 metres away, this section of road has clearly been subject to occasional severe flooding. The protection has been nicely finished with the flat faces of limestone rocks, and good (though often wide) brushed concrete pointing in between. The stone size is mainly in the 300 to 600 mm range, and has apparently been bedded directly on to the embankment so that it is only one stone, or about 300 mm, thick. There is a line of gabion at the toe. No provision has been made for water to drain out of the soil embankment.

Apparently the river used to overtop the road at this point, so the embankment has been raised to stop this happening. There is no erosion protection on the other side of the embankment.

This was said to be an example of the lowest cost type of hard engineering solution adopted by MPWT.

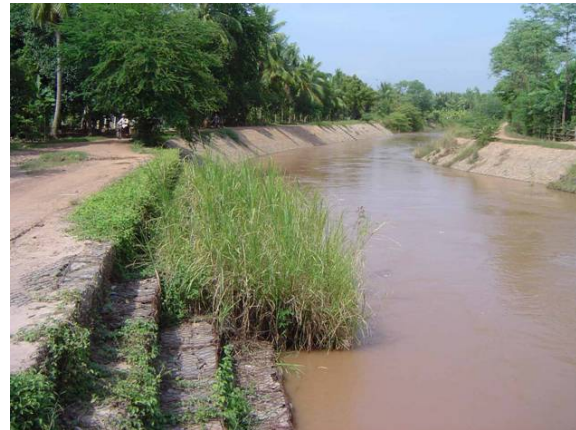
### *Km 39.5*

An irrigation channel crossed by the road; the bank protection on the channel was examined. The water passes under the road by means of a large culvert, with reinforced concrete walls projecting beyond the road like a big flume. At the end of these, a gabion revetment has been damaged by the swirl of water when in full flow. Where the channel goes round a bend, its sides have been protected with mortared masonry. Otherwise the channel banks seem to have been left unprotected.

There was an interesting grass growing here, which was later found to be very common in riverine areas. It is medium-sized in stature, 2 to 3 metres high; the leaves are 10 to 20 mm wide, with a distinctive single pale streak running up the inner spine. It grows on gabions, and therefore is probably tolerant of drought (unless the roots are penetrating right through); and it also grows on mud banks and along the water's edge, where it is inundated for long periods. It is not listed in Dy Phon's dictionary.

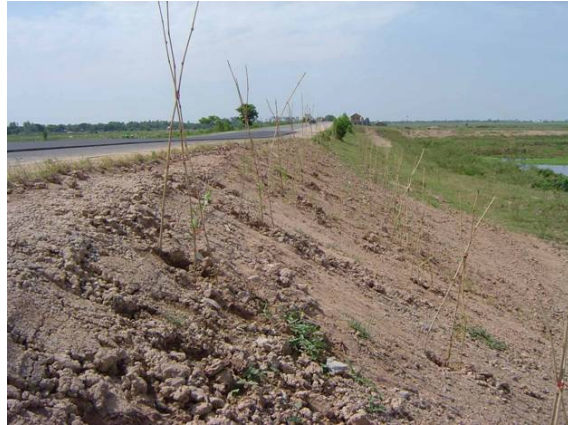
### *Km 42.5*

A plantation of *Acacia auriculiformis* (smach téhs) has recently been finished on the western slope of a newly formed embankment about 8 metres high, on the approach to a bridge, and continues for about 2 km. There is also a line of turfs of *Cynodon dactylon* (smau chénhchiën), the common creeping Bermuda grass, laid about 75 cm from the edge of the asphalt pavement on both sides. This is struggling to establish as the soil around it erodes due to runoff and spray from the road. There is no other protection on the steep slope of bare, unconsolidated soil. The trees were being watered.

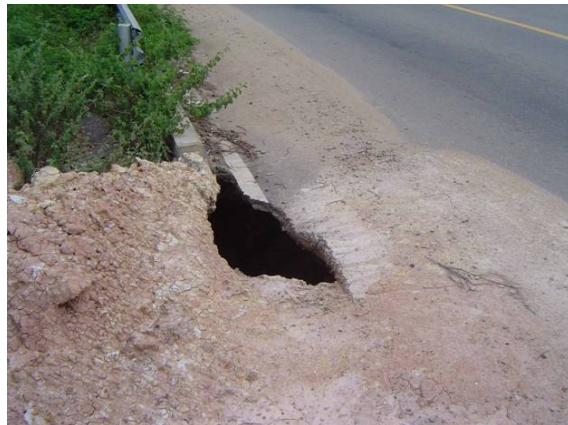
### ***Km 68***

An example of bad piping of soil from the internal structure of a high section of relatively new embankment (constructed in 2003 during rehabilitation), but obviously with problems of compaction and drainage. The piping has occurred right at the end of a section of mortared masonry slope protection about 800 metres long, on the southern side of the road. The fate of the eroded material is not clear, partly because an earth access track has recently been made on the side of the embankment at this point. However, there is a void of at least several cubic metres in volume in the embankment, including the edge of the road formation.

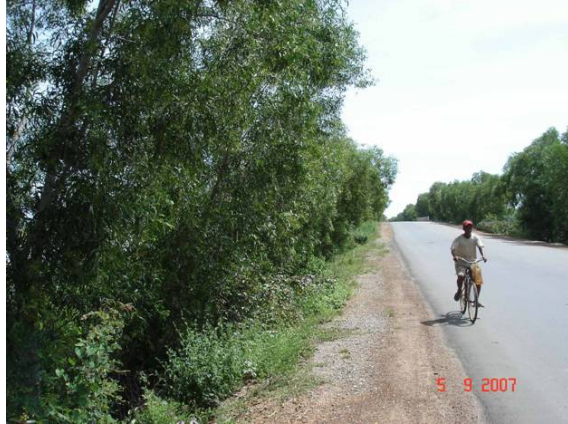
### *Km 51 (approx.)*

Along this section of road, north of the RN 6A-7 junction with RN 61, the embankment was re-made a few years ago. There are *Acacia auriculiformis* (smach téhs) and *Eucalyptus* sp. (doëm pré:ng) planted along the sides of the embankment, and these are growing well. However, nothing was planted in between, so the surface cover remains a weak mixture of creeping grasses and annual herbs.

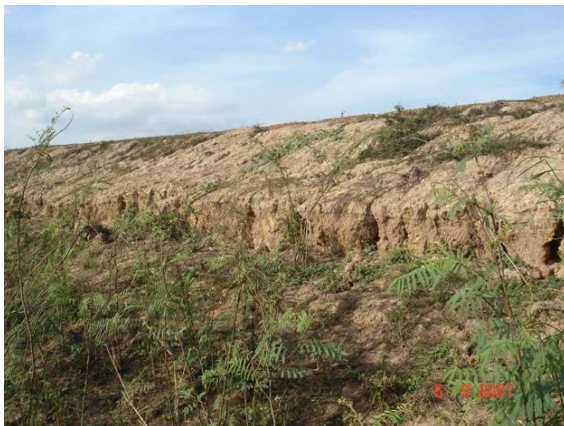
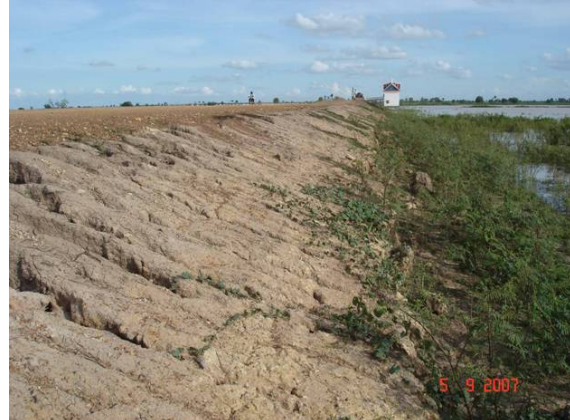
This is a new road, mainly gravel-surfaced, recently upgraded from an MRD local road. At the point of inspection, a few kilometres east of the Mekong ferry near Preah Prasab, there was an unprotected embankment 2 to 2.5 metres high and eroding badly. The land to the south was flooded, and it was clear that in the past, when the flood level was higher, waves had cut a step near the toe of the embankment slope. This had a vertical or

overhanging face about 50 to 60 cm high. Rills on the slope were 5 to 10 cm wide and about 50 cm deep. The material was very loose and unconsolidated, and in places pipe erosion was also taking place. The northern side was very similar, with just as large a wave step and as much active erosion. *Mimosa pigra* (prèah khlâ:b yiëk), the unpopular thorny shrub, was growing along the ground below the embankment, but nothing much was growing on the eroding slopes.

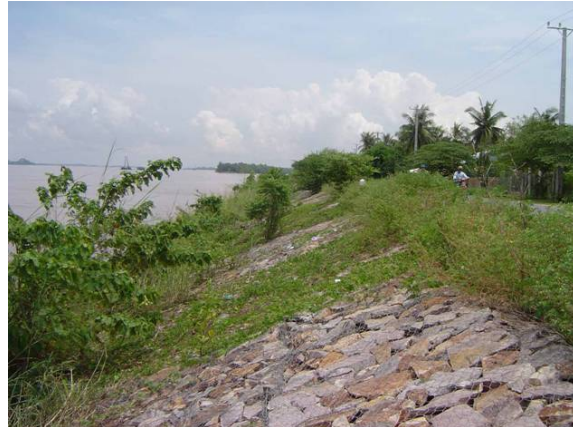
### *Km 65*

At this point the road runs very close to the main Mekong channel. There is a long section of gabion mattress to protect the western side of the embankment against river scour. This was presumably constructed in 2002 and 2003 under the Emergency Flood Rehabilitation Project. It seems to be performing well, except that there is worrying corrosion of the mesh wire on the lower levels. A wide range of plants are colonising the gabion, including the grass noted at km 39.1 on RN 1, and the common but unpopular *Mimosa pigra* (prèah khlâ:b yièk).

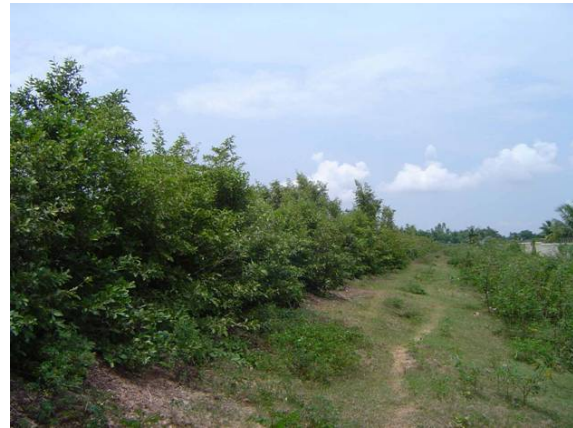
### *Km 70 (approx.)*

A long section of the embankment here has been planted with *Combretum quadrangulare* (sângkaè), again presumably in 2003 under the Emergency Flood Rehabilitation Project. These small trees appear to have been planted from hardwood cuttings (their form shows that they would certainly grow from such a method). They are growing well. Once established, they are obviously resistant to grazing by the numerous cattle roaming the area. However, there is no surface cover of the soil underneath the sângkaè, and since they are spaced around 1.5 to 2 metres apart, the result is that erosion is still taking place. The *Cynodon dactylon* (smau chéhnchiën) grass that is dense at the bottom of the embankment is very sparse among the sângkaè itself. There are numerous annual herbs colonising the bare ground in places, but these are mainly shallow-rooted plants like *Eupatorium adenophorum* and the legume *Cassia tora* (dânghèt chhniëng).

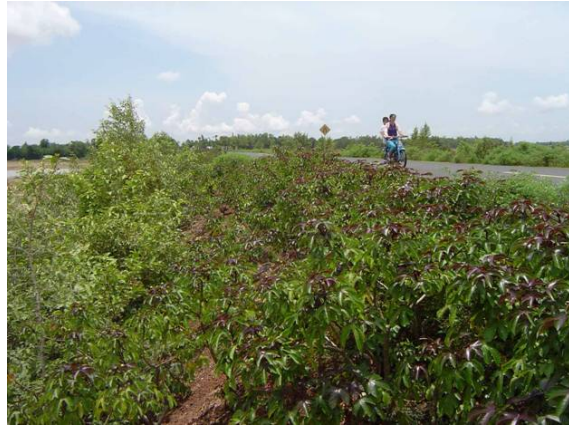
**Km 84**

A mixture of planting, with *Combretum quadrangulare* (sângkaè) on the lower half of the embankment slopes and *Jatropha curcas* (lông khwâ:ng) on the upper part. The embankment here is relatively low, being only about 2.5 metres in height. The shrubs are growing well and look good from a distance, but there is very little ground cover underneath, so that the soil surface remains bare and erodible under the canopy.

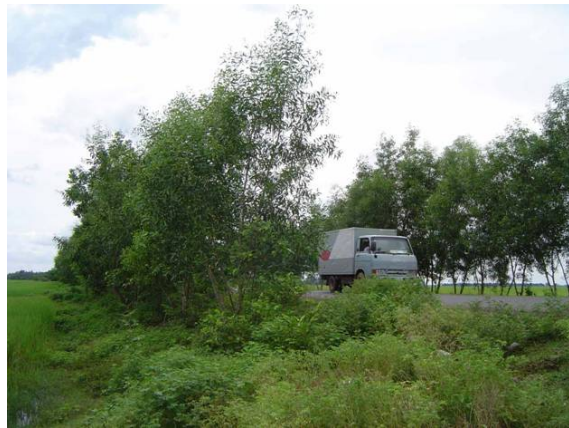
**Km 130**

In this area there are several kilometres of embankment slopes planted mainly with *Acacia auriculiformis* (smach téhs), but also with a few *Combretum quadrangulare* (sângkaè) mixed in. The smach téhs is now 4 to 5 metres in height and is shaping into a fine avenue. However, these large plants are quite sparse, forming one main line of trees at an average spacing of about 1.5 metres. The result is better ground cover than in the denser roadside plantations seen in the previous sites, but only with a cover of creeping low grass and annual legumes; so it does not appear that the slopes here are any better protected against the impacts of waves than are those elsewhere.

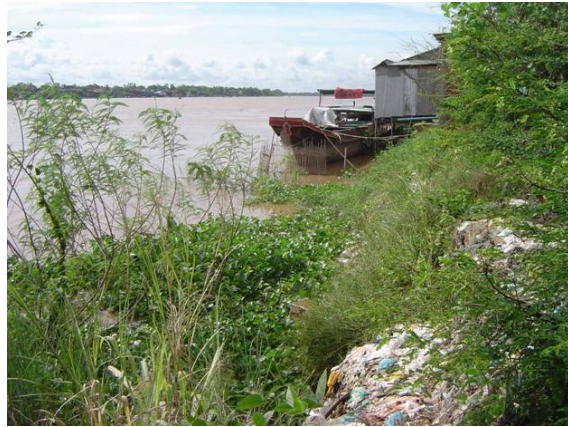
In fact the section of road threatened by bank erosion extends considerably beyond the section where gabion matting has been installed in the past. The slump has left a steep earth bank close to the road, along a stretch of at least 100 metres. Beyond this, the bank is further from the road (perhaps 10 to 15 metres), but its retreat is threatening the backs of a number of properties: it has a ragged plan, with some protrusions into the river and bays in between extending towards the road. There was evidence that the protrusions were associated with the presence of small trees like *Pithecellobium dulce* (âmpil tük). The local people claim that the bank is eroding at about 5 metres per year, and they are attempting to slow it by means of sand bag walls, and small piling of bamboos and tin sheets. It is difficult to determine how true this estimated rate of retreat is, but it is certainly gradual rather than sudden, and the vegetation seemed to be fairly thick along the river side of the bank. In August the river level was about 2 metres below the top of the embankment.

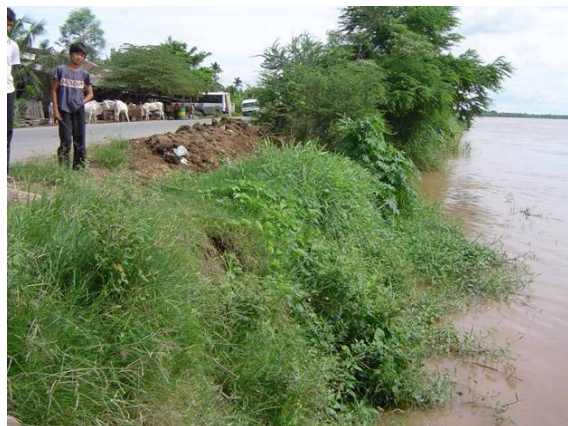
### ***Km 35 (approx.), Kaoh Khael (GPS 0503025 / 1244956)***

Another area of erosion of the bank of the Bassac, on the outside of a gentle bend. Along most of the length of the failing bank, the river is within a few metres of the road edge, so there are no houses at this site. In June it was noted that erosion may have been exacerbated locally by human and animal access to the river, and while this is true, the major cause is the flow of the main current against the earth bank. The material is a stiff light brown, clayey silt, and it was sampled for testing during the June visit. At the time of the August visit, some small slumps were active in the edge of the road embankment where it was closest to the river, but otherwise the retreat of the river bank is gradual, and vegetation is present along most of the embankment side, even if this only consists of grasses and a few shrubs.

There are small trees in places, up to 7 or 8 metres high and mainly of *Pithecellobium dulce* (âmpil tük). Where these are found, the river bank is further back, but it is eating in between them. Some of these trees are quite old, and appear to have

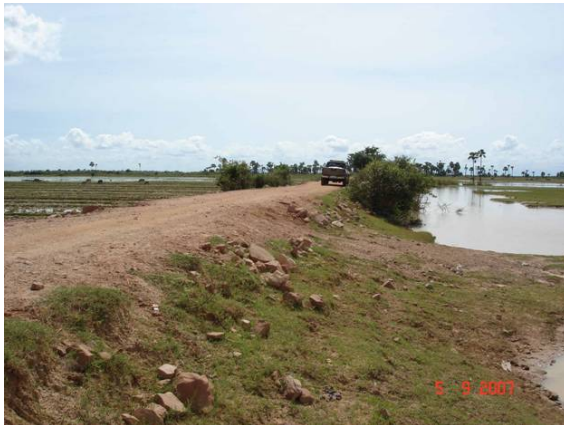
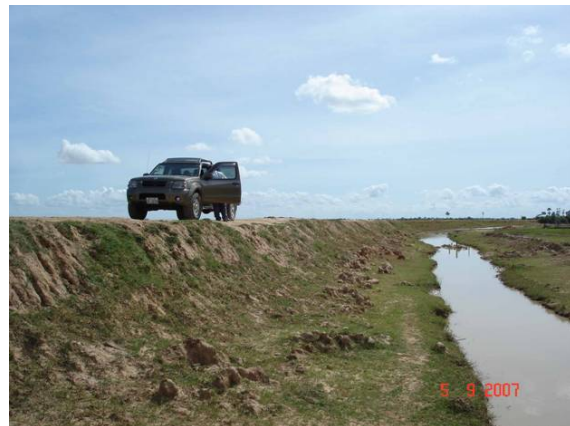
### *Bati Commune - Omal Village Road (off RN 7)*

This road is being upgraded progressively over a number of years. An earth track through the rice fields is being raised and improved to form an earth road on an embankment. There is no systematic effort to protect the embankment, but a number of both herbs, and annual and woody shrubs, have colonised the slopes in different places. There is a heavy grazing problem. At

one site, there seemed to have been some grasses planted, but they had been eaten nearly out of existence. Some *Acacia auriculiformis* (smach téhs) seedlings had been planted recently, but they were rather close to the road (which was very narrow in any case).

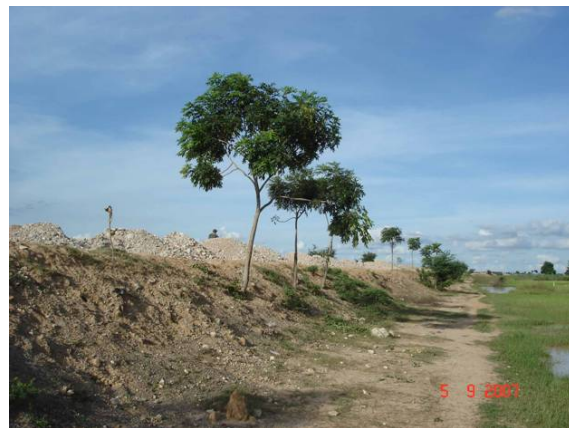
### *New Local Road off RN 8*

A steep embankment was being formed on this road, which was still under construction at the time of the visit. It was said that a number of shrubs had been planted on the slopes last year specifically to stop erosion, but they did not survive at all. No one was sure of the species used.
