**MINISTRY OF TRANSPORT
VIETNAM**

**RURAL ROAD SURFACING
RESEARCH**

SEACAP 1

Final Report

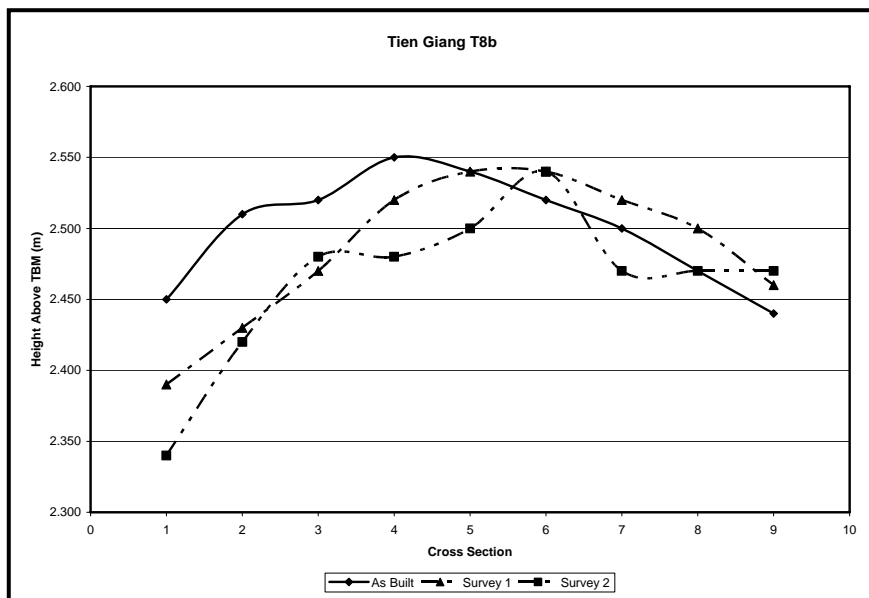
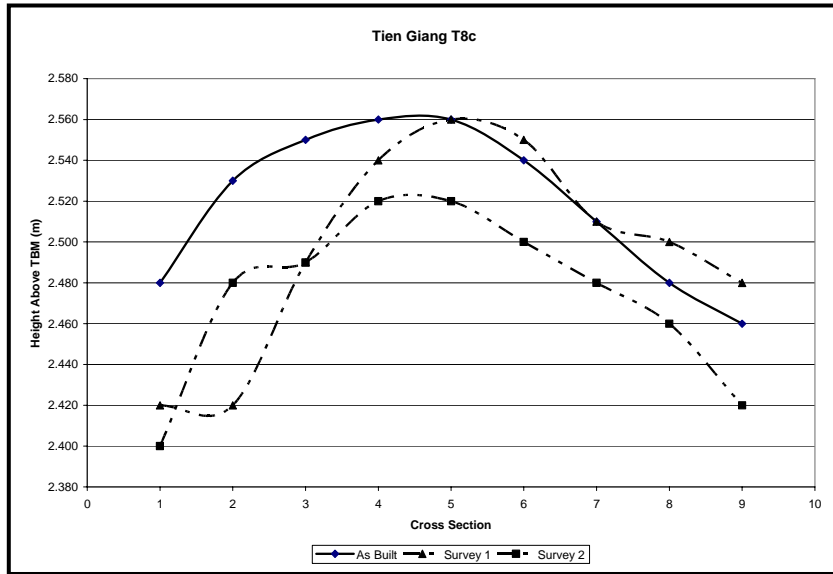
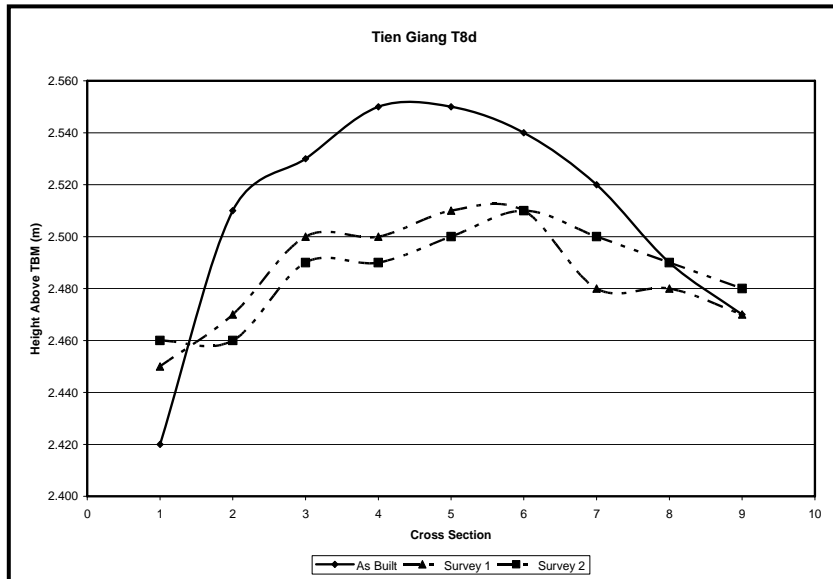
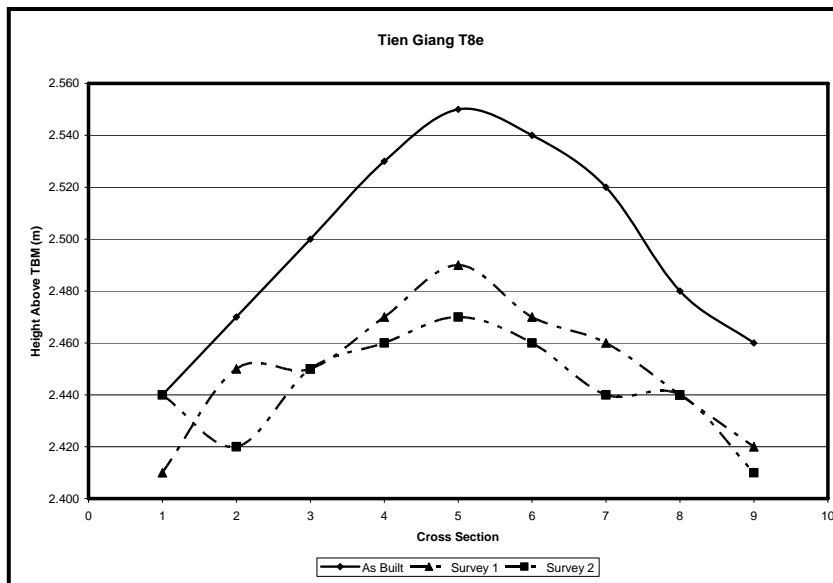
Tien Giang Trial section TG08
Cross sections at 5m; 20m; 40m 60m and 95m running left to right

Appendix D4 contains plots of monitored cross sections of unsealed control sections in Tien Giang, Dong Thap and Hue. No follow-up monitoring to the as-built survey has as yet been completed in Da Nang.

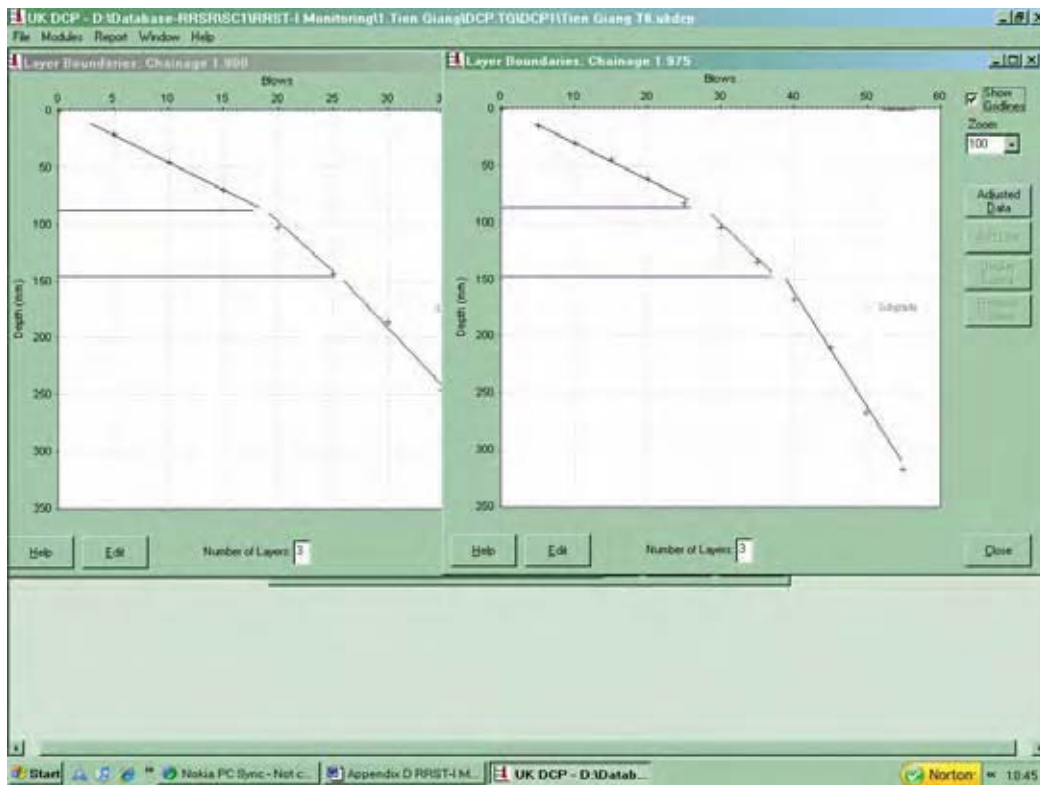
Figure D6.2: Lower strength layer within stabilised base; Section TG06, As Built Survey
 Plot from UKDCP interpretation shows Ch 1.900 CBR=70 to 90mm; CBR=40 below that
 Ch 1.975 CBR=88 to 90mm; CBR=45 below that

1. Significant deterioration in strength between July 2005 and January 2006, with a levelling off of the deterioration between January 2006 and July 2006
2. The strength profiles after the initial as built survey sometimes show considerable horizontal and vertical variation, with a general retention of strength within the top 50-75mm, Figure D6.1,
3. Some profiles show a significant weaker zone at the bottom of the base layer, particularly in TG06, Figure D6.2
