USE OF LOCALLY-PRODUCED MATERIALS FOR LOW-VOLUME ROAD PAVING

Eng. Nkululeko V. Leta, Technical Assistant, Mozambique National Roads Administration (ANE)

Raquel Langa, Researcher, Monitoring Department, ANE

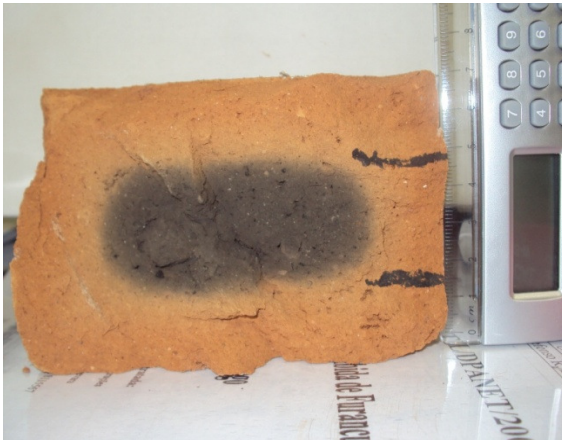
Appearance of poorly burnt clay at the surface of the brick was observed after 18 months. The firing was also not uniform as the size of the “black core” varied from brick to brick.

Photo nº 1: Poorly-fired clay brick

- Appearance of black colour in the central area of the brick indicates poor firing of bricks. It should also be noted that the bricks were not improved in any way for use as road pavers, but were provided by the local suppliers of bricks for building construction;

- Need for better facilities and processes for improving the quality of bricks. The firing must be such that the black core of the brick turns to a reddish brown colour;

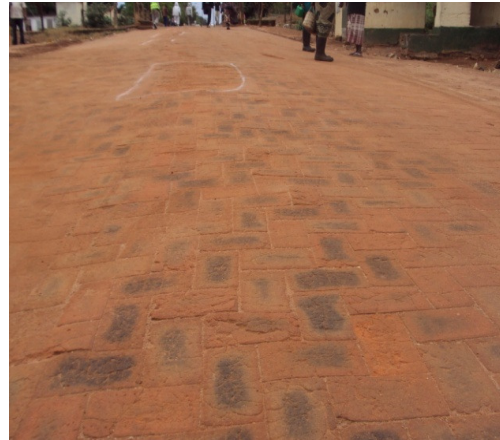
Photo nº 2: Visual signs of bricks wearing off

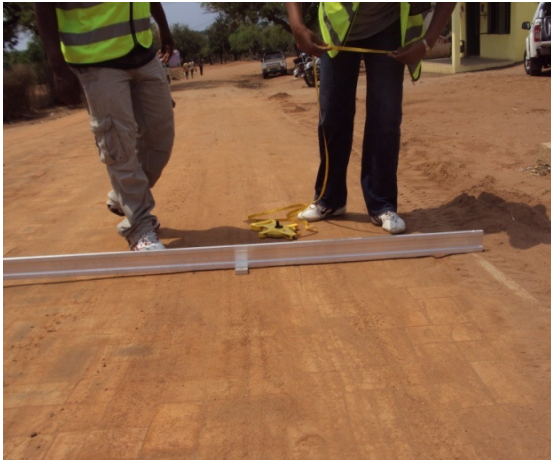
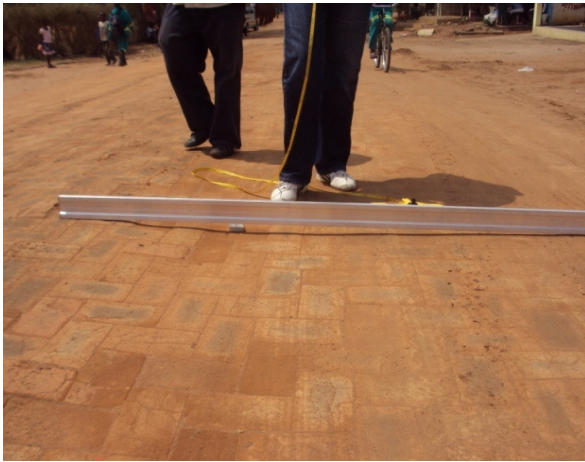
- **Traffic Counting.** Assessment of type and volume of traffic using the section is done during these monitoring visits. Formal traffic counts are conducted over a one-week period, starting at 05.00Hrs up to 1800Hrs. Table 2 shows sample results for 13 July 2009 and 26 June 2010.
- **Measurement of rutting deformation.** As expected, deeper ruts were observed along the wheel paths, and especially on the sections that were repaired prior to laying of bricks. This would suggest settlement, rather than wearing off of the bricks, as the main cause of the rutting.

Photos n° 3 & 4: Use of straight edge and wedge

to measure rut depth

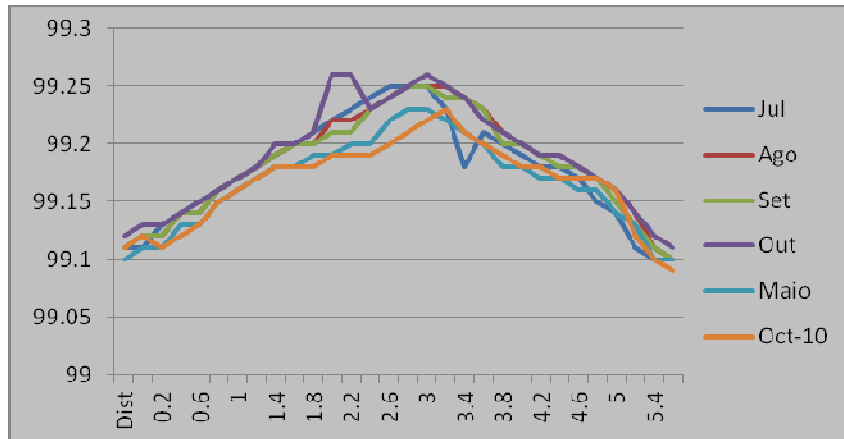
Cross-sections at 5 locations along the experimental section (see Plan Diagram)

Figure 1: PTI - Cross-section nº 1

- **Drainage Assessment.** To date no adverse drainage problems have been observed on the section. This could be attributed to tight packing of the bricks and adequate camber (2-4.5%), as well as a steep longitudinal slope (6%) which facilitates efficient drainage away from the surface.
- **Measurement of Brick Wear-off.** Level control of identified points along 5 cross-sections, drawn at 10m intervals along the length of the section is conducted during each visit. These sections are identified as PT I up to PT V. Thirty points, at 20cm intervals along each cross-section are marked with paint for position control purposes. Two steel reference pegs were concreted *in-situ* at a distance of 3m and 2m from the edge of the kerbing on either side. These pegs function both for level control and for ensuring the same points are surveyed each time. (See Figure 1-5 below)

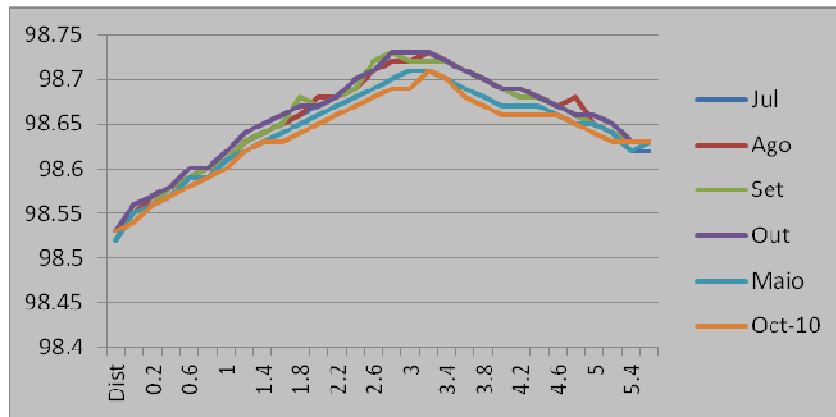
Figure 2: PTII - Cross-section nº 2

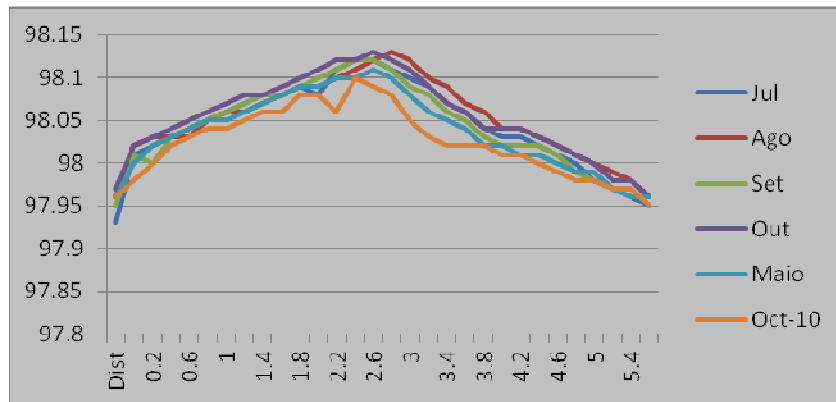
Figure 3: PTIII - Cross-section nº 3

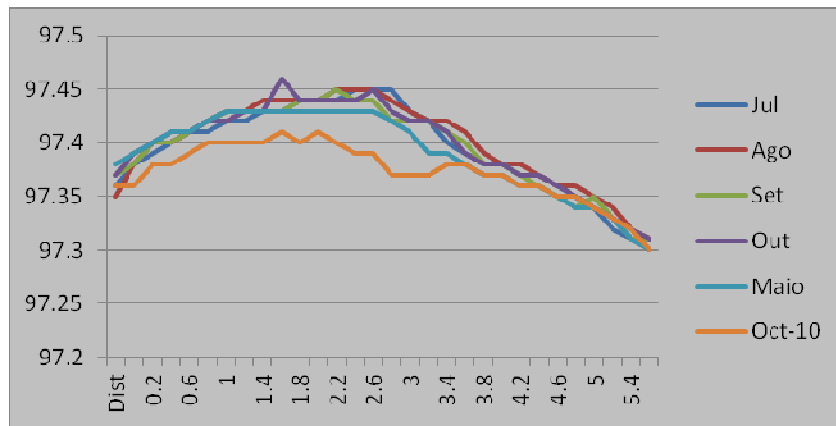
Figure 4: PTIV – Cross-section nº 4

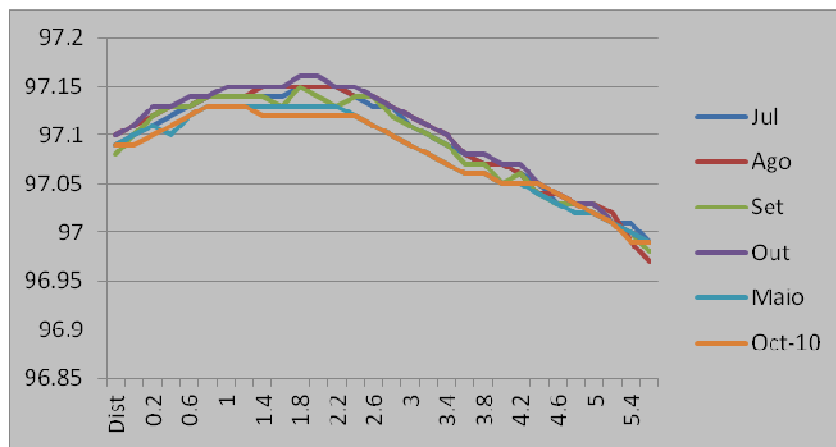
Figure 5: PTV – Cross-section nº 5

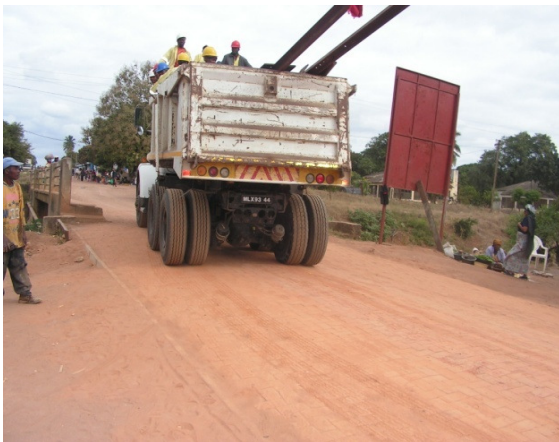
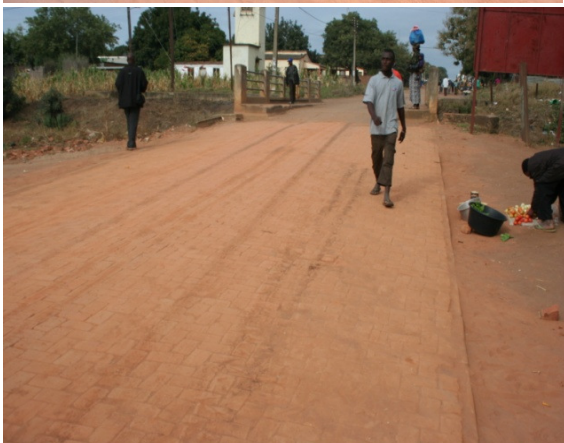
Photos nº 5 & 6: Paved section just after construction (May 2009)

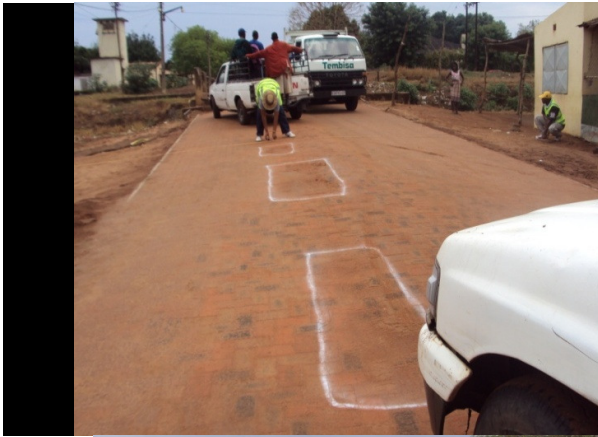
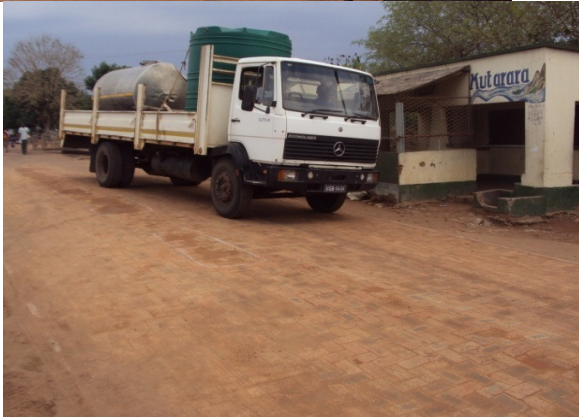
Photo nº 7 & 8: Section as at 28 October 2010 - marked areas show crushed bricks to be replaced

- It was also noted that once bricks were broken and not immediately replaced, deterioration accelerated leading to pulverization of damaged brick. In time, this also exposed the surrounding bricks to the same deterioration processes. **Rapid replacement of broken bricks is therefore a key maintenance activity;**

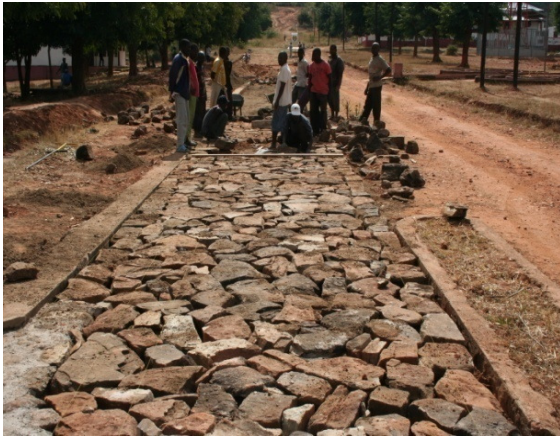
Photo n° 9: Hand-laid stones before spreading sand;

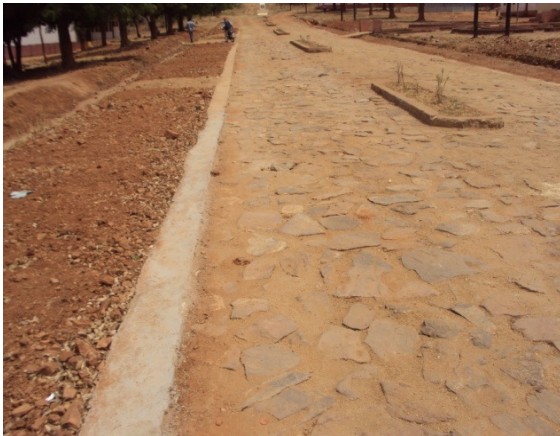
Photo n° 10 Completed section (July 2010)

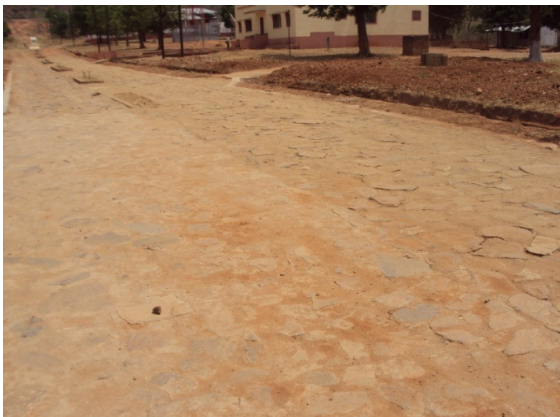
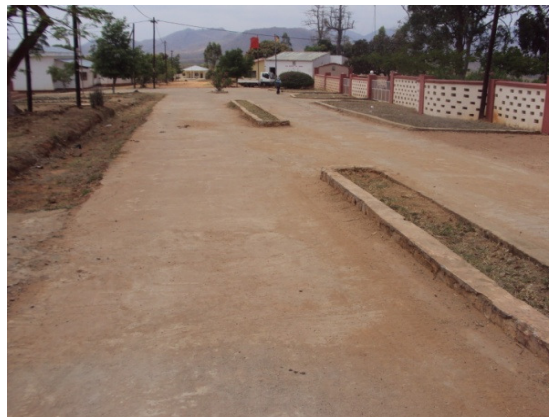
Photo

n° 11: Cement-grouted stone on LHS

Cement-grouted stone+cement mortar screed

The section with cement-grouted stone + 50mm cement mortar screed was constructed 5 years ago (2005), and is still holding up reasonably well with no major cracking or deformation observed. This could be also due to low traffic levels on that section which is located just off the main road, and passing through the District Administration offices.

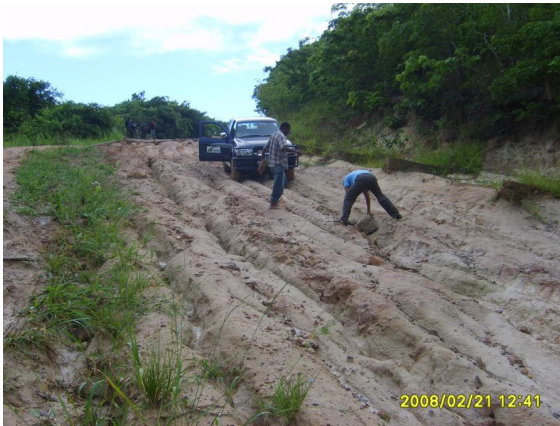
Photos n° 13: Before intervention, Feb 2008

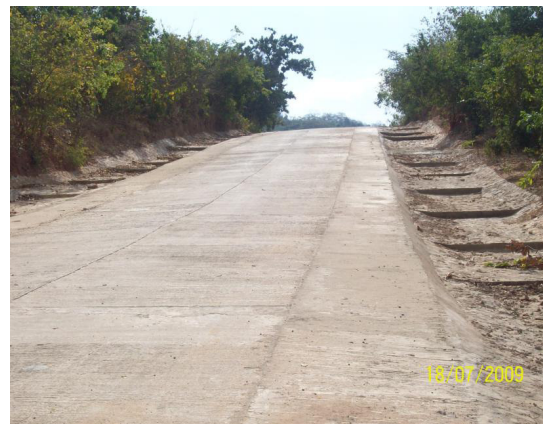
Photo n° 14: After intervention, July 2009

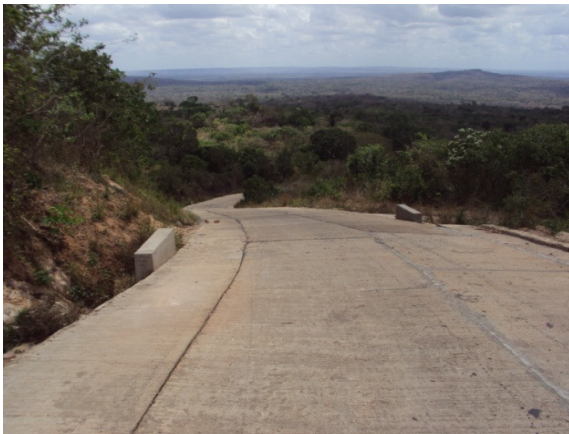
Photos n° 15: Section as at October 2010 - no tensile cracking observed

Two years after completion, no tensile cracking has been observed on this section. A few sections that were not adequately ribbed during construction have smoothed out creating a few slippery sections along the slope.
