## Ground Improvement for Khulna Soft Clay Soil

*Interim Laboratory Test Report*

*AFCAP Project Reference Number: BAN2082A*

**February 2017**

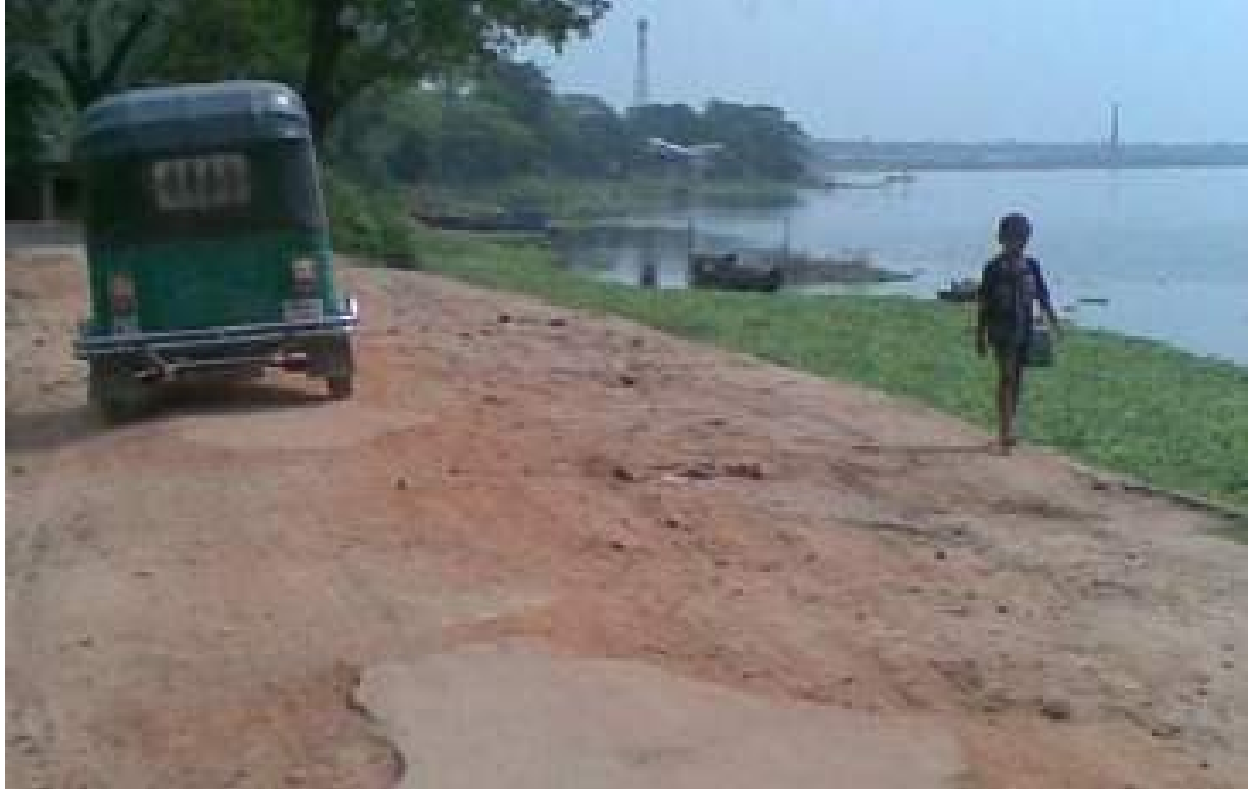
A typical rural road in Bangladesh: (source unknown)

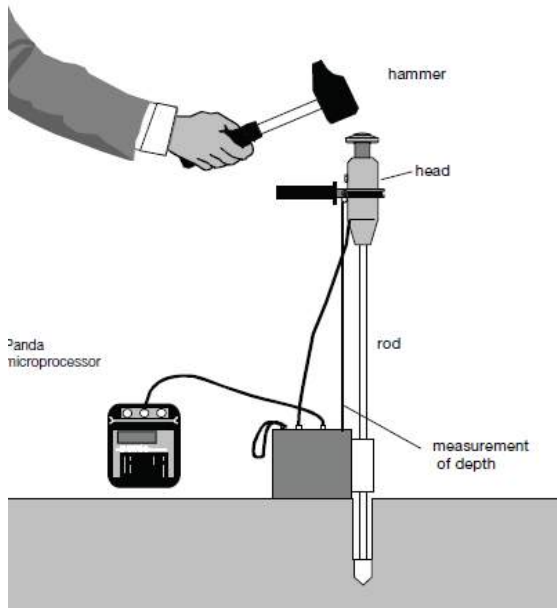
**Figure 1 - Panda 2 Probe Set-Up**

The Panda 2 Probe is a variable energy input dynamic cone penetrometer used to gain information from ground conditions in relation to soils investigation or compaction. It is portable (total weight of 20kg) which allow for single person operation with no enabling works required where bound layers are not found on surface. The Panda 2 Probe is also suitable for use in conjunction with core sampling to ascertain ground resistance or compaction values in underlying unbound layers.

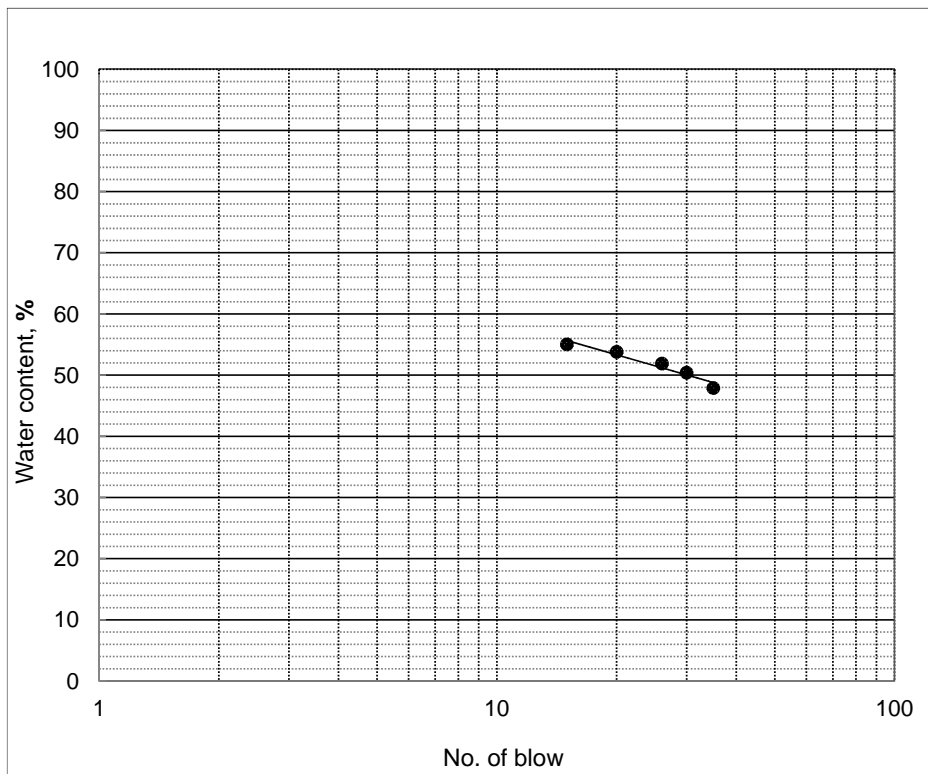
Liquid Limit, LL=	<b>52.21</b>	%
Plastic Limit, PL=	<b>27.93</b>	%
Plasticity Index, PI=	<b>24.28</b>

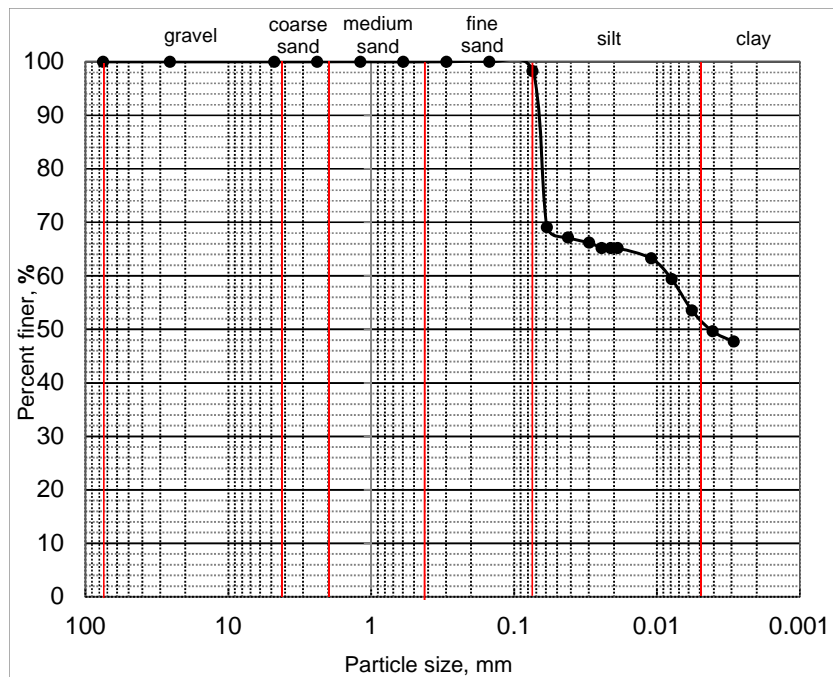
D10 (mm)	D30 (mm)	D50 (mm)	D60 (mm)	D95 (mm)	Sand (%)	Fines (%)	Cc	Cu	LL (%)	PI (%)	USCS
0.002	0.002	0.004	0.008	0.072	1.75	98.25	0.39	5.05	52.21	24.28	CH

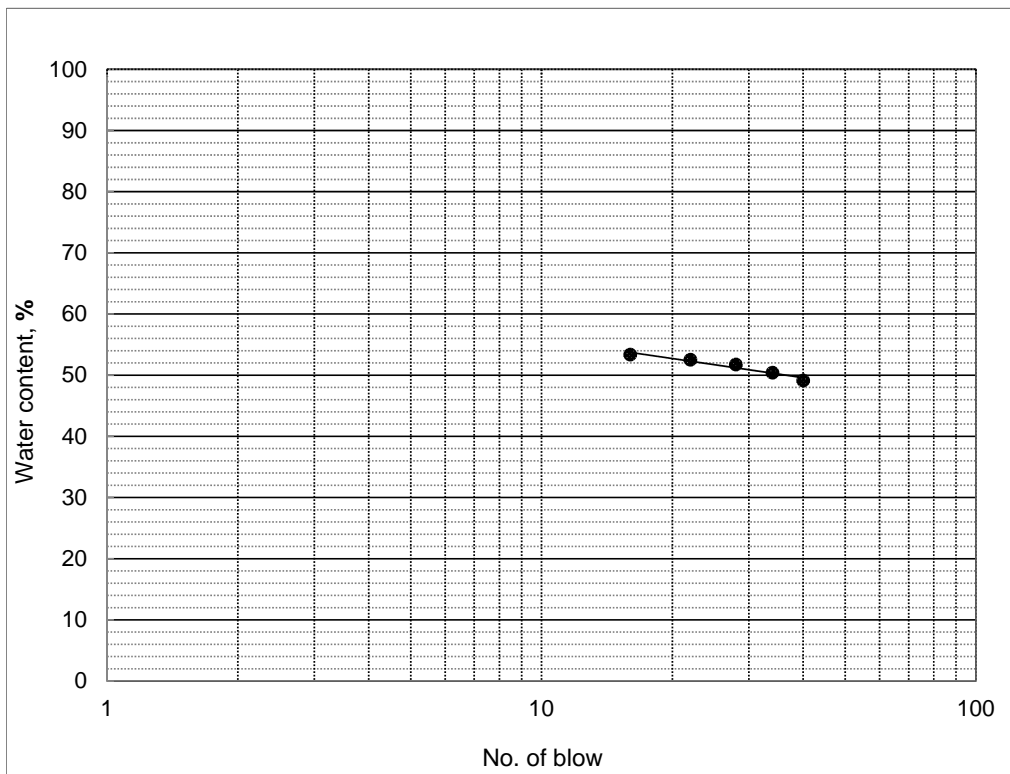
Liquid Limit, LL=	<b>52.12</b>	%
Plastic Limit, PL=	<b>24.99</b>	%
Plasticity Index, PI=	<b>27.13</b>

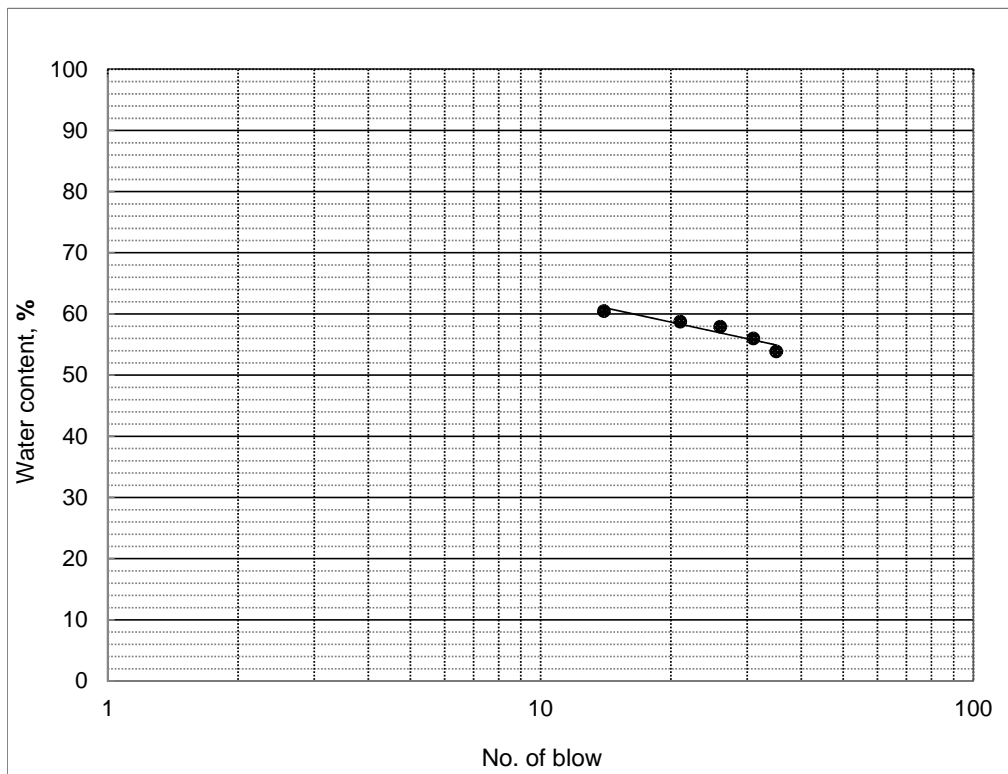
Liquid Limit, LL=	<b>58.07</b>	%
Plastic Limit, PL=	<b>25.41</b>	%
Plasticity Index, PI=	<b>32.66</b>

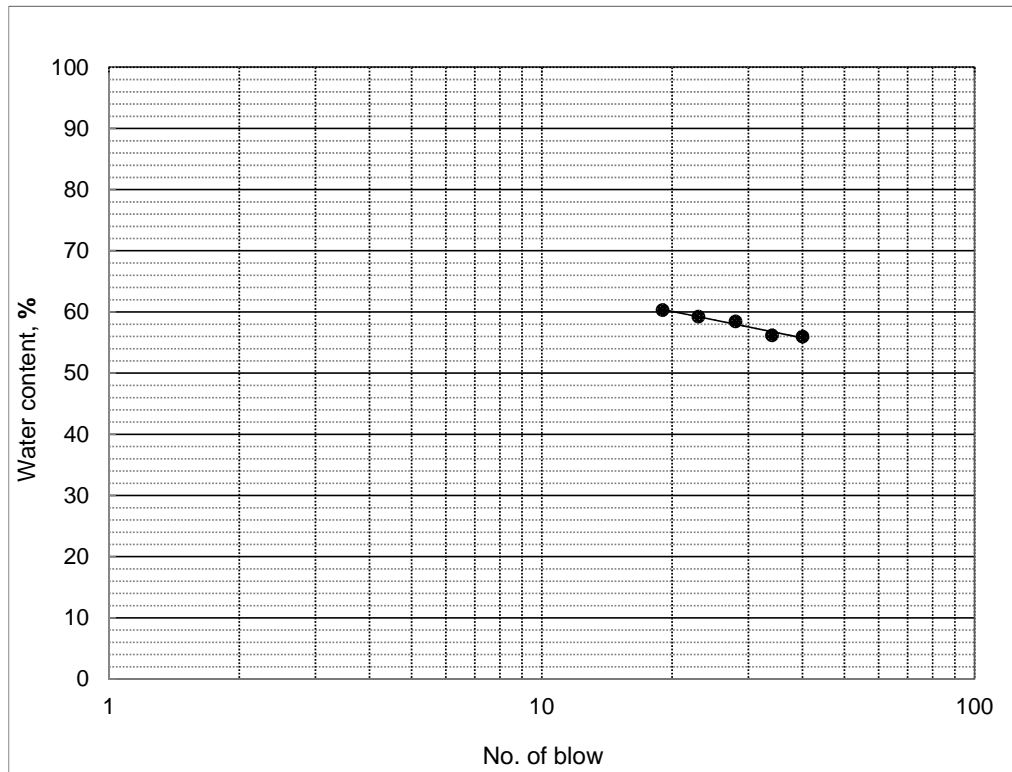
Liquid Limit, LL=	<b>58.92</b>	%
Plastic Limit, PL=	<b>24.90</b>	%
Plasticity Index, PI=	<b>34.02</b>

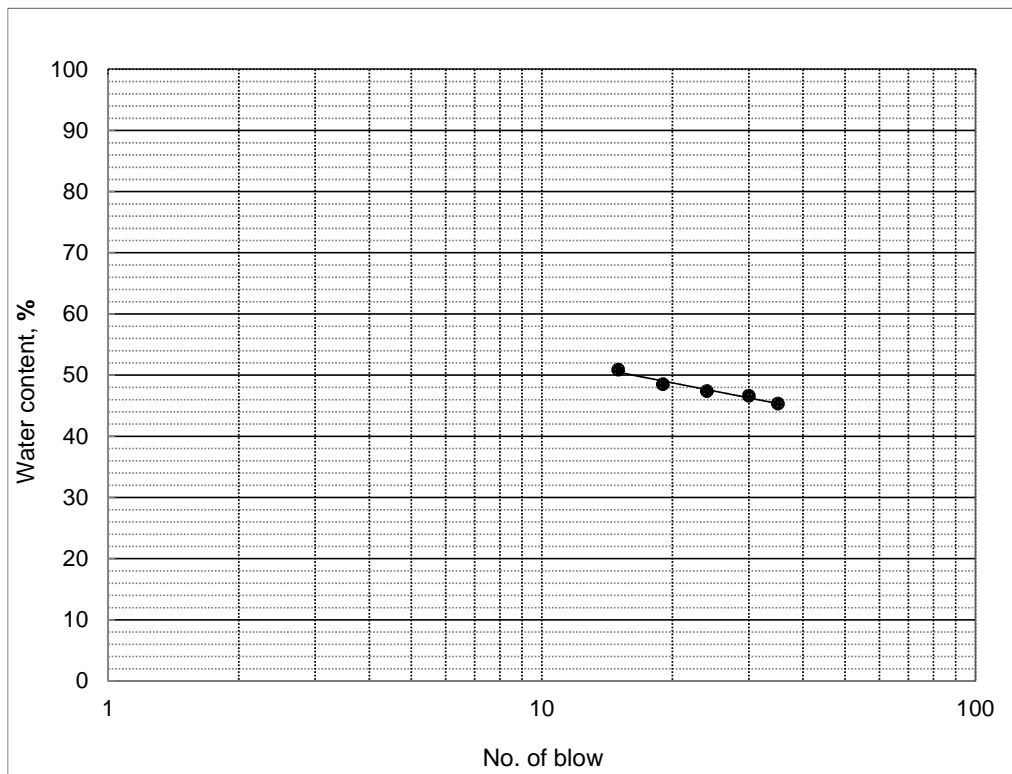
Liquid Limit, LL=	<b>47.27</b>	%
Plastic Limit, PL=	<b>21.19</b>	%
Plasticity Index, PI=	<b>26.08</b>

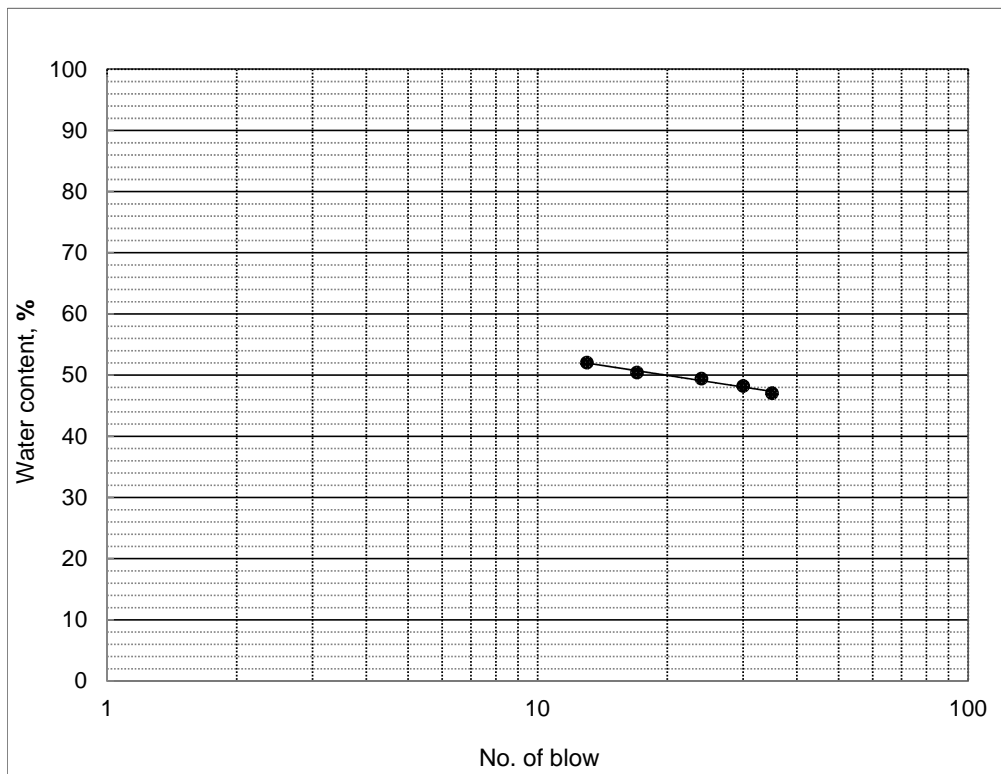
Liquid Limit, LL=	<b>49.23</b>	%
Plastice Limit, PL=	<b>20.88</b>	%
Plasticity Index, PI=	<b>28.36</b>

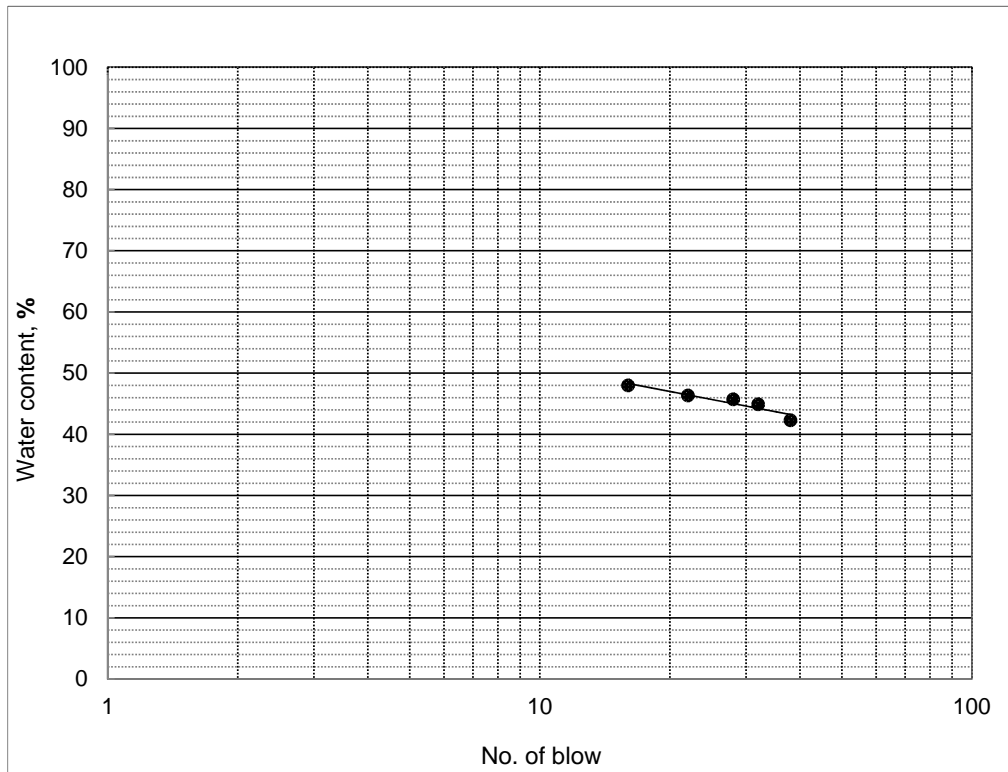
Liquid Limit, LL=	<b>46.03</b>	%
Plastice Limit, PL=	<b>20.22</b>	%
Plasticity Index, PI=	<b>25.81</b>

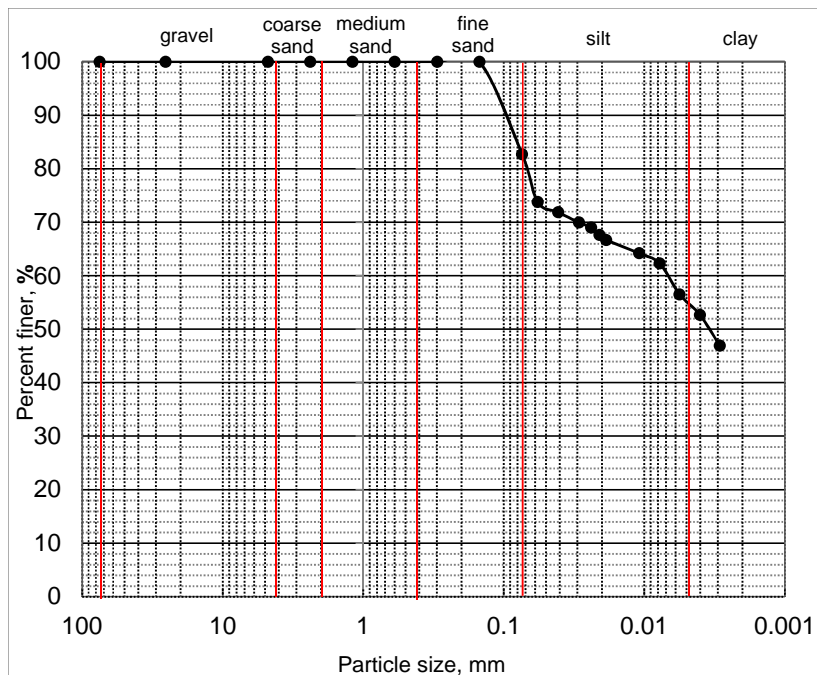
D10 (mm)	D30 (mm)	D50 (mm)	D60 (mm)	D95 (mm)	Sand (%)	Fines (%)	Cc	Cu	LL (%)	PI (%)	USCS
0.002	0.002	0.003	0.007	0.127	17.28	82.72	0.47	4.15	52.12	27.13	CH

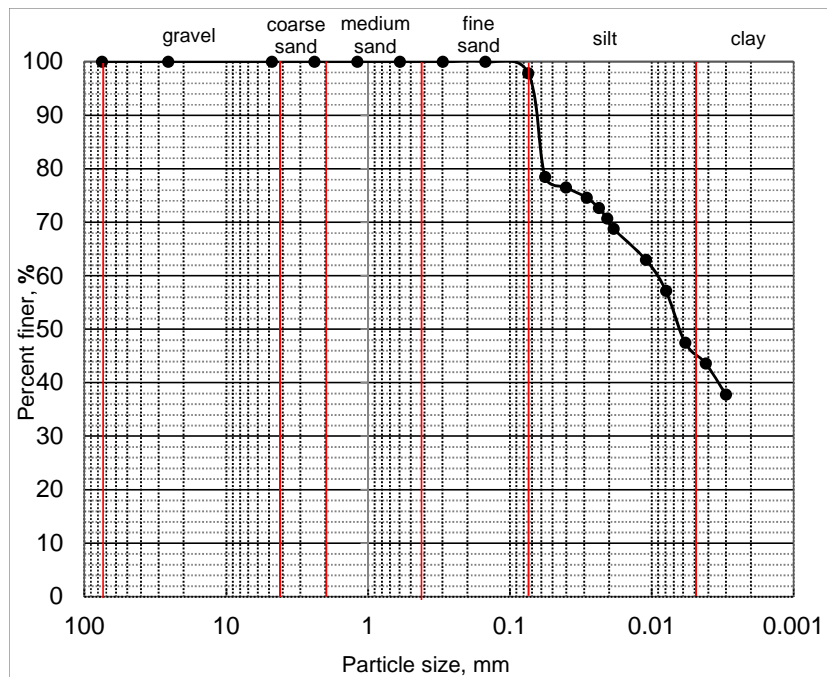
D10 (mm)	D30 (mm)	D50 (mm)	D60 (mm)	D95 (mm)	Sand (%)	Fines (%)	Cc	Cu	LL (%)	PI (%)	USCS
0.002	0.003	0.006	0.009	0.071	2.13	97.87	0.42	5.35	58.07	32.66	CH

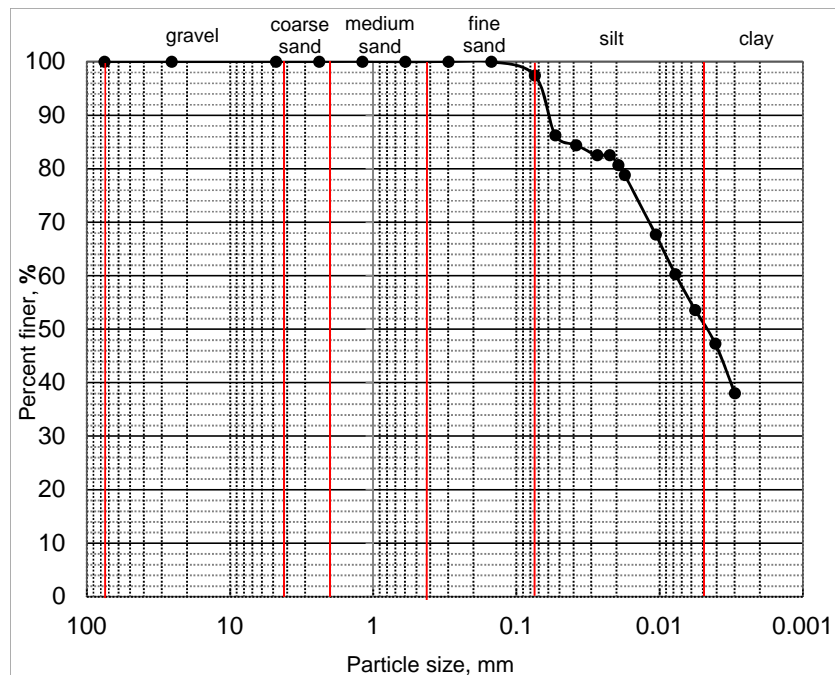
D10 (mm)	D30 (mm)	D50 (mm)	D60 (mm)	D95 (mm)	Sand (%)	Fines (%)	Cc	Cu	LL (%)	PI (%)	USCS
0.002	0.003	0.005	0.008	0.070	2.60	97.40	0.51	4.36	58.92	34.02	CH

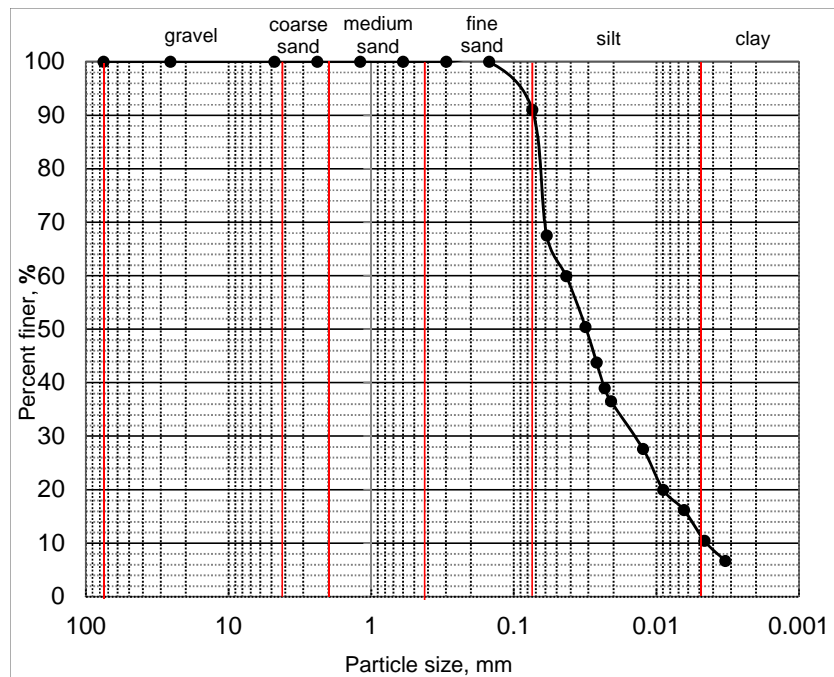
D10 (mm)	D30 (mm)	D50 (mm)	D60 (mm)	D95 (mm)	Sand (%)	Fines (%)	Cc	Cu	LL (%)	PI (%)	USCS
0.004	0.015	0.031	0.043	0.107	8.95	91.05	1.12	9.69	47.27	26.08	CL

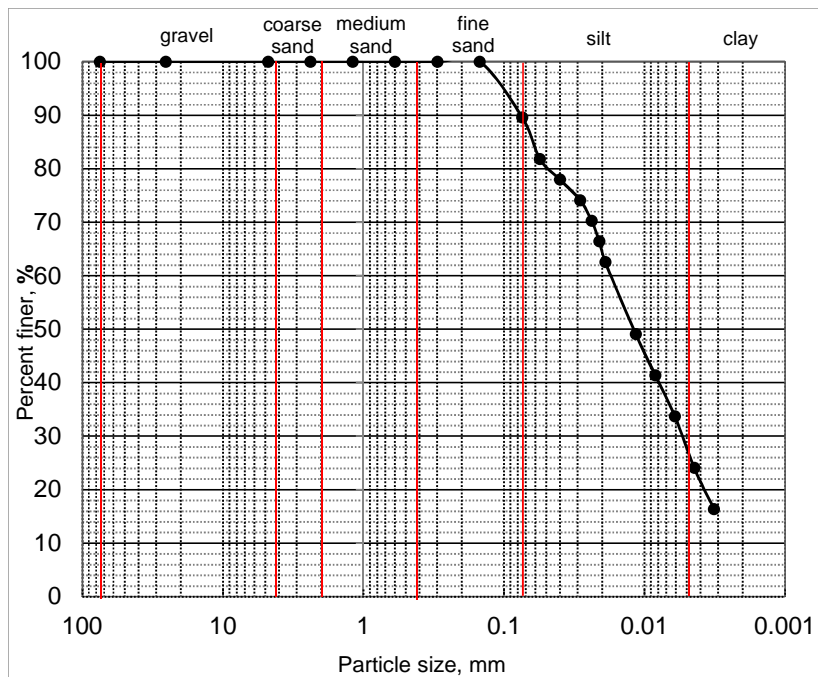
D10 (mm)	D30 (mm)	D50 (mm)	D60 (mm)	D95 (mm)	Sand (%)	Fines (%)	Cc	Cu	LL (%)	PI (%)	USCS
0.002	0.005	0.012	0.018	0.113	10.41	89.59	0.69	7.21	49.23	28.35	CL

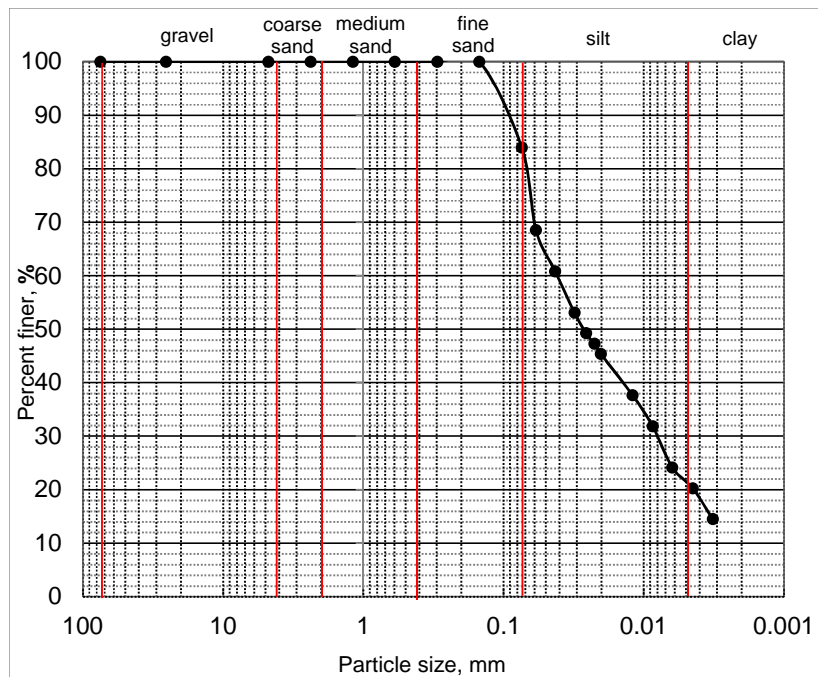
D10 (mm)	D30 (mm)	D50 (mm)	D60 (mm)	D95 (mm)	Sand (%)	Fines (%)	Cc	Cu	LL (%)	PI (%)	USCS
0.003	0.008	0.027	0.042	0.126	16.05	83.95	0.60	15.98	46.03	25.81	CL

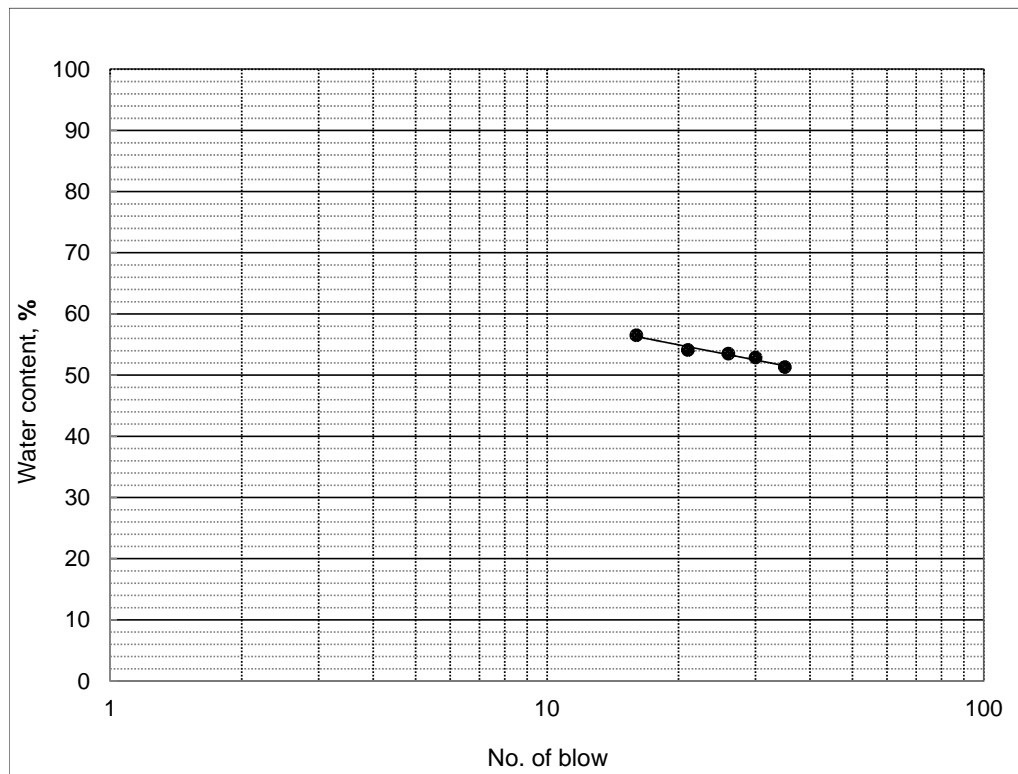
Liquid Limit, LL=	<b>53.62</b>	%
Plastic Limit, PL=	<b>20.95</b>	%
Plasticity Index, PI=	<b>32.67</b>

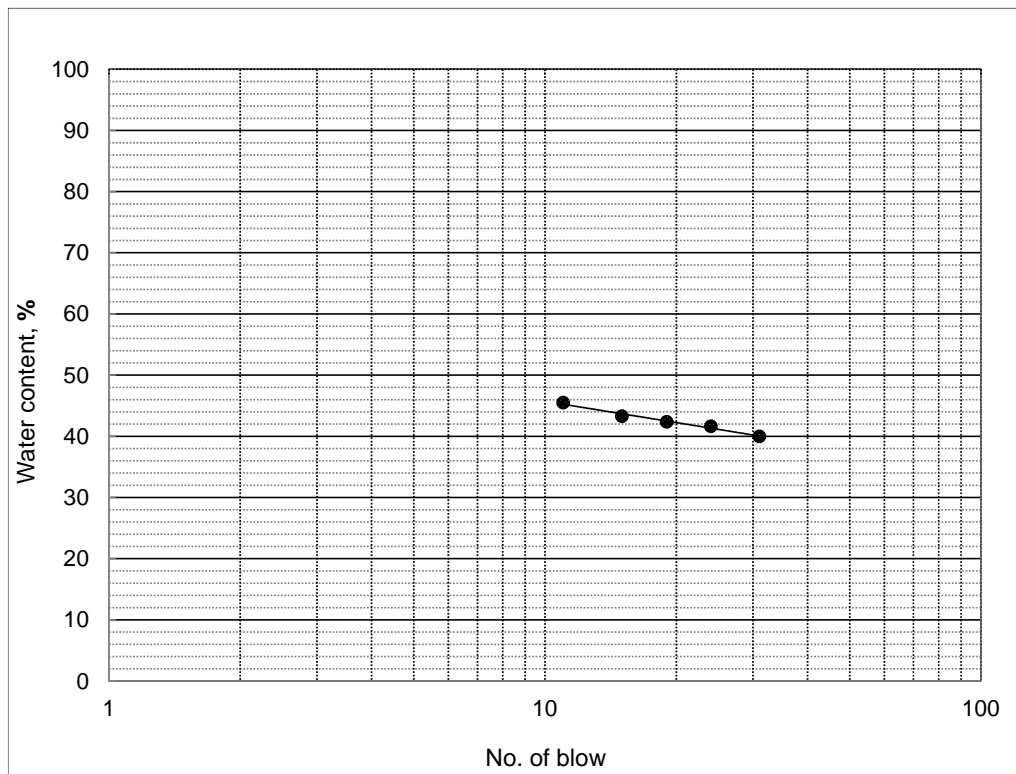
Liquid Limit, LL=	<b>41.41</b>	%
Plastic Limit, PL=	<b>23.63</b>	%
Plasticity Index, PI=	<b>17.78</b>

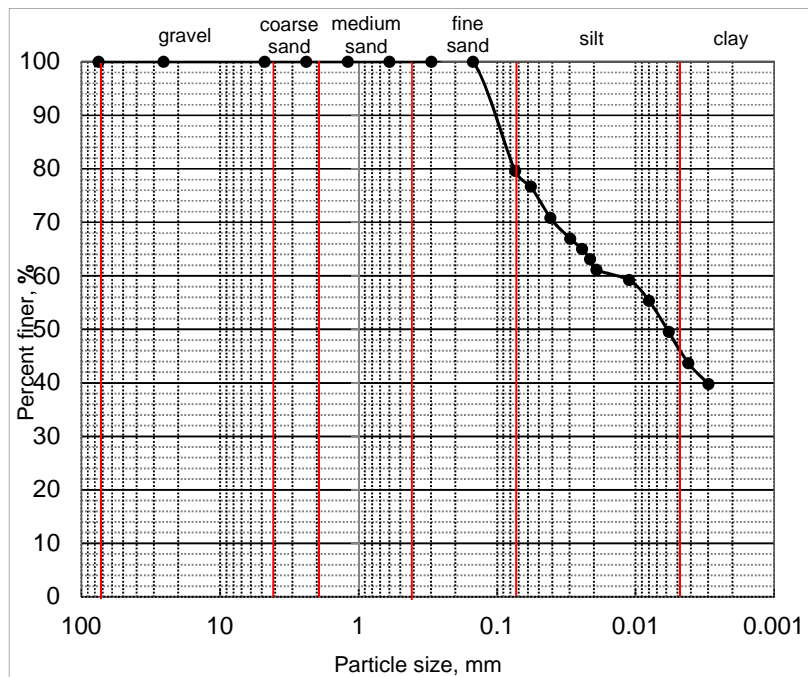
D10 (mm)	D30 (mm)	D50 (mm)	D60 (mm)	D95 (mm)	Sand (%)	Fines (%)	Cc	Cu	LL (%)	PI (%)	USCS
0.002	0.003	0.006	0.015	0.131	20.41	79.59	0.26	8.36	53.62	32.67	CH

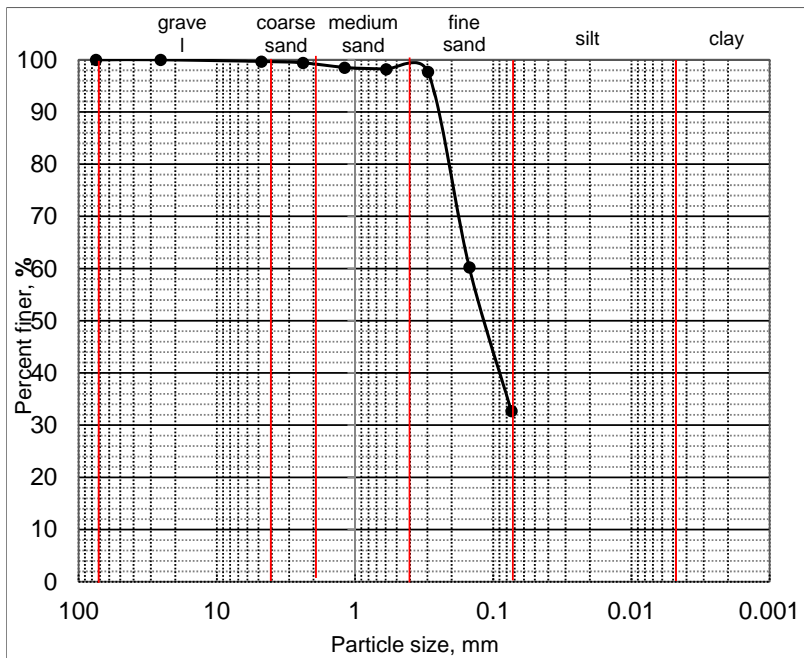
D10 (mm)	D30 (mm)	D50 (mm)	D60 (mm)	D95 (mm)	Sand (%)	Fines (%)	Cc	Cu	LL (%)	PI (%)	USCS
-	-	0.121	0.148	0.286	66.94	32.73	-	-	-	-	SM

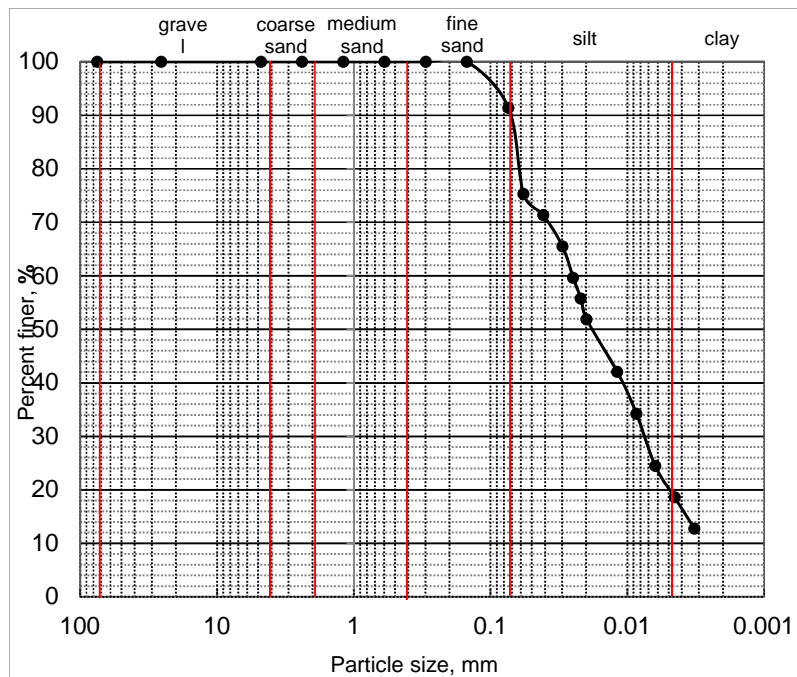
D10 (mm)	D30 (mm)	D50 (mm)	D60 (mm)	D95 (mm)	Sand (%)	Fines (%)	Cc	Cu	LL (%)	PI (%)	USCS
0.003	0.008	0.018	0.025	0.105	8.62	91.38	0.81	9.00	41.41	17.78	CL

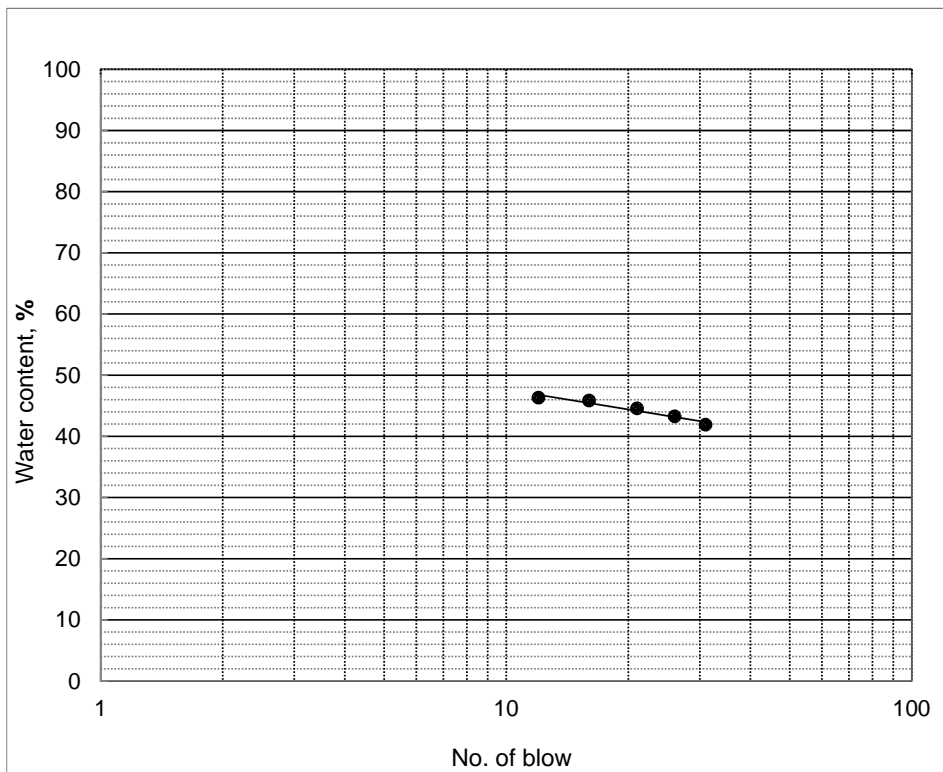
Liquid Limit, LL=	<b>43.53</b>	%
Plastic Limit, PL	<b>23.03</b>	%
Plasticity Index, F	<b>20.50</b>

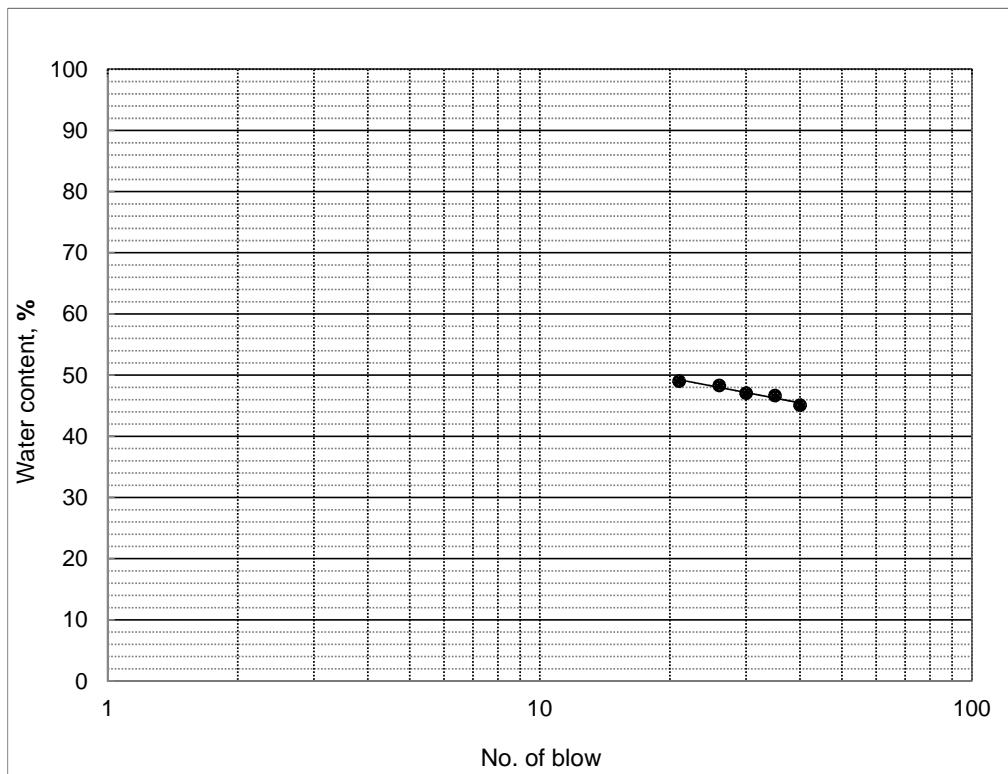
Liquid Limit, LL=	<b>48.44</b>	%
Plastic Limit, PL=	<b>20.35</b>	%
Plasticity Index, PI=	<b>28.08</b>

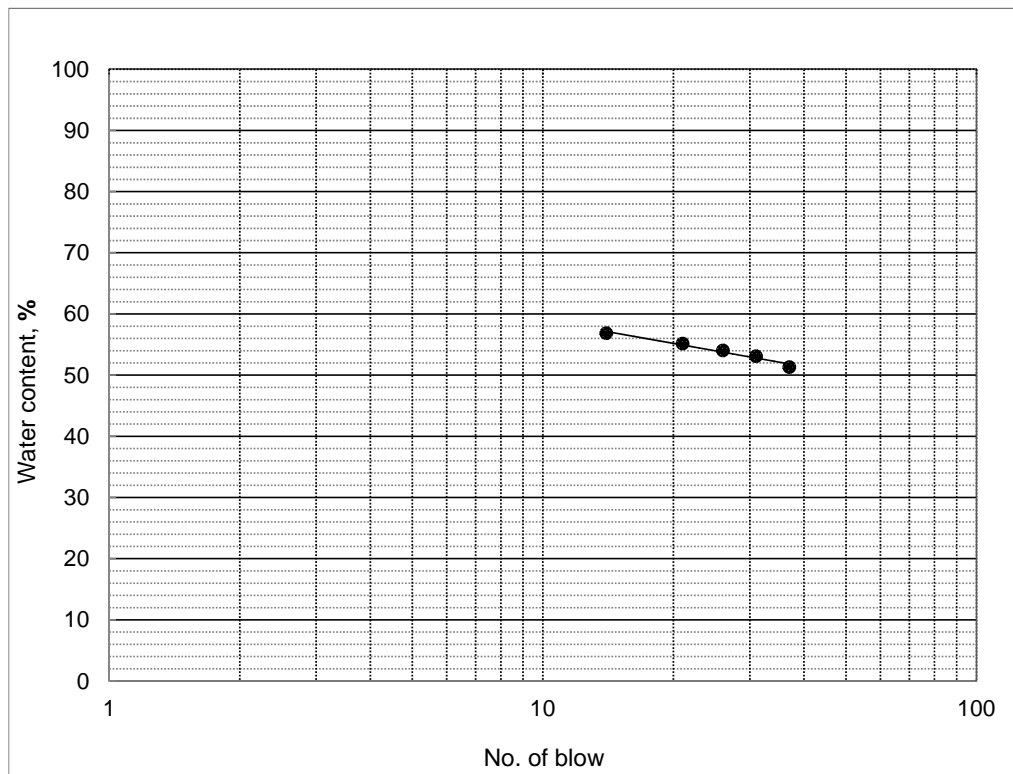
Liquid Limit, LL=	<b>54.26</b>	%
Plastic Limit, PL=	<b>25.51</b>	%
Plasticity Index, PI=	<b>28.75</b>

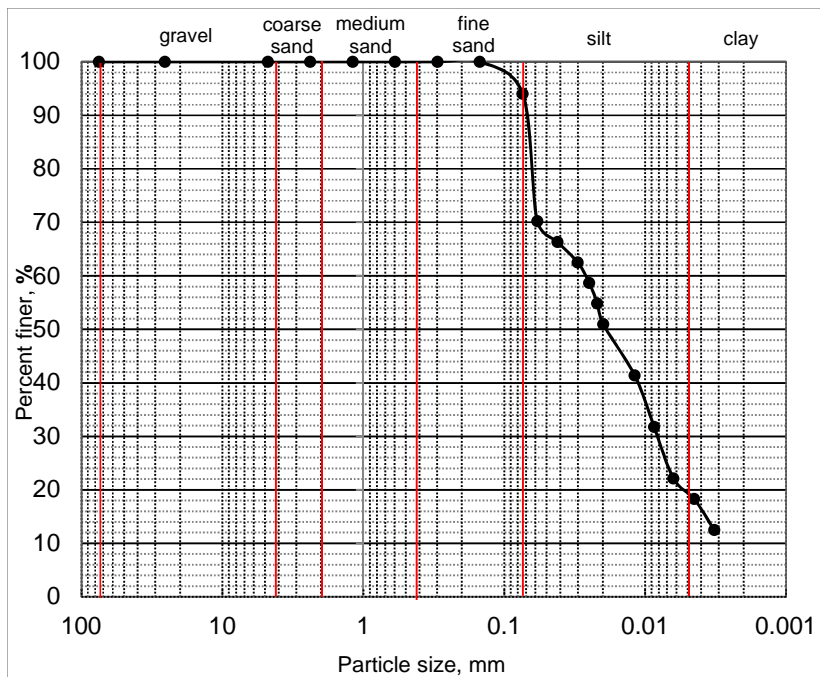
D10 (mm)	D30 (mm)	D50 (mm)	D60 (mm)	D95 (mm)	Sand (%)	Fines (%)	Cc	Cu	LL (%)	PI (%)	USCS
0.003	0.008	0.019	0.027	0.086	5.97	94.03	0.89	9.45	43.53	20.50	CL

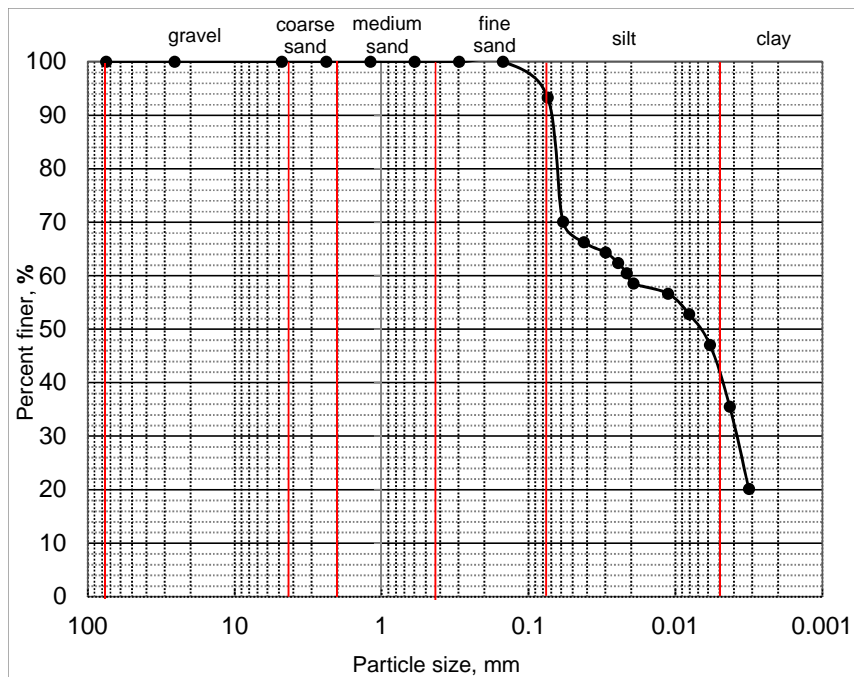
D10 (mm)	D30 (mm)	D50 (mm)	D60 (mm)	D95 (mm)	Sand (%)	Fines (%)	Cc	Cu	LL (%)	PI (%)	USCS
0.002	0.004	0.007	0.021	0.093	6.73	93.27	0.32	9.45	48.44	28.09	CL

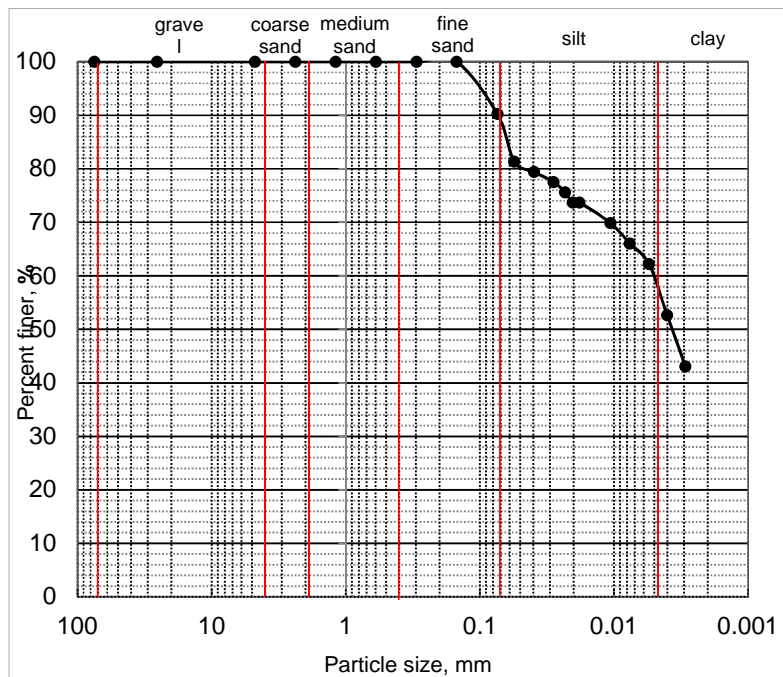
D10 (mm)	D30 (mm)	D50 (mm)	D60 (mm)	D95 (mm)	Sand (%)	Fines (%)	Cc	Cu	LL (%)	PI (%)	USCS
0.002	0.002	0.004	0.005	0.111	9.78	90.22	0.69	3.03	54.26	28.75	CH

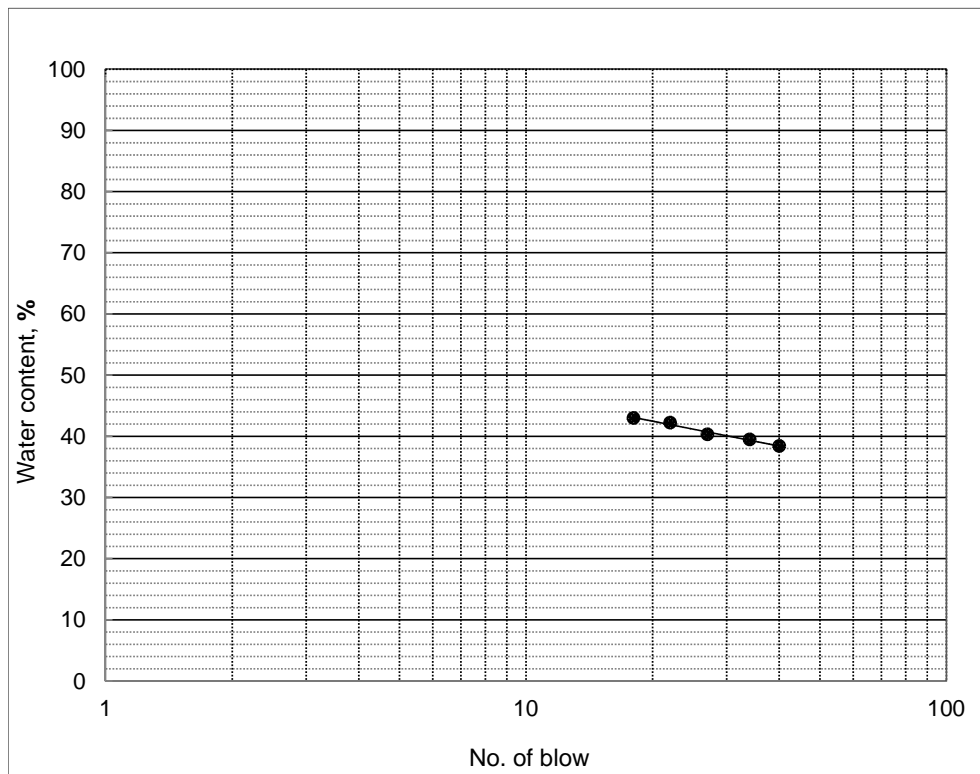
Liquid Limit, LL=	<b>41.09</b>	%
Plastic Limit, PL=	<b>21.43</b>	%
Plasticity Index, PI=	<b>19.66</b>

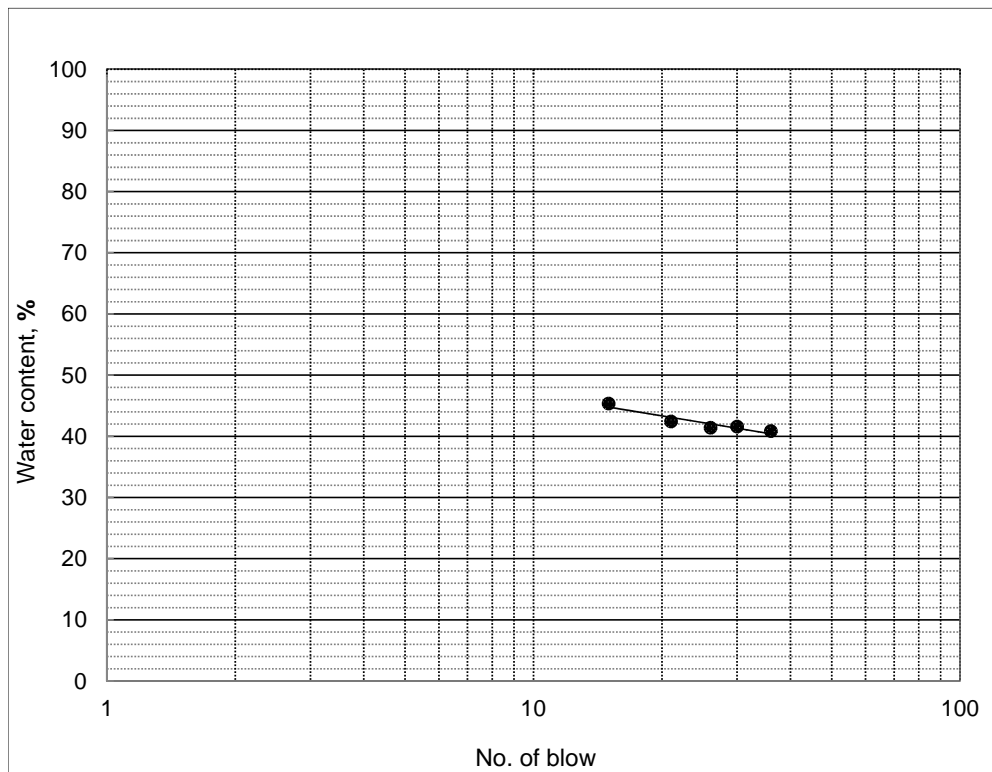
Liquid Limit, LL=	<b>41.60</b>	%
Plastic Limit, PL=	<b>21.06</b>	%
Plasticity Index, PI=	<b>20.55</b>

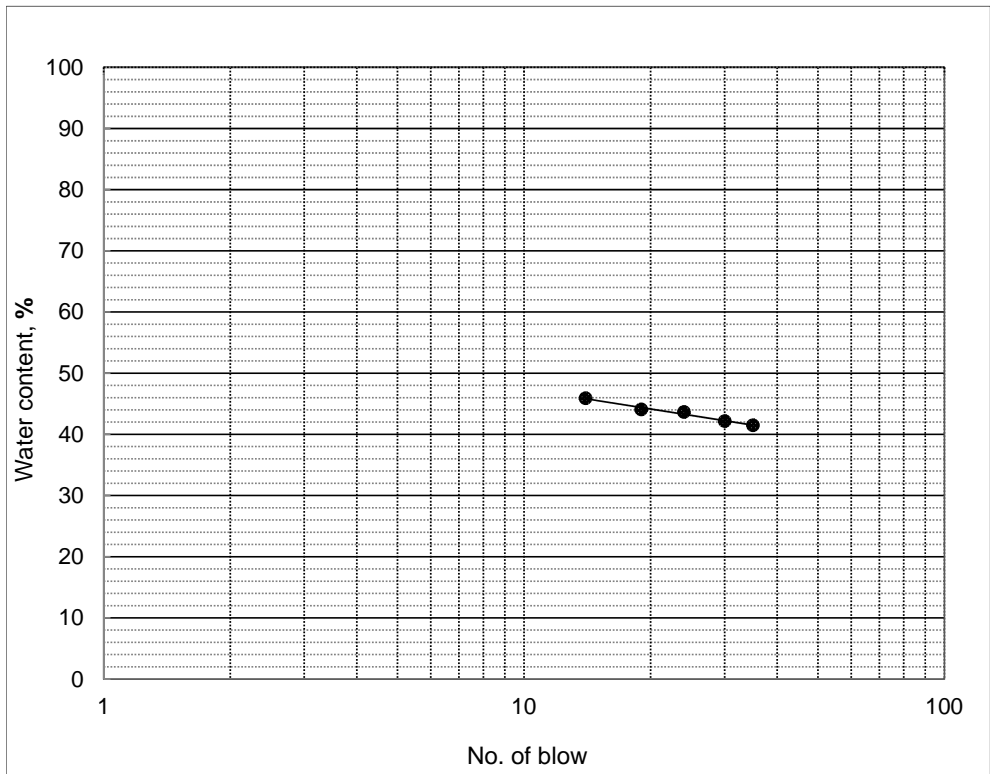
Liquid Limit, LL=	<b>43.40</b>	%
Plastic Limit, PL=	<b>26.70</b>	%
Plasticity Index, PI=	<b>16.69</b>

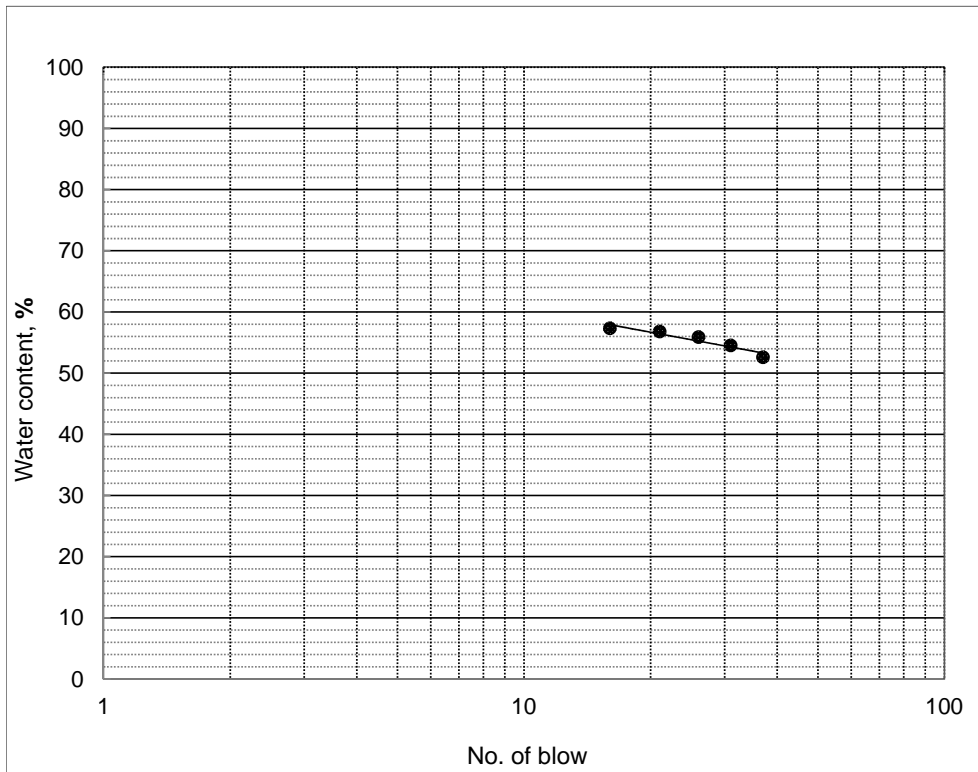
Liquid Limit, LL=	<b>56.06</b>	%
Plastic Limit, PL=	<b>24.43</b>	%
Plasticity Index, PI=	<b>31.63</b>

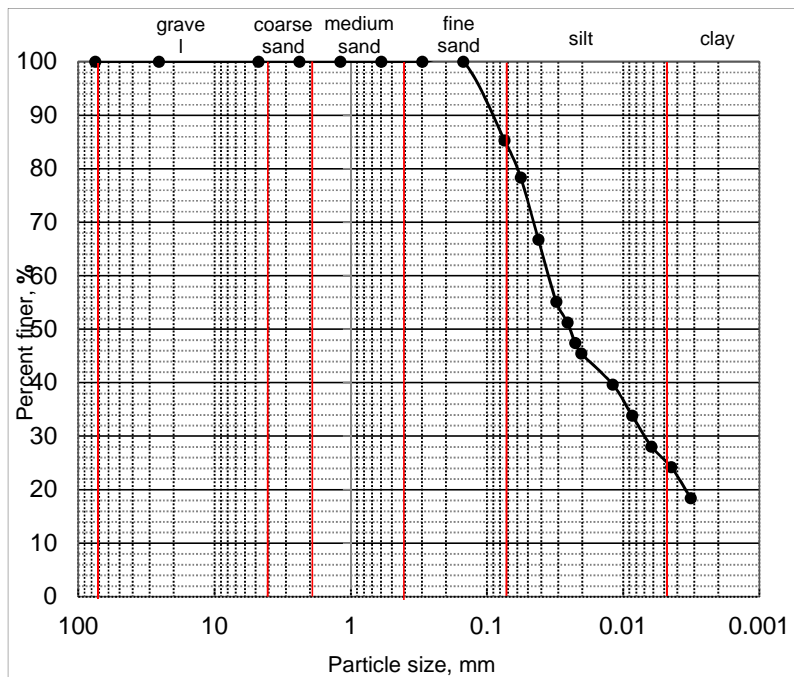
D10 (mm)	D30 (mm)	D50 (mm)	D60 (mm)	D95 (mm)	Sand (%)	Fines (%)	Cc	Cu	LL (%)	PI (%)	USCS
0.002	0.007	0.025	0.036	0.124	14.73	85.27	0.60	15.40	41.09	19.66	CL

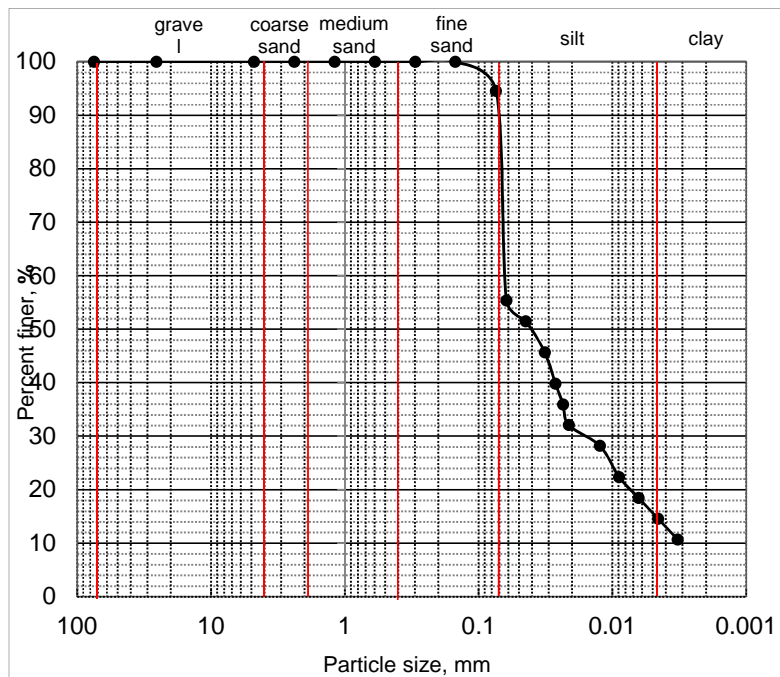
D10 (mm)	D30 (mm)	D50 (mm)	D60 (mm)	D95 (mm)	Sand (%)	Fines (%)	Cc	Cu	LL (%)	PI (%)	USCS
0.003	0.016	0.041	0.063	0.080	5.45	94.55	1.38	20.31	41.60	20.54	CL
