## Ground Improvement for Khulna Soft Clay Soil

*Interim Laboratory Test Report*

*AFCAP Project Reference Number: BAN2082A*

**February 2017**

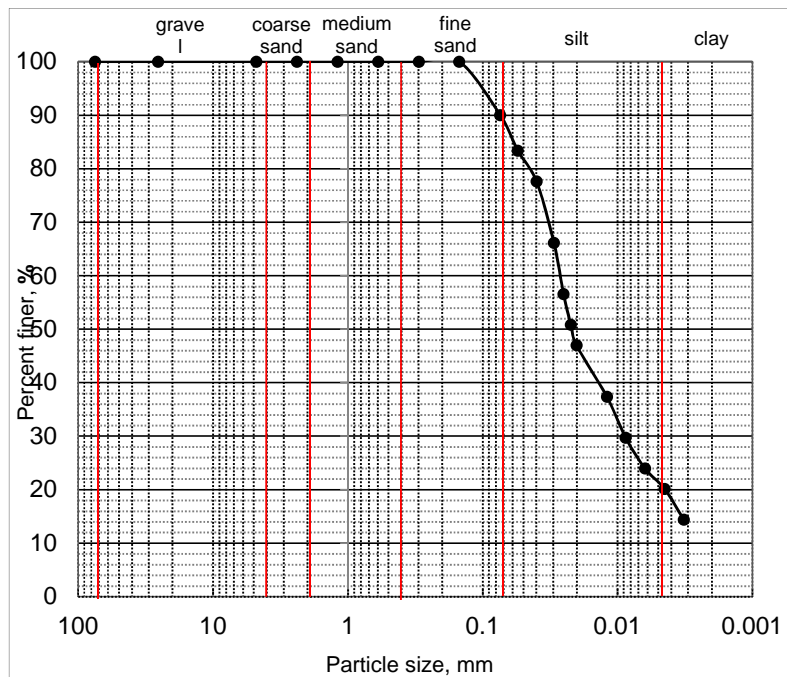
D10 (mm)	D30 (mm)	D50 (mm)	D60 (mm)	D95 (mm)	Sand (%)	Fines (%)	Cc	Cu	LL (%)	PI (%)	USCS
0.003	0.009	0.022	0.027	0.111	9.99	90.01	1.11	10.23	43.4	16.70	CL

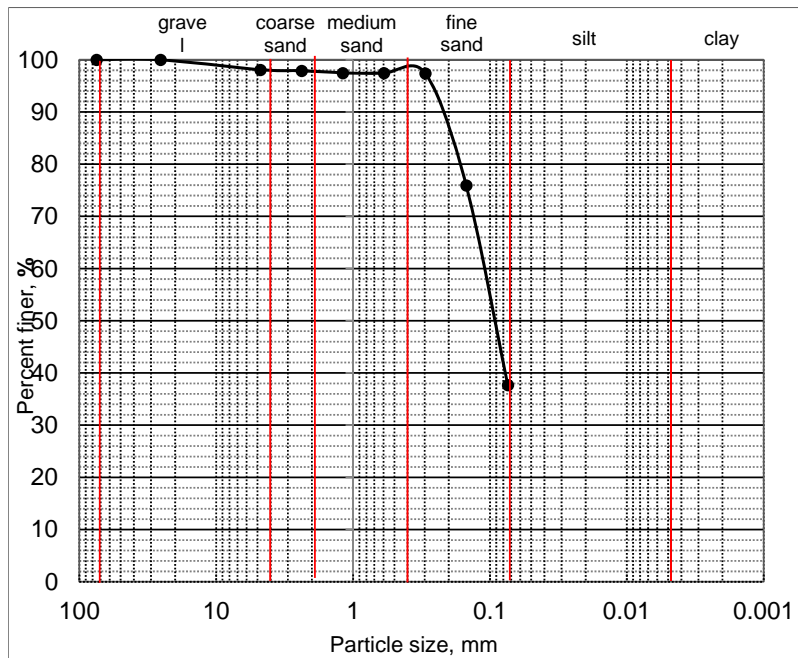
D10 (mm)	D30 (mm)	D50 (mm)	D60 (mm)	D95 (mm)	Sand (%)	Fines (%)	Cc	Cu	LL (%)	PI (%)	USCS
-	-	0.098	0.118	0.280	60.40	37.68	-	-	-	-	SM

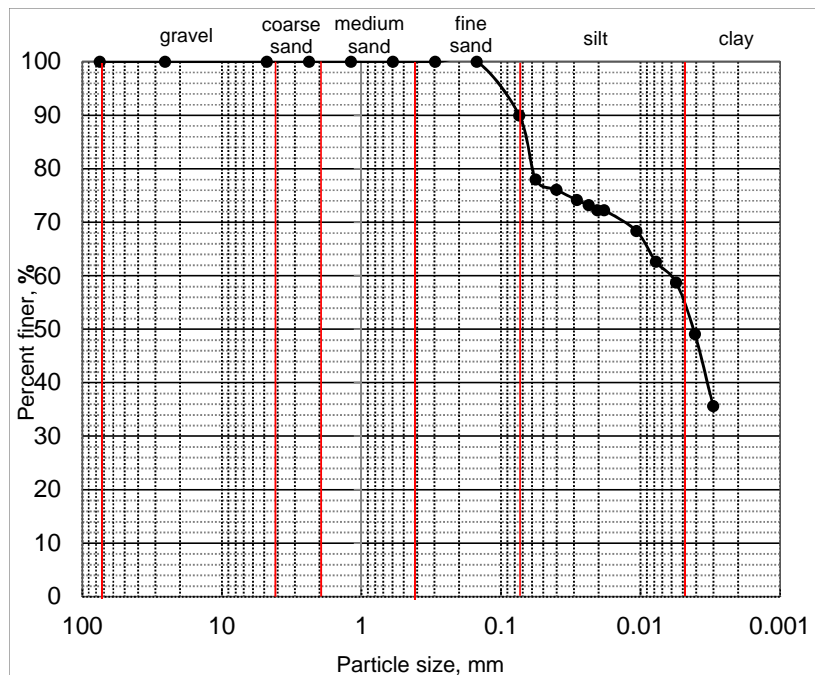
D10 (mm)	D30 (mm)	D50 (mm)	D60 (mm)	D95 (mm)	Sand (%)	Fines (%)	Cc	Cu	LL (%)	PI (%)	USCS
0.002	0.003	0.004	0.006	0.112	10.03	89.97	0.67	3.51	56.06	31.63	CH]

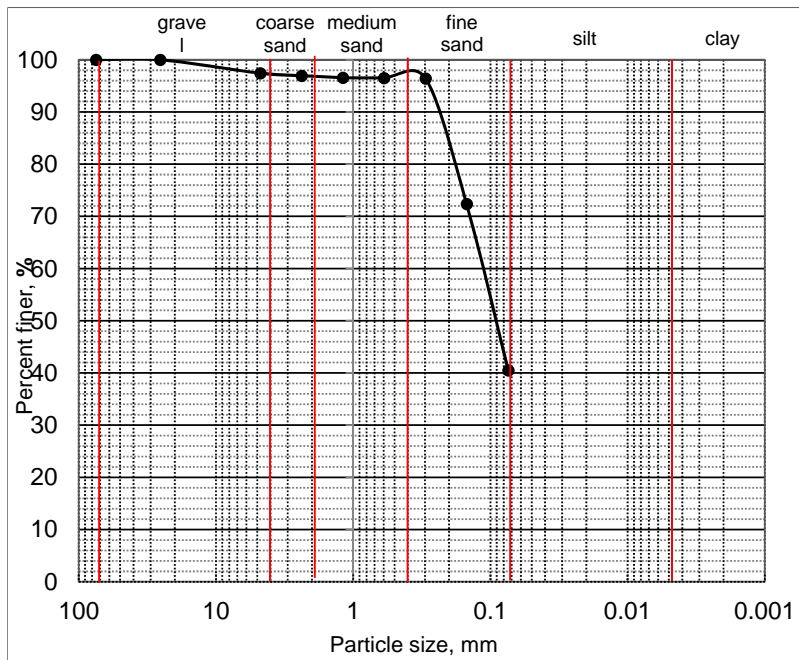
D10 (mm)	D30 (mm)	D50 (mm)	D60 (mm)	D95 (mm)	Sand (%)	Fines (%)	Cc	Cu	LL (%)	PI (%)	USCS
-	-	0.096	0.120	0.288	56.92	40.51	-	-	-	-	SM
