## Development of Pavement Design Standards for Low-Volume Roads in Ethiopia AFCAP/ETH/005/A

Combolcha Otta Seal Demonstration Site: Construction Report  
CPR 1613

A. Otto

April 2013

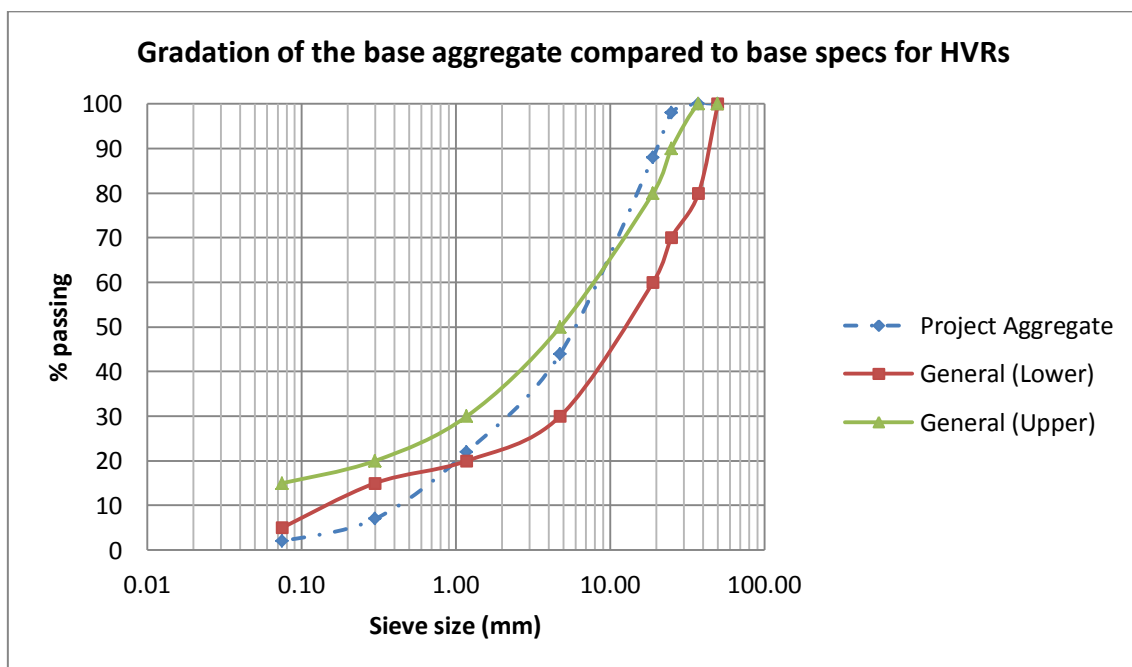
The gradation of the existing wearing course aggregate is shown in Figure 2-2 and falls partially outside the specifications for both the high volume and low volume roads. The wearing course (used as base course) has a plasticity index (PI) of 12 which is significantly above the value of 9 recommended in ERA 2011 Low Volume Roads Manual Part B. This means in practice the base must be kept on the drier side of the material OMC through the use of sealed shoulders as was the case. Based on the strength exhibited in the laboratory and in the field, it was decided to use the material despite the marginal grading. The only work recommended to be done to the existing road was scarifying, re-shaping and re-compaction.

Figure 2-2 Gradation of the base material used in comparison with ERA Draft HVR Manual 2011

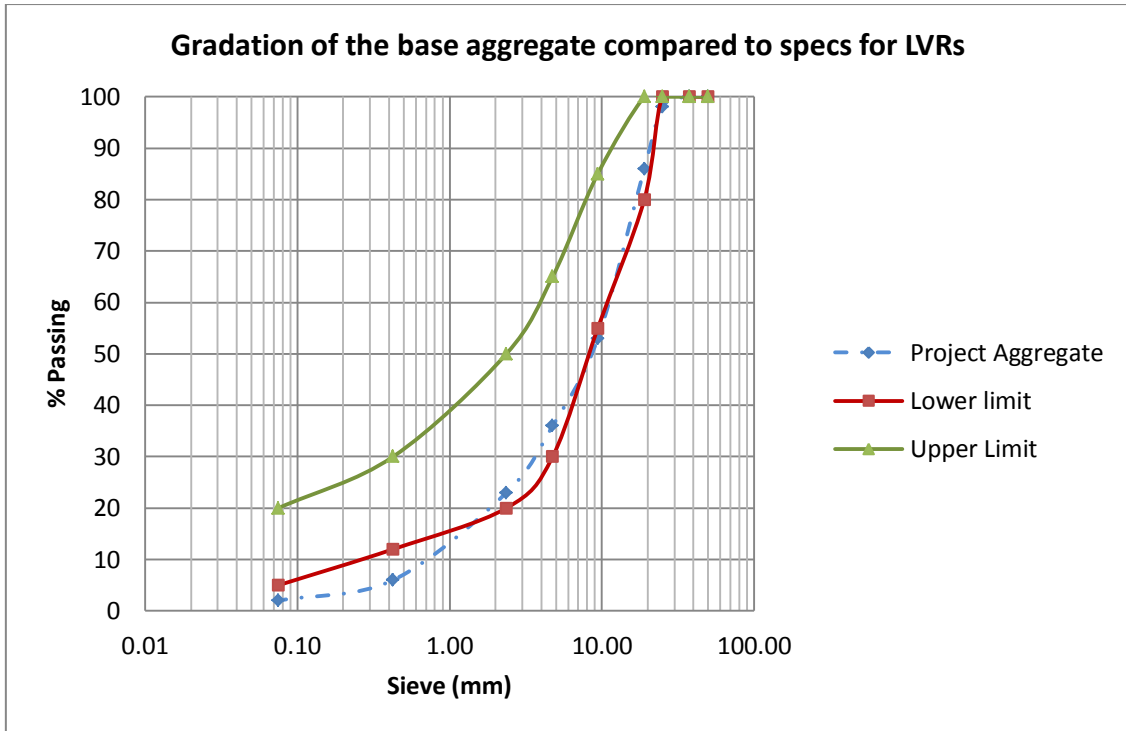
Figure 2-3 Gradation of the base materials used; in comparison with ERA Draft LVR Manual 2011

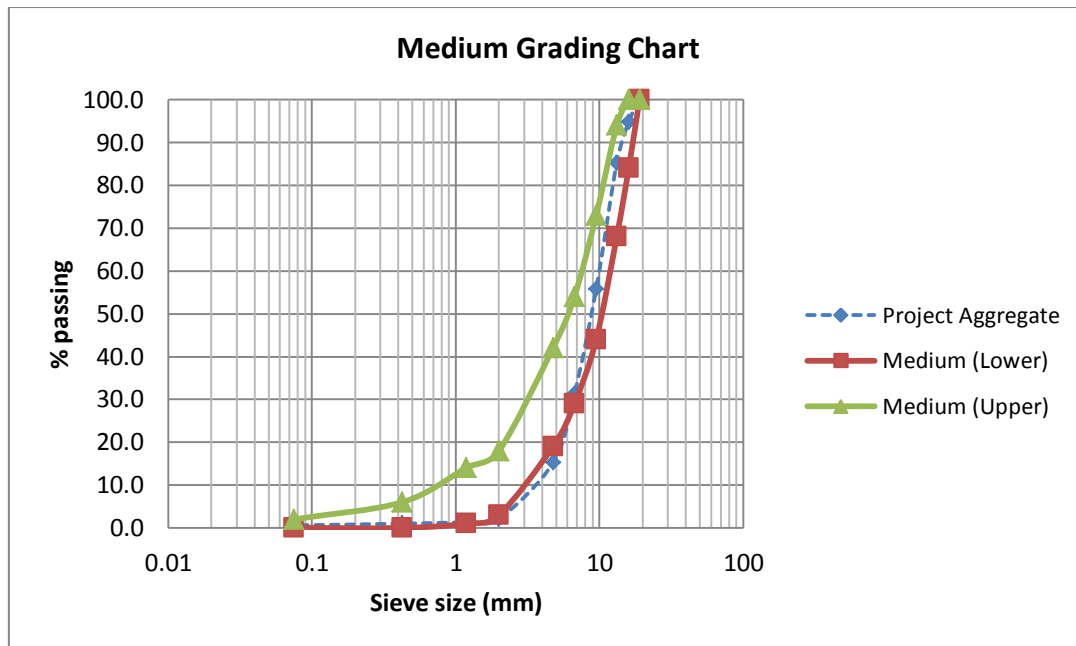
Figure 3-1 Grading of the Otta Seal aggregate

The design binder spraying rates (using the aggregate properties) from NPRA guideline number 93, were MC 3000 at 1.8 l/m<sup>2</sup> on the primed section and MC 800 at 2.0 l/m<sup>2</sup> on the un-primed section. MC 800 was chosen on the un-primed base section because it has a higher penetration than MC 3000 and acts as both prime and binder.

The design guideline (NPRA guideline number 93) recommends an application rate for medium graded aggregates of 13-16 l/m<sup>2</sup>, it was however decided that 22 l/m<sup>2</sup> be used – with the understanding that any excess aggregate will be broomed, collected and used in the second seal. This was to minimise any risk of bleeding.

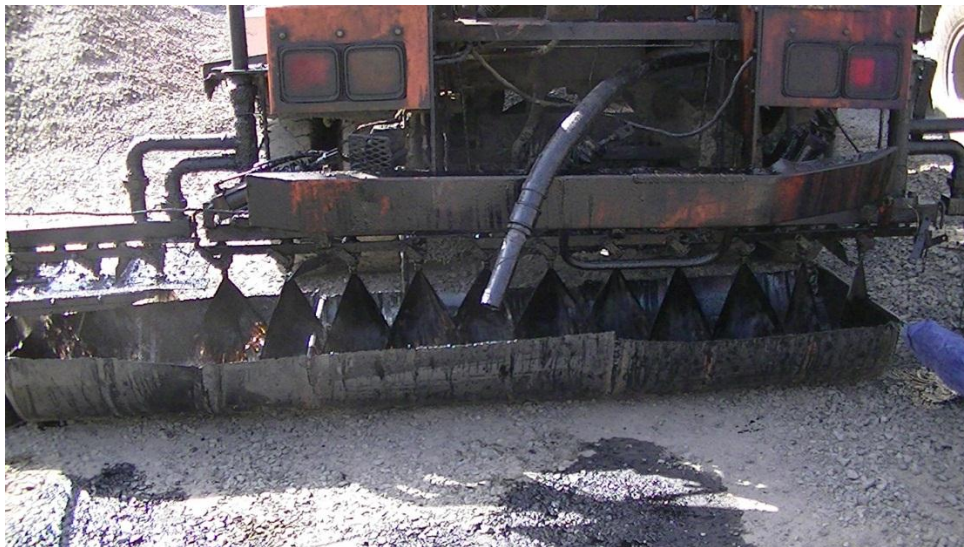
Prior to each spraying pull, the nozzles of the bitumen distributor were checked at site as shown in Figure 4-1.

**Figure 4-1 Checking of the nozzles prior to sealing operations and spraying of binder**

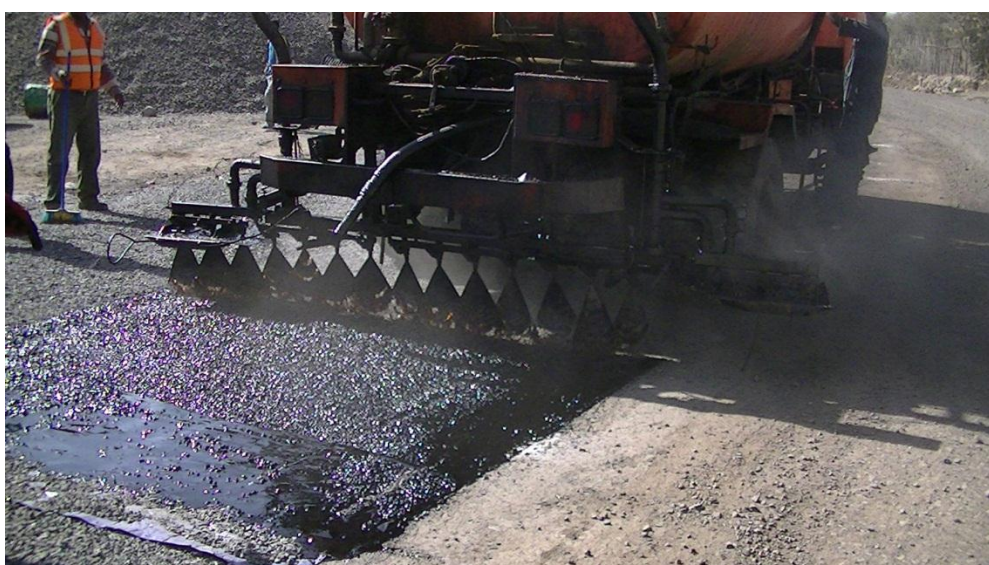
In all cases, joint paper was used to ensure a good overlap and straight joints. A labourer and a supervisor were specifically assigned to supervise these tasks.

Figure 4-2 shows paper laid for each start and stop for the distributor in order to achieve straight transverse joints.

**Figure 4-2 Paper used to achieve straight transverse joints**

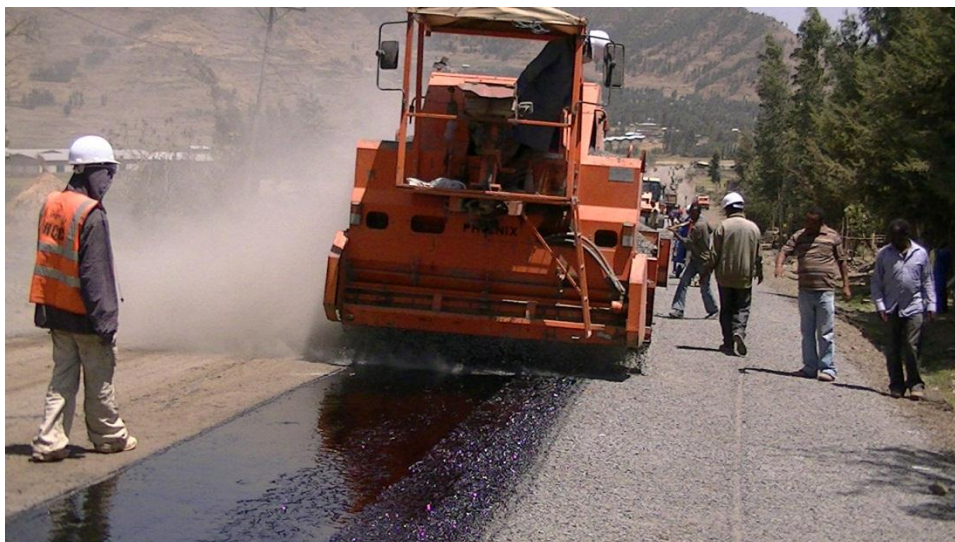
The aggregate application was carried out by a self-propelled chip spreader which applied the aggregate quite evenly. The rates of application are shown in Table 4-2. In most cases re-chipping

was done at a rate of 6 l/m<sup>2</sup> to make up for deficient application of aggregate in the first run. Re-chipping was done either immediately or the following day if work was done late in the evening. Figure 4-3 shows the chip spreader in operation – note the amount of dust acceptable for Otta Seals but not acceptable for other bituminous surfacings.

**Figure 4-3 Self-propelled chipspreader in operation**

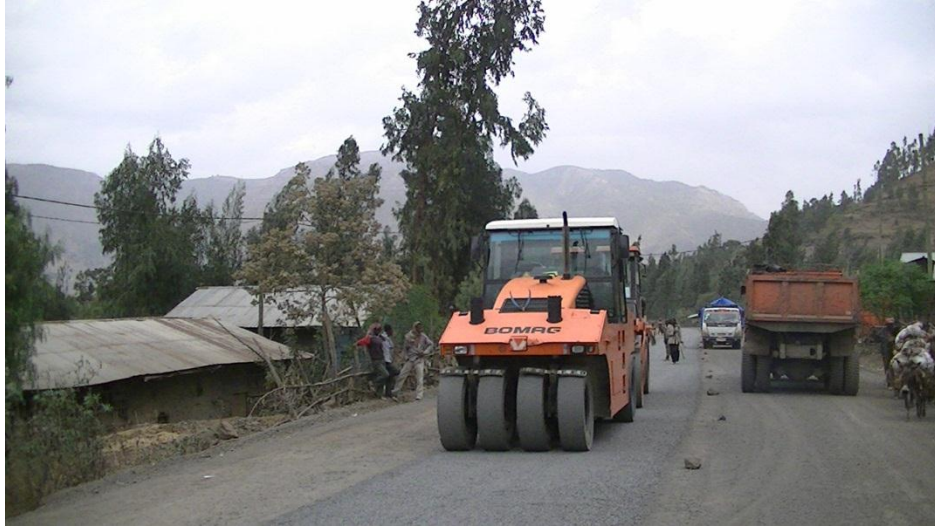
The rolling during construction and afterwards was carried out using a 24 tonne pneumatic roller followed closely behind by a 10 tonne steel roller in non-vibratory mode – as shown in Figure 4-4. The rolling was carefully supervised so that the entire width of the surfacing and all sections received adequate rolling.

After completion of the sealing operations, the entire section received three days of rolling at slow speed (less than 10km/hr) by the pneumatic roller. The steel roller also stayed on site to roll and flatten out the longitudinal joints.

**Figure 4-4 Rolling in progress by the use of both a pneumatic roller and the loaded tipper truck**
