ADDIS ABABA LVR WORKSHOP: Unpaved roads

Prof Phil Paige-Green
Paige-Green Consulting (Pty) Ltd
Pretoria, South Africa

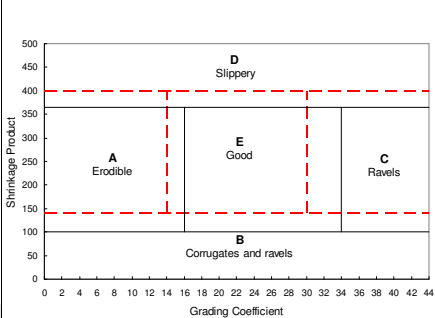
Grading Coefficient	Shrinkage Product	Category
0 - 16	0 - 100	A Erodible
16 - 34	0 - 100	
0 - 34	0 - 100	B Corrugates and ravels
0 - 16	100 - 365	E Good
16 - 34	100 - 365	
34 - 44	100 - 365	C Ravels
0 - 44	365 - 500	D Slippery

- Used in a number of countries in Africa, Middle East, USA, South America, Australia and New Zealand
- Appears to work if interpreted/calculated correctly
- Most people don't normalise the grading for %age passing 37.5 mm to determine GC and SP
- Different test methods
- Correlation study for BS

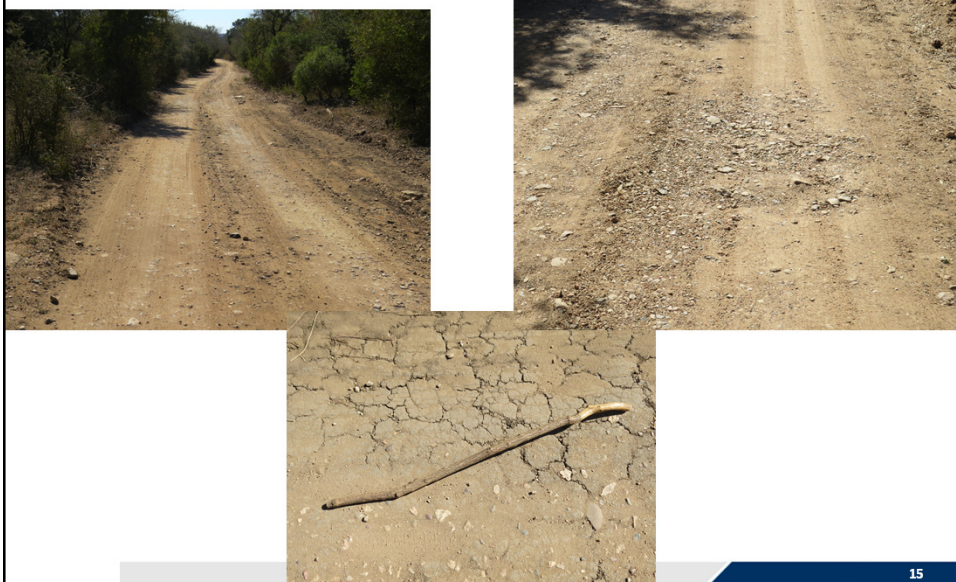
UNPAVED ROAD STRUCTURE

This slide, titled 'UNPAVED ROAD STRUCTURE', features three photographs. The top-left photo shows a long, straight dirt road stretching into the distance, flanked by green bushes. The top-right photo is a close-up of the road surface, showing a mix of sand and small stones. The bottom-center photo shows a close-up of the soil, which is heavily cracked and dry, with a thin wooden stick lying across the cracks for scale.

- UNPAVED ROAD STRUCTURE**
- All 110 sections of SA investigation were 0 – 150 mm layer WC on in situ
 - Even the low fills were in situ material from side
- 14
