# Raters' Guideline for Visual Assessment of Low Volume Rural Road Pavements

## Part B: Flexible Pavements

GEN 2132A

September 2020

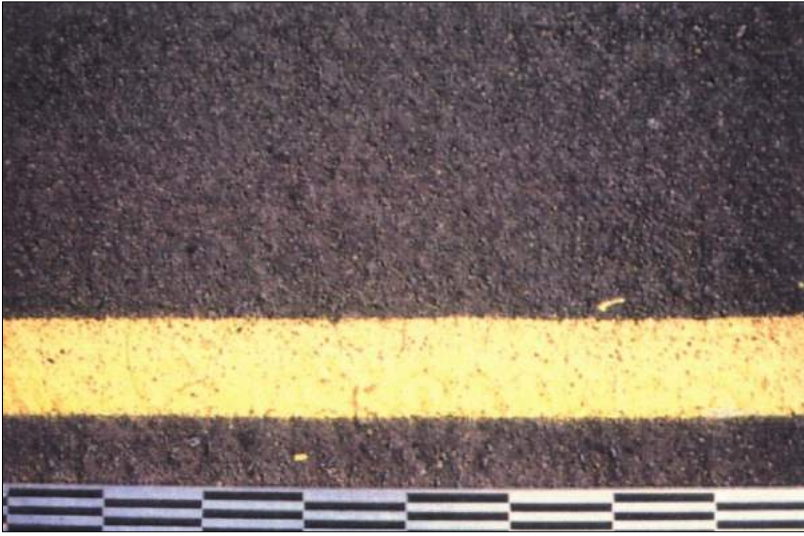
Fine
	Slurry seal

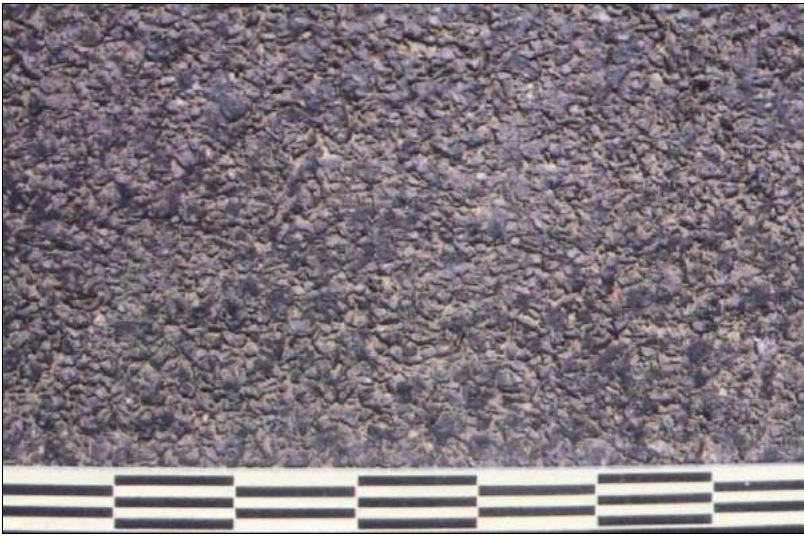
Medium
	Double seal

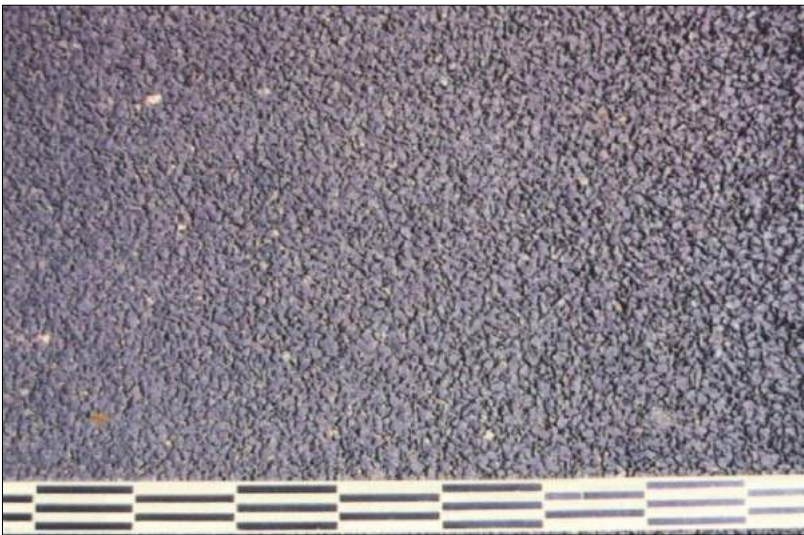
Medium
	6 mm or 9 mm single seal

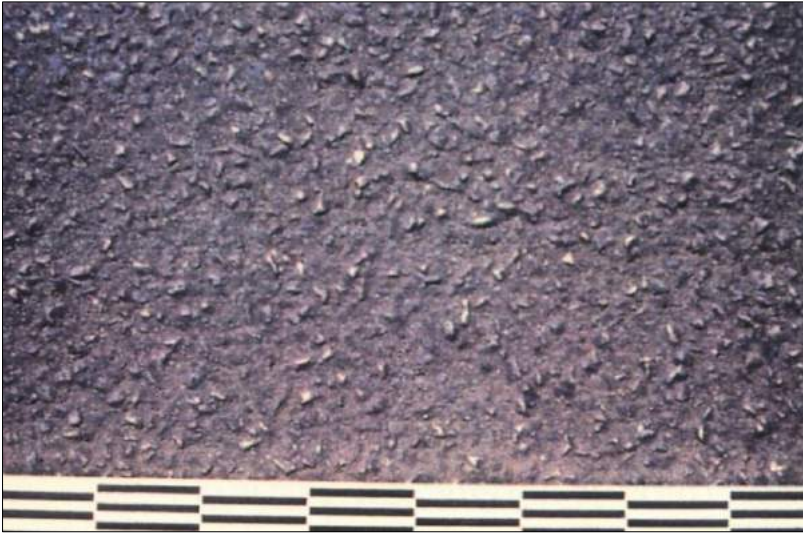
Medium
	Cape seal

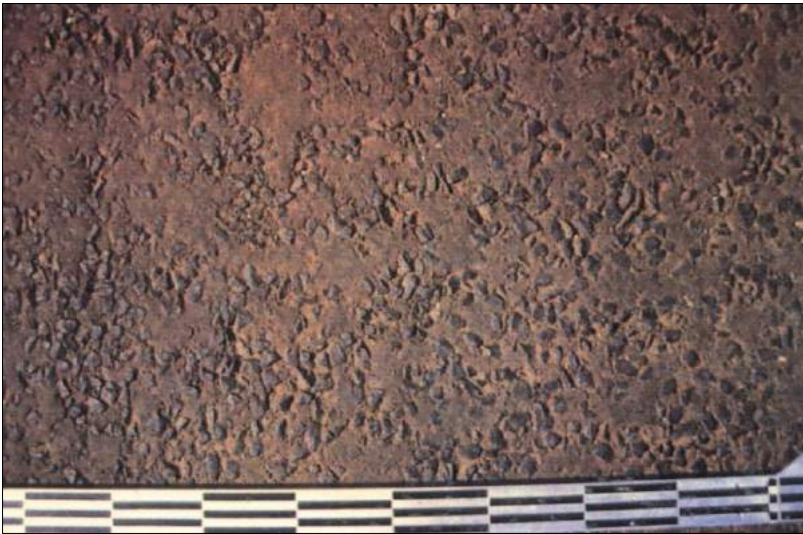
Medium
	Asphalt with rolled in chips

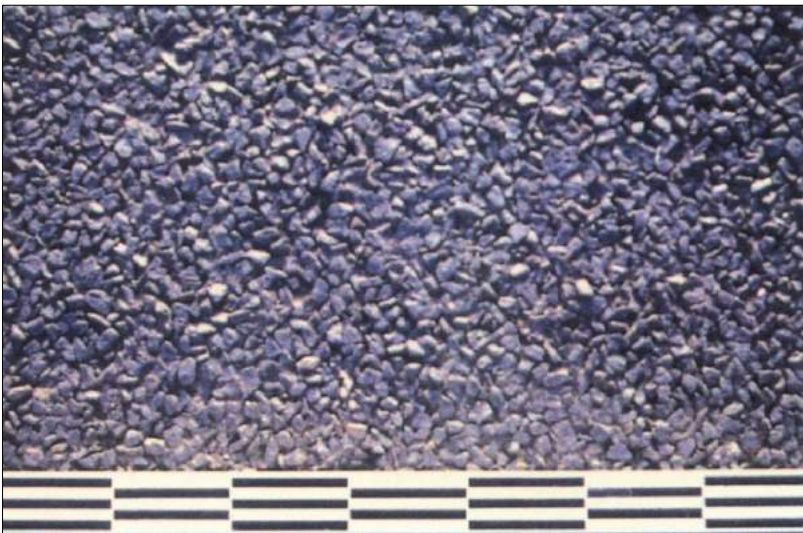
Coarse
	13 mm single seal

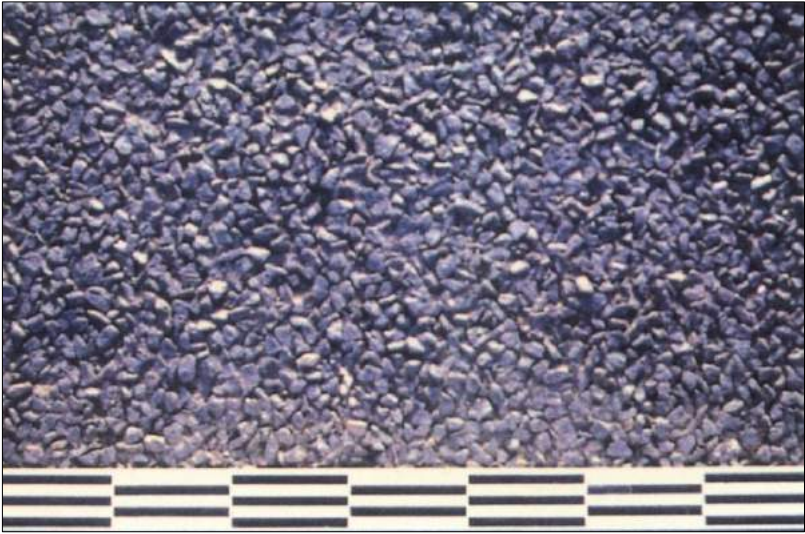
None
	Cape seal

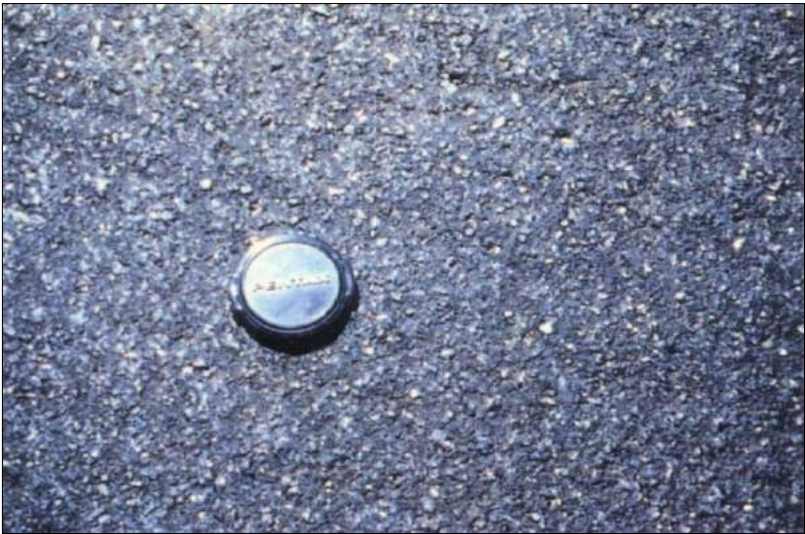
Few
	Slurry seal

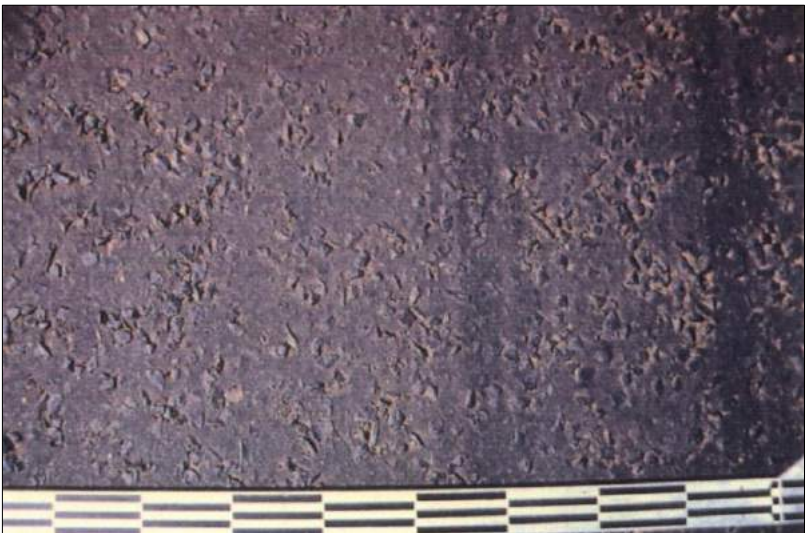
Few
	Asphalt

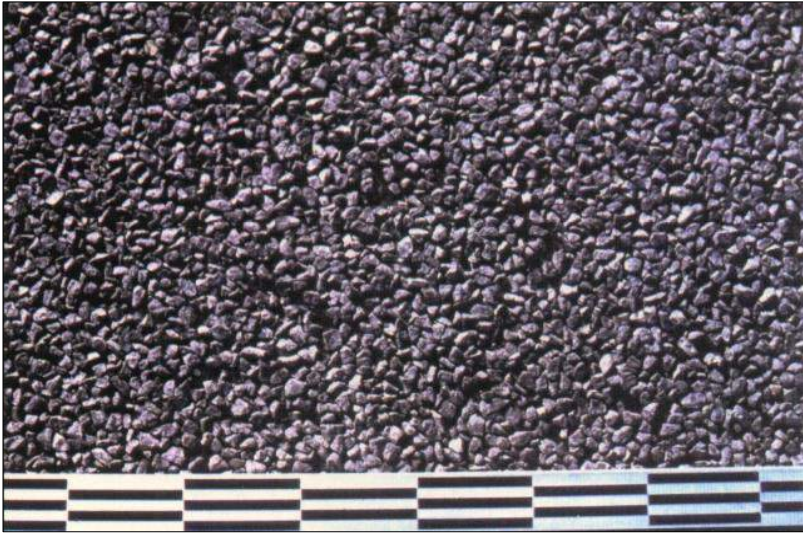
Many
	Single seal

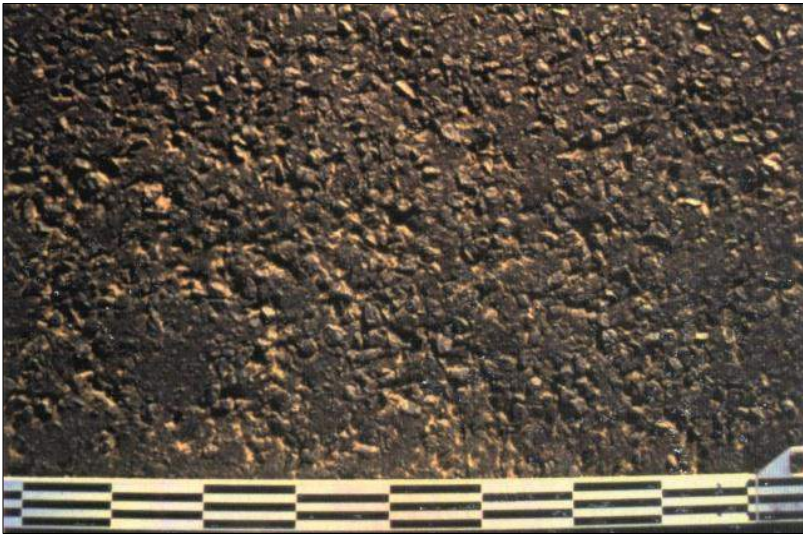
Many
	Asphalt

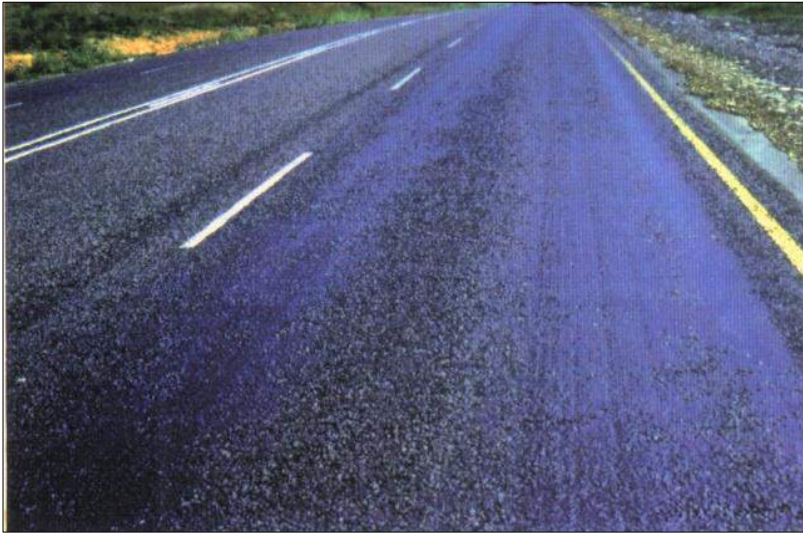
Varying (none to many)

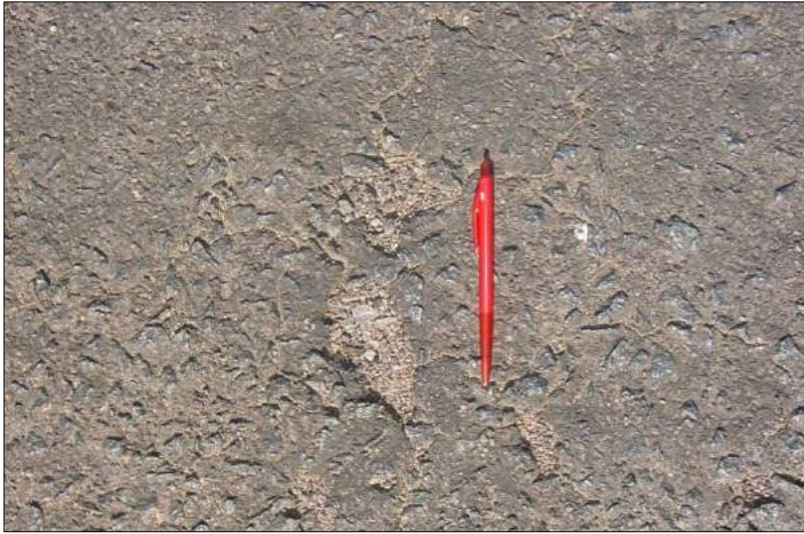
1				
	X	2	3	4	5
	<p>Small areas of surfacing are lost (diameter &lt;50 mm), not easily visible from a moving vehicle</p>

Degree	Description
1	Failures difficult to discern from moving vehicle. Small areas of surfacing are lost (diameter < 50 mm).
3	Significant failure is visible from a moving vehicle (diameter ≈ 150 mm).
5	Failure occurs over large areas and/or secondary defects have developed owing to the failure (diameter > 300 mm).

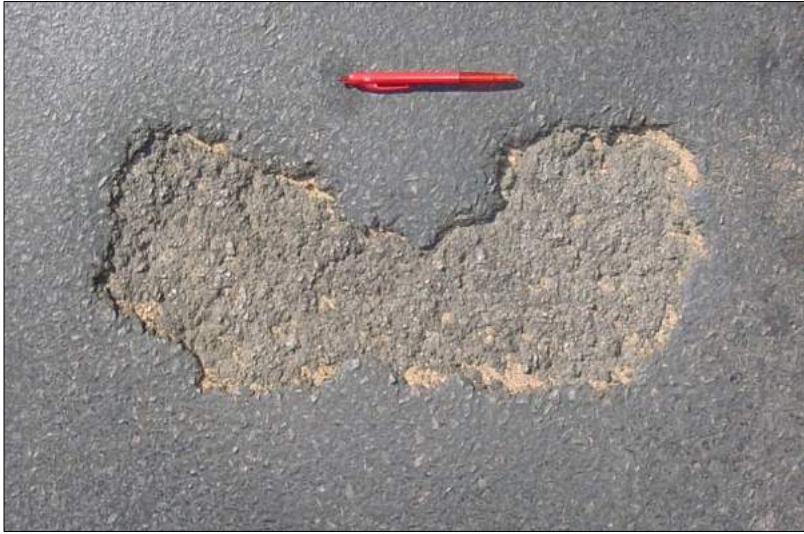
3				
	1	2	X	3	4
	<p>Significant failure visible from a moving vehicle (diameter ≈ 150 mm)</p>

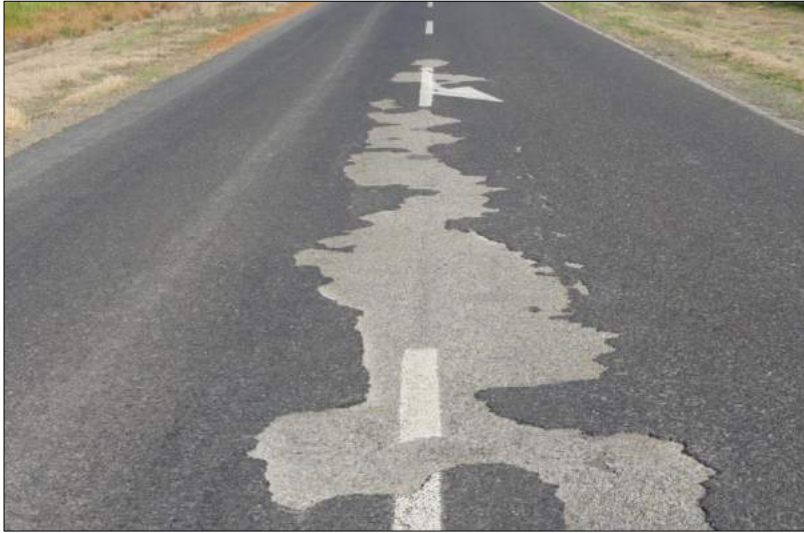
5				
	1	2	3	4	X
	<p>Occur over large areas, failures &gt; 300 mm in diameter.</p>

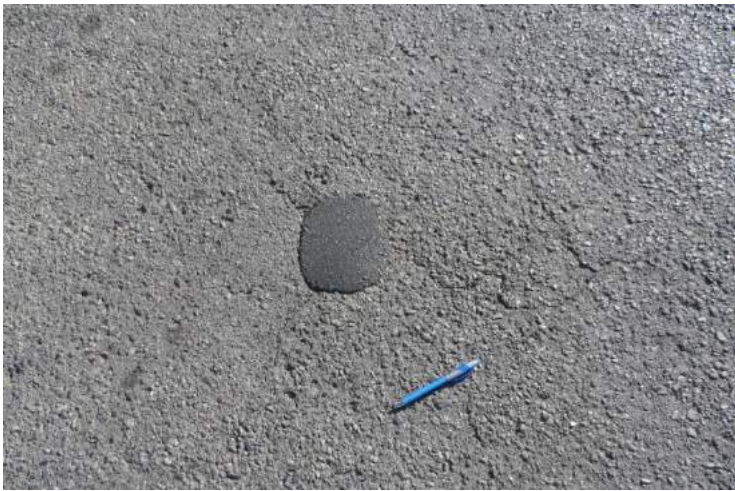
1				
	X	2	3	4	5
	Small areas of surfacing are patched (diameter < 100 mm).

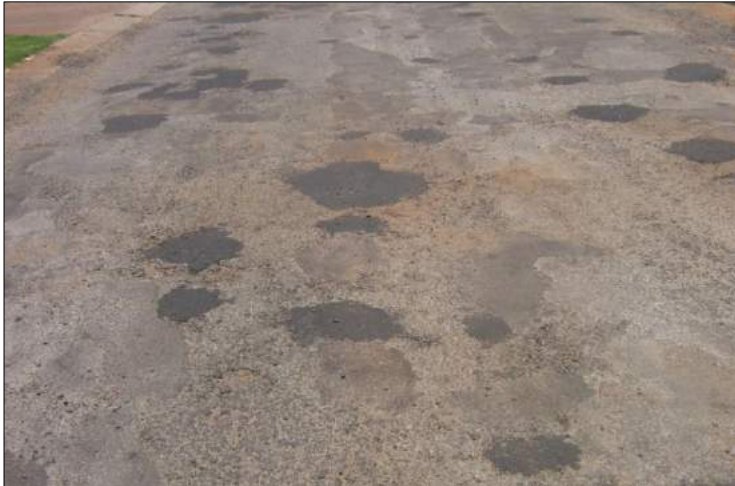
5				
	1	2	3	4	X
	Patching occur over large areas (diameter > 500 mm) or concentration of significant patching.

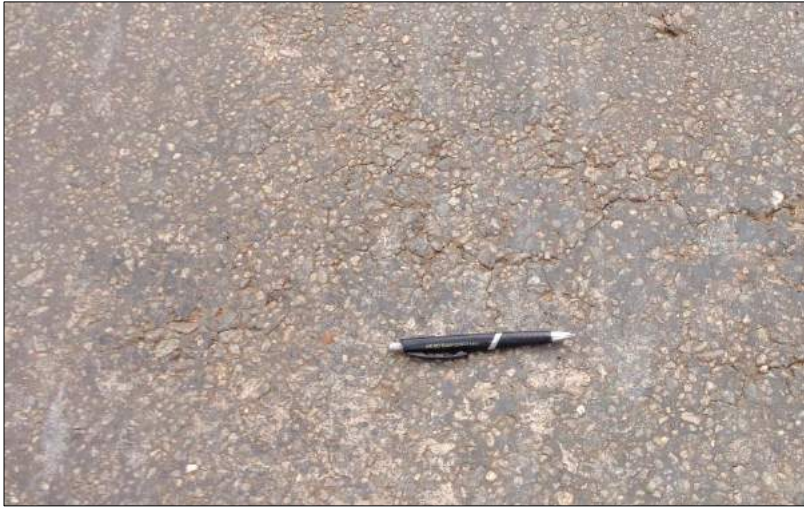
1				
	X	2	3	4	5
	Faint cracks.

Degree	Description
1	Faint cracks. In some instances, small cracks appear in a star pattern.
3	Distinct cracks. Slight spalling may be visible. Easily observable when driving slowly. Emergence of a map crack pattern.
5	Open cracks with severe spalling. Map crack pattern complete.

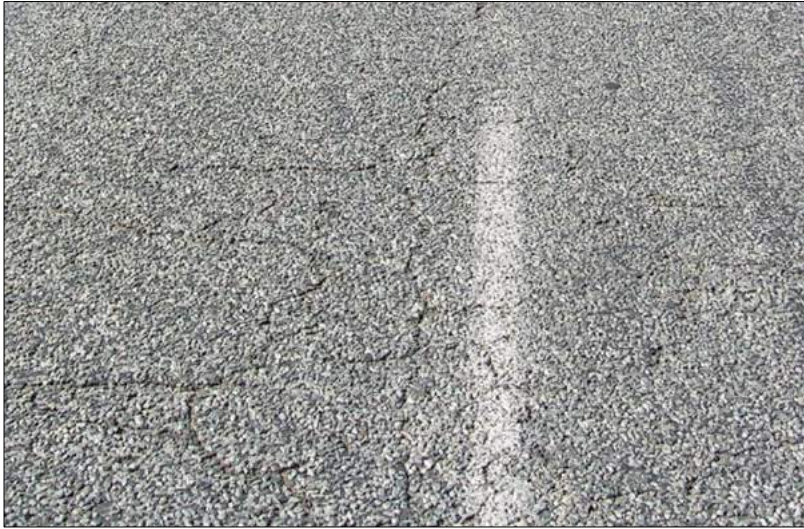
3				
	1	2	X	3	4
	Distinct cracks, easily observable from a slow-moving vehicle.

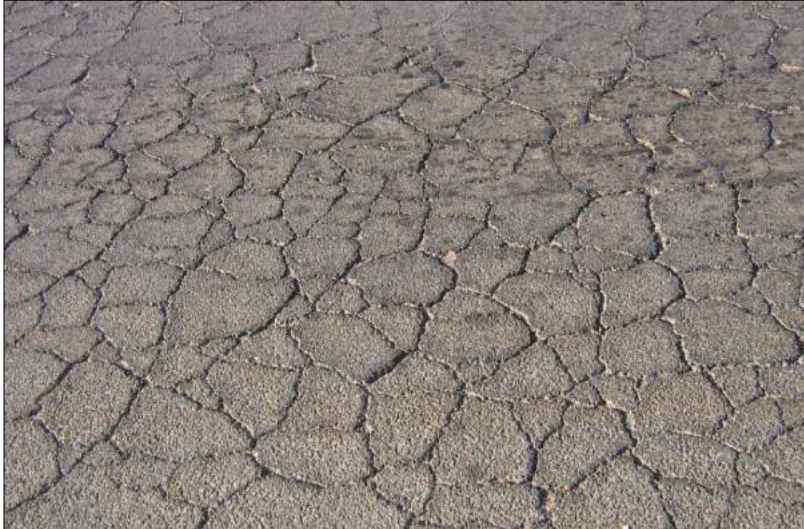
5				
	1	2	3	4	X
	Open cracks with severe spalling.

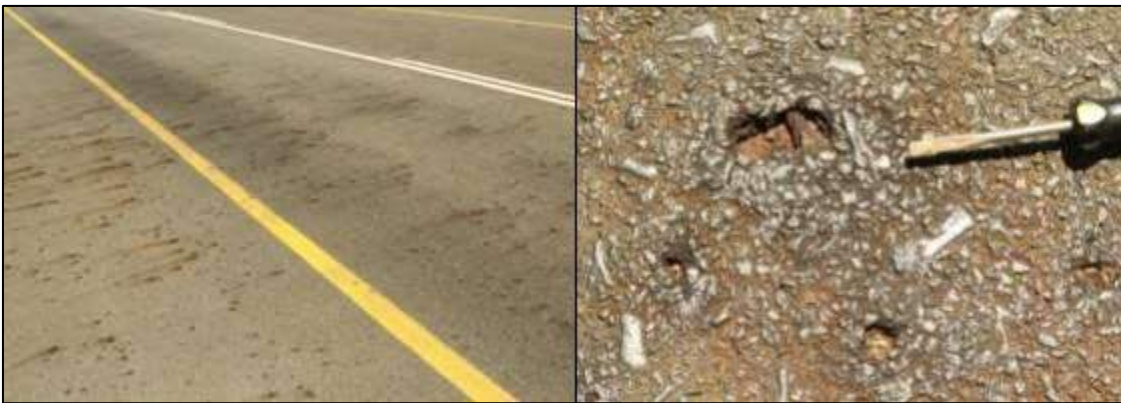
**Figure B.2-8: Aggregate loss due to disintegration**

Aggregate loss later in the life of surface layer may be related to the use of certain types of aggregate (for example white quartzite) that disintegrates over time, as seen in Figure B.2-8.

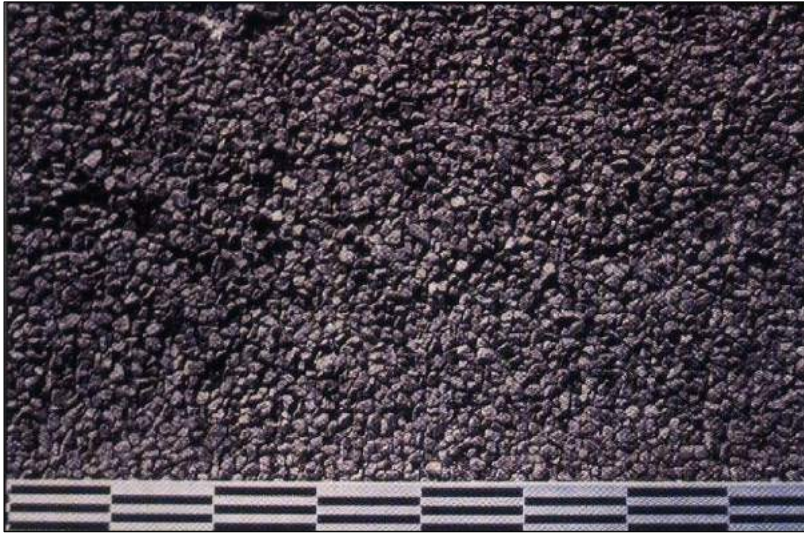
1				
	X	2	3	4	5
	Loss of individual stones visible on close inspection.

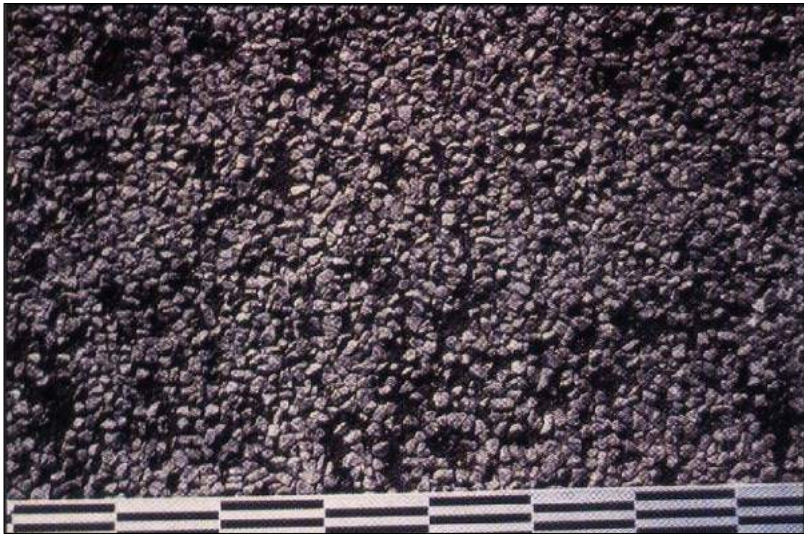
3				
	1	2	X	3	4
	Distinct stone loss in small areas.

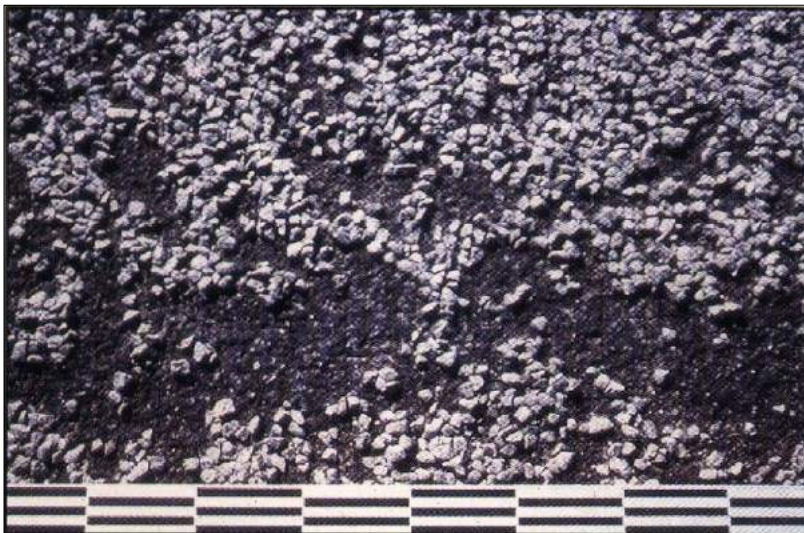
5				
	1	2	3	4	X
	General loss of stone from all layers in large areas.

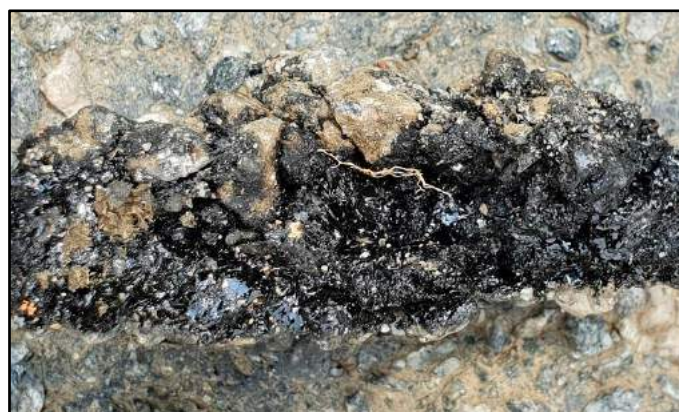
**Figure B.2-10: Example of binder Degree 1**

Degree	Description
1	Binder not fresh but is sticky, and colour still bright black and/or very difficult to dislodge aggregate from seal. (No shrinkage cracks yet).
3	Binder appears dull (brownish), binder is brittle owing to hardening and/or aggregates can be dislodged from seal with relatively little effort. (Shrinkage cracks may have appeared in slurries or asphalt.)
5	Binder is dull (brown) and very brittle (not sticky at all), binder elasticity is very low and/or aggregate can be dislodged from seal without effort. (Except surface cracks in asphalt and slurries, and aggregate loss on stone seals.)

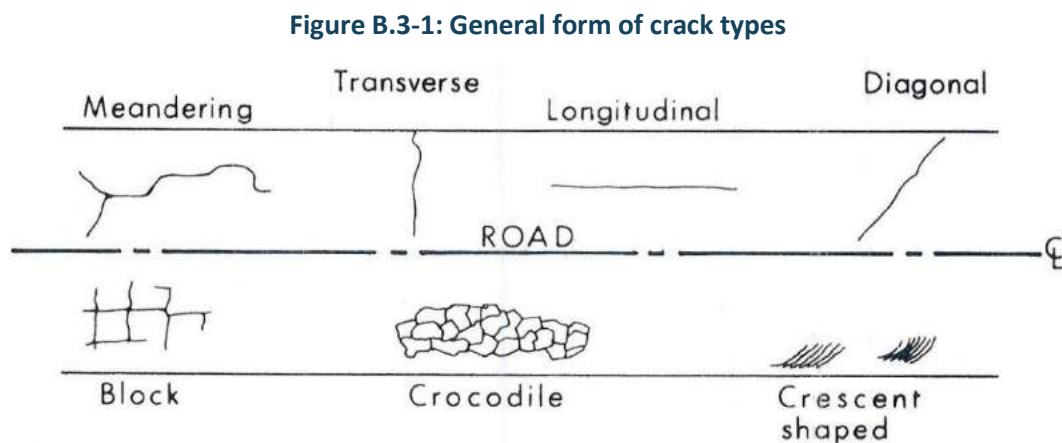
The general form of the various crack types is illustrated in Figure B.3-1.

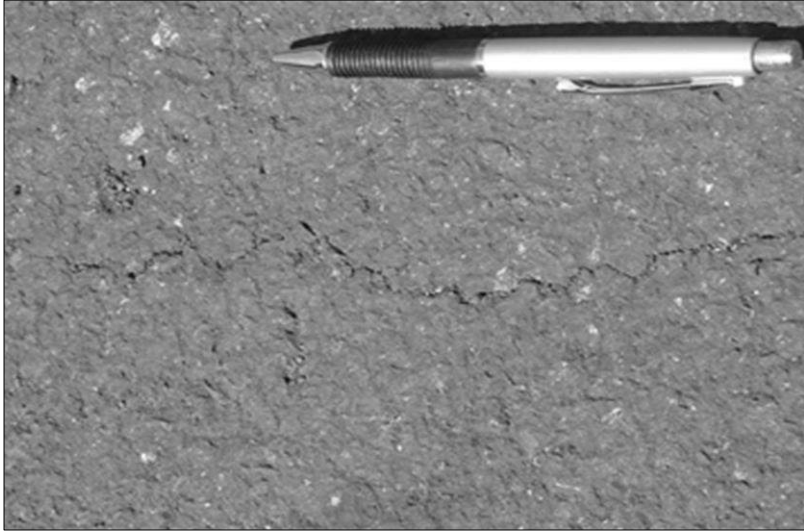
1				
	X	2	3	4	5
	Faint.

Degree	Description
1	Faint cracks.
3	Distinct, open cracks ( $\approx 3$ mm) with slight spalling, deformation, or secondary cracking at corners in the form of triangles.
5	Open cracks ( $> 3$ mm) with significant spalling, secondary cracking or deformation evident around open cracks, or wide, open cracks ( $> 10$ mm) with little or no secondary defects.

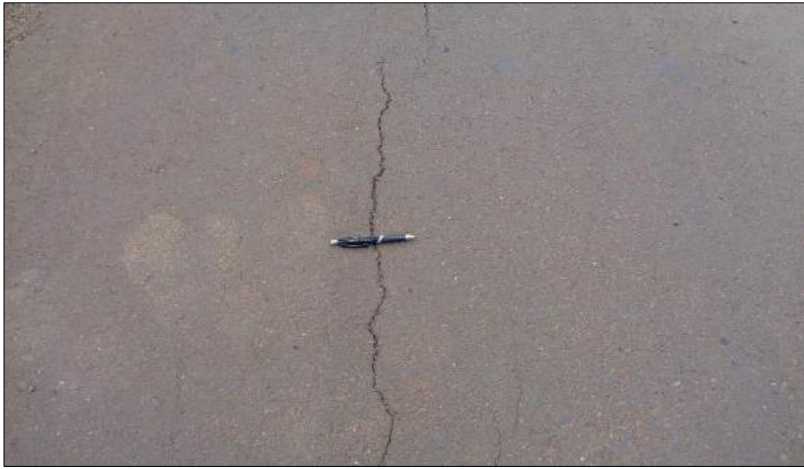
3				
	1	2	X	3	4
	Distinct, open ( $\approx 3$ mm) with slight spalling.

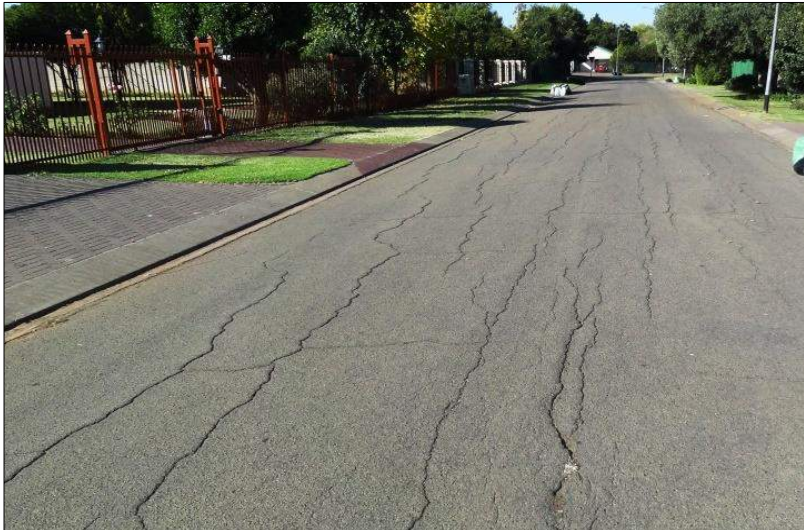
5				
	1	2	3	4	X
	Open cracks ( $> 3$ mm) with significant spalling, or wide open cracks ( $> 10$ mm).

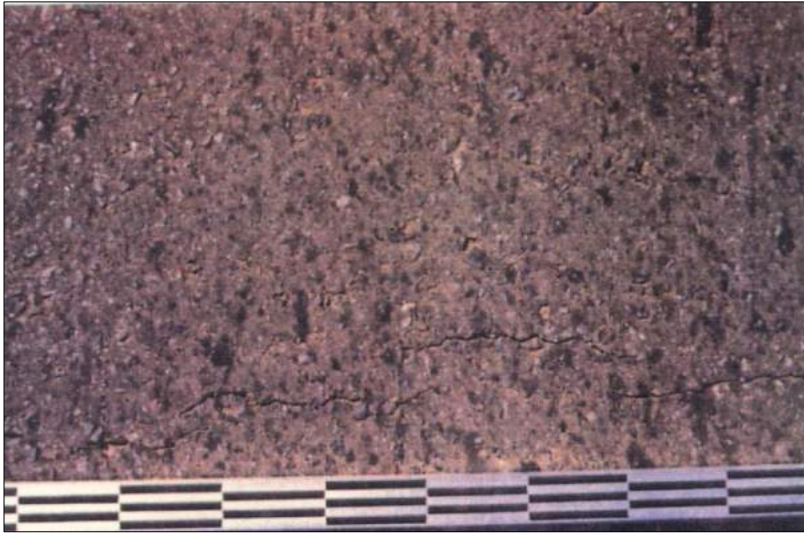
1				
	X	2	3	4	5
	Faint.

Degree	Description
1	Faint cracks.
3	Distinct, open cracks ( $\approx 3$ mm) with slight spalling, deformation, or secondary cracking at corners in the form of triangles.
5	Open cracks ( $> 3$ mm) with spalling, secondary cracking or deformation evident around open cracks, or wide open cracks ( $> 10$ mm) with little or no secondary defects.

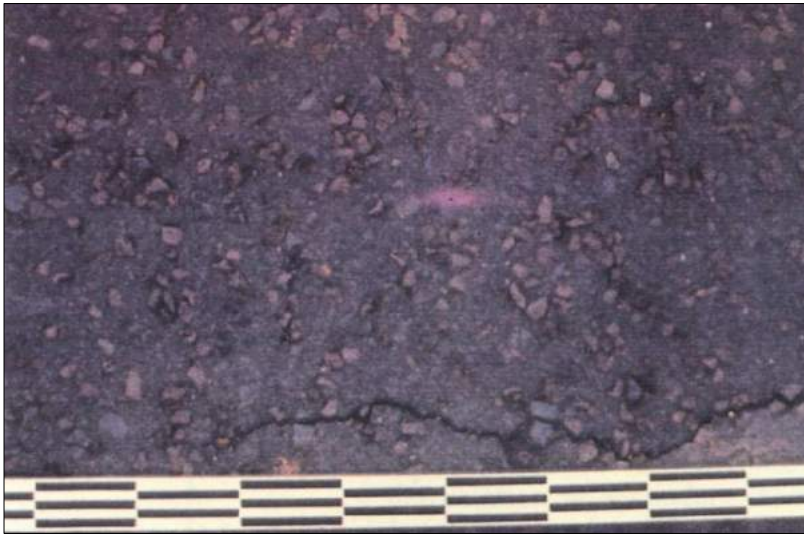
3				
	1	2	X	3	4
	Distinct, open ( $\approx 3$ mm) with slight spalling.

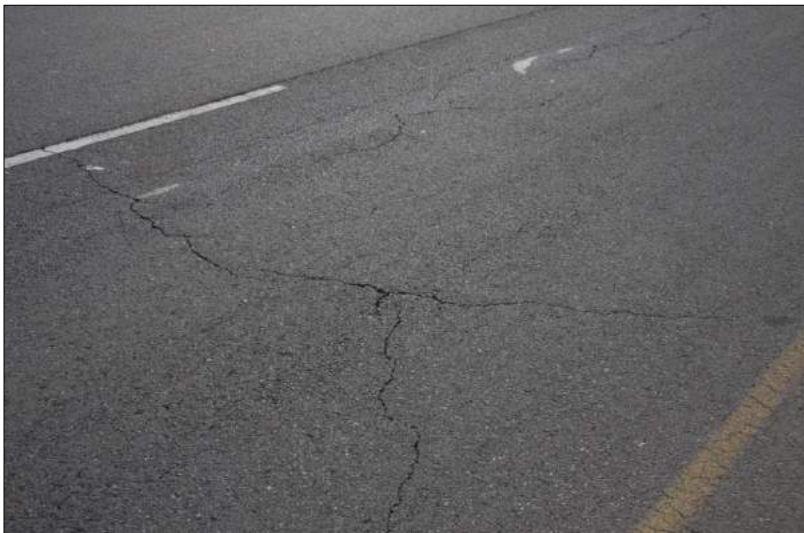
5				
	1	2	3	4	X
	Open cracks ( $> 3$ mm) with significant spalling, or wide open cracks ( $> 10$ mm).

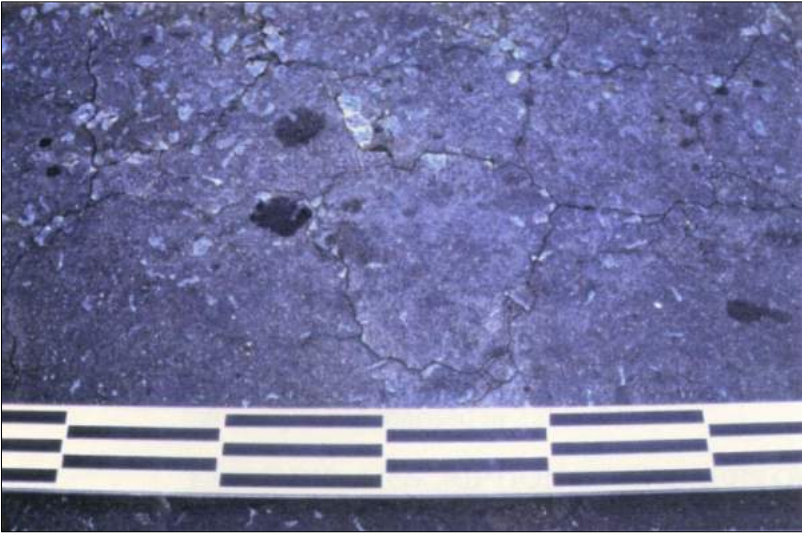
1				
	X	2	3	4	5
	Faint.

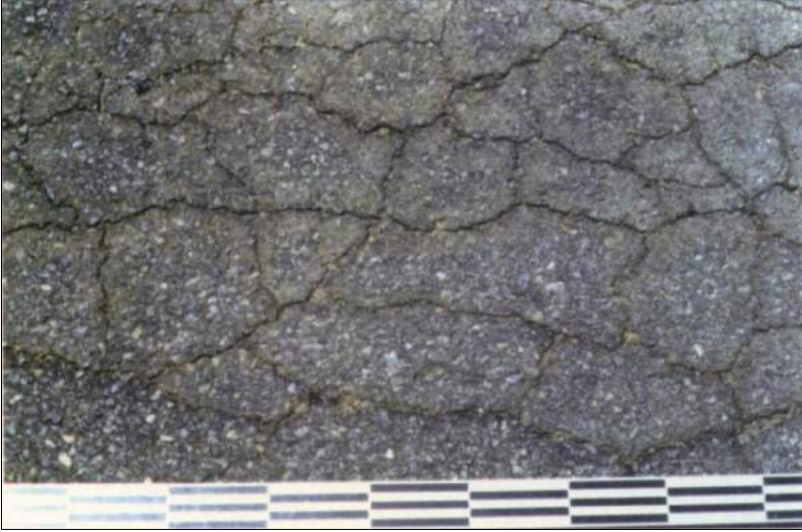
3				
	1	2	X	3	4
	Distinct, open ( $\approx 3$ mm) with slight deformation/movement and/or pumping.

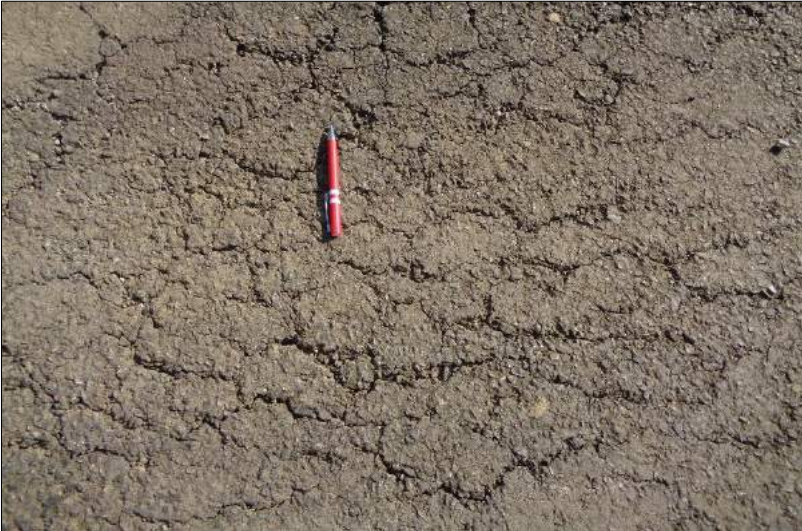
5				
	1	2	3	4	X
	Open ( $> 3$ mm) with severe deformation/movement and/or pumping.

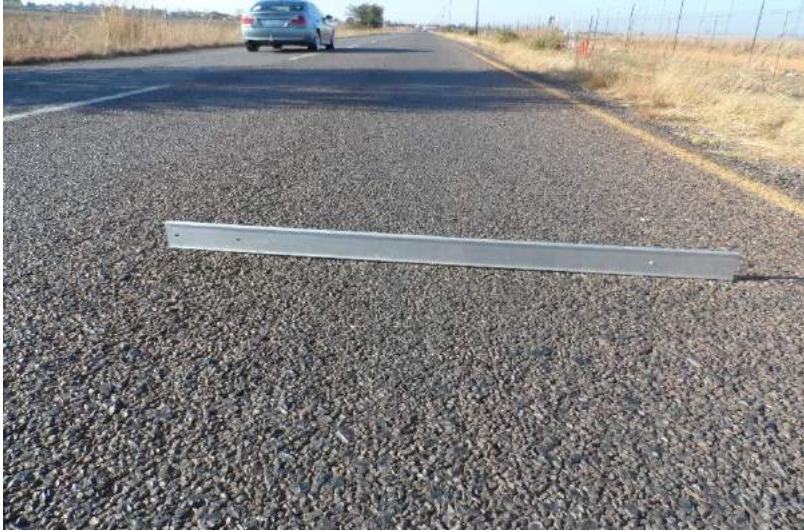
<p>1</p> <table border="1"> <tr> <td>X</td> <td>2</td> <td>3</td> <td>4</td> <td>5</td> </tr> </table> <p>&lt; 5 mm - not readily visible with the eye.</p>	X	2	3	4	5
	X	2	3	4	5

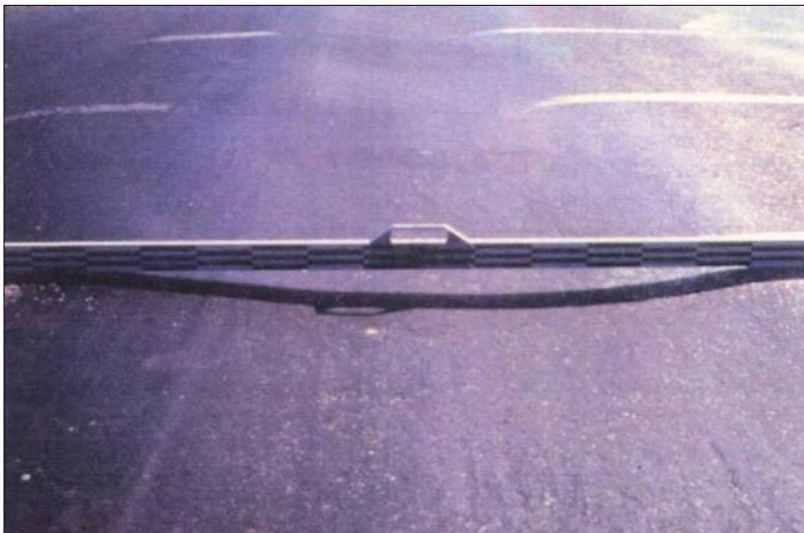
<p>5</p> <table border="1"> <tr> <td>1</td> <td>2</td> <td>3</td> <td>4</td> <td>X</td> </tr> </table> <p>&gt; 30 mm - obvious from moving vehicle, even at high speed.</p>	1	2	3	4
	1	2	3	4	X

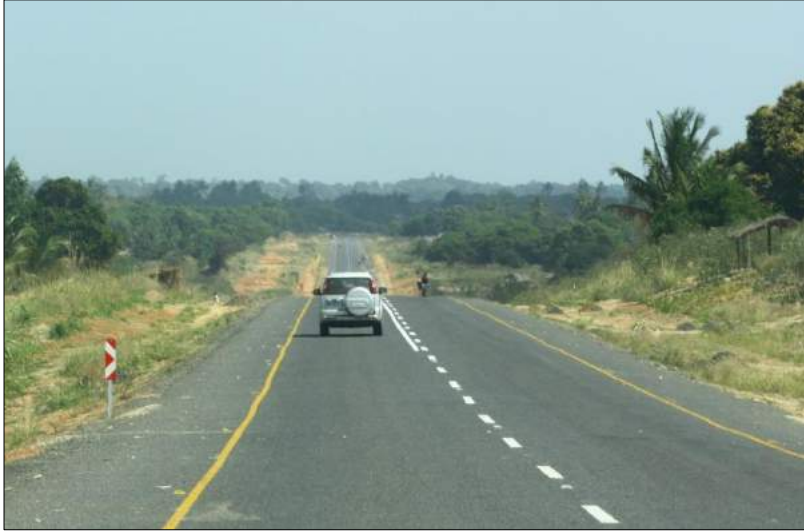
1				
	X	2	3	4	5
	Visible but not felt in a light vehicle.

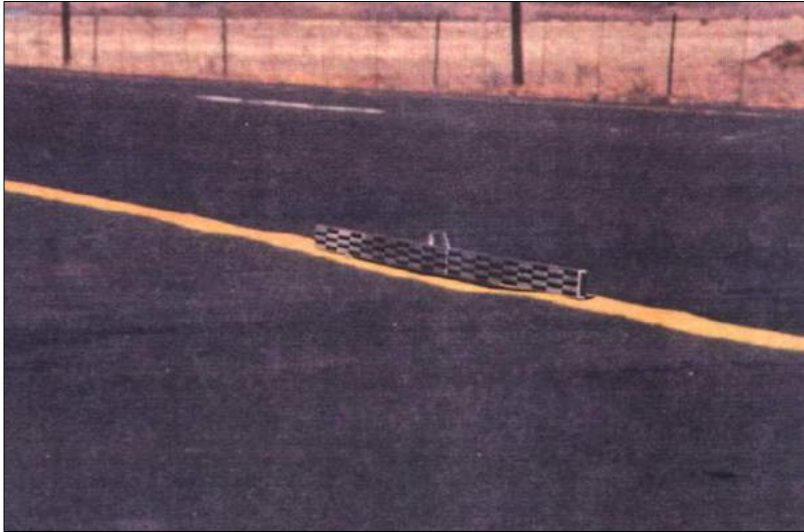
3				
	1	2	X	3	4
	Can be felt – speed reduction necessary.

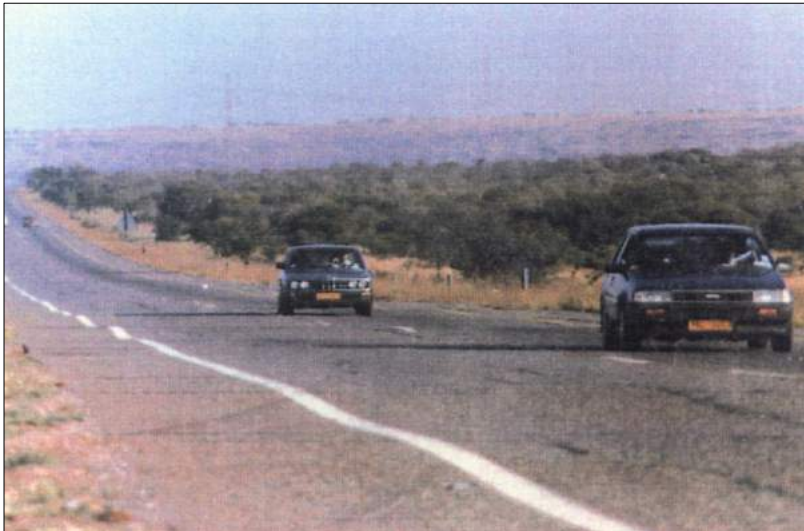
5				
	1	2	3	4	X
	Vehicles select a different path and drive very slowly.

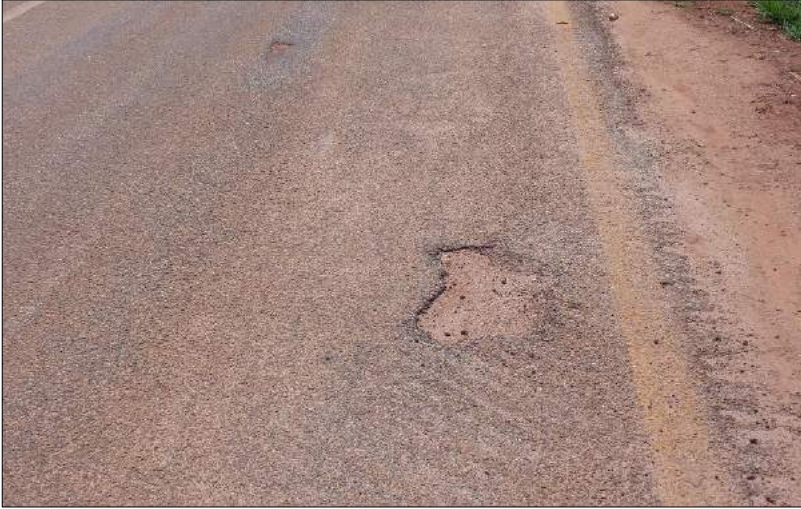
1				
	X	2	3	4	5
	< 250 mm diameter and ~ 25 mm deep.

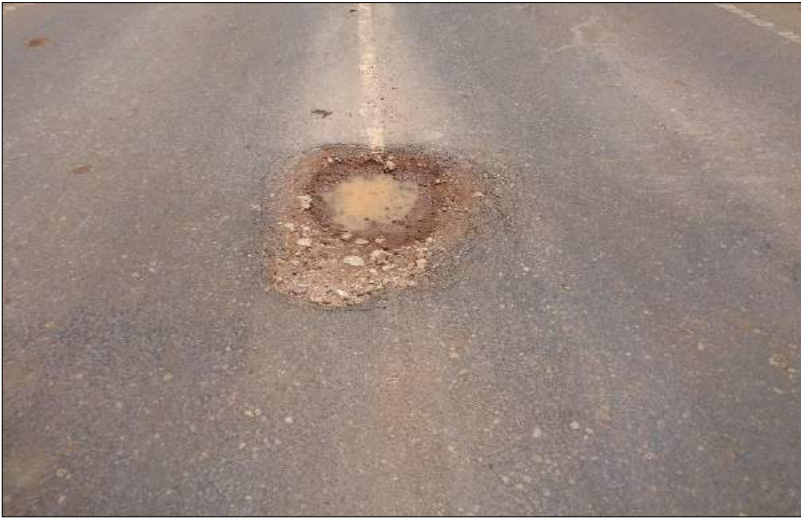
3				
	1	2	X	3	4
	> 250 mm diameter and > 50 mm deep.

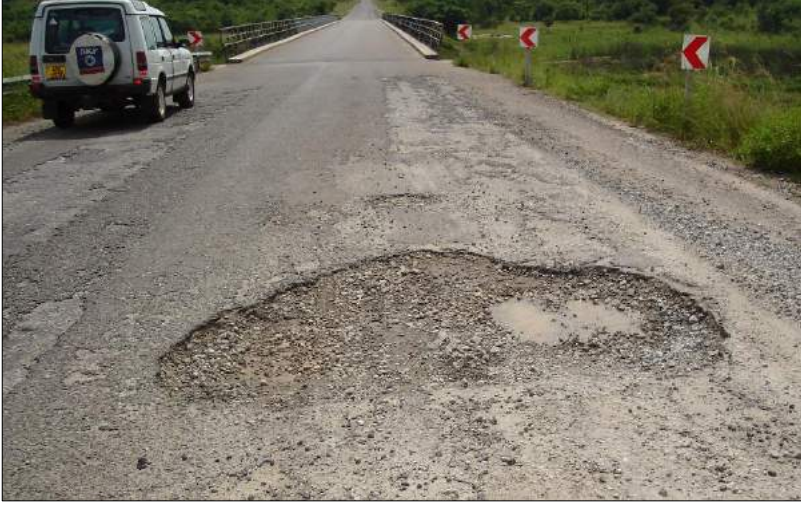
5				
	1	2	3	4	X
	> 500 mm diameter and > 75 mm deep

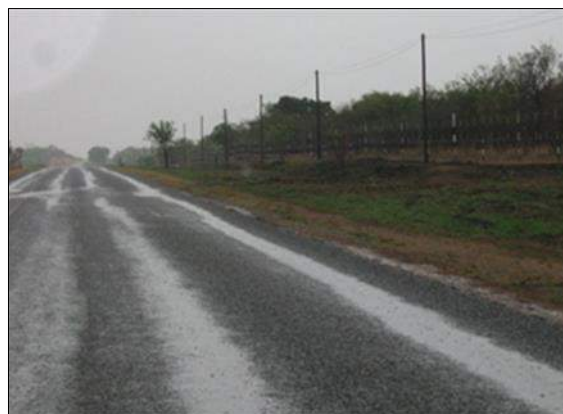
**Figure B.4-1: Water ponding in wheel track**

- Rutting: Water ponding in wheel path on relatively flat roads (see Figure B.4-1);
- Shoulders: Too high or overgrown, leading to ponding of water on the road; and
- Alignment: Horizontal or vertical alignment problem, for example, the bottom of a sag curve or inside of a super-elevated horizontal curve.

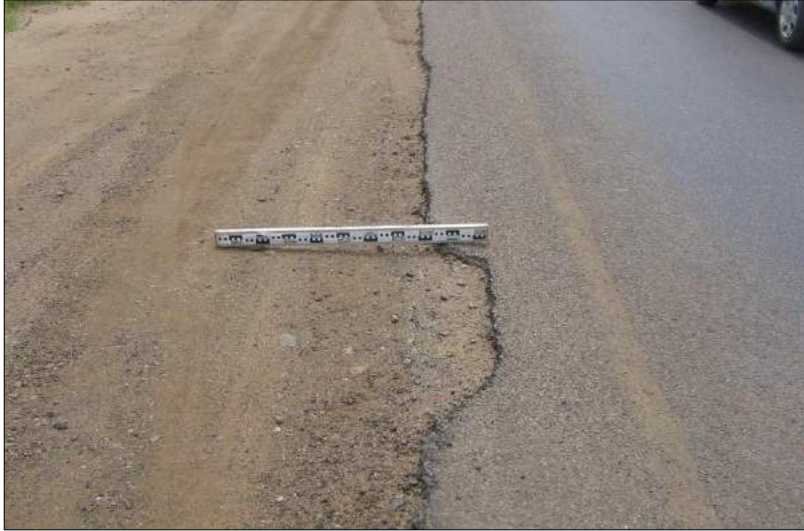
<p>1</p> <table border="1"> <tr> <td>X</td> <td>2</td> <td>3</td> <td>4</td> <td>5</td> </tr> </table> <p>&lt; 50 mm.</p>	X	2	3	4	5
	X	2	3	4	5

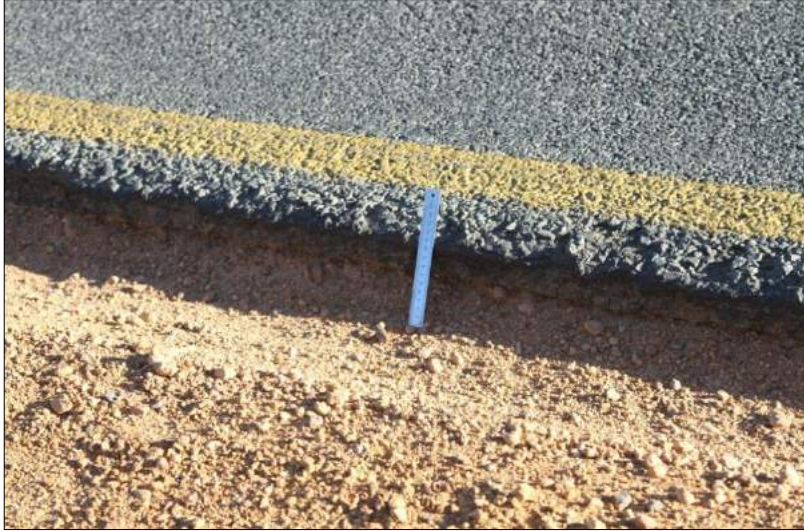
<p>3</p> <table border="1"> <tr> <td>1</td> <td>2</td> <td>X</td> <td>3</td> <td>4</td> </tr> </table> <p>≈ 75 mm.</p>	1	2	X	3
1		2	X	3	4	
 		<p>5</p> <table border="1"> <tr> <td>1</td> <td>2</td> <td>3</td> <td>4</td> <td>X</td> </tr> </table> <p>&gt; 100 mm.</p>	1	2	3	4
	1	2	3	4	X
