## **Responding to climate change effects on rural roads through application of cost effective erosion control measures.**

### **A case study in Zimbabwe**

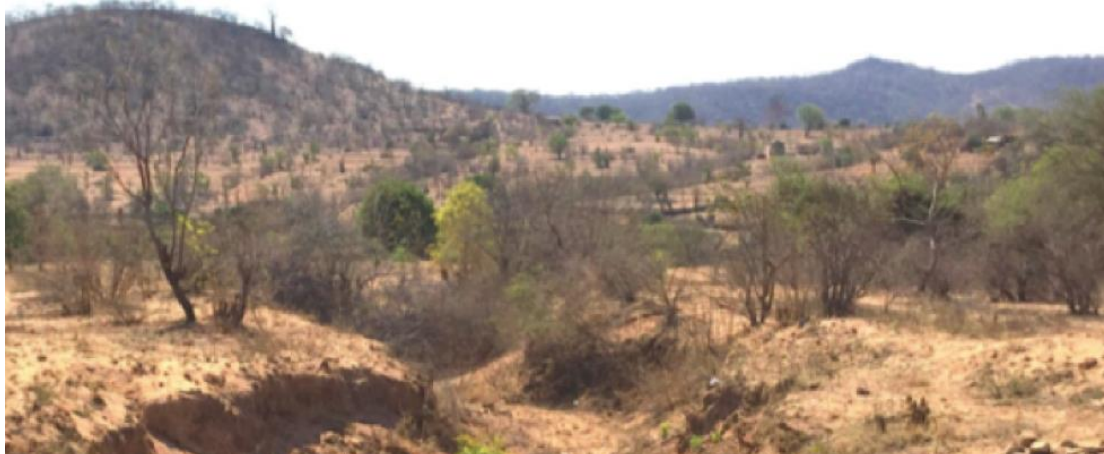
Some of the typical the road related erosion damages were:

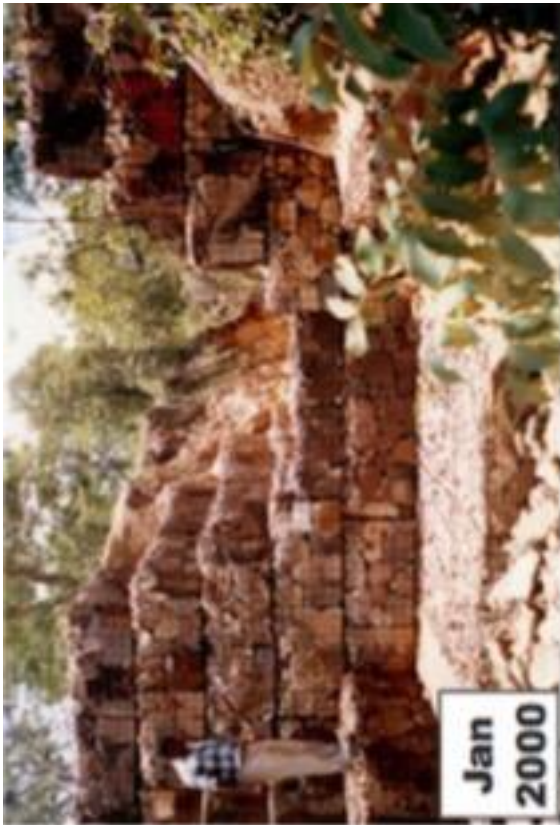
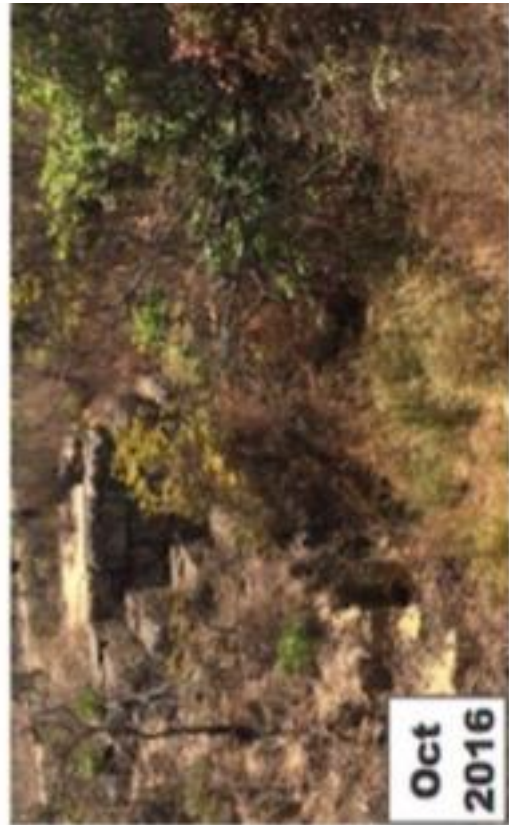
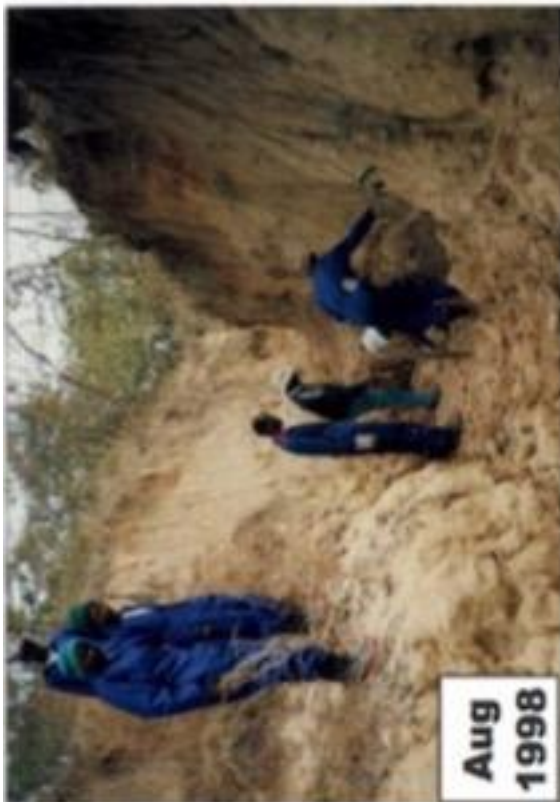
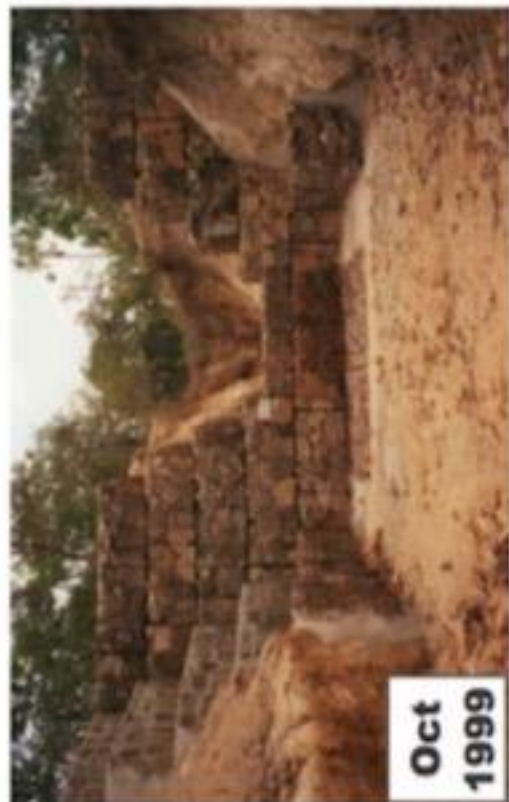
Fig 8: Construction of Gabion Retaining Wall with planting of Vetiver Grass to stop inlet erosion on drainage channel (see page 10).

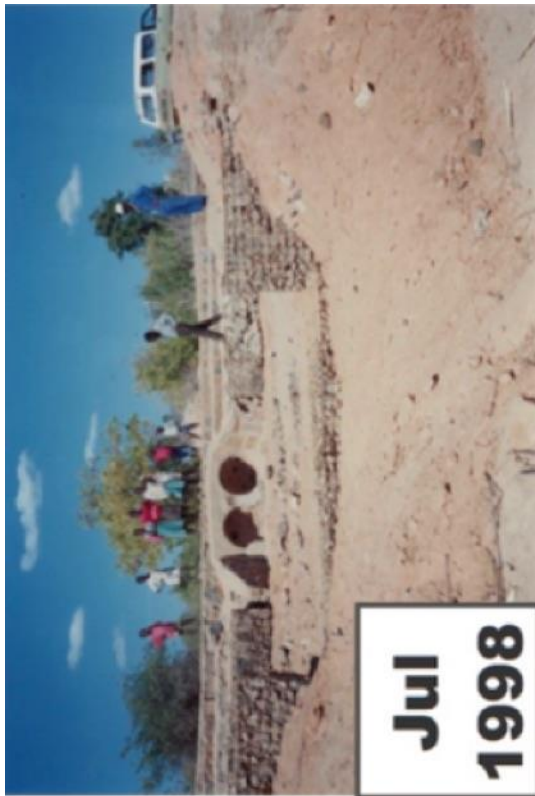
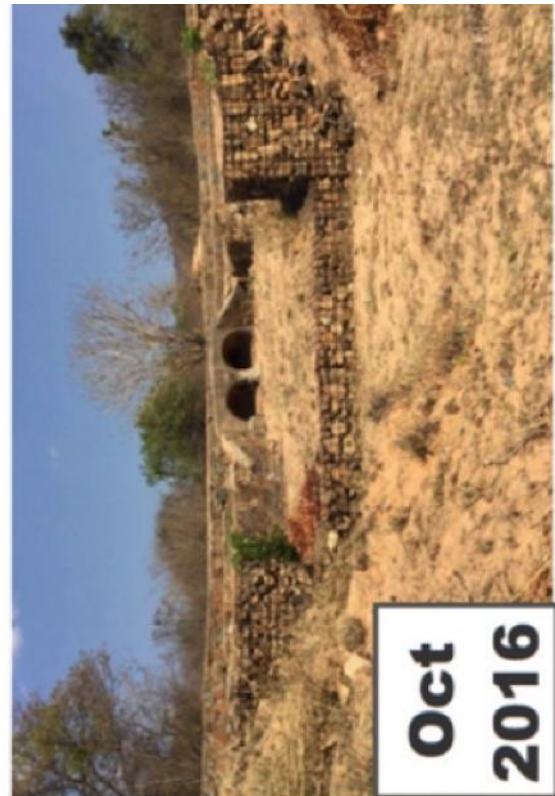
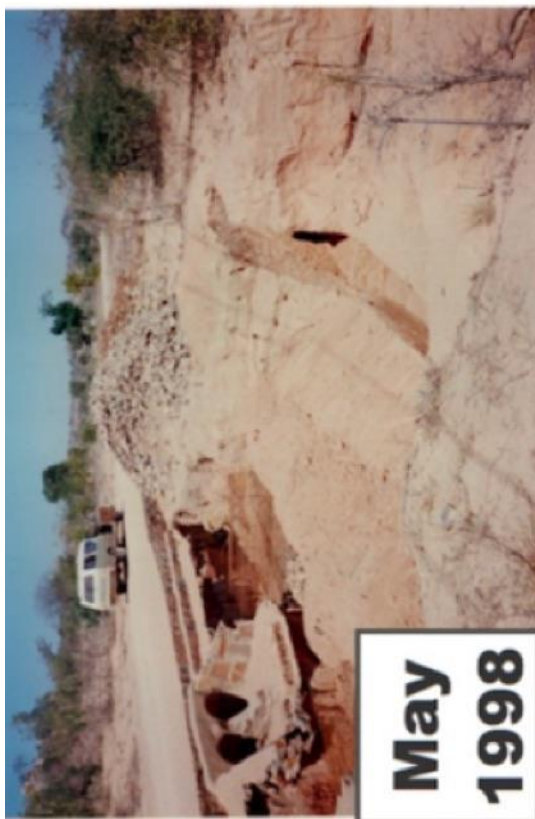
## **F. Recommendations**
