## The use of appropriate high-tech solutions for road network and condition analysis, with a focus on satellite imagery

DRAFT Interim Trials Report

*AFCAP Project Reference  
Number. GEN2070A*

**28<sup>th</sup> February 2017**

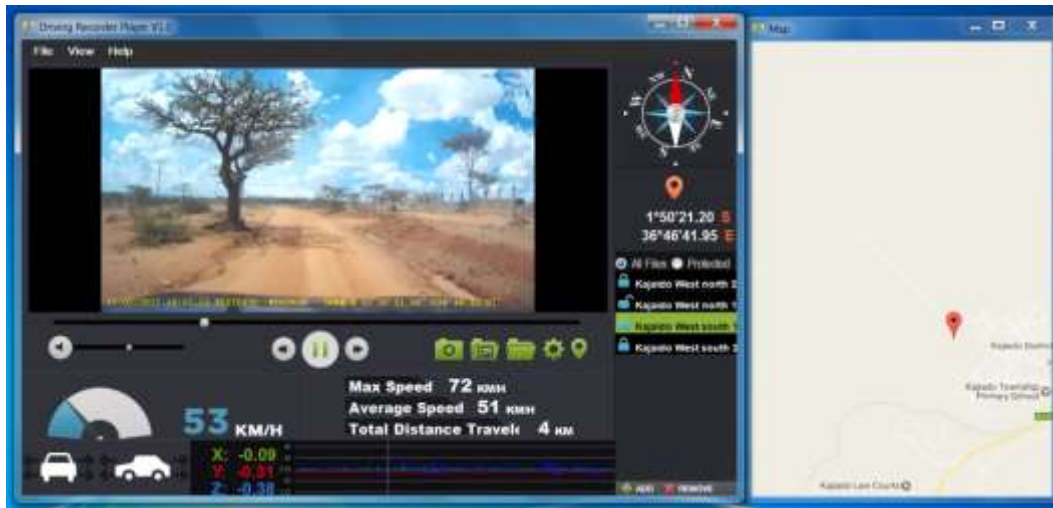
Figure 1 below shows a screen shot of the DashCam recorder software, which clearly shows the video of the road and associated information, such as speed, location, orientation and the map. It can be seen from the speed and the X/Y/Z movements at the bottom of the screen that the vehicle is currently in an area that is in reasonable condition, as the speed is 53kph and the blue 'Z' line from the GPS is fairly flat. However, the 'Z' line can be seen to increase to the right of the present position (shown by the white vertical line), indicating that the road will deteriorate in the near future.

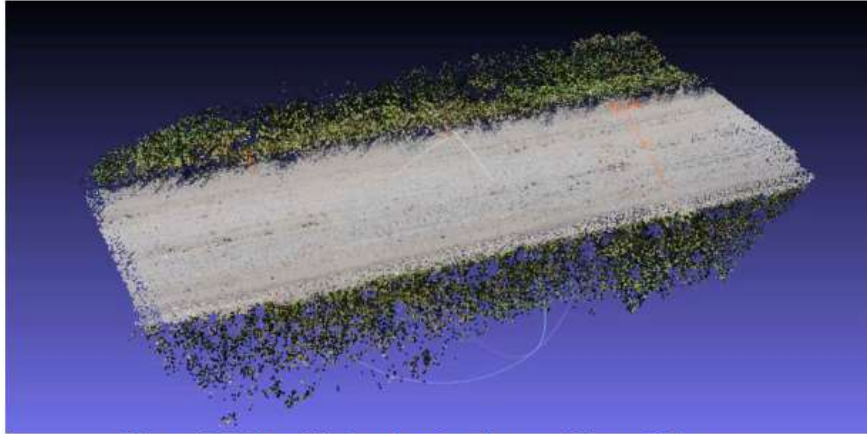
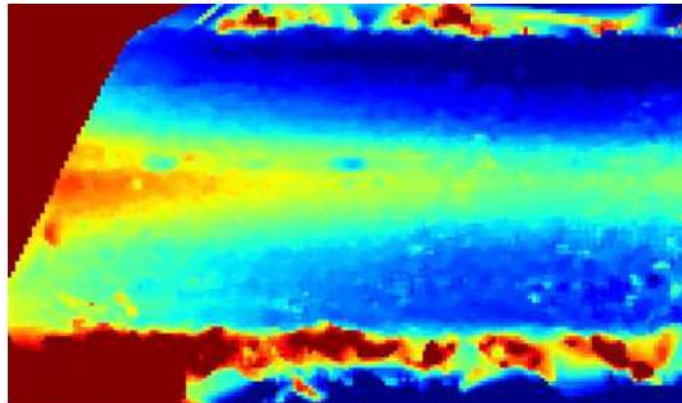
**Figure A2.2**

Extracts from the above report, showing the point cloud image created from the drone photographs, and a depth map of the surface using colours to show the elevations.

**Figure 3-7: Densified point cloud created from 28 images.**

**Figure 3-8: Depth map after median filtering. Blue colors represent lower elevations, red colors represent higher elevations.**

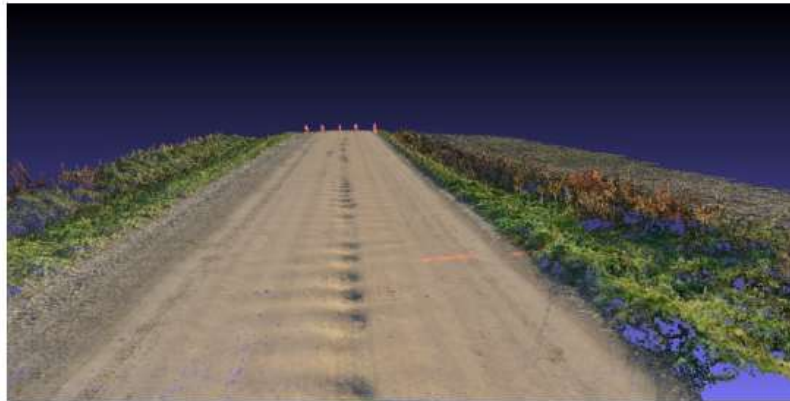
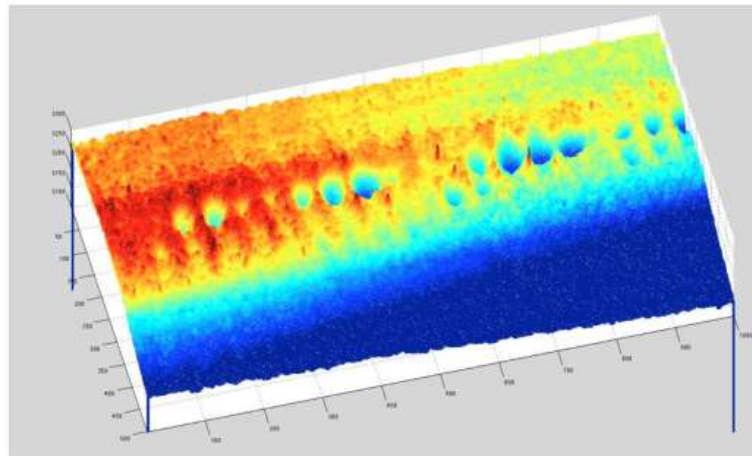
**Figure A2.3**

Extracts from the report showing a 3D image of the road created from a point cloud, generated by overlapping visual images from the UAV platform, with a height map of the same area showing potholes and their depths.

**Figure 3-11: A 3-D point cloud generated through the project's structure-from-motion based remote sensing processing system software using overlapping UAV-collected imagery of Welch Road.**

**Figure 3-12: Part of the Welch Road segment displaying a height map where potholes and their depths can be seen.**

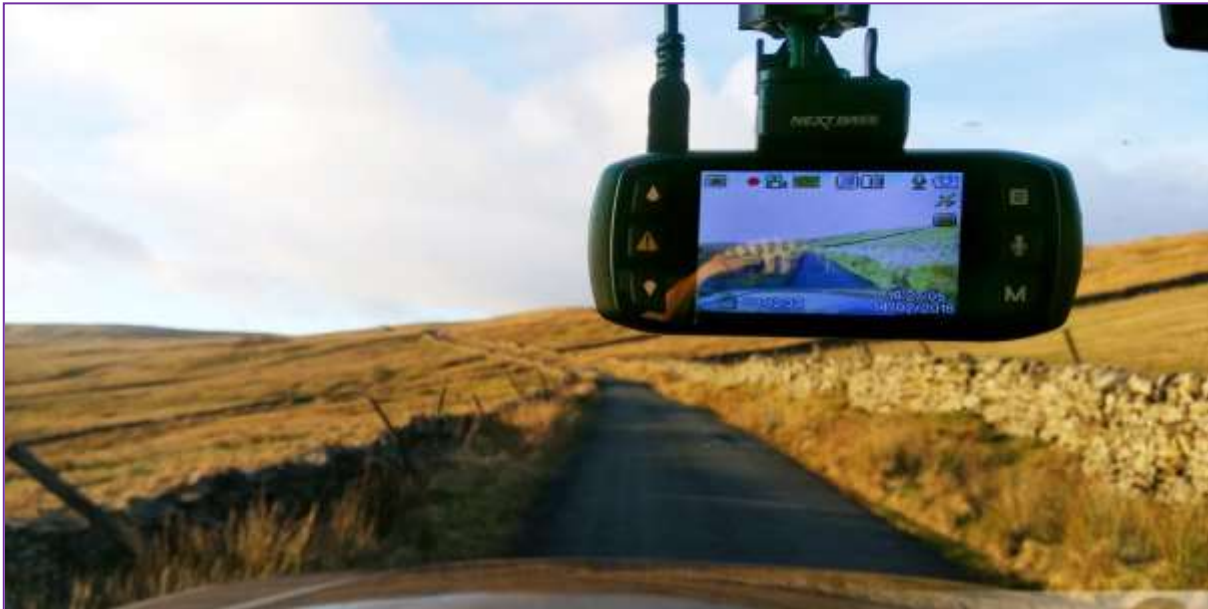
Figure A3.1 shows the DashCam located in the vehicle, attached to the windscreen with a sucker cup.

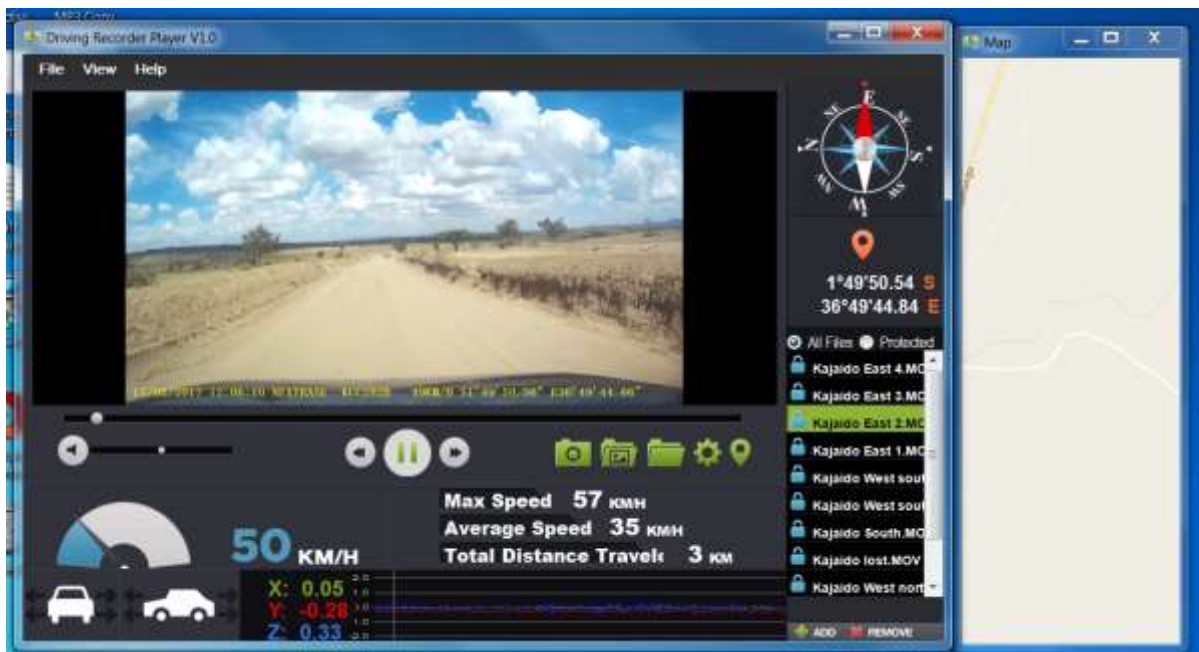
Figure A3.2 shows the video images as presented in the DashCam software.

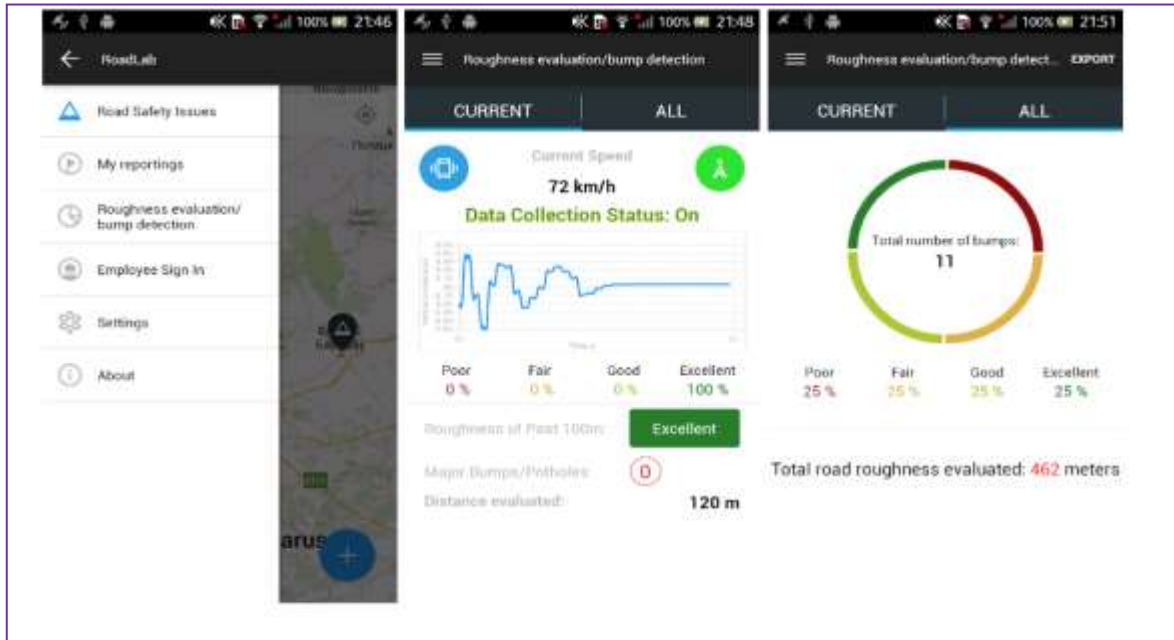
Figure A4.1 shows the interface of the RoadLab app.

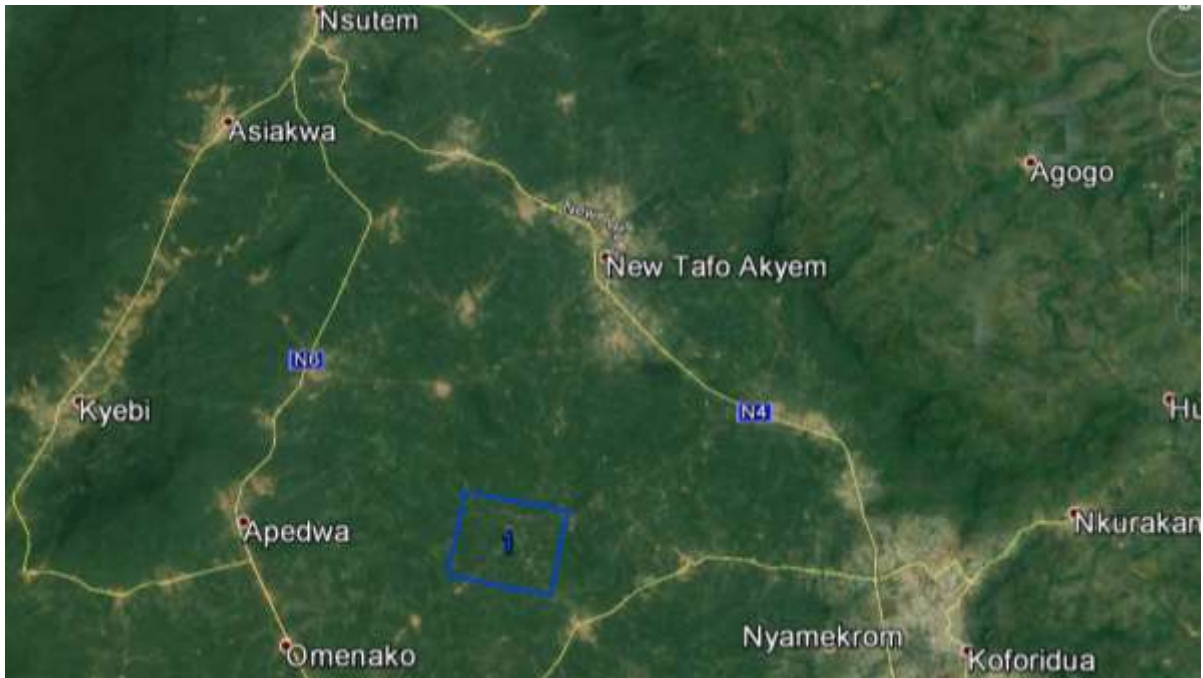
Figure A12.1 shows the proposed Area of Interest for SAR imagery in Ghana, which is inside the main Aol.

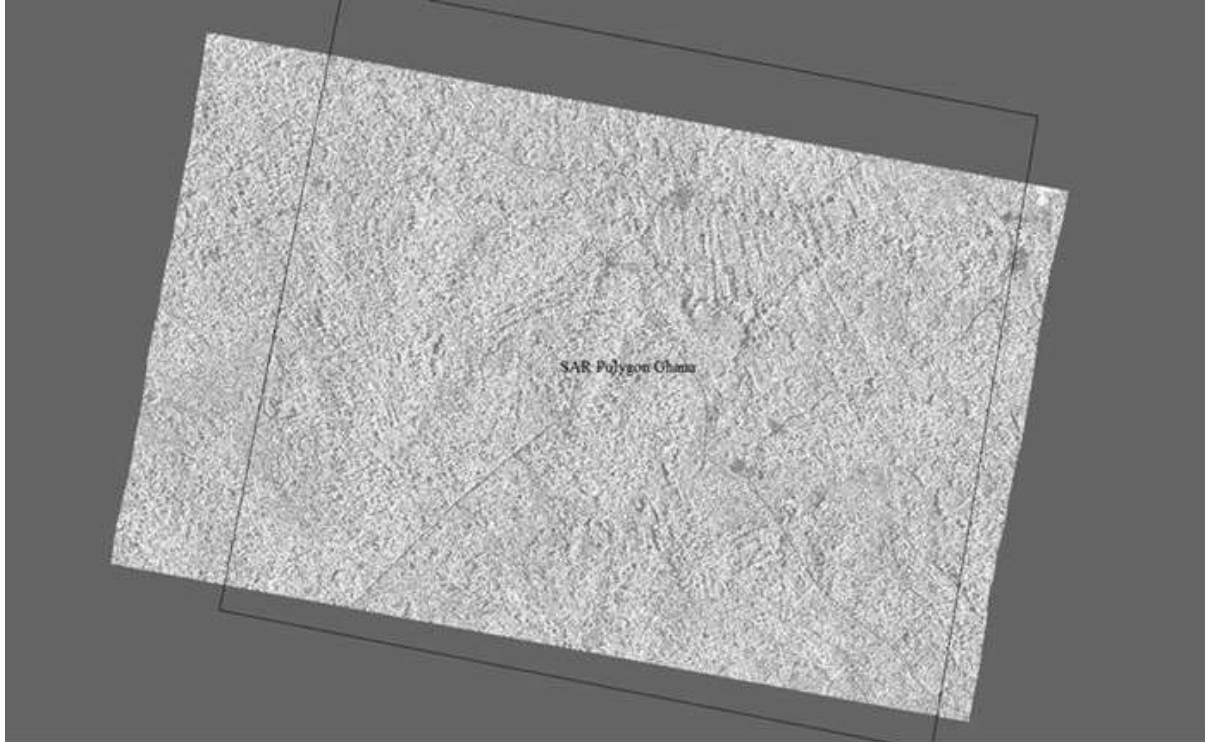
**Figure A12.2**

Figure A12.2 shows the acquired SAR imagery for Ghana, with the proposed AoI outlined in black. It was not possible to acquire the exact area as SAR imagery is sold in 'scenes' and is dependent on the location and orientation of the satellite when it passes the area.

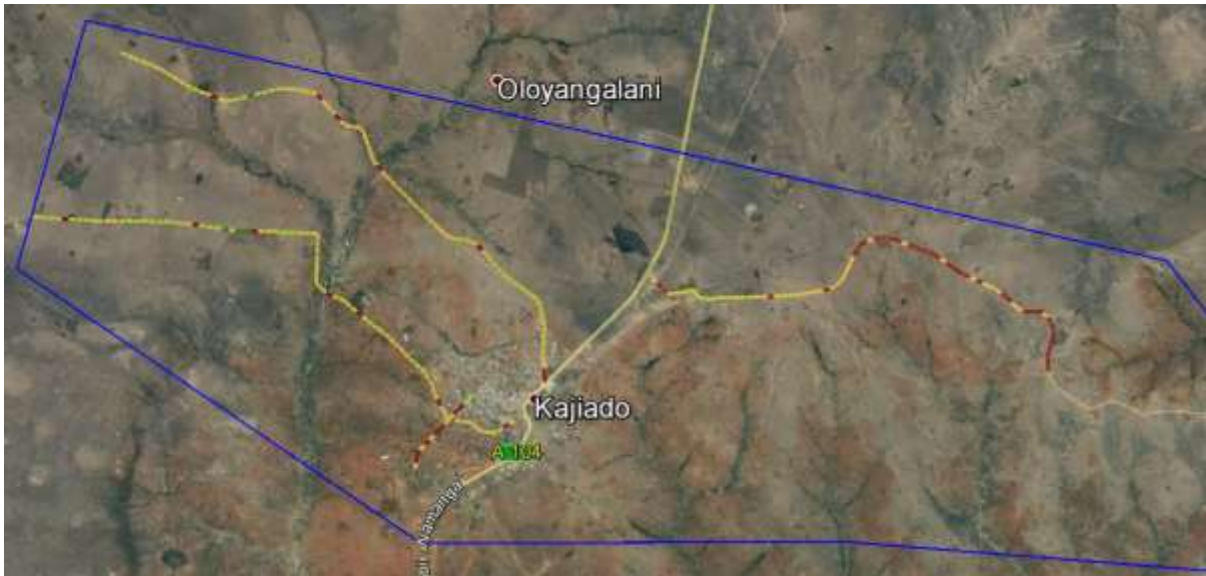
Figure A15.1 shows the tracks for the roads surveyed using the RoadLab mobile app. with the condition colour coding shown for sections of approximately 100m.

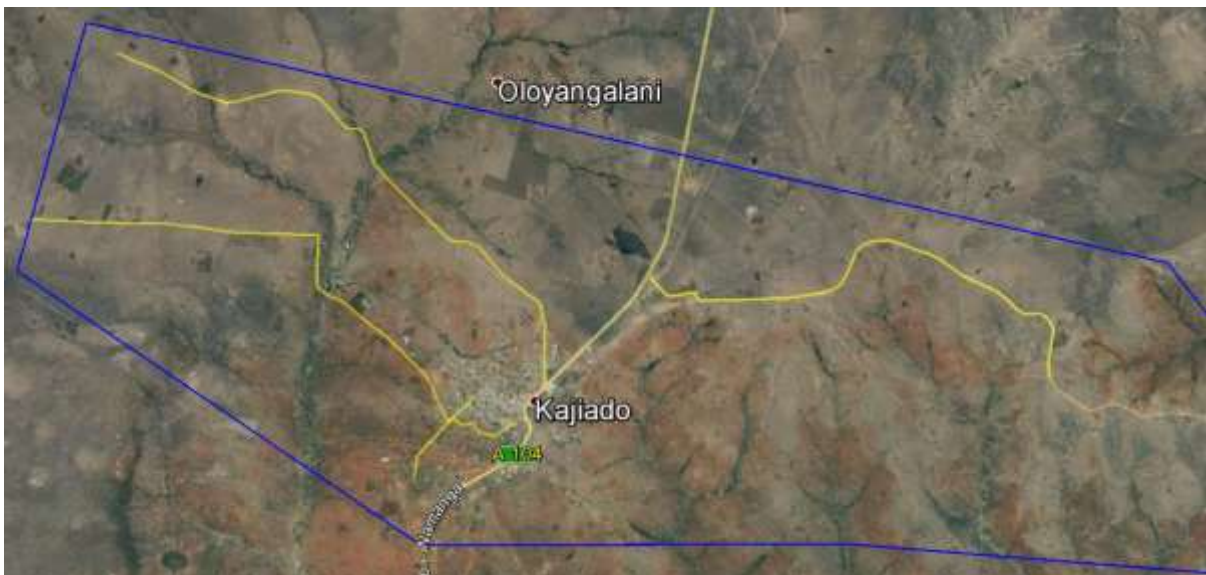
Figure A15.2 shows the GPS tracks from the DashCam.
