ReCAP
Research for Community Access Partnership

Baseline Survey Report for 11 Low-Volume Sealed Roads in Kenya

Final Report

AFCAP Project – KEN2043C

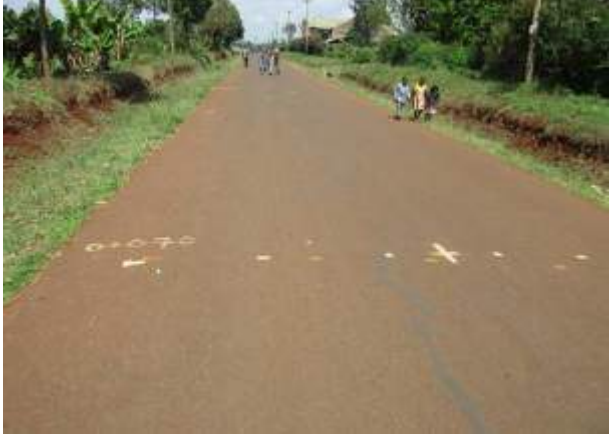
<p>Fig 4</p>	<p>Km 0+060 – 0+075 main carriage way at the centreline</p>	<p>-Cracks sealing on the carriage way</p>

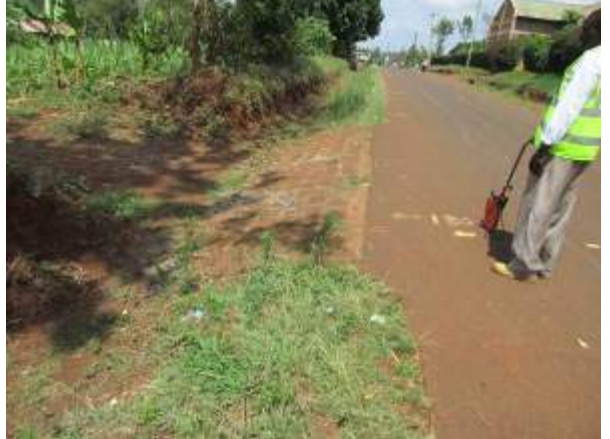
<p>Fig 5</p>	<p>Km 0+100 – 0+130 main carriage way at the centreline</p>	<p>-Crack sealing on carriage way -Vegetation on the encroaching the road edge</p>

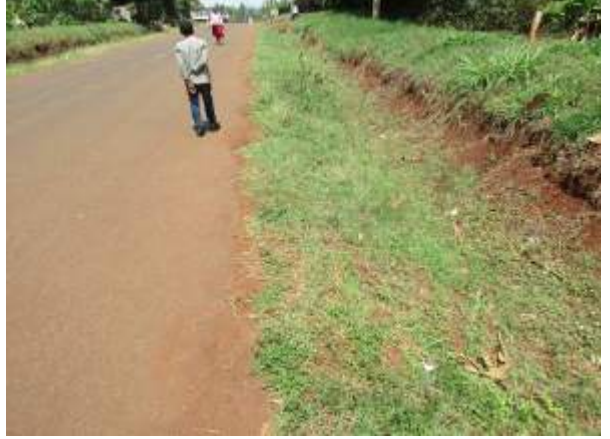
<p>Fig6</p>	<p>Km 0+120 – 0+130 LHS</p>	<p>-Vegetation on side slope hindering free flow of water to the side drain</p>

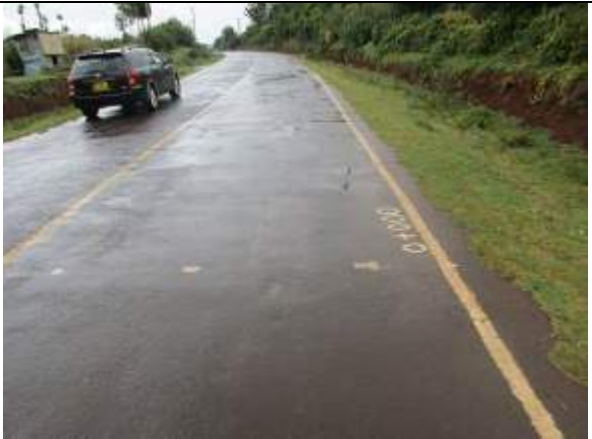
Fig No	Location (Km)	Defect assessment and description	Photos illustrating the pavement distress & defect
Fig 1	Km 0+000-0+008 LHS	-Alligator cracks on the carriage way

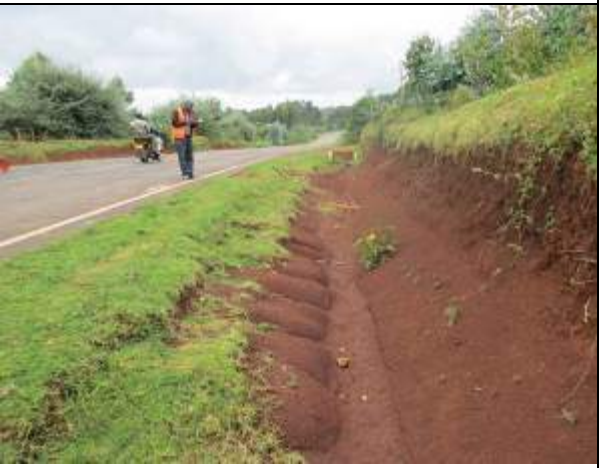
<p>Fig 15</p>	<p>Km 0+356 -0+380 LHS</p>	<p>-Gully erosion on the side and side slope drain approx. 30m long</p>

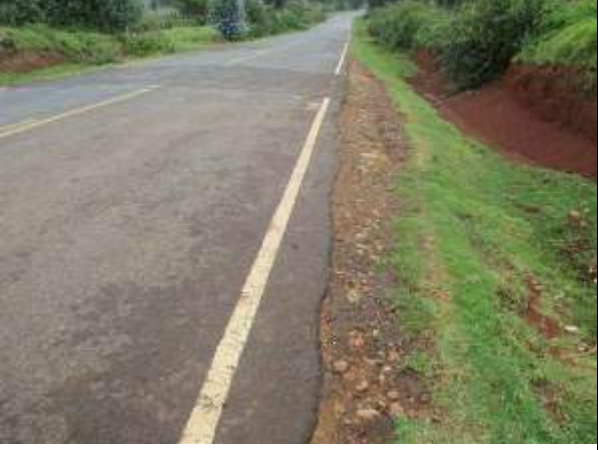
<p>Fig 17</p>	<p>Km 0+380 – 0+420 RHS</p>	<p>-Eroded side slope approximately and edge 20m long</p>

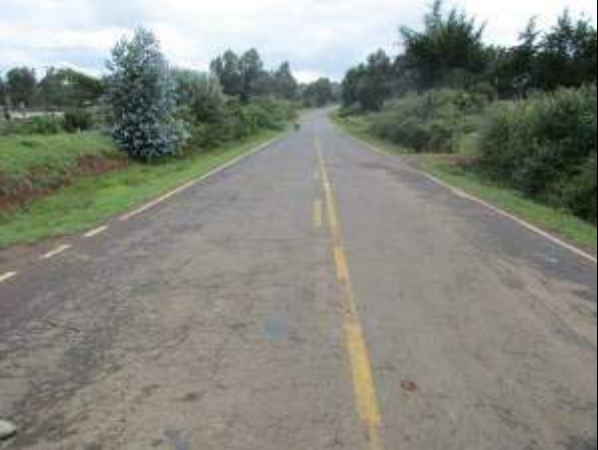
<p>Fig 18</p>	<p>Km 0+400 – 0+420 main carriage way</p>	<p>-Alligator cracks all over the carriage way -Vegetation on the side slope hindering free flow of water along drain</p>

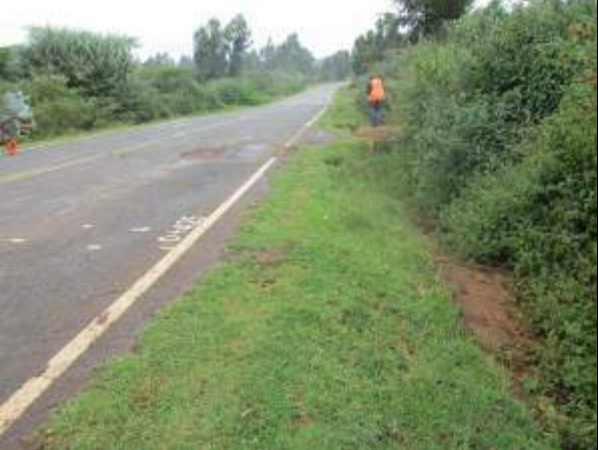
<p>Fig 19</p>	<p>Km 0+420 -0+440 LHS</p>	<p>-Alligator cracks and Longitudinal depression on the outer wheel path approx. 1.3m by 22m long -Heavy vegetation on the side drain</p>

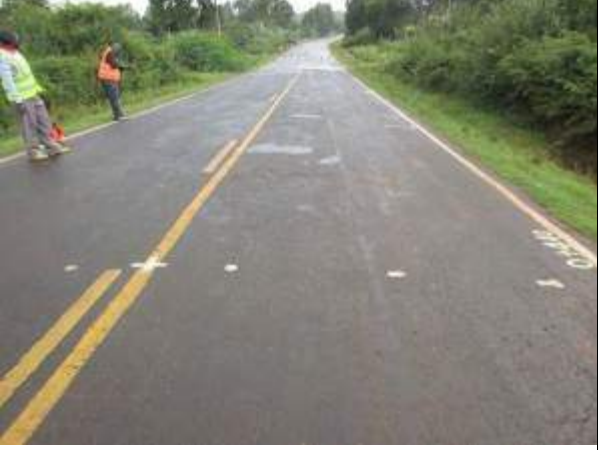
<p>Fig 15</p>	<p>Km 0+430 -0+460 RHS main carriage way</p>	<p>-Alligator cracks all over the carriage way most predominant on the outer wheel path right hand side Line -Vegetation on the side slope hindering free flow of water along drain</p>

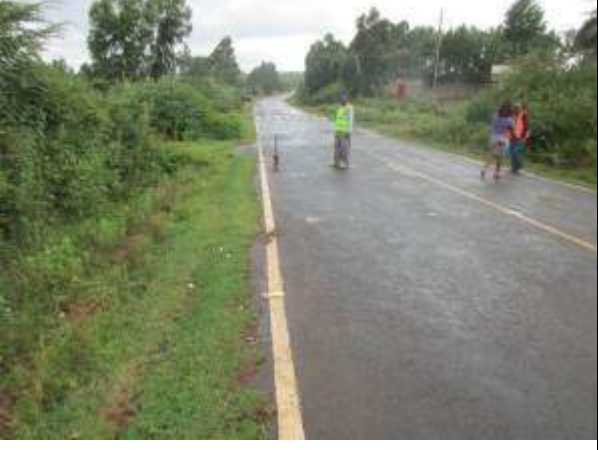
<p>Fig 17</p>	<p>Km 0+490 – 0+500 both sides</p>	<p>-Alligator cracks on the carriage way -Heavy vegetation on the side drains both sides</p>

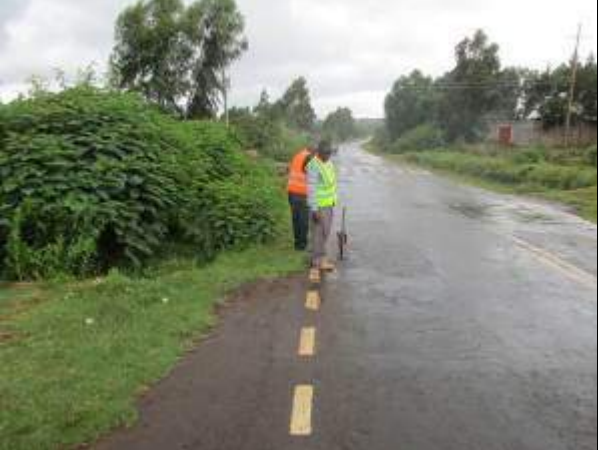
<p>Fig 18</p>	<p>Km 0+515 – 0+560 LHS</p>	<p>-Heavy vegetation on the side drain especially on the LHS drain -Extensive potholes and deformation on the outer wheel path,</p>

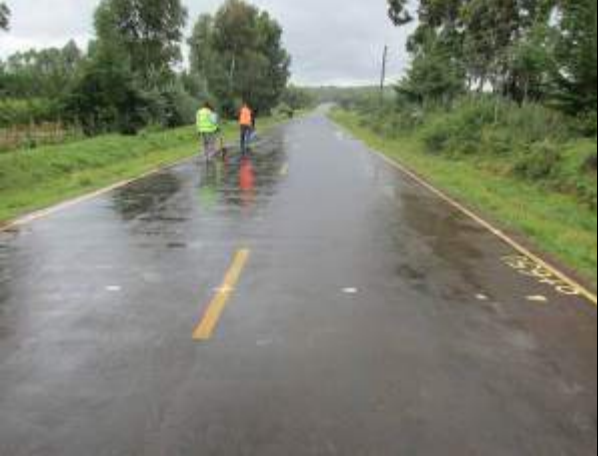
<p>Fig 18</p>	<p>Km 0+640 – 0+680 main carriage way</p>	<ul style="list-style-type: none"> -Surface bumpy and irregular -Edge deformation and subsidence on the outer wheel path covering about 20mlong and 7m width with a depth 30mm

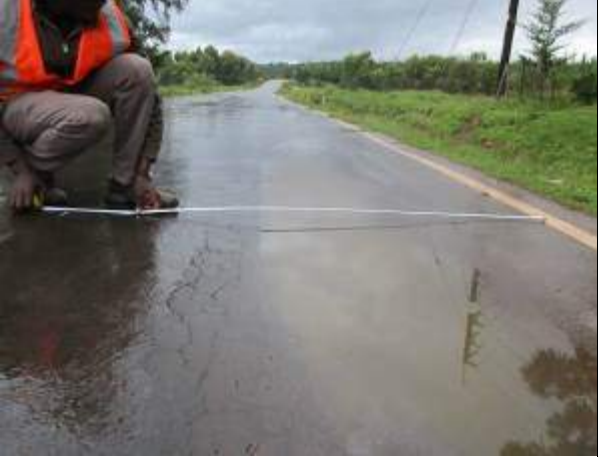
<p>Fig 19</p>	<p>Km 0+717 – 0+737 RHS lane</p>	<ul style="list-style-type: none"> -Longitudinal depression and alligator on the outer wheel path approx. 1.3m by 22m long -Vegetation encroaching towards the RHS edge

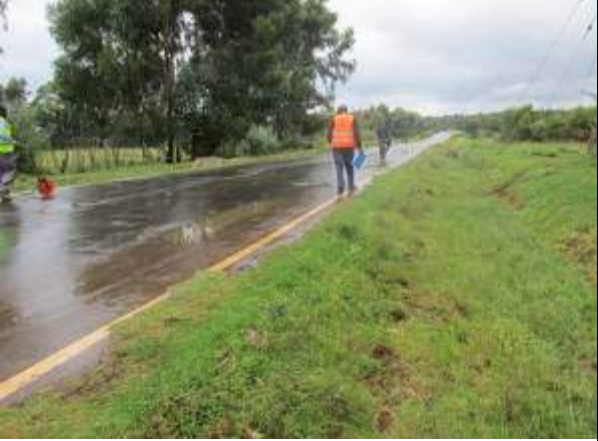
<p>Fig 20</p>	<p>Km 0+750- 0+800 RHS carriage way</p>	<ul style="list-style-type: none"> -Depression and ponding on the carriage way 20m long -Grass encroaching from the side drain, side slope, shoulders and extending towards the edge - Surface bumpy and irregular

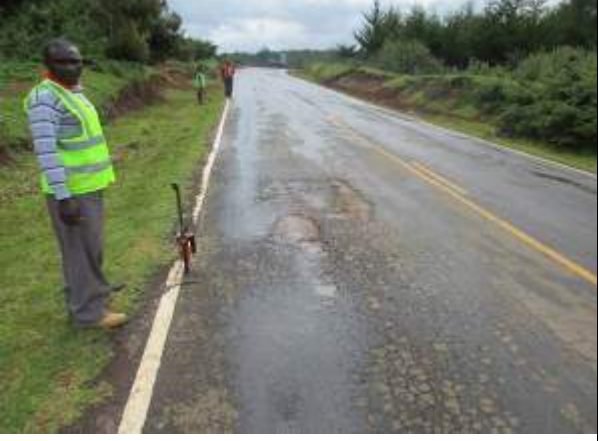
<p>Fig 21</p>	<p>Km 0+896 -0+920 LHS</p> <p>main carriage way both sides of the outer wheel path</p>	<p>-Deformation and depression leading extensive loss of surfacing material</p>

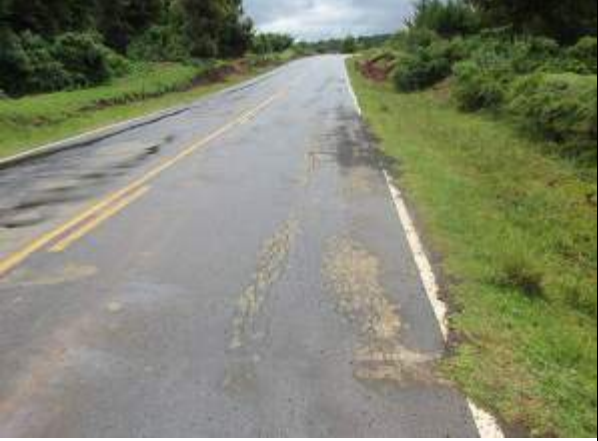
<p>Fig 22</p>	<p>Km 0+896 -0+920 RHS</p> <p>main carriage way both sides of the outer wheel path</p>	<p>-Longitudinal depression and deformation on the RHS carriage way covering 30m long and 1.3m width caused by poor drainage system</p>

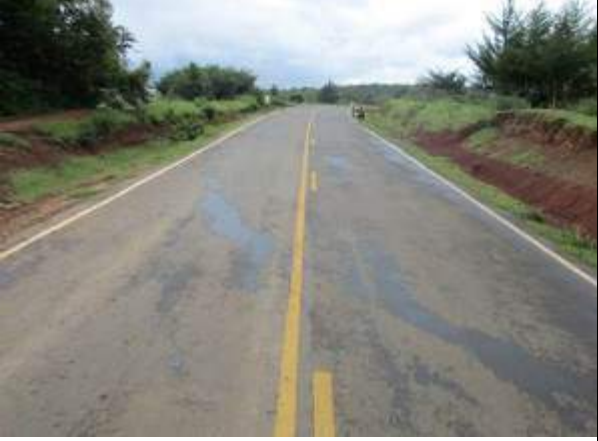
<p>Fig 23</p>	<p>Km 0+900 – 1+000</p>	<p>-Alligator cracks all over the carriage way and Gully erosion on the side drain and side slope especially on the RHS</p>

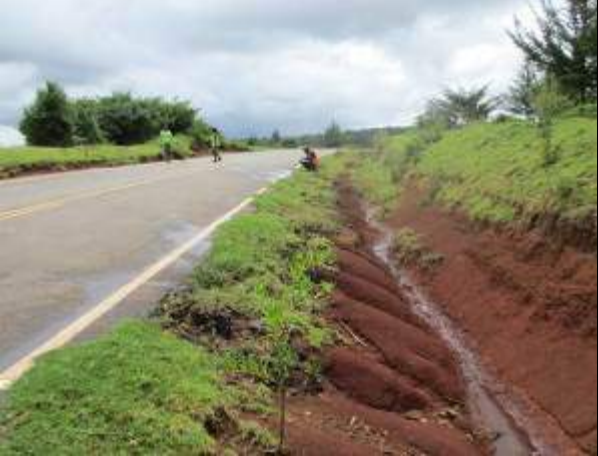
Fig 20	Km 0+950 – 1+000	<p>-Gully erosion on the side drain and side slope</p> <p>-Alligator cracks all over the carriage way</p>

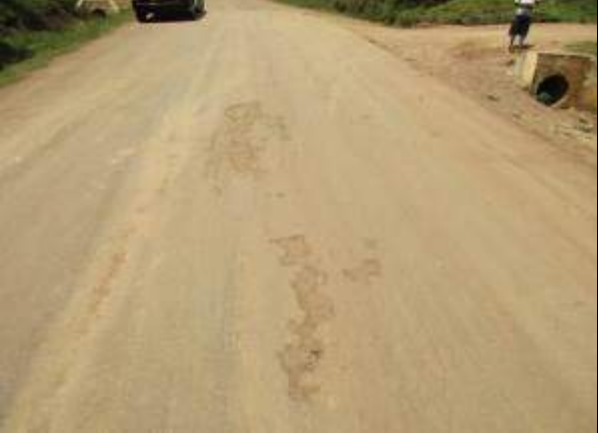
Fig No	Location (Km)	Defect assessment and description	Photos illustrating the pavement distress & defect
Fig 1	Km 0+000 – 0+011 main carriage way	Alligator cracks and localized loose of pavement materials covering an area 1m by 5m long(A-5m ²) at the centreline

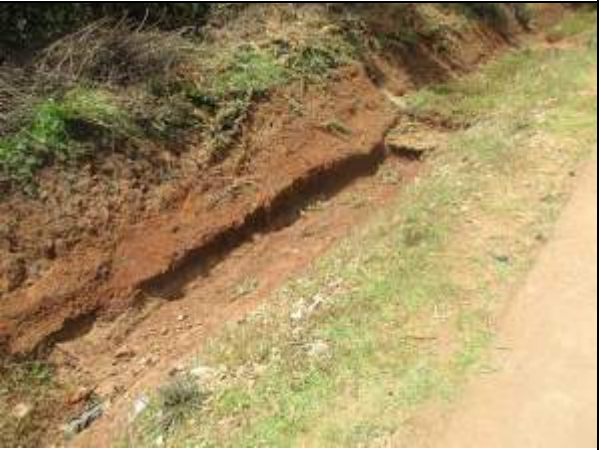
<p>Fig 3</p>	<p>K 0+120 LHS</p>	<p>-Erosion gullies on the side drain</p>

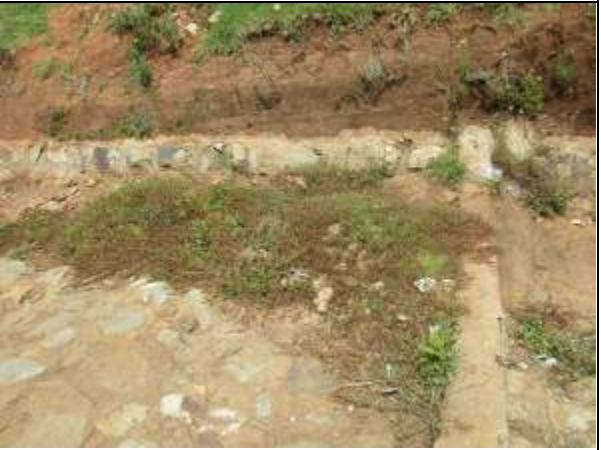
<p>Fig 4</p>	<p>Km 0+030 – 0+045</p>	<p>-Silted and vegetated stone pitching on the side drain and scour checks</p>

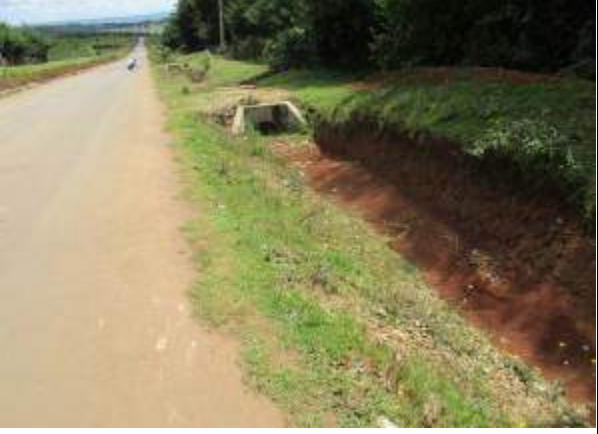
<p>Fig6</p>	<p>Km 0+145 – 0+190 RHS</p>	<p>-Grass encroaching the road edge moistening and softening the pavement that would eventually lead to premature pavement deformation and failure</p>

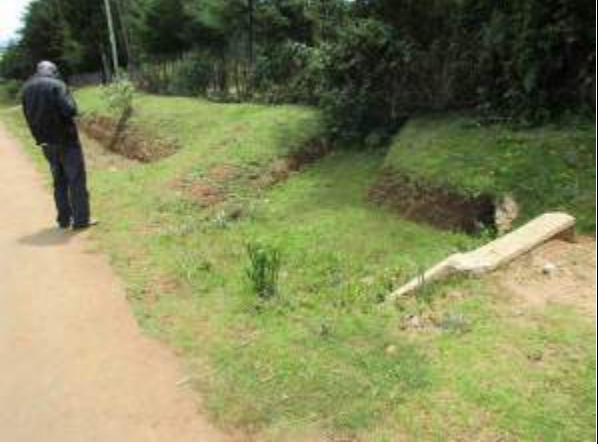
<p>Fig 7</p>	<p>Km 0+140 LHS</p>	<p>-Blocked side drain and silted access culvert</p>

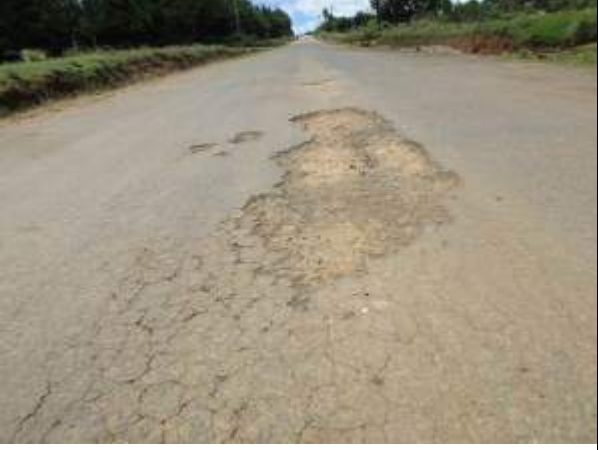
<p>Fig 15</p>	<p>Km 0+335 main carriage way at the centreline</p>	<p>-Alligator cracks on the surface</p>

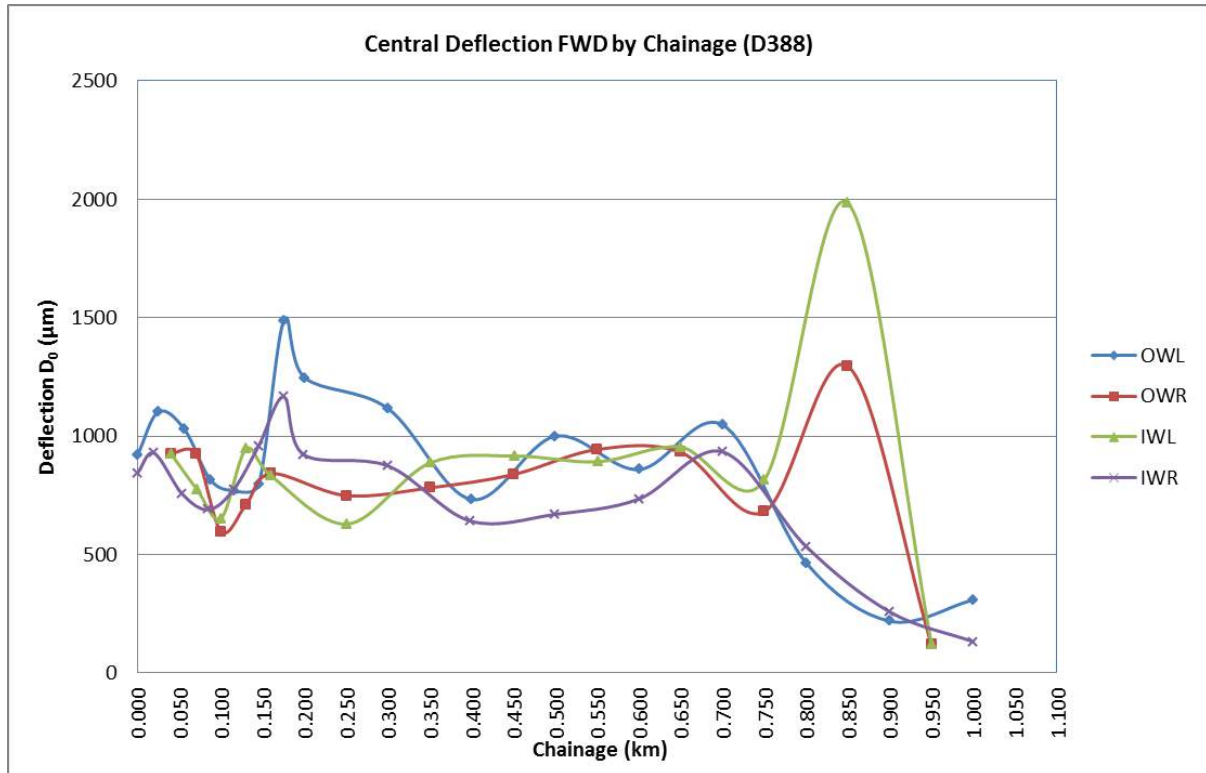
Figure 6-3: Central deflection by chainage (D388)

The complete deflection outputs from the FWD for all the sensors (D₀ up to D₆) for all the test locations are presented in the Appendix section of the report. Figure 6-3 shows the central deflection along each wheel path. The values vary significantly.

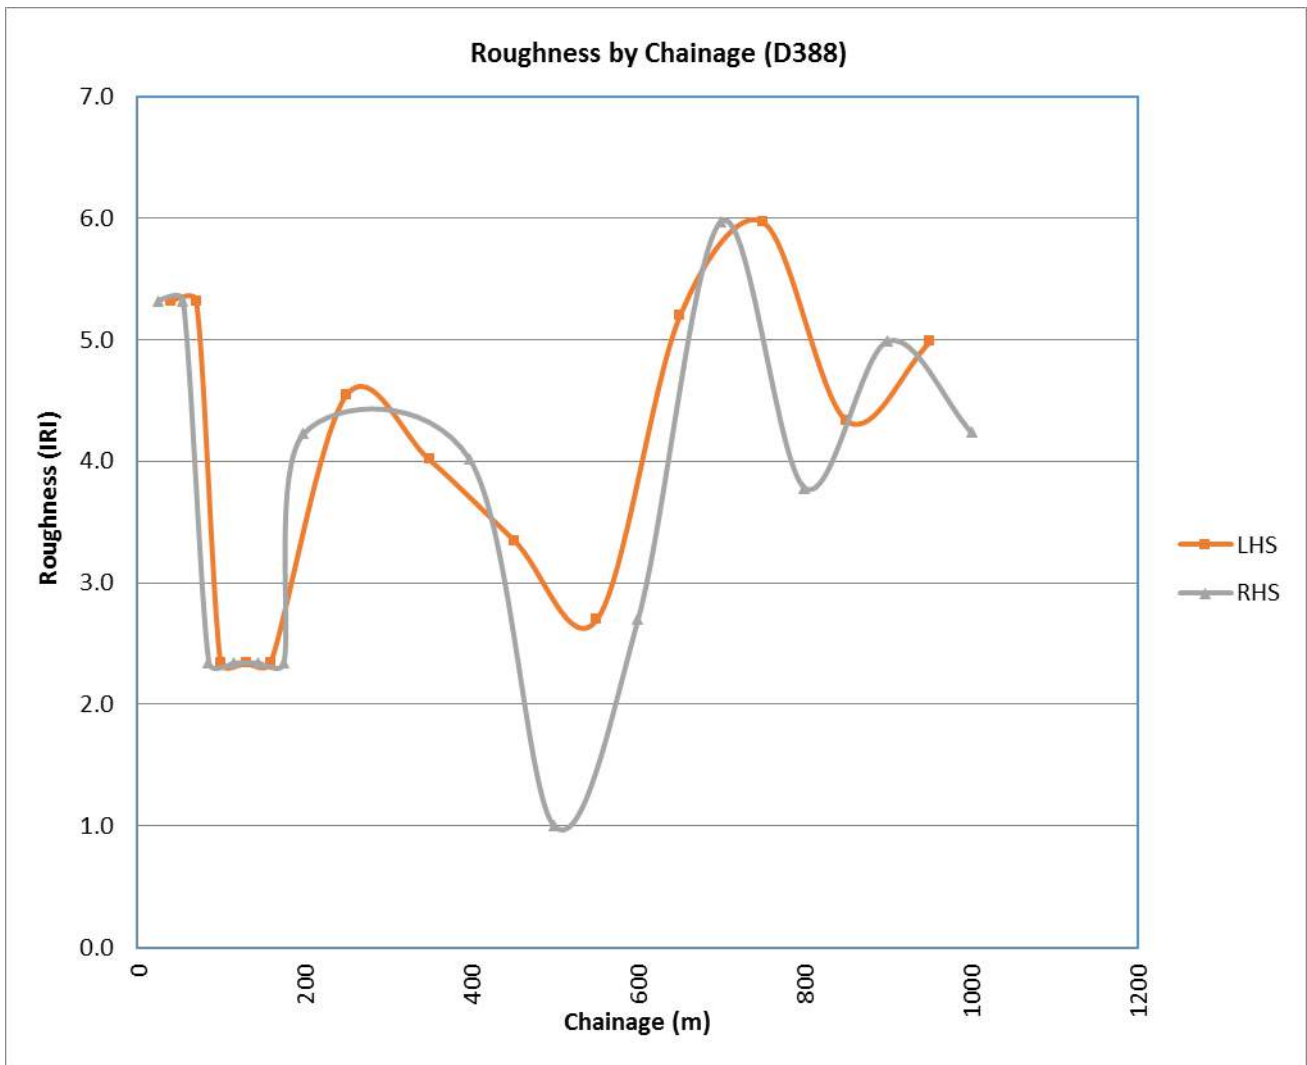
Figure 6-4: Roughness values including humps by chainage (D388)

Roughness values shown in Table 6-6 and Table 6-7 are acceptable for LVSRs. Figure 6-4 shows the roughness of each lane along the road section.

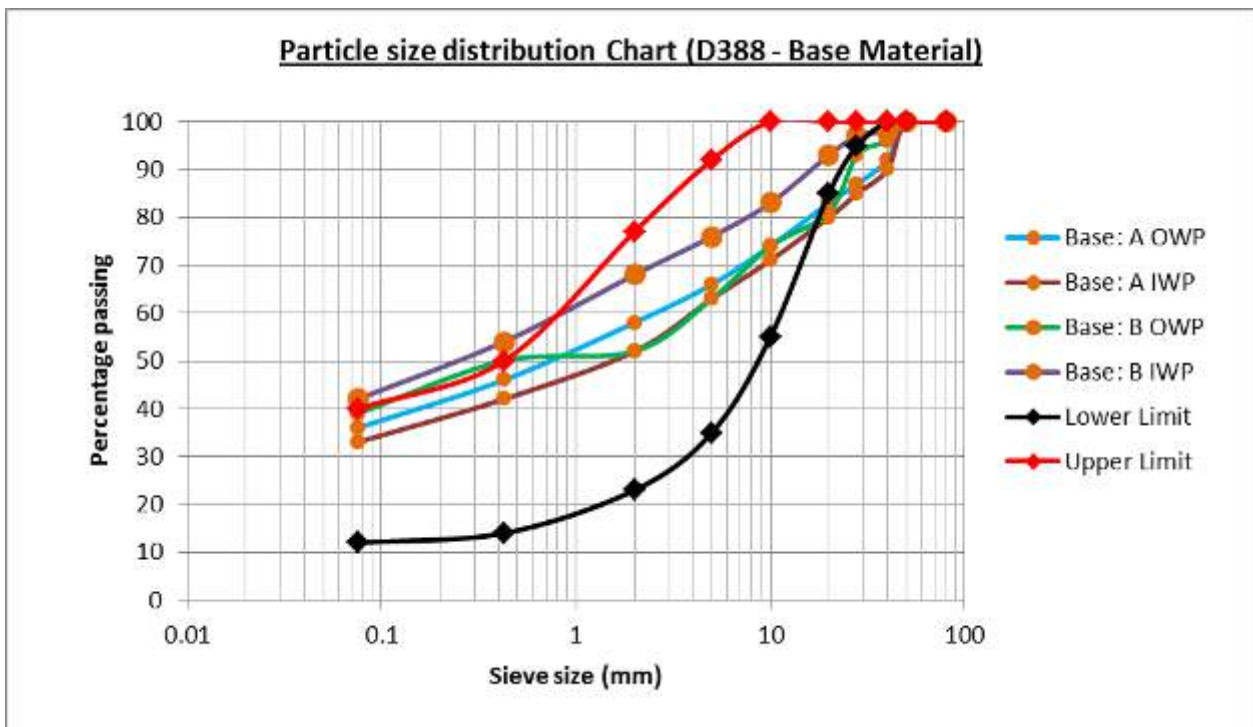
Figure 6-6: Particle size distribution for base material (D388)

The plots in Figure 6-6, Figure 6-7, and Figure 6-8 below show the particle size distribution for each layer. The base material generally fits into the ASTM D6913 specification envelope, except on the larger sieves, where the material is generally coarser.

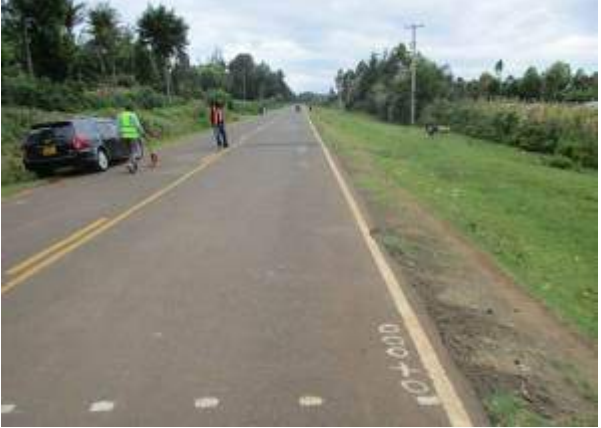
Fig No	Location (Km)	Defect assessment and description	Photos illustrating the pavement distress & defect
Fig 1	Km 0+000 – 0+010 RHS	Eroded and breaking edge at Km 0+007RHS

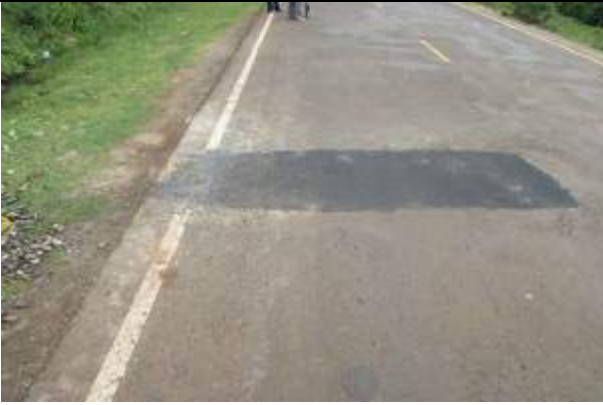
<p>Fig 9</p>	<p>Km 0+300 – 0+350 main carriage way</p>	<p>-Alligator cracks scattered all over the carriage way covering 100m long and 3m width</p> <p>-Bleeding on the LHS main carriage way</p>

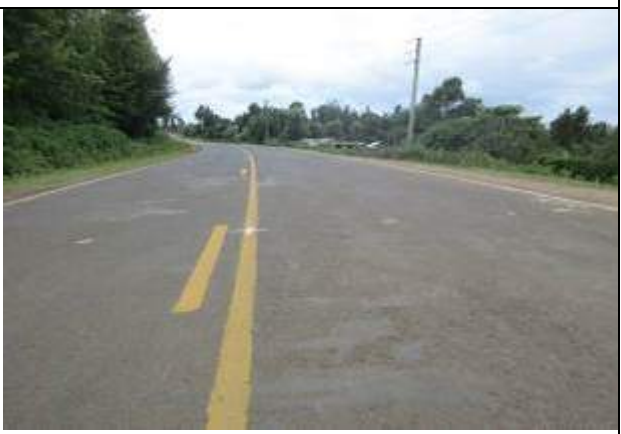
<p>Fig 13</p>	<p>Km 0+500 -0+600</p>	<p>-Alligator cracks all over the carriage way covering 100m long and 4m width especially on the centreline</p>

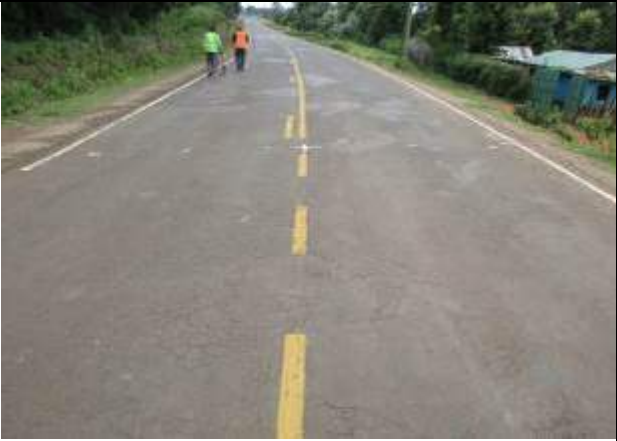
<p>A photograph showing a paved road with a yellow dashed centerline. The road surface is heavily cracked, particularly along the centerline, indicating alligator cracking. Two people are walking on the road in the distance.</p>
<p>Fig 14</p>	<p>Km 0+600 – 0+642 at the centreline</p>	<p>-Pothole developing at the centreline -Visible alligator cracks on the LHS carriage way</p>

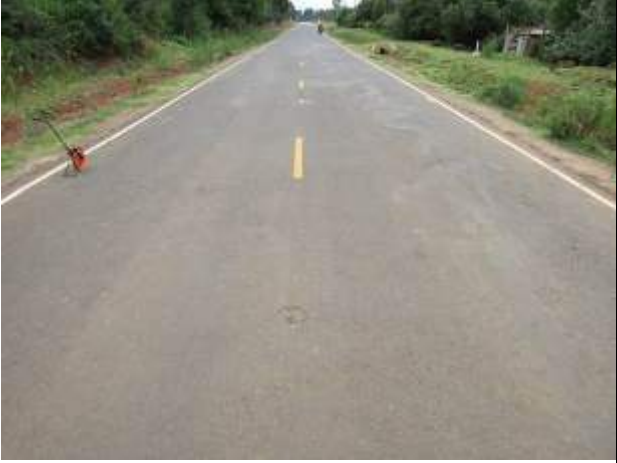
<p>A photograph of a paved road with a yellow dashed centerline. A pothole is visible in the centerline, and there are visible alligator cracks on the left-hand side (LHS) of the road. A person is standing on the left side of the road.</p>
<p>Fig 15</p>	<p>Km 0+683 – 0+816 main carriage way</p>	<p>-No visible defect on the main carriage way</p>

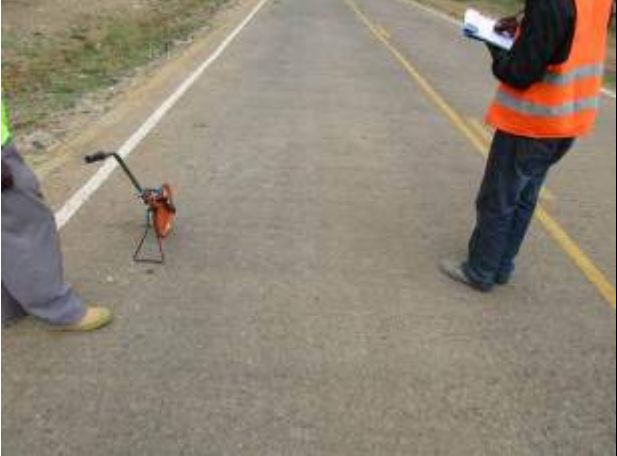
Fig 19	Km 0+963-0+990 LHS	-Transverse cracks on the concrete slab on LHS

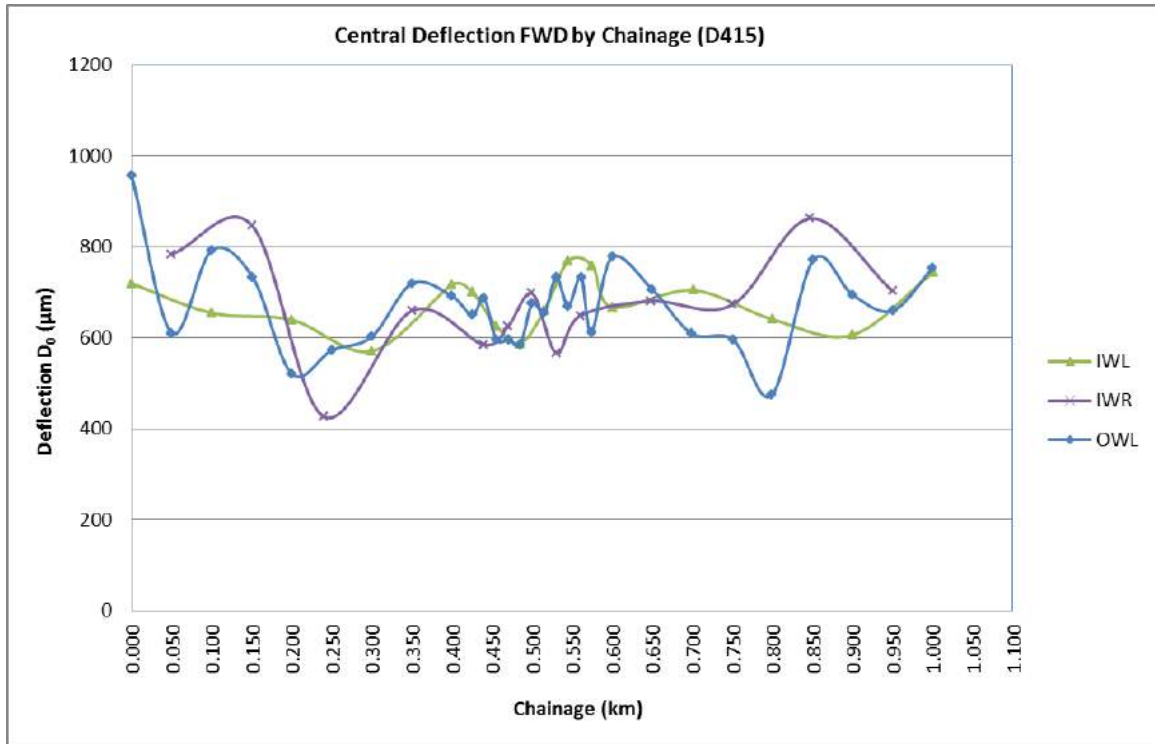
Figure 7-3: Central deflection by chainage (D415)

The complete deflection outputs from the FWD for all the sensors (D₀ up to D₆) for all the test locations are presented in the Appendix section of the report. Figure 7-3 shows a plot of the central deflection by chainage for each wheel path. The values are highly variable.

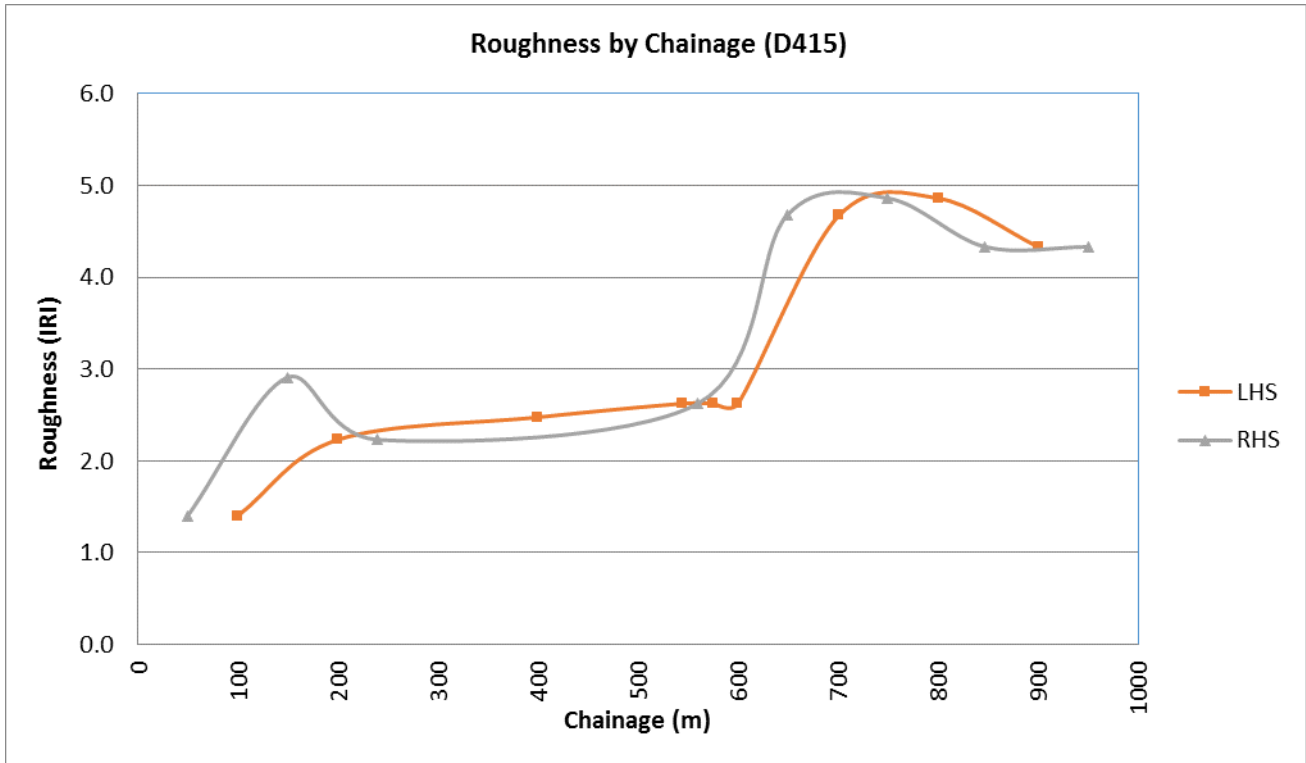
Figure 7-4: Roughness values including bumps by chainage (D415)

The roughness values in Table 7-6 and Table 7-7 are within the acceptable range for LVSRs. Figure 7-4 shows the roughness of each lane along the road section.

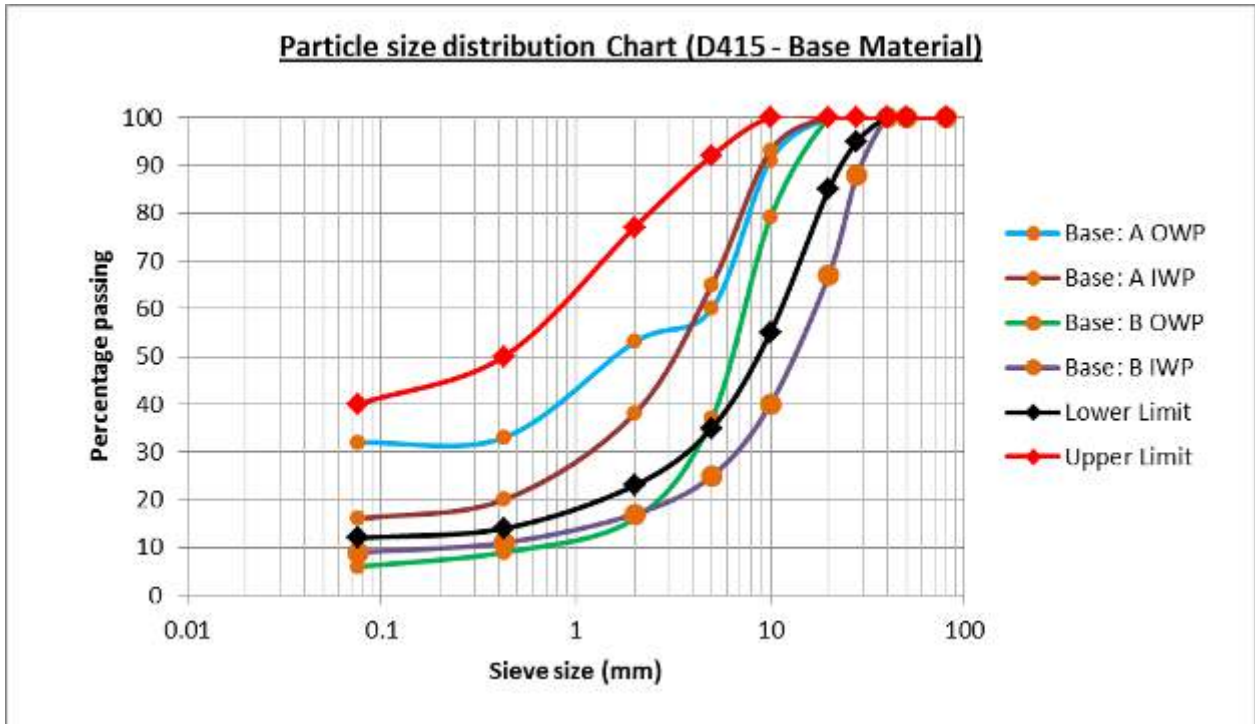
Figure 7-6: Particle size distribution for base material (D415)

The plots in Figure 7-6, Figure 7-7, and Figure 7-8 below show the particle size distribution for each layer. Except for one point, all the base materials lie within the ASTM D6913 specification envelope.

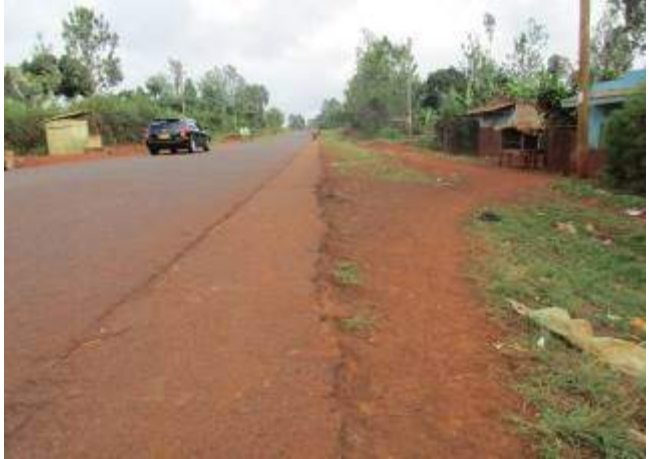
<p>Fig 14</p>	<p>Km 0+820 – 0+850 main carriage and RHS</p>	<p>-Alligator cracks on the LHS carriage way -Erosion on the side slope and shoulders</p>

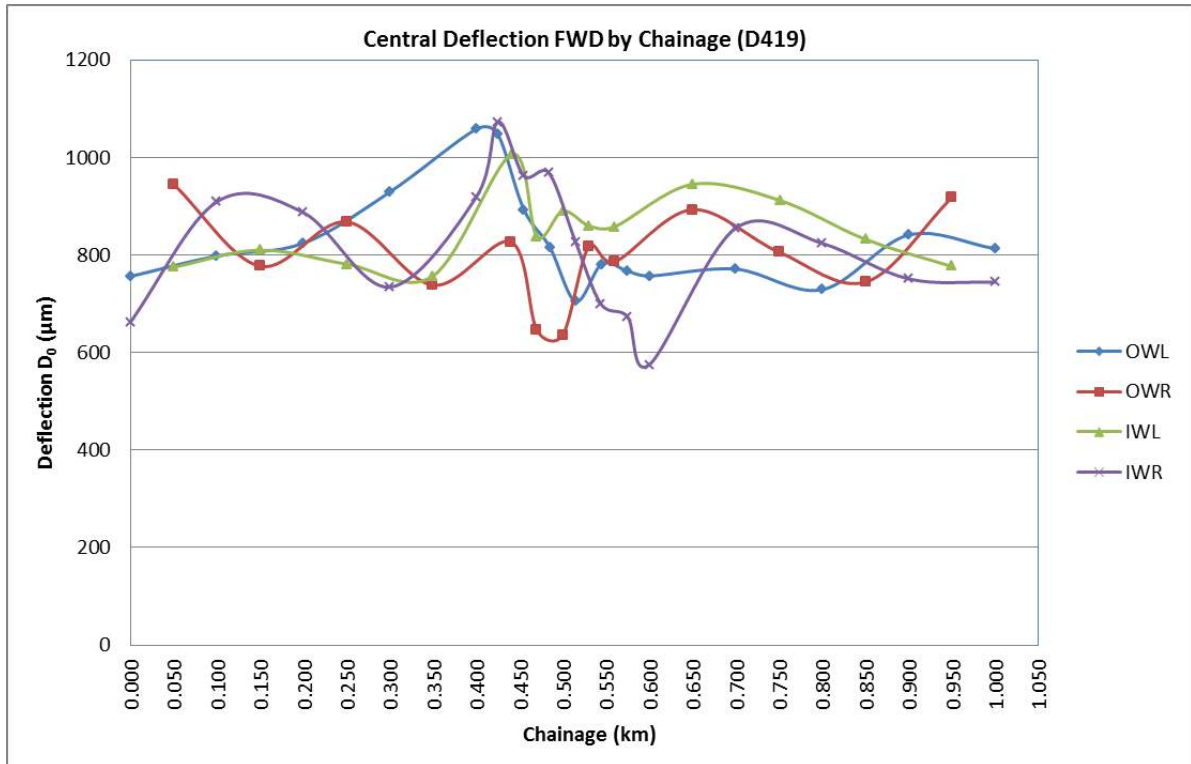
Figure 8-3: Central deflection by chainage (D419)

The complete deflection outputs from the FWD for all the sensors (D₀ up to D₆) for all the test locations are presented in the Appendix section of the report. Figure 8-3 shows the central deflection by chainage along each wheel path. The values are highly variable.

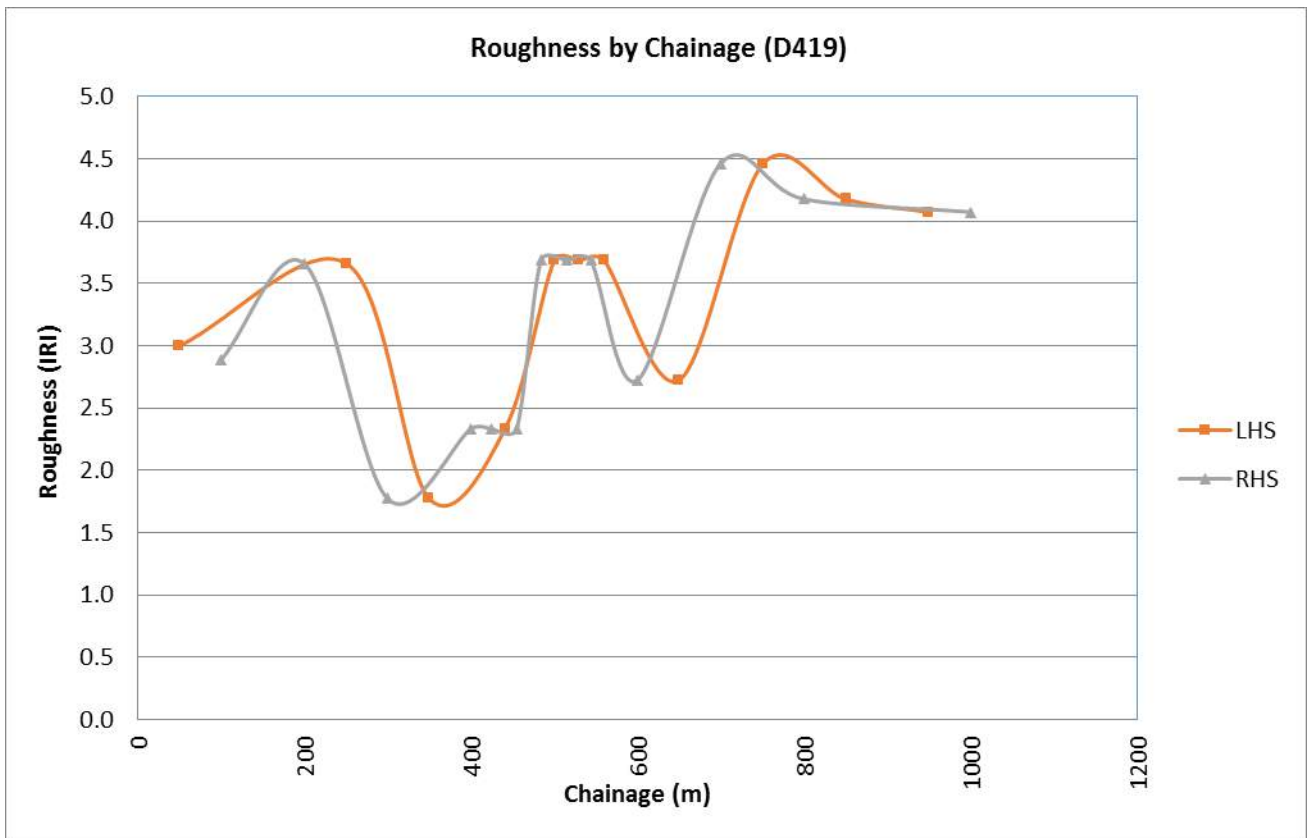
Figure 8-4: Roughness values including humps by chainage (D421)

The roughness values in Table 8-6 and Table 8-7 are within the expected values for LVSRs. Figure 8-4 shows the roughness of each lane along the road section.

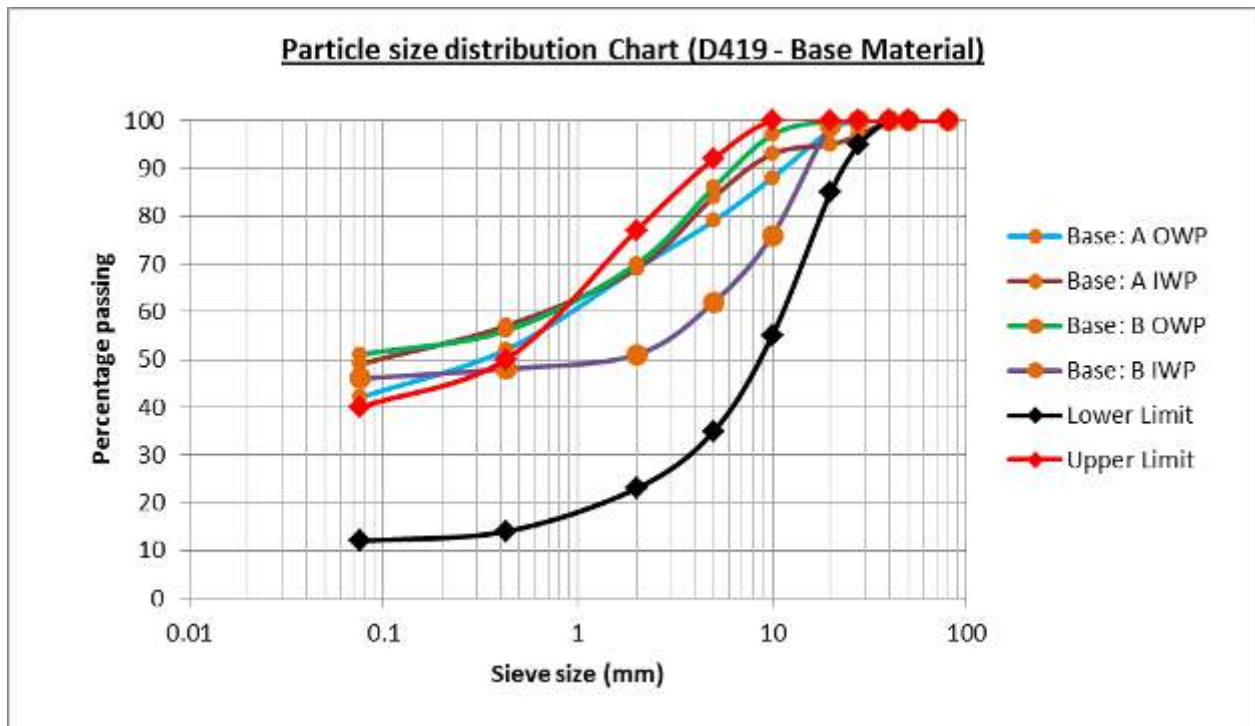
Figure 8-6: Particle size distribution for base material (D419)

The plots in Figure 8-6, Figure 8-7, and Figure 8-8 below show the particle size distribution for each layer. The base materials are generally finer than the ASTM D6913 specification envelope.

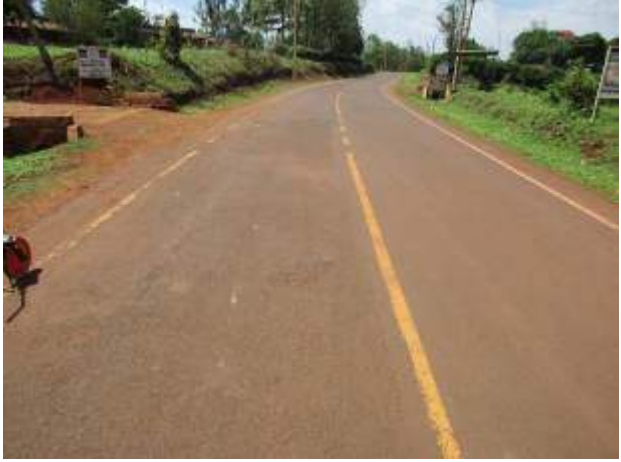
<p>Fig 5</p>	<p>Km 0+360-0+380 main carriage way</p>	<p>-Noticeable inconsistency in the mix</p>

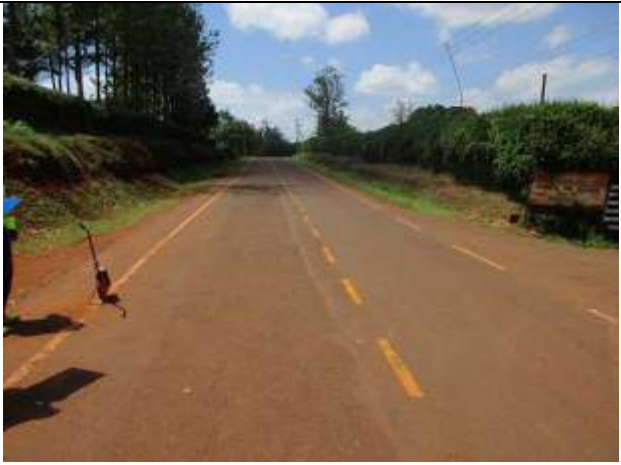
<p>Fig 6</p>	<p>Km 0+400 -0+420 RHS lane</p>	<p>-2No Potholes on the RHS carriage way approximate area of - 0.5m*0.5m (Area -0.25m²) and 0.3m*0.5m (Area 0.15m²) respectively on both outer and inner wheel path</p> <p>-The mix used appears too coarse</p>

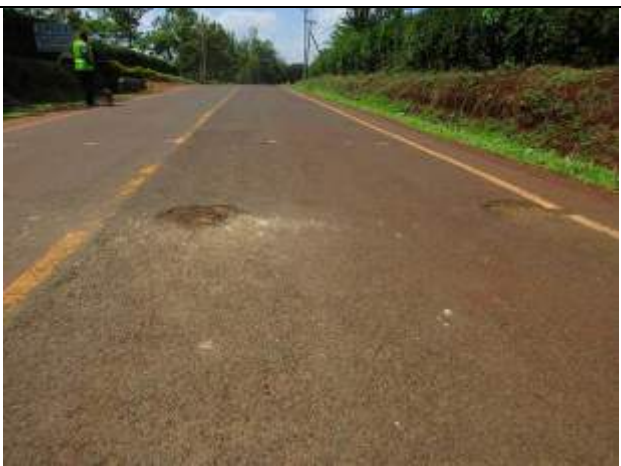
<p>Fig 7</p>	<p>Km 0+479 RHS</p>	<p>1No Pothole at the inner wheel path covering 0.6m by 0.5m with a depth of 65mm</p>

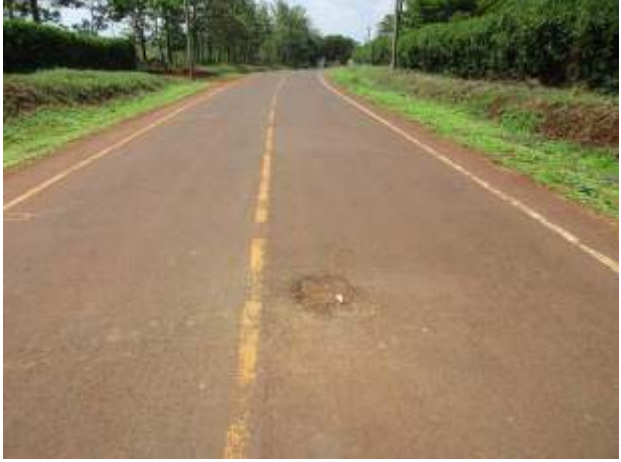
<p>Fig 8</p>	<p>Km 0+560 LHS</p>	<p>-Pothole developing on the LHS carriage way at inner wheel path</p>

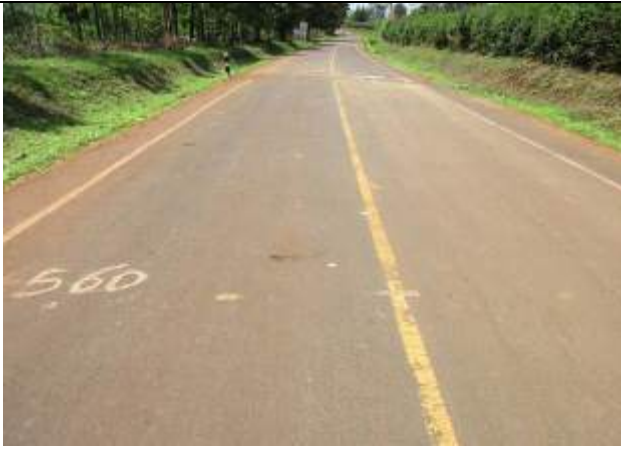
<p>Fig 9</p>	<p>Km 0+693RHS</p>	<p>-Pothole developing on the RHS carriage way at inner wheel path</p>

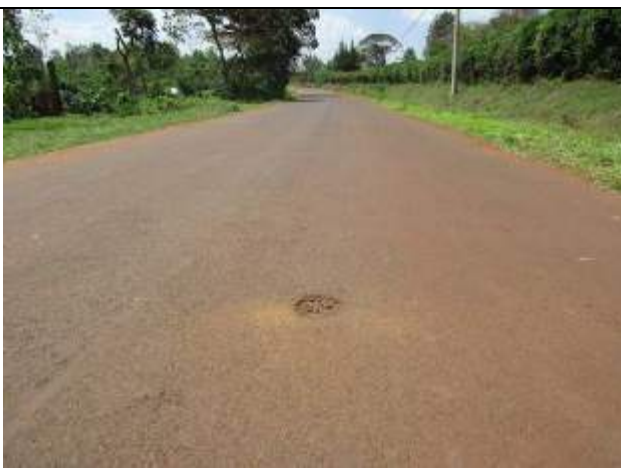
<p>Fig 10</p>	<p>Km 0+600 main carriage way</p>	<p>-No road marking starting from 0+600 main carriage way</p>

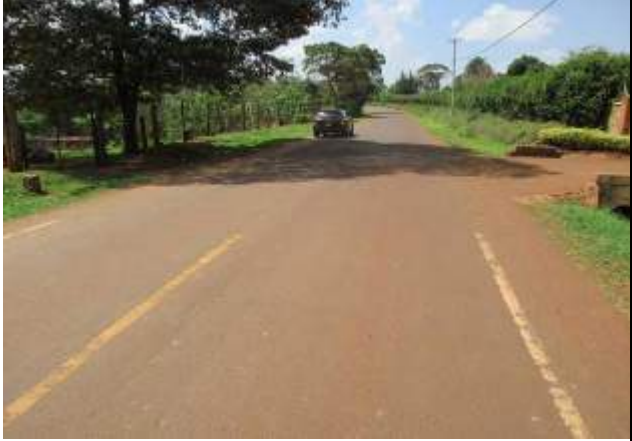
<p>Fig 11</p>	<p>Km 0+675 -0+690 RHS</p>	<p>-Silted and blocked with vegetation</p>

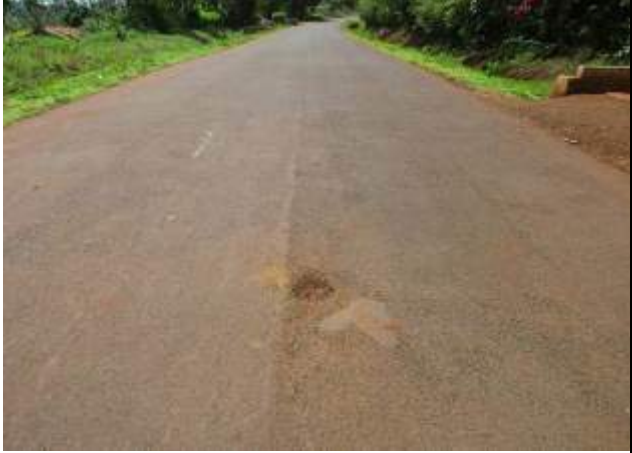
<p>Fig 14</p>	<p>Km 0+889 RHS</p>	<p>-Silted side drain and access culvert</p>

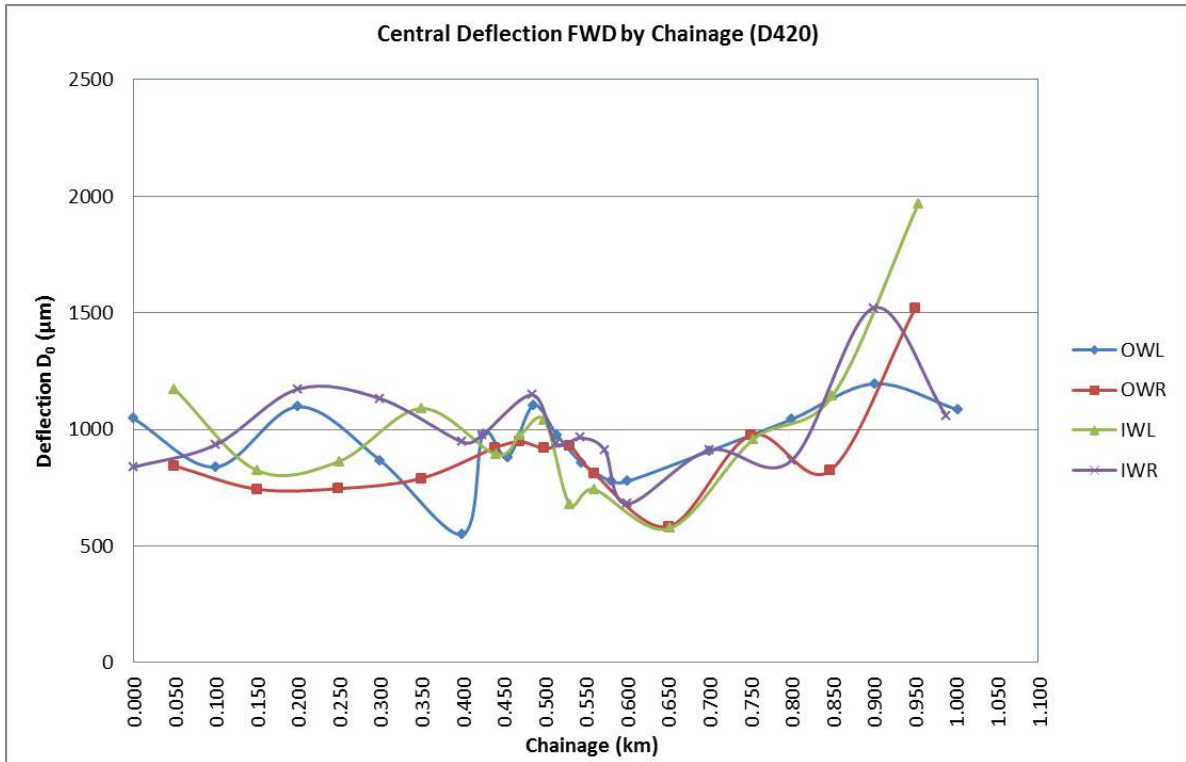
Figure 9-3: Central deflection by chainage (D420)

All the deflection outputs from the FWD for all the sensors (D_0 up to D_6) for all the test locations are presented in the Appendix section of the report. Figure 9-3 shows a lot of the central deflection of each wheel path along the road. There is high variability in the central deflection.
