ReCAP
Research for Community Access Partnership

Baseline Survey Report for 11 Low-Volume Sealed Roads in Kenya

Final Report

AFCAP Project – KEN2043C

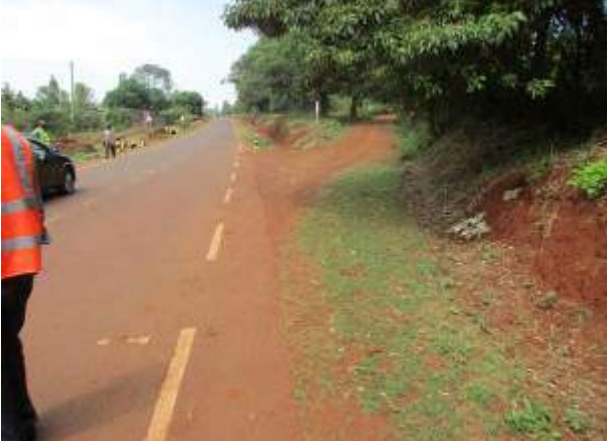
<p>Fig 4</p>	<p>Km 0+100 – 0+126 RHS</p>	<p>-Water crossing over the carriage way due to blocked drain</p> <p>-Blocked and silted side drain</p>

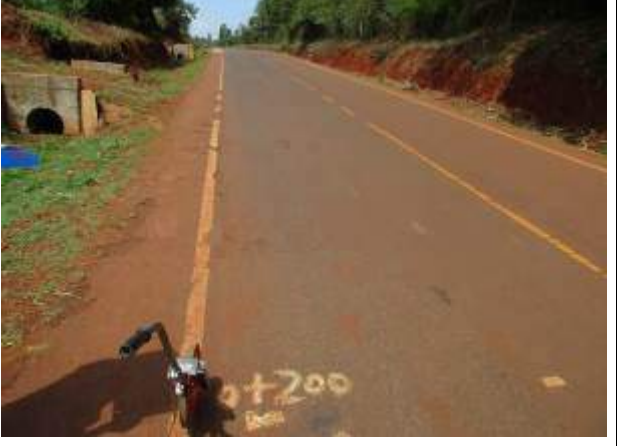
<p>Fig 6</p>	<p>Km 0+200 – 0+230 LHS</p>	<p>-Localized disintegration of ac layer leading to the potholes on the LHS carriage way on the shoulders and outer wheel path</p> <p>-Silted side drain and access culvert</p>

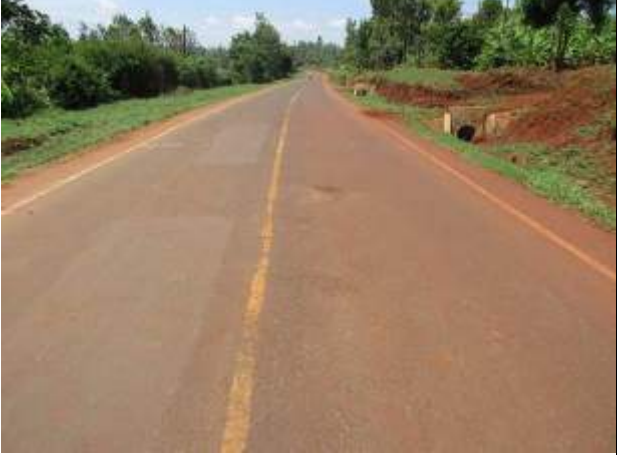
<p>Fig 7</p>	<p>Km 0+455RHS</p>	<p>-Potholes on the RHS lane on the inner wheel a path covering 100mm by 50mm</p> <p>-Surface appears rough and course</p>

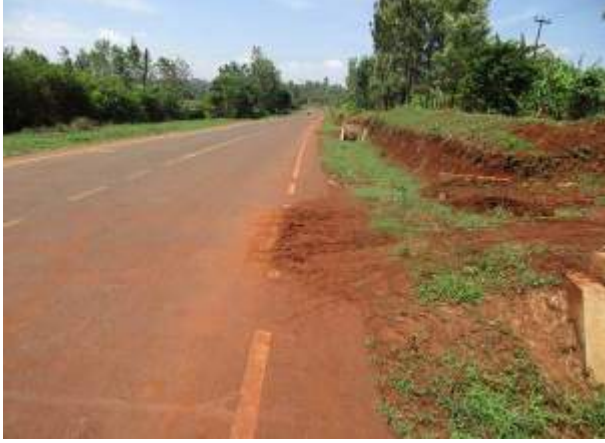
<p>Fig 8</p>	<p>Km 0+660-0+665LHS</p>	<p>-Silted shoulders and edge extending to main carriage way</p> <p>-Soaking of the shoulders and edge with erosion deposits from a poorly placed access culvert</p>

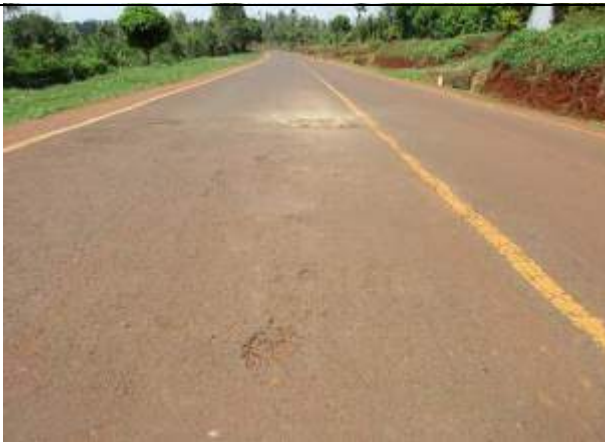
<p>Fig 9</p>	<p>Km 0+716 -0+750 LHS lane</p>	<p>-Disintegration and alligator cracks of asphalt layer leading ravelling, potholes, stripping and crack sealing done on the carriage way Km 0+716-0+750</p>

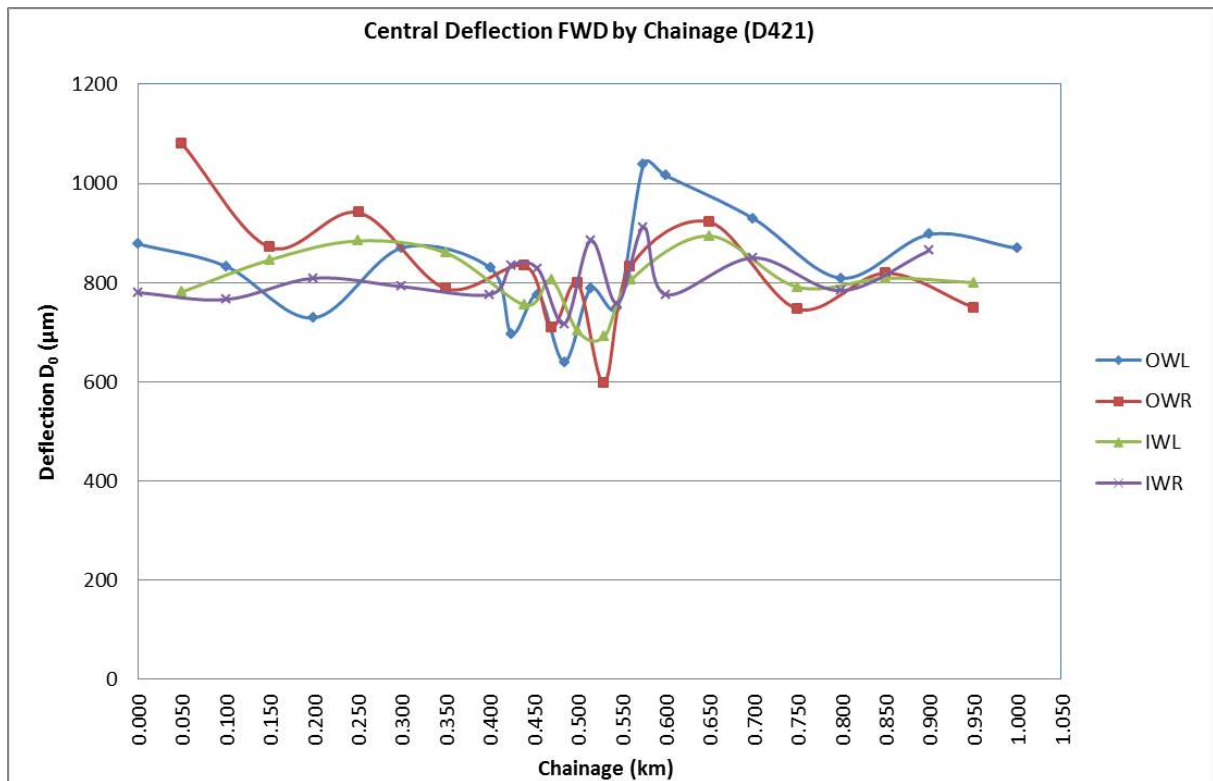
Figure 10-3: Central deflection by chainage (D421)

All the deflection outputs from the FWD for all the sensors (D_0 up to D_6) for all the test locations are presented in the Appendix section of the report. Figure 10-3 shows the central deflection for each wheel path along the road. The deflection shows a high variability as for all the previous roads.

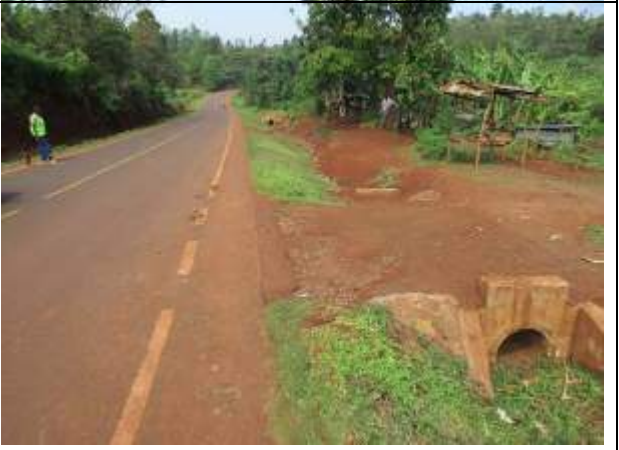
<p>Fig 6</p>	<p>Km 0+754 – 0+758 RHS</p>	<p>-Blocked and silted side drain and access culvert</p>

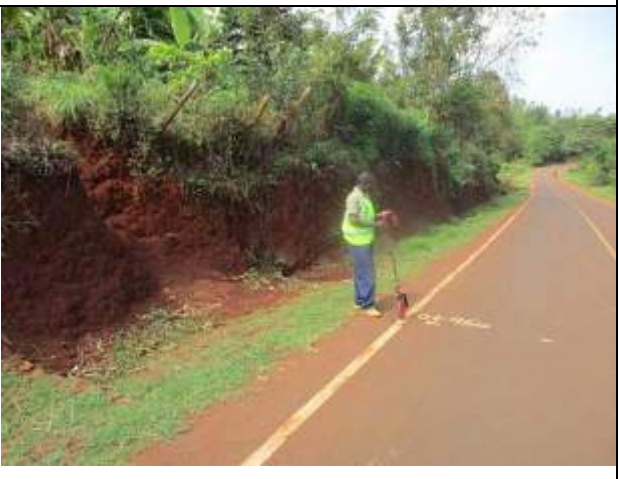
<p>Fig 7</p>	<p>Km 0+850 – 0+950 LHS</p>	<p>Silted due to the collapsing side slope</p>

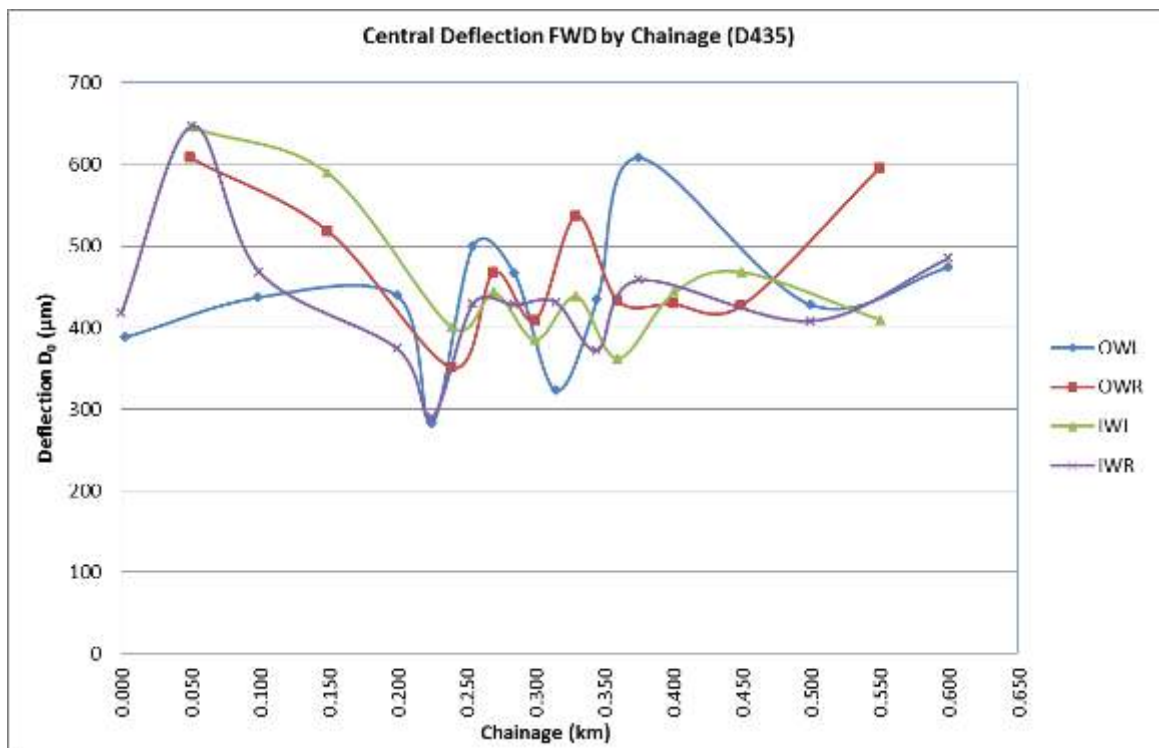
Figure 11-3: Central deflection by chainage (D435)

All the deflection outputs from the FWD for all the sensors (D_0 up to D_6) for all the test locations are presented in the Appendix section of the report. Figure 11-3 shows a plot of the central deflection for each wheel path along the road. The deflection values are highly variable with chainage.

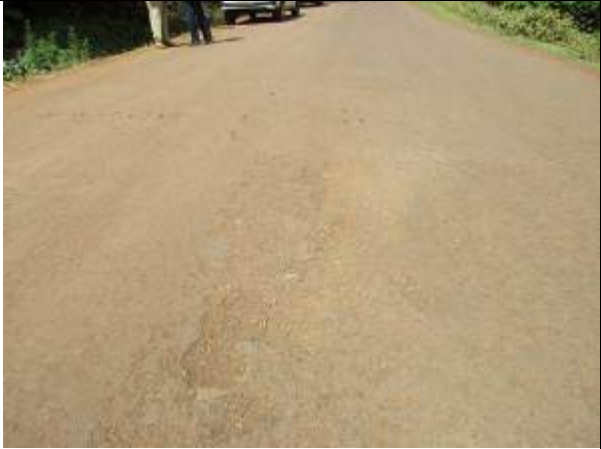
Fig No	Location (Km)	Defect assessment and description	Photos illustrating the pavement distress & defect
Fig 1	Km 0+028 – 0+030 at the centreline	-Localized loss of the asphalt concrete layer -Pothole covering an area of about (1.2m*1.0 m)1.2m ²

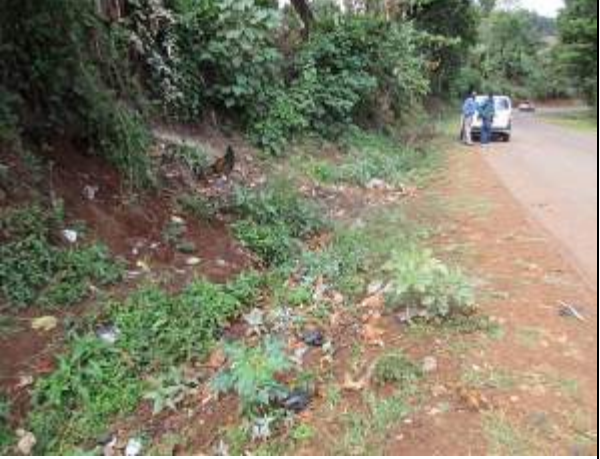
<p>Fig 2</p>	<p>Km 0+015- 0+057LHS drain</p>	<p>-Blocked and silted with waste debris</p>

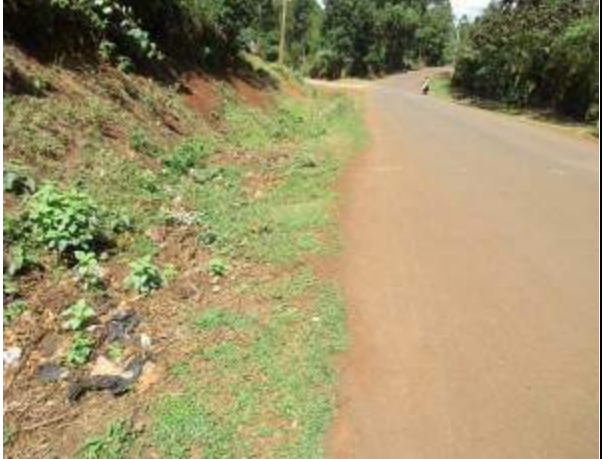
<p>Fig 5</p>	<p>Km 0+058 – 0+150LHS drain</p>	<p>-Blocked and silted on the LHS drain</p>

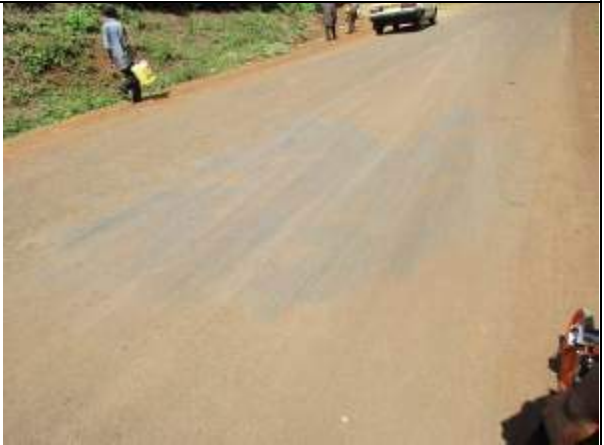
<p>Fig 6</p>	<p>Km 0+177 RHS</p>	<p>-Slight bleeding on the surface inner wheel path and extending to the centreline</p>

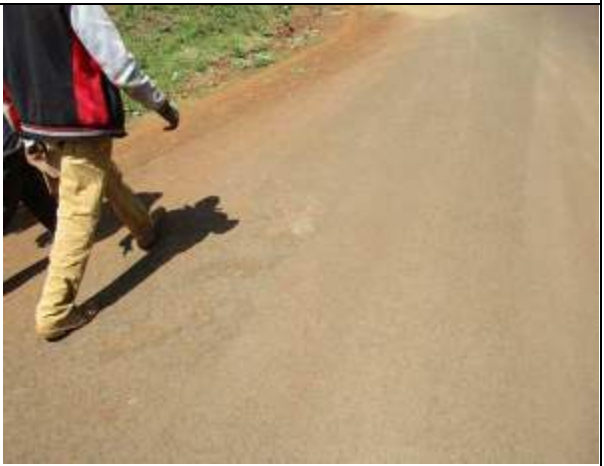
<p>Fig 7</p>	<p>Km 0+180 RHS</p>	<p>-Localized loss of the asphalt concrete layer</p> <p>-Pothole covering an area of about (1.2m*1.0 m)1.2m²</p> <p>-Potholes developing on the carriage way -the surface texture looks very coarse</p>

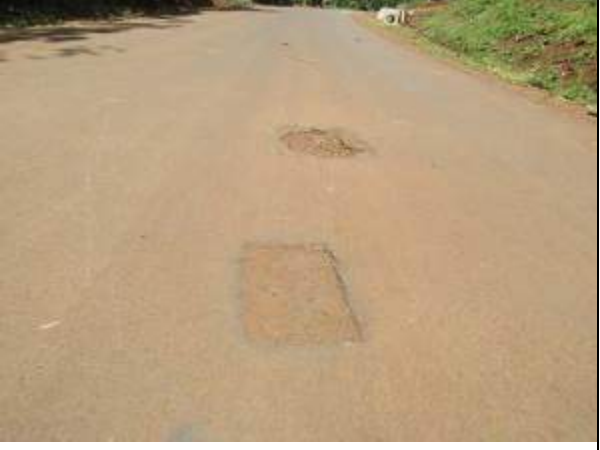
<p>Fig 8</p>	<p>Km 0+235RHS lane</p>	<p>-2no -Potholes on outer wheel path -approximate area of about A (1.6m*0.5m) and a depth 60mm</p>

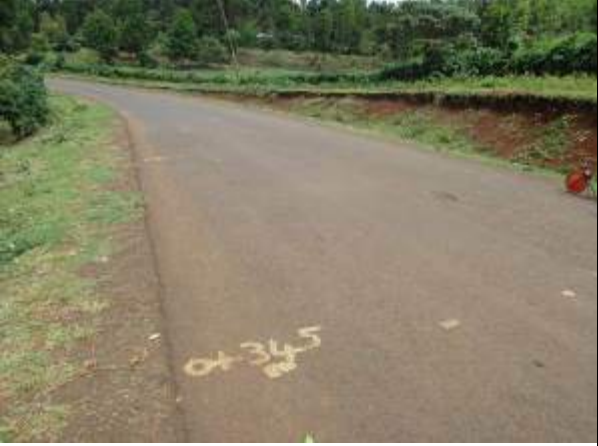
<p>Fig 11</p>	<p>Km 0+357 RHS</p>	<p>-Pothole on the outer wheel path</p>

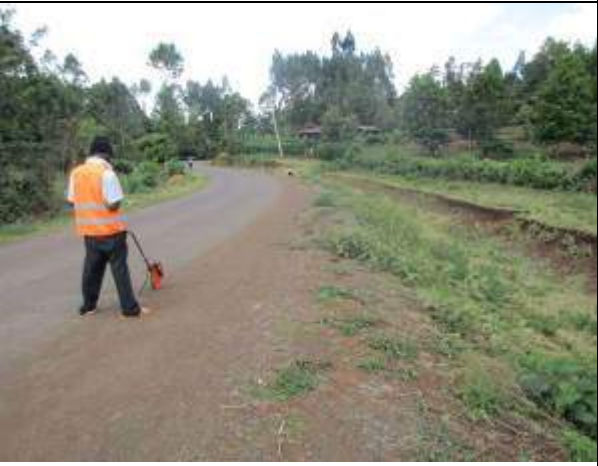
<p>Fig 12</p>	<p>Km 0+375 – 0+400 RHS lane</p>	<p>-Erosion deposits on shoulders hindering free flow of water to side drain km 0+375 - 0+400</p>

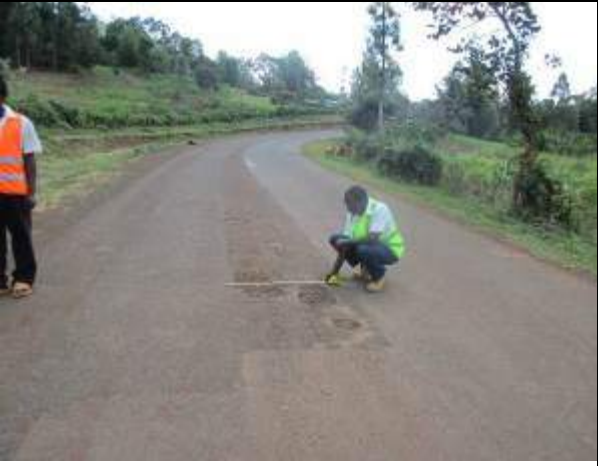
<p>Fig 13</p>	<p>Km 0+400 – 0+455 RHS</p>	<p>-3No potholes on carriage way coving (1.0m*1.5m) m2</p> <p>-Ravelling and extensive loss of surface texture leading to the development of potholes on the surface</p>

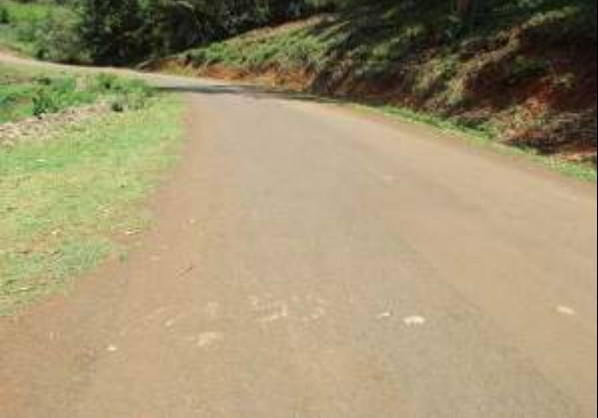
<p>Fig 14</p>	<p>Km 0+520 – 0+540 LHS main carriage way</p>	<p>-The surface texture looks very coarse</p>

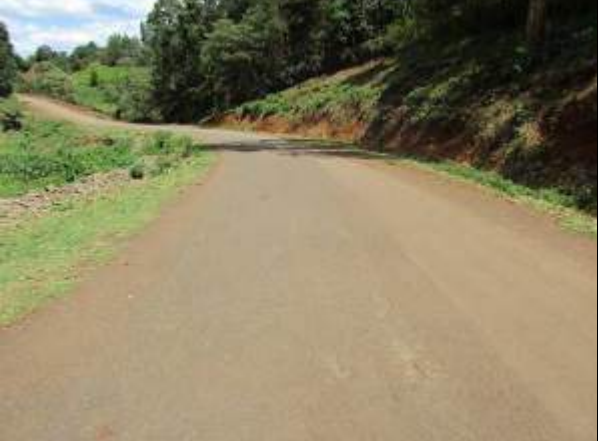
<p>Fig 15</p>	<p>Km 0+530 – 0+550 main carriage way</p>	<p>-The surface texture looks very coarse especially on LHS lane -No side drain on the LHS</p>

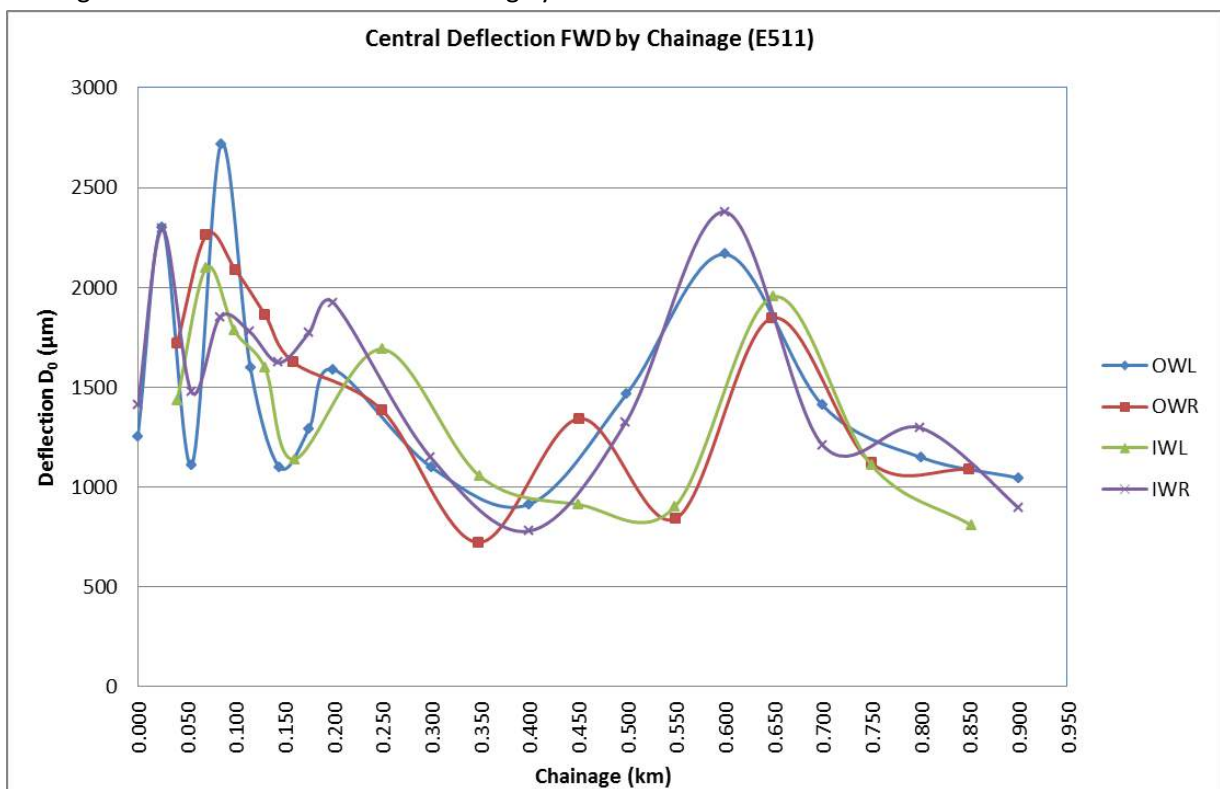
Figure 12-3: Central deflection by chainage (E511)

The entire deflection outputs from the FWD for all the sensors (D_0 up to D_6) for all the test locations are presented in the Appendix section of the report. Figure 12-3 shows the central deflection for each wheel path along the road section. The values are highly variable.

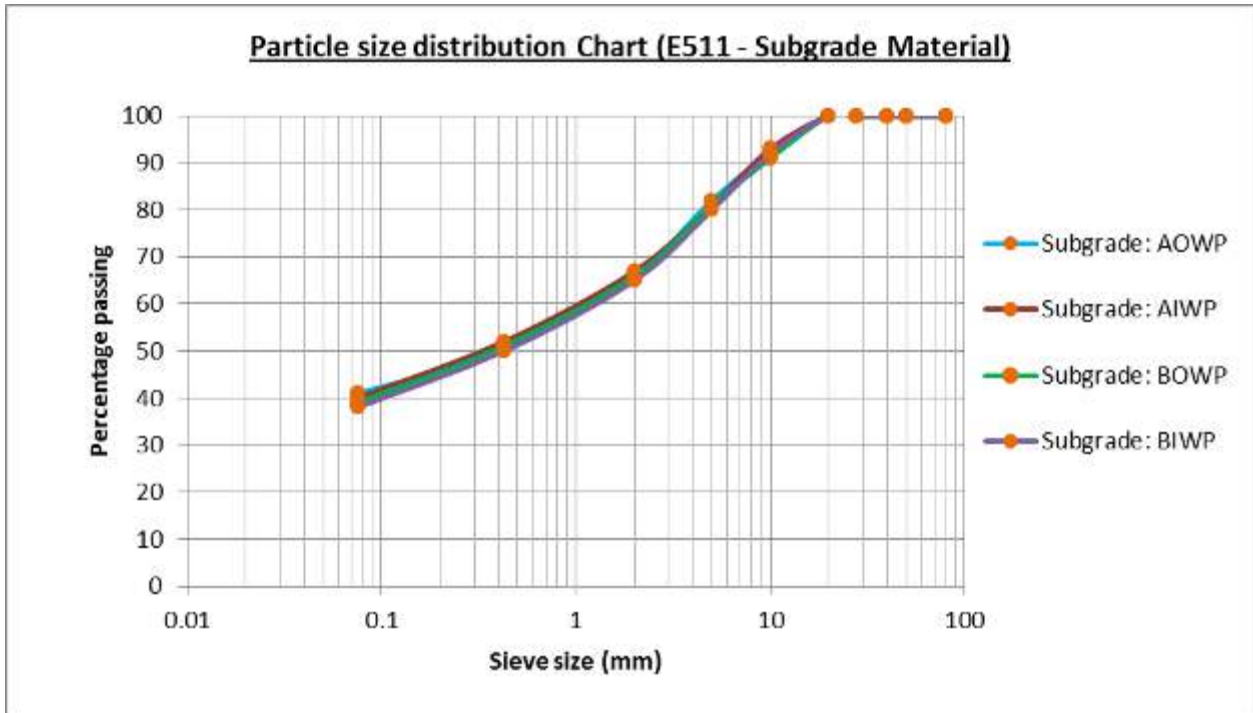
Figure 12-8: Particle size distribution for subgrade material (E511)

The plots in Figure 12-6, Figure 12-7, and Figure 12-8 show the particle size distribution for each layer. The base materials fit within the ASTM D6913 specification envelope. At Pit B, OWP, the material is gap graded at 2 – 5 mm sieves.

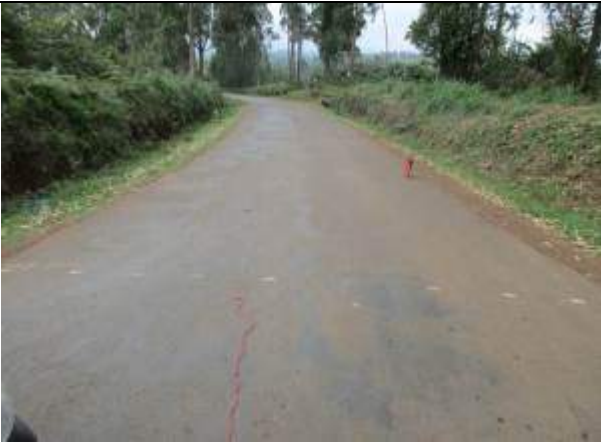
Fig No	Location (Km)	Defect assessment and description	Photos illustrating the pavement distress & defect
Fig 1	Km 0+000 – 0+050 centreline	-Bleeding on the main carriage way at the centreline

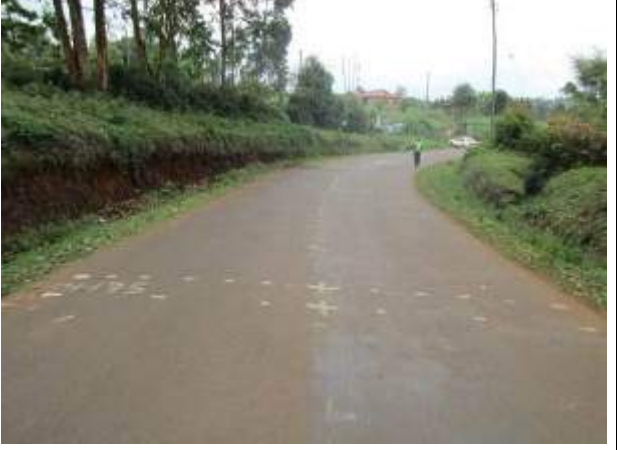
<p>Fig 5</p>	<p>Km 0+060 – 0+175 RHS main carriage way</p>	<p>-Bleeding on the inner wheel path on the RHS lane</p>

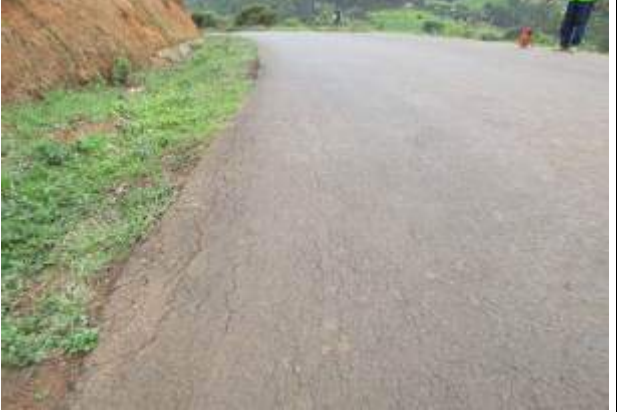
<p>Fig 8</p>	<p>Km 0+030 - 0+320LHS</p>	<p>-Extensive alligator cracks on the outer wheel path causing deformation and alligator cracks at the edge</p> <p>-Silted side drain hindering free flow of water along the drain and enhancing accumulation of deposits</p>

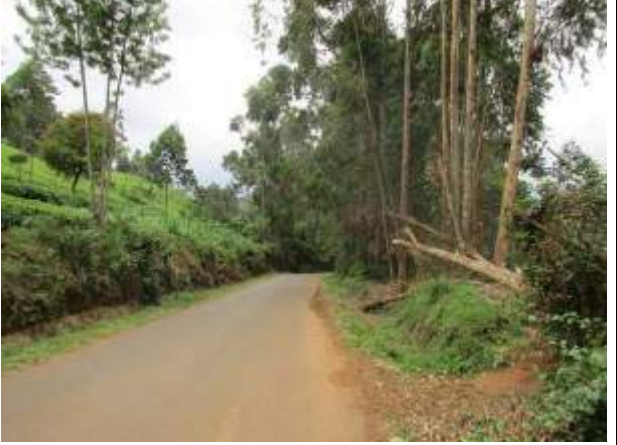
<p>Fig 11</p>	<p>Km 0+533 – 0+600 both sides</p>	<p>-Blocked and silted with waste debris side drain</p>

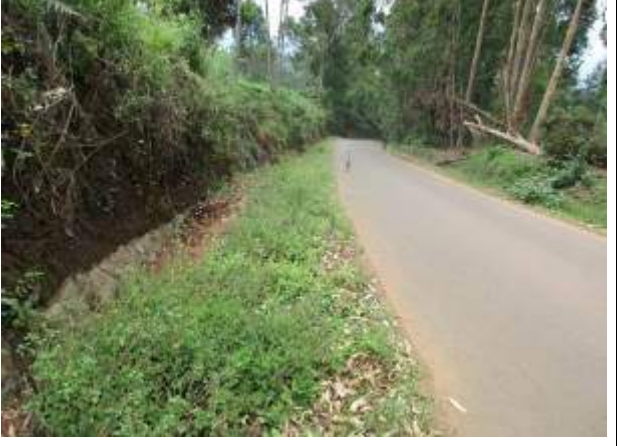
<p>Fig 12</p>	<p>0+601 – 0+613 LHS</p>	<p>-Silted side drain and Vegetated side slope allowing the accumulation of erosion deposits on shoulders and edge</p>

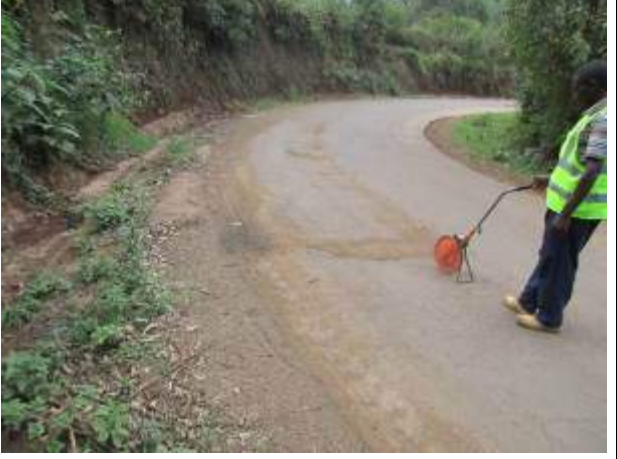
<p>A photograph showing a paved road with a significant collapse of the left side slope. The collapsed earth is piled up against the road edge, partially blocking the side drain. The soil is reddish-brown.</p>
<p>Fig 16</p>	<p>Km 0+768 – 0+800 main carriage way</p>	<p>-Pavement deformation, depression and failure</p>

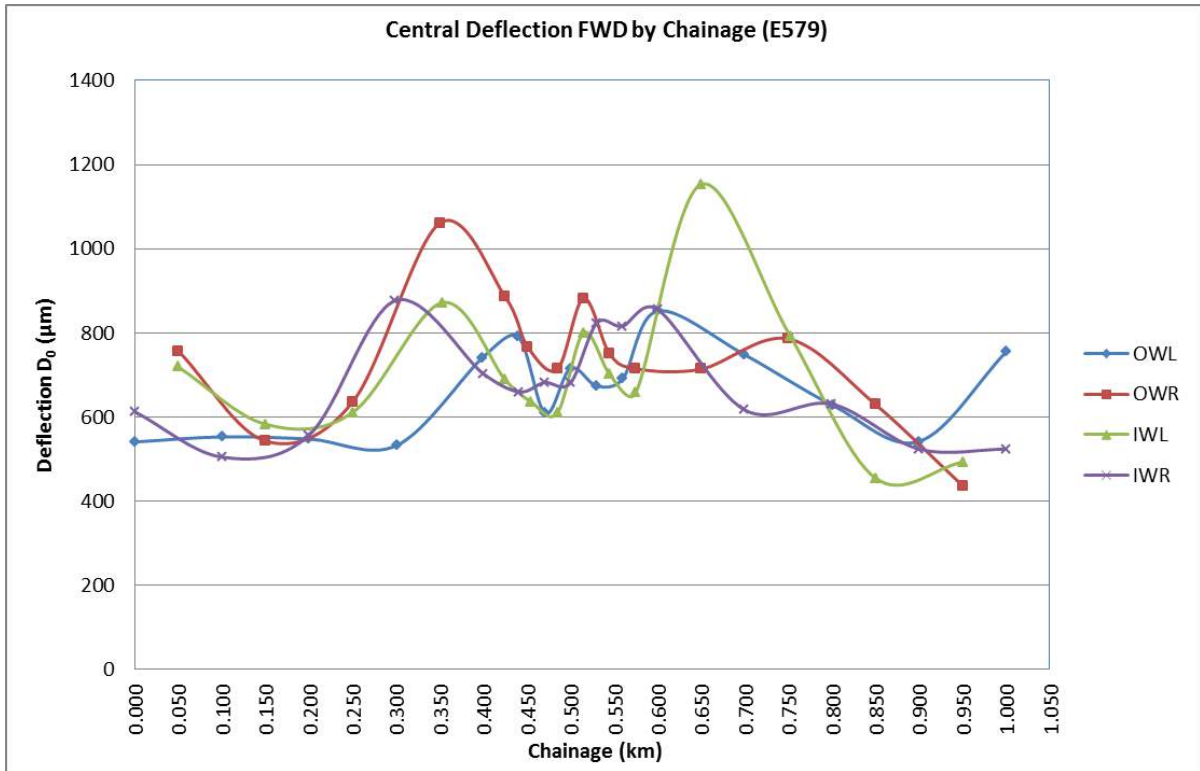
Figure 13-2: Central deflection by chainage (E579)

All the deflection outputs from the FWD for all the sensors (D_0 up to D_6) for all the test locations are presented in the Appendix section of the report. Figure 13-2 shows the central deflection of each wheel path along the road. The values are highly variable.

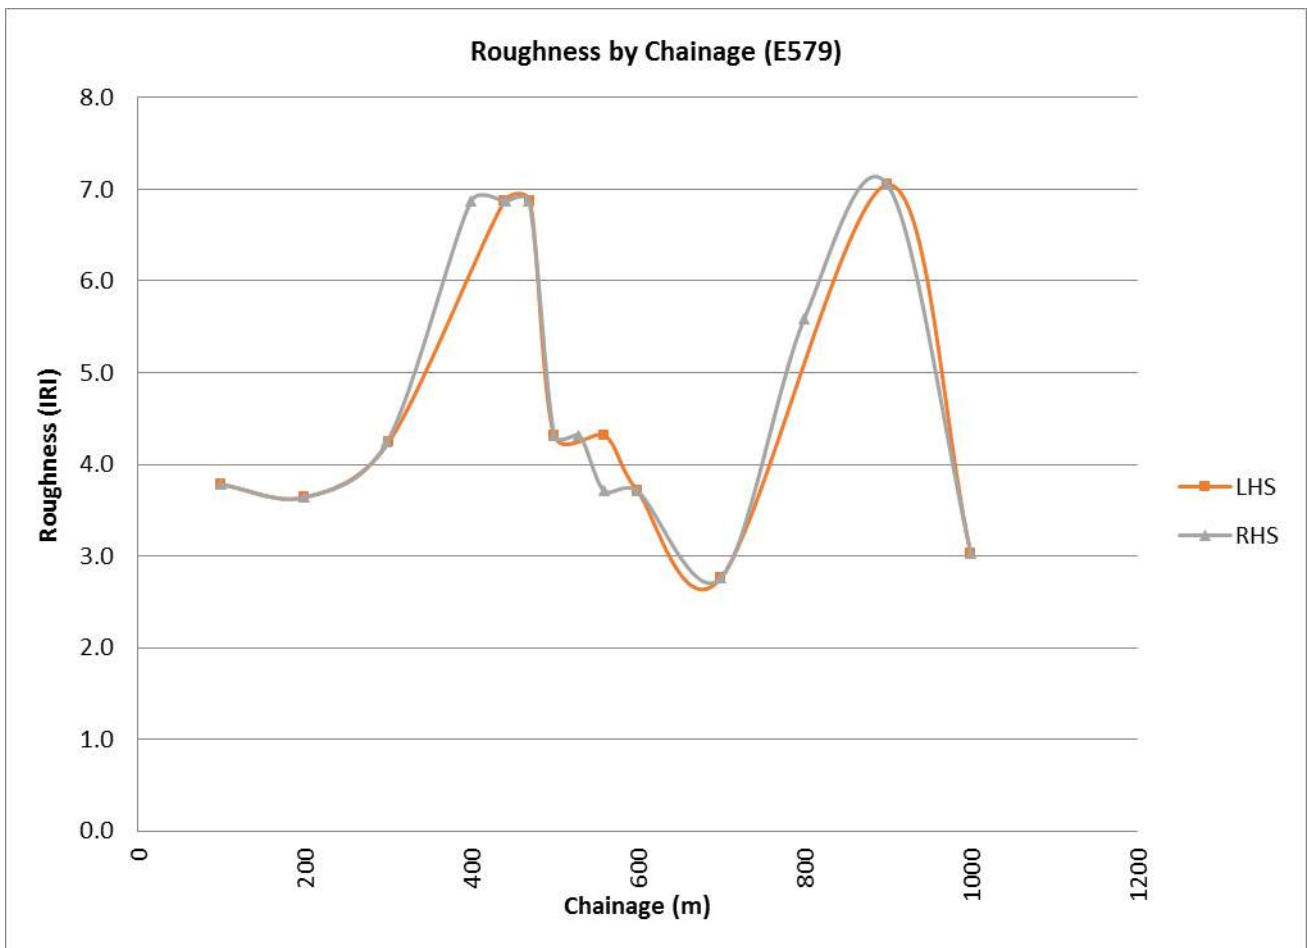
Figure 13-3: Roughness values including humps by chainage (E579)

The roughness values are shown in Table 13-7 and Table 13-8. The former includes values with humps and the latter values where hump locations have been subjectively removed. The values are within the range expected for LVSRs. Figure 13-3 shows the roughness of each lane along the road section.

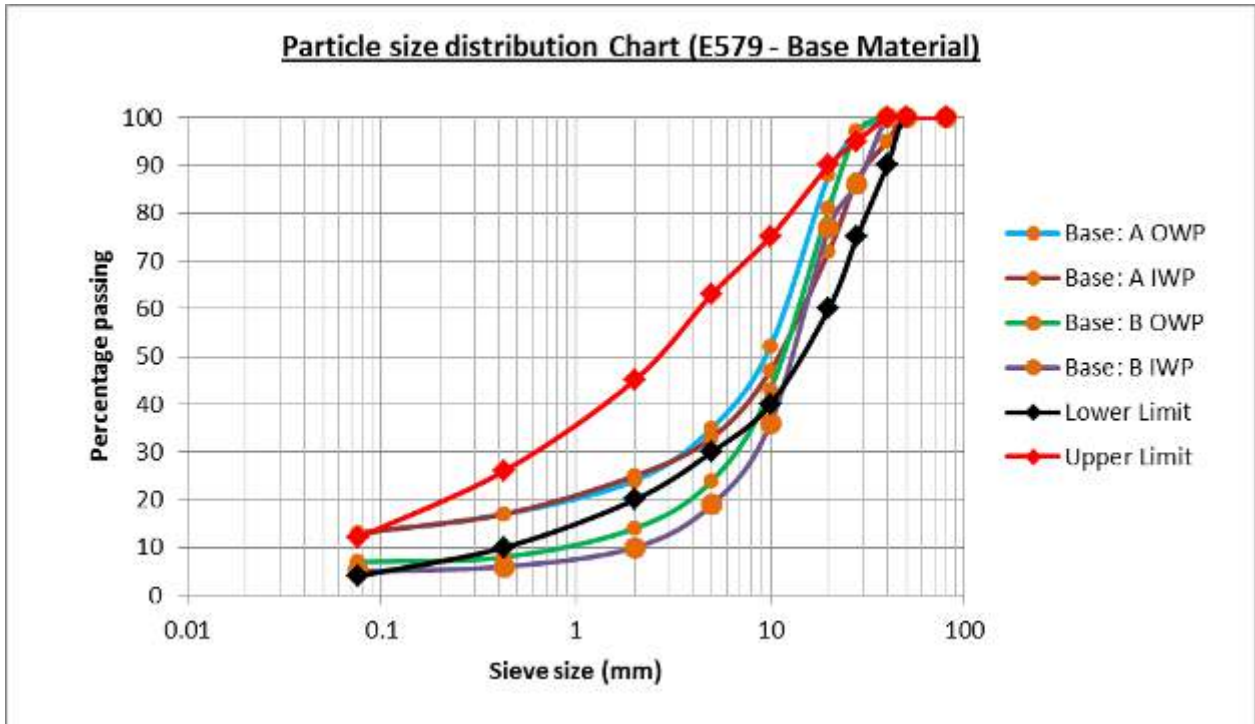
Figure 13-5: Particle size distribution for base material (E579)

The plots in Figure 13-5, Figure 13-6, and Figure 13-7 below show the particle size distribution for each layer. The base materials mostly lie outside the ASTM D6913 specification envelope.
