SEACAP 24

CASE STUDY OF DAK LAK RRST PAVEMENT AND SURFACE DETERIORATION

SEACAP 24 is concerned primarily with research into the premature failure of two RRST-II trial roads in Dak Lak province – Boun Ho and Ea Soup.

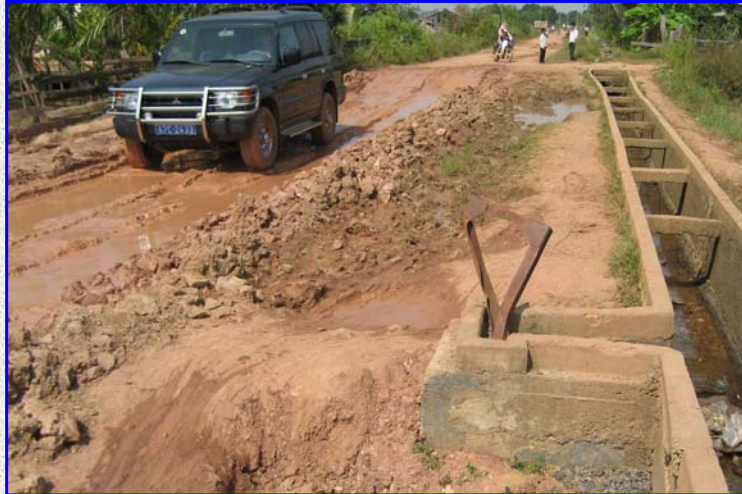
Ea Soup Road

The work undertaken was similar to Boun Ho with investigation pits, sampling, testing and visual condition surveying, with the principal difference being that the investigation was concentrated on a specific length of Ea Soup road from Ch 3+000 to Ch4+000 which had suffered severe deterioration since completion in June 2006.

An irrigation ditch had been heightened very shortly after the construction of the Trial road, so that the water in this channel was above road level in the crucial section. No provision had been made for drainage of water leaking from this channel – hence water was able to soak the sub-grade and flood the macadam sub-base

It is our opinion that the primary cause of the failure of the section of Ea Soup road was the weakening of the sub-base and sub-grade due to soaking by a high water table resulting from leakage from a recently constructed irrigation channel.
