Training-of-Trainers Programme for participants from Ghana, Sierra Leone and Liberia in the use of the DCP-DN Pavement Design Method

Construction Report 2

AFCAP Project Reference: GHA2100A

March 2018

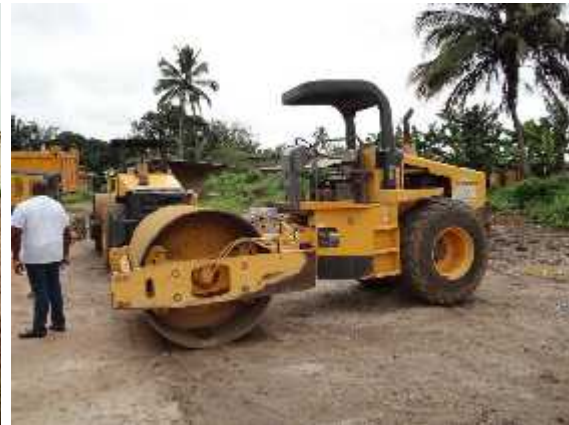
Figure 3: One of the two 10-ton vibrating rollers

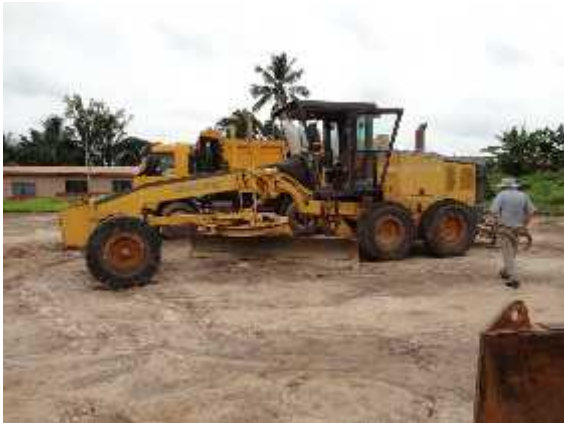
Figure 4: One of the two graders

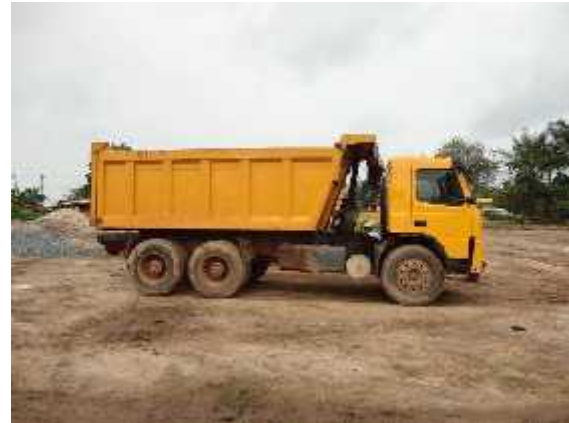
Figure 5: One of five tipper trucks

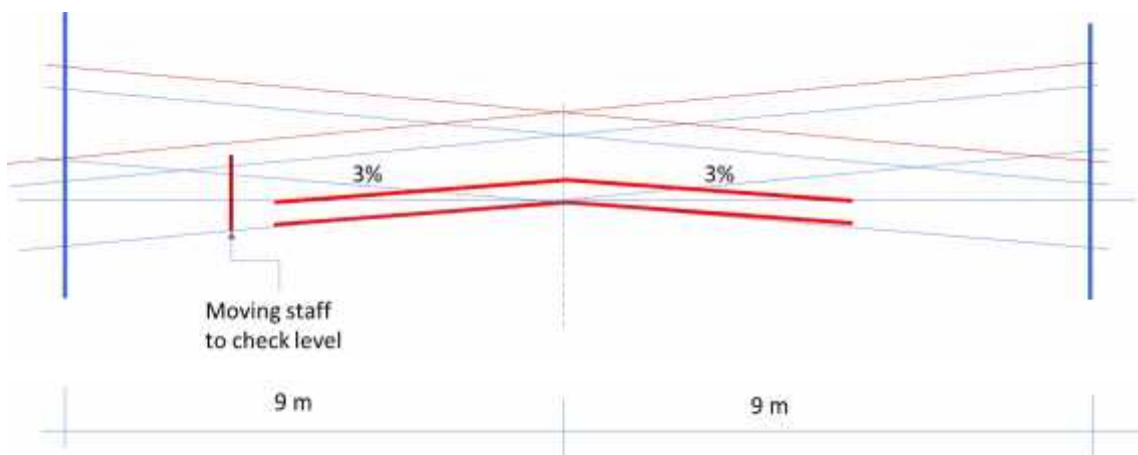
It was apparent that the Site Staff were just following what they considered to be normal construction practices on Feeder Roads projects with little regard for quality control, especially as regards compaction, the shape of the road and achievement of correct camber. DFR therefore needs to take immediate measure to ensure that proper quality control is e

Much of the time on site was therefore devoted to the correction of the camber using standard construction practice with level pegs and string lines to guide the grader operator as illustrate in Figure 9 below.

Figure 9: Common construction practice for checking camber and layer thickness

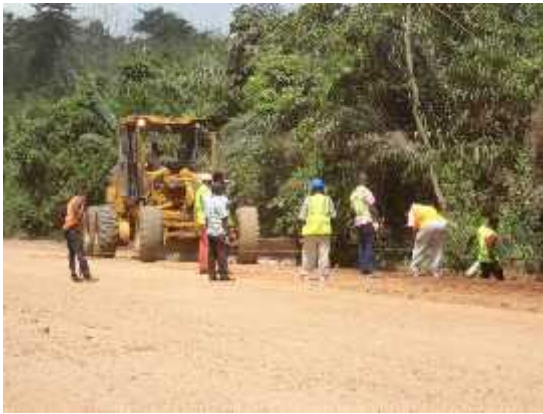
Figure 10: Establishing level pegs

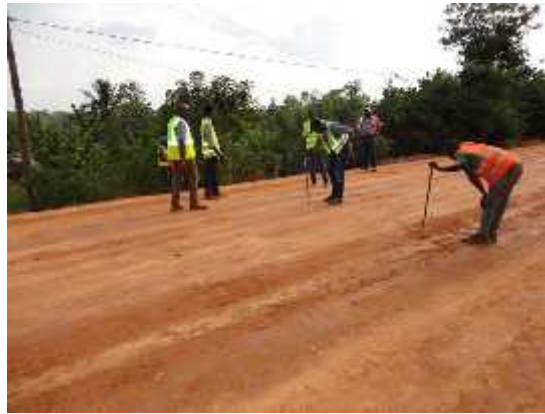
After some attempts, the grader operator understood the procedure. His skill level in achieving a proper camber subsequently increased significantly.

Figure 11: Checking the camber

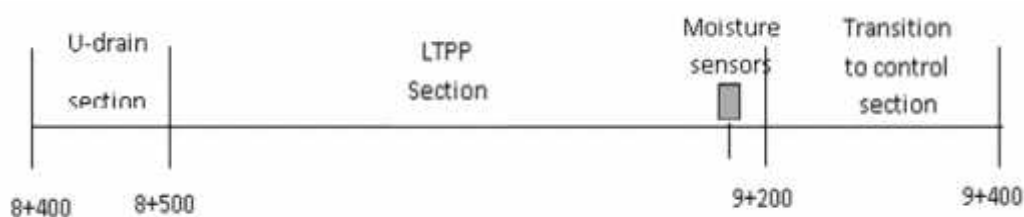
With the above design adaptations, the length of the actual Trial Section will be reduced, but it will still accommodate a Long-Term Pavement Performance (LTPP) monitoring section of at least 500 m, schematically illustrated in Figure 16.

Figure 16: Schematic layout of Trial Section

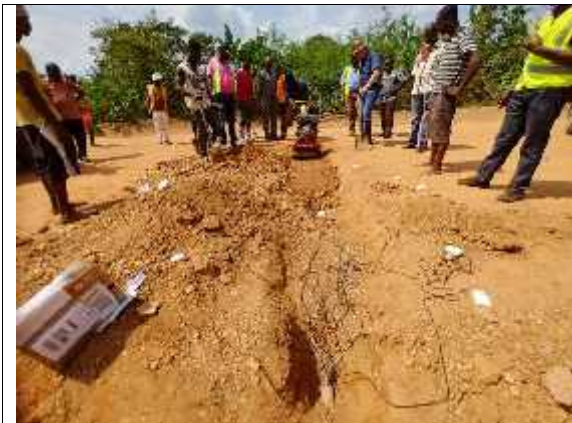
The moisture sensor equipment was installed at km 9+175. The sensors were installed in the subgrade and subbase during the correction of the subbase, whereas the sensors in the base were installed on the last day of the visit after compaction of the new base.

Figure 21: Installation of sensors in the subgrade and subbase

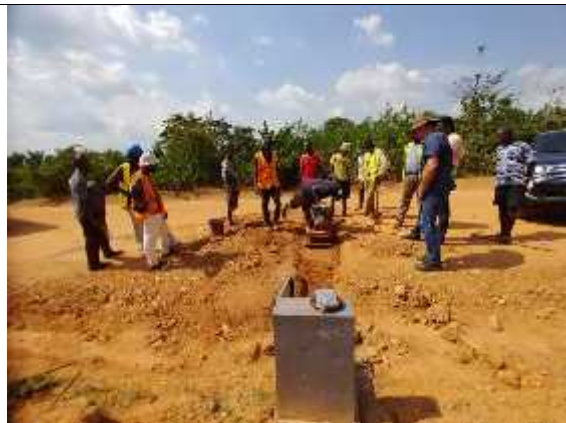
Figure 22: Compaction of trench after installation

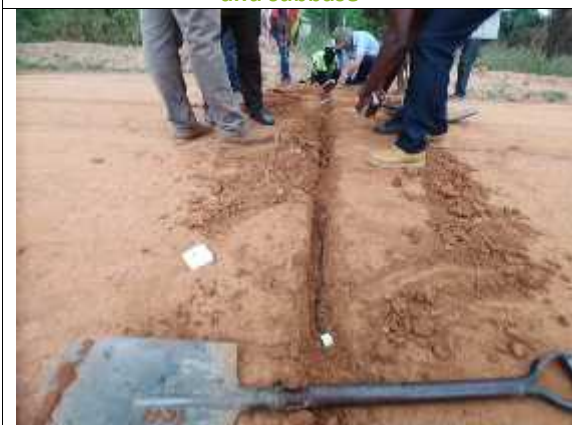
Figure 23: Installation of sensors in the base

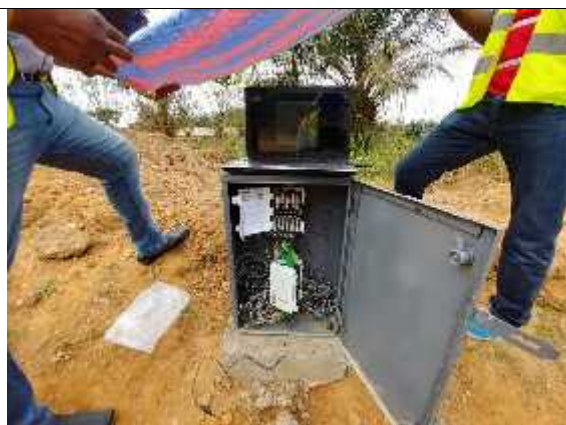
Figure 24: Data loggers connected to all sensors

As shown in Figure 24, the data loggers are mounted in a solid steel cabinet, which is securely mounted on a concrete foundation and locked with two padlocks and, in the opinion of DFR, are satisfactory secured against theft and tampering.

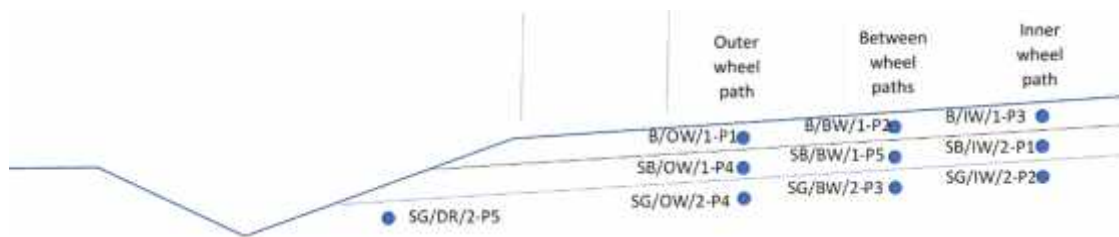
The sensors were installed and coded as shown in

Figure 25 to enable sorting of the moisture data downloads.

Figure 25: Sensor positions and coding
