**PERFORMANCE MONITORING
OF
THE NEC-ADB PACKAGE I
TRIAL AND GRAVEL ROADS**

SEACAP 17.02

**FINAL REPORT
JUNE 2009**

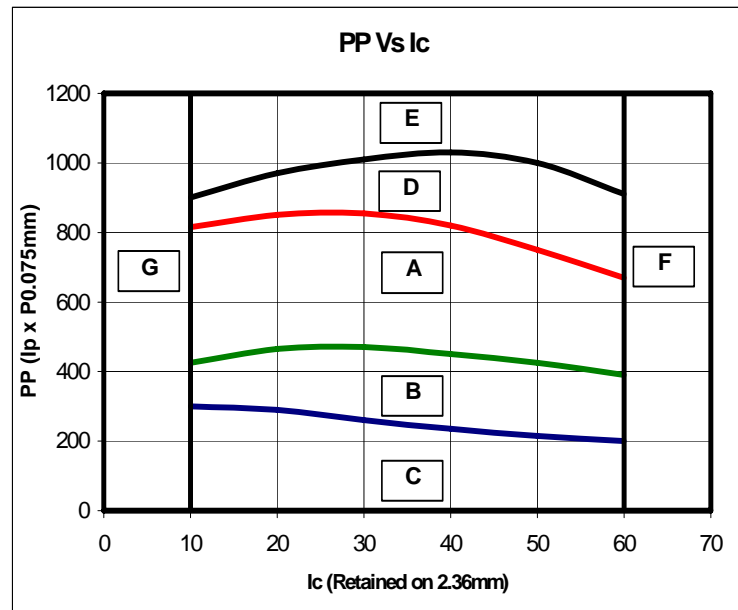
Figure 3.1 Gravel Suitability Assessment

The above plot indicates that only 6 out of the 22 approved materials sources fell into “good performance categories” and that the remaining materials could be described as being susceptible to rapid erosion. It should be noted however that figure 3.1 was originally derived for Southern African road environment conditions and may require some re-calibration for the higher and more intense rainfall environments of S E Asia. It nevertheless provides valuable relative comparison for gravel source assessment.

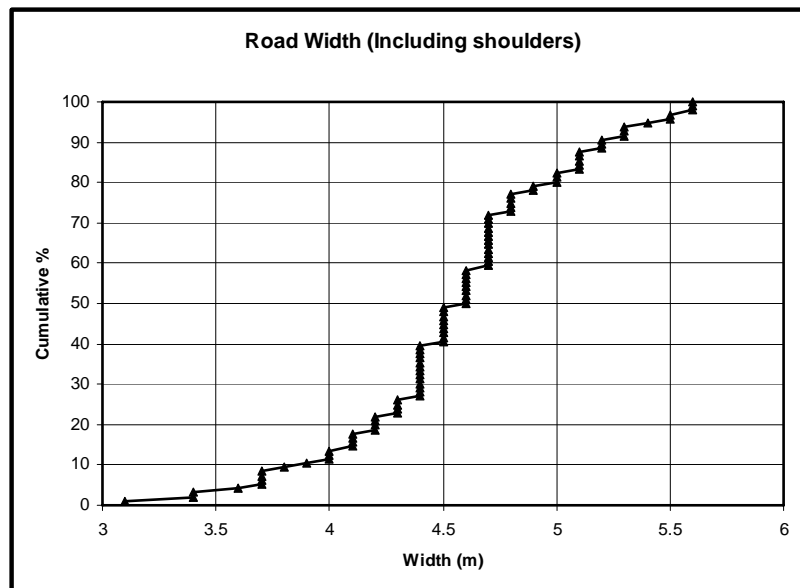
Figure 5.1 Surveyed Road Widths

The overall road widths were however below standard at about 40% of the sites, largely due to the narrow shoulders, Figure 5.1. Shoulders below 1.0m are not permitted in the proposed LVRR standards.
