**MID TERM PAVEMENT CONDITION MONITORING
OF THE RURAL ROAD SURFACES RESEARCH**

Technical Paper 1

**Visual Condition Assessment of RRSR Trial Road
Options**

SEACAP 27

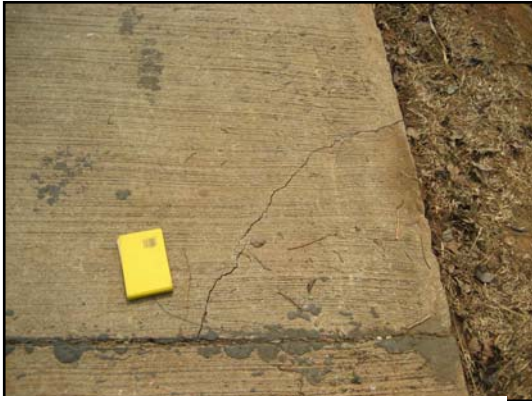
Figure 3.3 Single crack in RRST slab

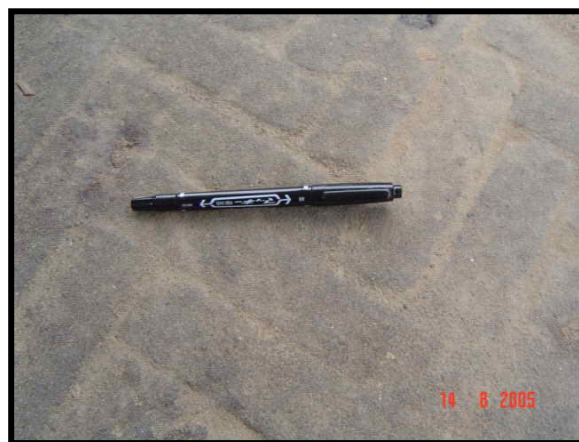
The above Tables would seem to indicate that, overall, the block paving has not performed particularly well. However it is important to note that the overall poor performance indicator is heavily influenced by the deterioration of the emulsion sand seals which have not worked well under the existing environment conditions. The aim was to waterproof the surface and prevent erosion of the sand between the blocks (Figure 5.7). The condition of the seals and of the joints indicates that this has not been successful.

**Figure 5.7 recently completed sand sealed concrete block pavement (H07)**

provided that the dimensions of the blocks are reasonably uniform, the gaps between blocks are small and suitable 'sharp' sand is used to fill the gaps between blocks. It seems that this process has generally not worked. Evidence indicates that the sand between the blocks has simply been eroded by rain and floods and that the poor performance of the joints is now leading directly to movement of the blocks and the subsequent deterioration of the road surface as an integral structure.
