Interactions between improved rural access infrastructure and transport services provision

Report of Tanzania Surveys

ReCAP GEN2136A

June 2020

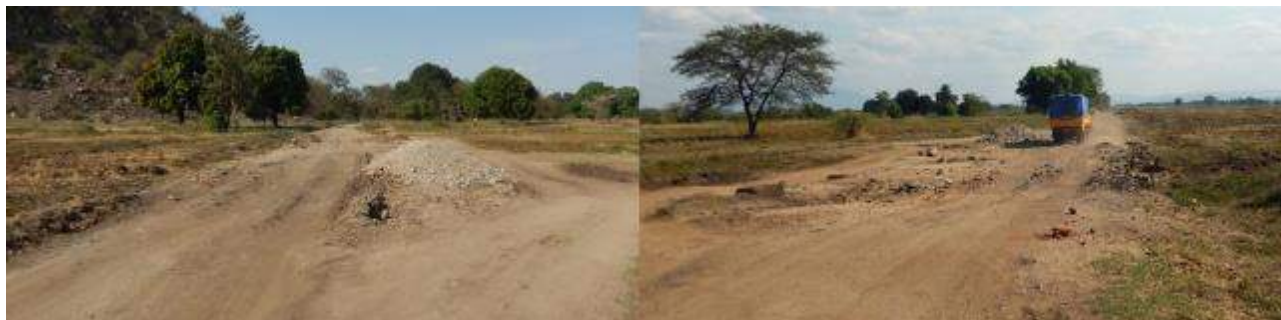
Figure 32 Site of a critical low-lying bottleneck section and failed culvert in 2015 before IRAT investments

By 2014, one low-lying section of the road passing through a swampy area had become so bad that it was very difficult to pass in the rainy season. The 'bottleneck' area in 2015 is shown in Figure 32.

The IRAT interventions were implemented between 2015-2016 and involved the construction of one 4 m x 1.2 m box culvert and three 2 m x 2 m culverts complemented by a 800 m long raised embankment that crossed the low-lying area that had been a major blackspot. The result was an all-season road. One of the culverts constructed and the slightly raised area is illustrated in Figure 33.

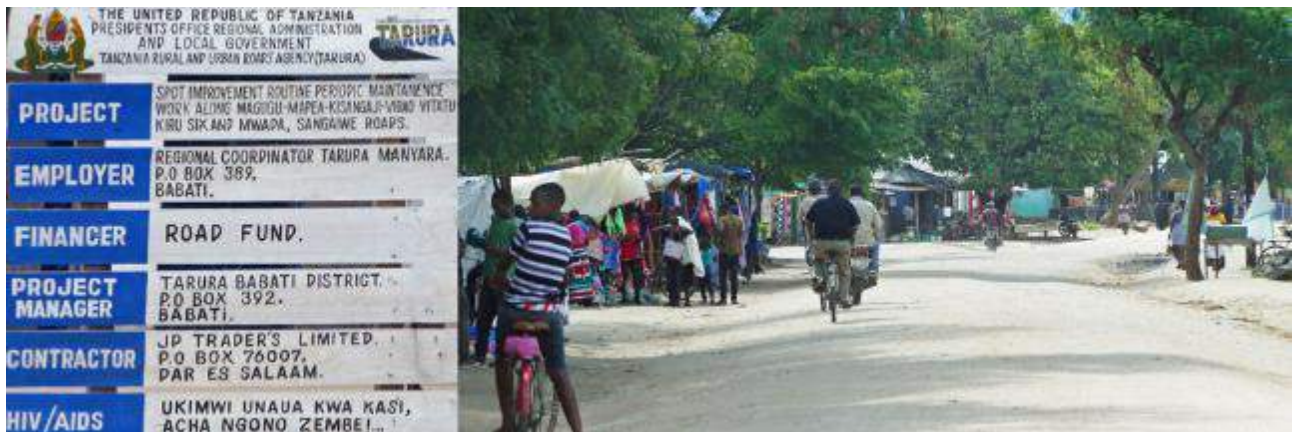
Figure 34 TARURA maintenance sign (left) and first section of the road close to Magugu (right)

The first part of the road up to 1 km is peri-urban (as shown in Figure 34) and has a good camber and earthen side drains. There is a small narrow bridge at 0.7 km with some erosion at the abutment, within the urban area. The road is approximately 5 m wide on average, but the width is variable and can be up to 6 or 7 m in places.

A contract has been awarded for road maintenance (see Figure 34). There is evidence of routine maintenance on the first section, with drains kept clear and the vegetation controlled. There has been obvious recent periodic maintenance with grading work on the last section and a new culvert. There are several problematic structures and the section immediately before the IRAT-funded culverts is likely to become a bottleneck, if it is allowed to deteriorate further.

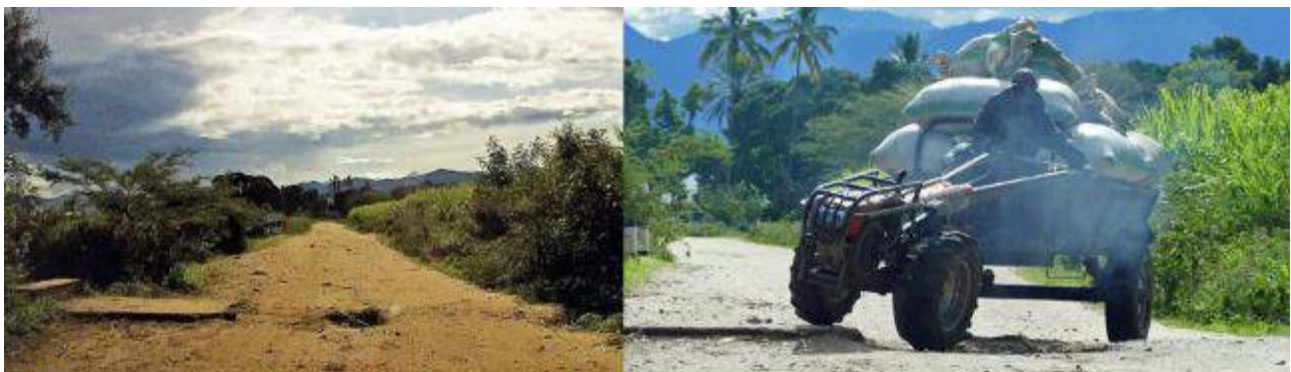
Figure 36 A broken culvert showing a two-wheel tractor negotiating the problem

The road is in fair to poor condition in the agricultural area up to the junction at 6.6 km. Culverts are raised above road level because of the low-lying surrounding land, and some culverts are in poor repair, as shown in Figure 36.

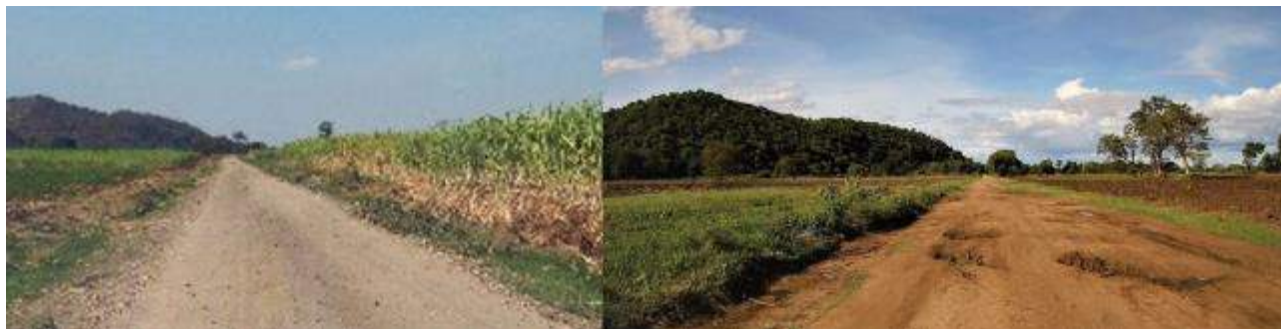
Figure 37 Low-lying section in 2015 at the time of IRAT investments (left) and potholed in 2019 (right)

Some large potholes are evident, the drains are overgrown and there is obvious variation in width due to deterioration of the carriageway, forcing drivers to use the shoulder to avoid rough areas, as shown in Figure 37. The general area is low lying, up to approximately 8.45 km.

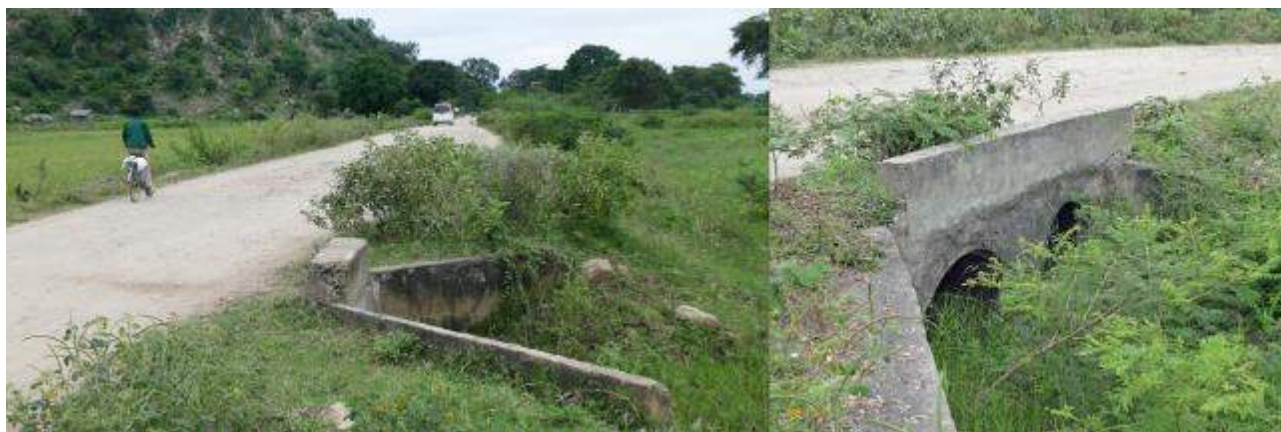
Figure 38 IRAT-funded culverts, showing vegetation growing in the silt

From 8.45 km to 9.22 km there is an improvement in condition. The first IRAT culvert is at 8.69 km, the second is at 8.70 km (as shown in Figure 38) and the box culvert is at 9 km (Figure 33). The IRAT investment was limited to removing the bottleneck at this point of the road.

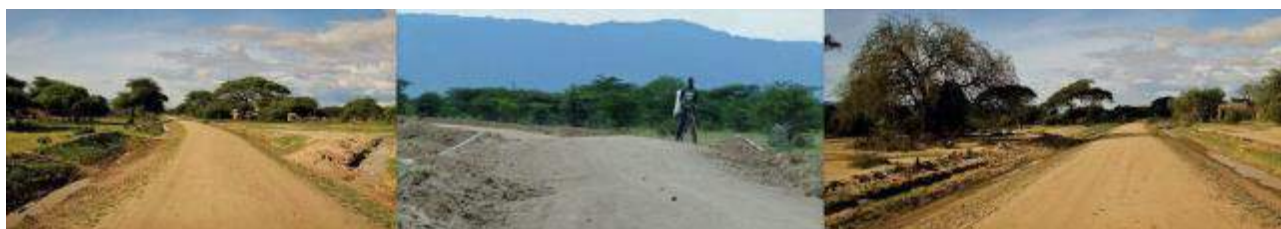
Figure 39 Recently maintained end section showing turnouts, a new culvert and side drains

From approximately 10 km the road has been recently graded and is in better shape. The drains are clear and have been maintained more thoroughly. There is another subtle change from about 11.3 km, where the road has good shape with adequate camber and deeper side drains, but the road is not elevated above the surrounding land. For this reason, there are few culverts and the side drains have been constructed fairly deep, with turnouts established. These turnouts do not have a positive drainage outlet but do provide a soakaway function in the surrounding land, which seems to be effective in keeping water away from the road. Standing water can be seen in the turnouts and occasionally in the side drains as shown in Figure 39. The carriageway width is approximately 5 m and the surface is in good condition, with low roughness.

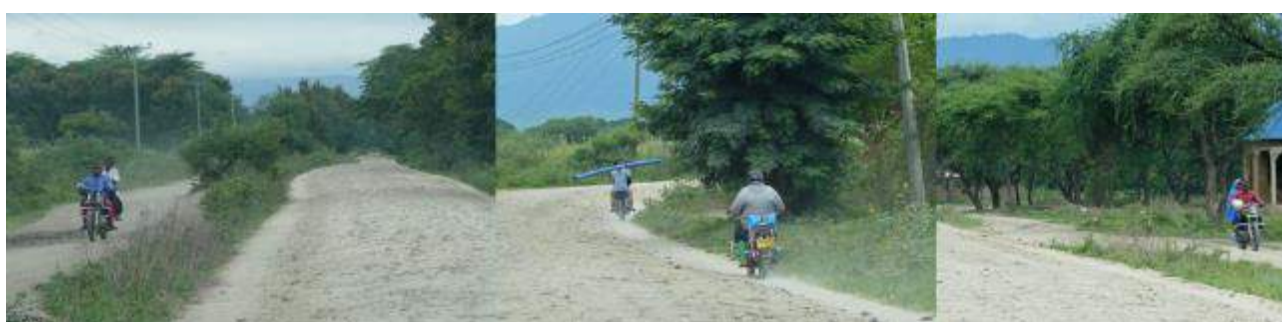
Figure 42 Motorcycle on-road and off-road side trails to avoid the rough road surface

The road is rough, and motorcycles are generally better at coping with rough roads than four wheeled vehicles as they can change their trajectories and weave around difficult obstacles on the road. However, they prefer to use smooth trails, and often create them on the road shoulder or on a side trail, by repeatedly travelling along the same trajectory that gradually becomes worn smooth. On the middle section of the road there are several side trails, which can be seen in Figure 42.

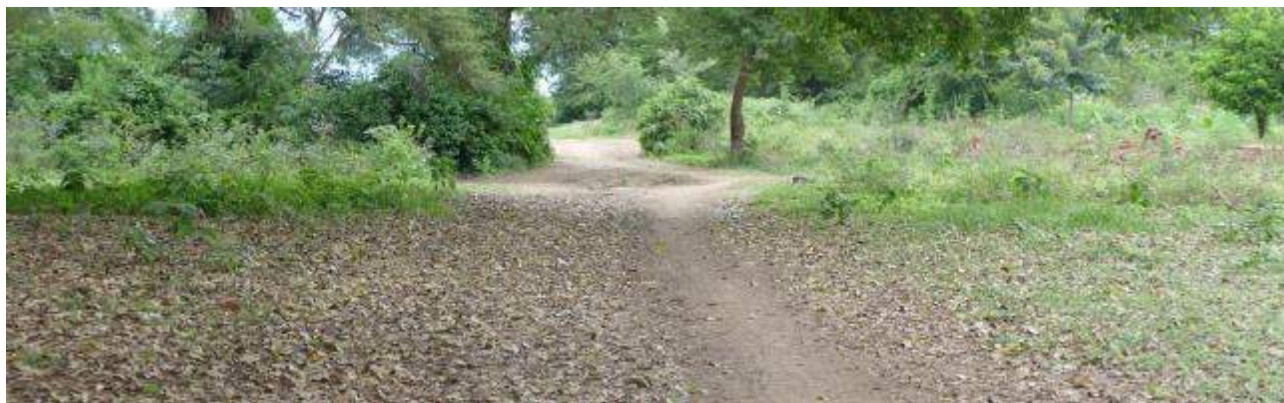
Figure 43 A motorcycle trail used in the dry season to bypass several kilometres of rough road

This road has a traditional footpath running from Mapea (near Magagu) to a small village just after the IRAT culverts (around 9.5 km). Motorcycles have started to use this as a motorcycle trail, as it is smoother than the road, and shorter too (it cuts a corner). The section near the IRAT culverts becomes difficult to pass in the rainy season, and so this motorcycle trail is mainly used in the dry season. The start/end of the trail at 9.5 km is shown in Figure 43.

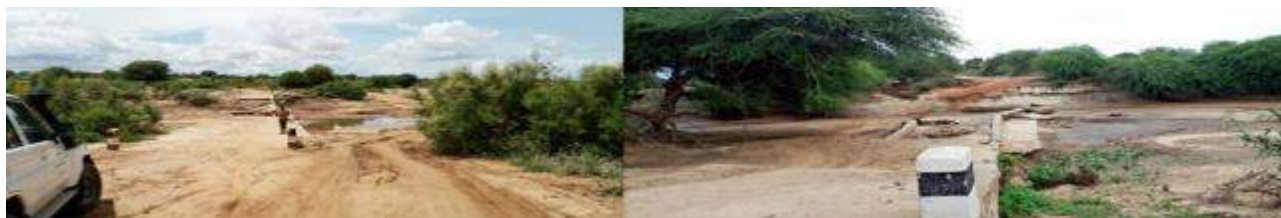
Figure 50 Chigongwe-Chipanga river crossing bottleneck prior IRAT intervention in 2016

The first 'bridge' was technically a 6-cell box culvert, but it is locally referred to as a bridge, and this document uses the word 'bridge' as well, as it is a significant water crossing (see Figure 51 and Figure 60) and referring to the two 'bridges' aids the description of the traffic and transport services issues. Figure 50 shows the state of a drift before the first bottleneck investment and Figure 51 shows the Bridge 1 (technically a multi-celled box culvert) that replaced it, shortly after its construction in 2017.

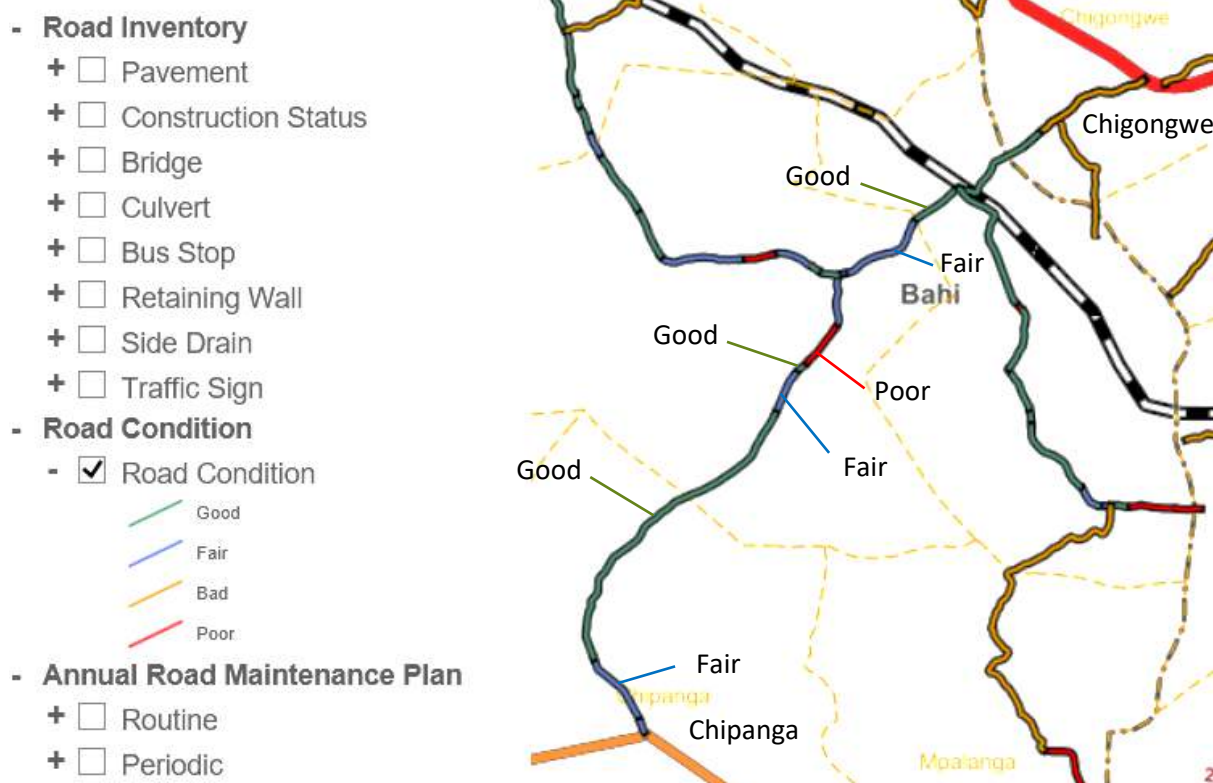
Figure 54 Extract from the DROMAS2 database (2018/19) showing road condition

In DROMAS2, the first part of the road is shown as bad condition (amber colour) in 2018, but this was not the observation from the project survey (although there were some rough and rocky outcrops and a broken culvert). It appears that this part of the road has been maintained quite recently and the 2019/20 condition surveys should now show that most of this part of the road is in fair condition. The other assessments along the road are consistent with the surveys undertaken by the team in November 2019. The parts of the road adjacent to the IRAT bridges are in good condition.

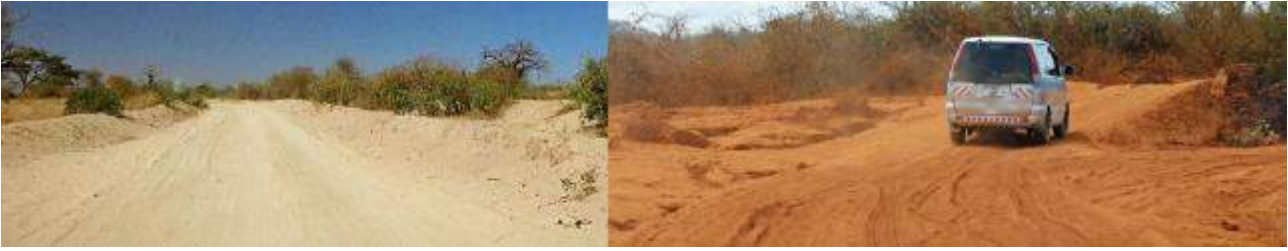
Figure 56 Chigongwe-Chipanga road showing some sandy patches

The road is between 6 m and 7 m wide. This is a low rainfall area and no soft spots or muddy areas were noticed, but the road surface is quite sandy in places, as shown in Figure 56.

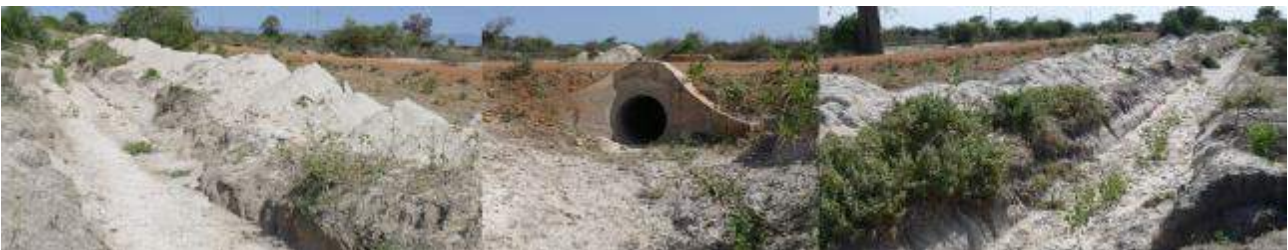
Figure 58 Chigongwe-Chipanga road showing side drains to catch run-off from the land

The road is not raised and in places is lower than the surrounding land, with little drainage apart from side drains. This is possible in a dry area but can still pose problems during heavy rains. Some large side drains have been constructed to the south side of parts of the road, and appear to be designed to capture surface water running off from the gently sloping land during a rain storm, and direct this run-off to culverts passing under the road, as shown in Figure 58.

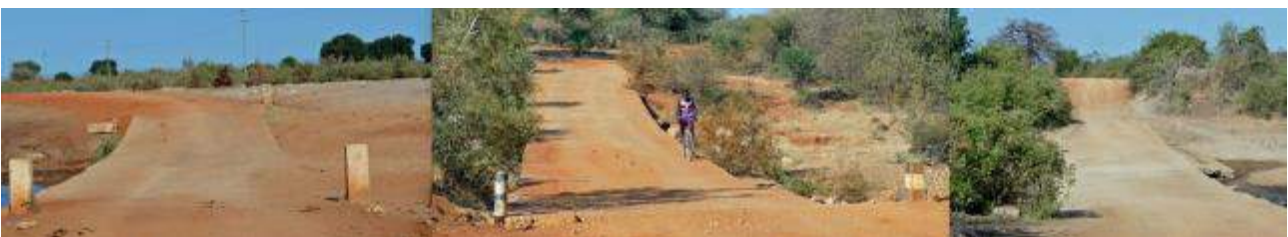
Figure 59 Chigongwe-Chipanga road showing some of the drifts

There are also several concrete drifts along the road. These are appropriate for dry areas where there is not constant flow along a watercourse. The drifts were constructed with markers at the entrances and exits so that drivers can see the carriageway when the drift is submerged. Some of these bollards have been damaged.

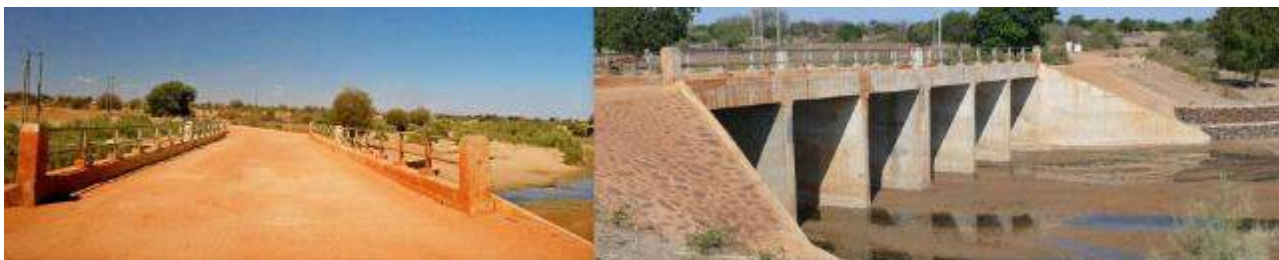
Figure 60 Chigongwe-Chipanga road Bridge 1 (6-cell box culvert)

The first 'bridge' constructed under IRAT at 14 km is a double lane 6-cell box culvert with a span of 28 m, as shown in Figure 60. It is across a river that is constantly flowing, although the flow is minimal in the dry

season. It is of concrete construction with a concrete deck, with kerbs and handrails, but no pedestrian walkways.

Both bridges are 5 m wide and in good condition and provide reliable access throughout the year. There have been no issues with accessibility at these water crossings since the bridges were constructed between 2016 and 2018 and they do not have any signs of deterioration.

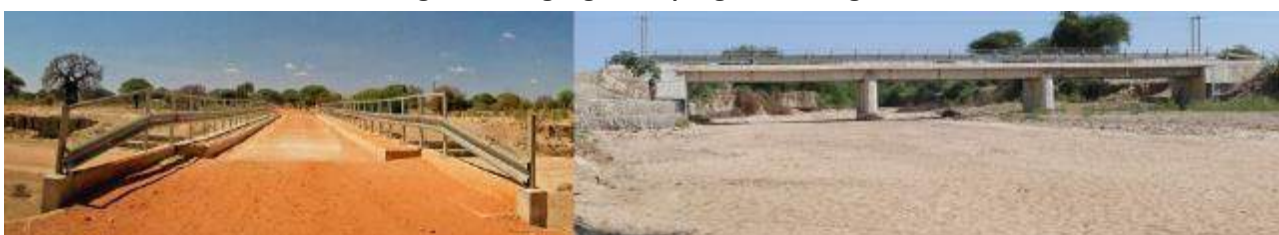
Figure 61 Chigongwe-Chipanga road Bridge 2

The second bridge (Figure 61) constructed under IRAT at 31.7 km. It is a double lane bridge with a span of 48 m. It is of concrete construction with a concrete deck and kerbs (that can act as pedestrian walkways) and steel handrails.

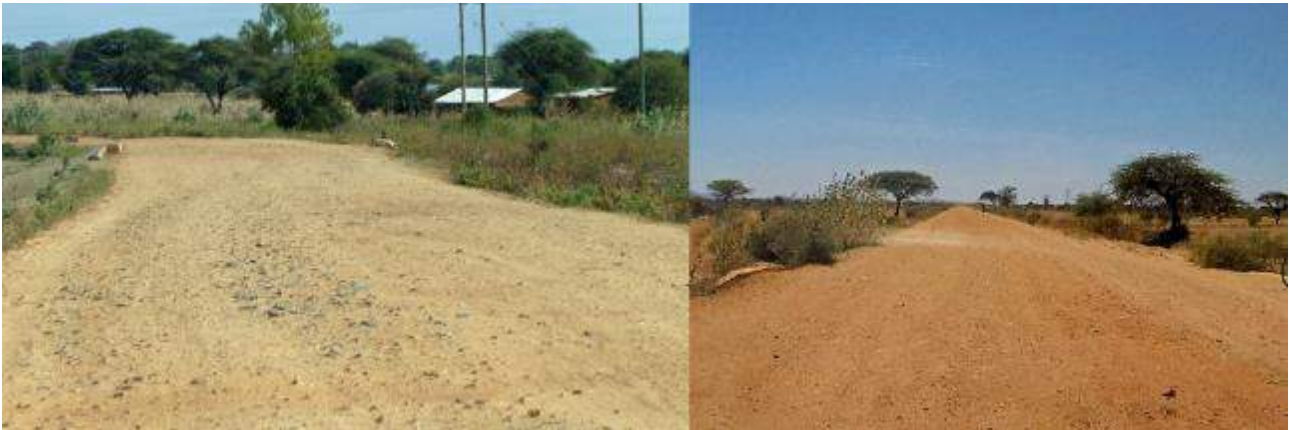
Figure 71 Mpunguzi-Mwitikira road showing the shape and surface in 2019

The road is gravel construction and has good shape and camber for much of its length. It starts at approximately 6 m wide in a populated area at Mpunguzi, continues at 6 m to 7 m wide for the first 15 km. It narrows towards the end of the road at Nagulo to about 5 m. The first 15 km is constructed on a low embankment up to 1 m high, to raise the road above the low-lying land and avoid the risk of flooding, which was an issue for this road before the IRAT works were undertaken, as shown in Figure 68. The surface is motorable all year, but the gravel has a lot of oversize stones that are now on the surface, following erosion of the smaller gravel particles and can be seen in Figure 71. The oversize stones make the surface uneven and consequently the ride is less smooth, leading to reduced travel speeds. Some corrugations are also evident.

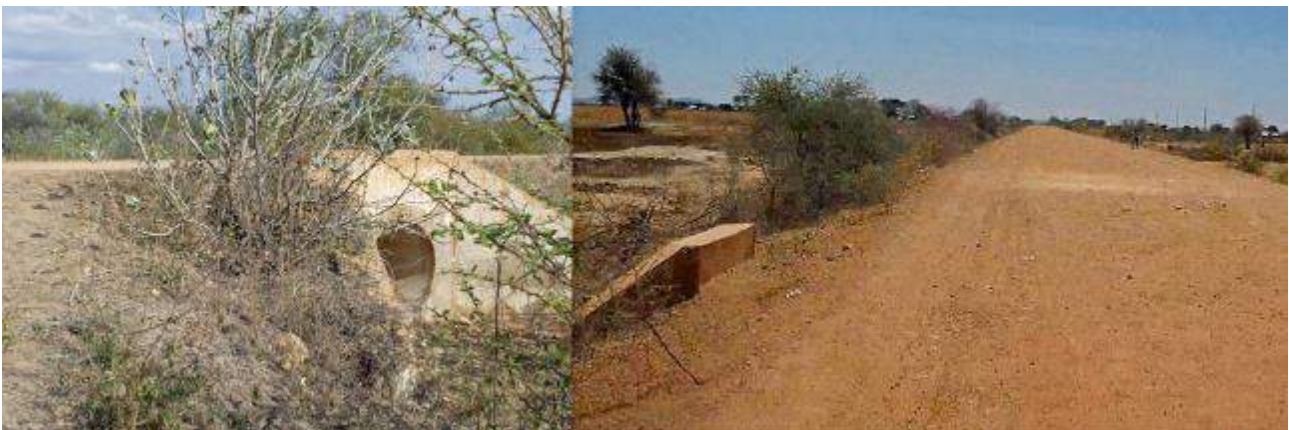
Figure 72 Mpunguzi-Mwitikira road showing ring culverts included in the IRAT investments

Three box culverts each of one cell of 2.5 m x 1.5 m, as well as a 277 m run of ring culverts of 900 mm diameter that have been installed by the IRAT programme (as shown in Figure 72). These seem to act as balancing culverts as there are no main watercourses and no significant side drainage. These culverts have maintained the all-season nature of the road by allowing water to flow freely from one side of the road to the other and preventing the road structure from becoming saturated and consequently weakened.

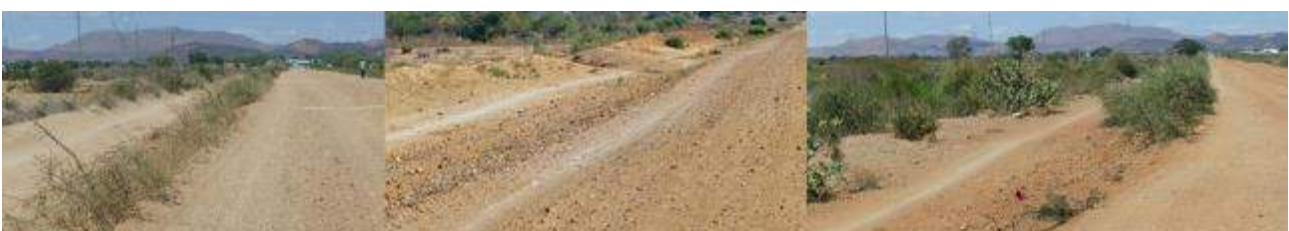
Figure 73 Mpunguzi-Mwitikira road showing smoother motorcycle trails developed alongside the roads

As the road has become rough due to the oversize stones, motorcycles and bicycles have started to use smoother side trails, either on the shoulder of the road or off the embankment along parallel trails. These are shown in Figure 73.

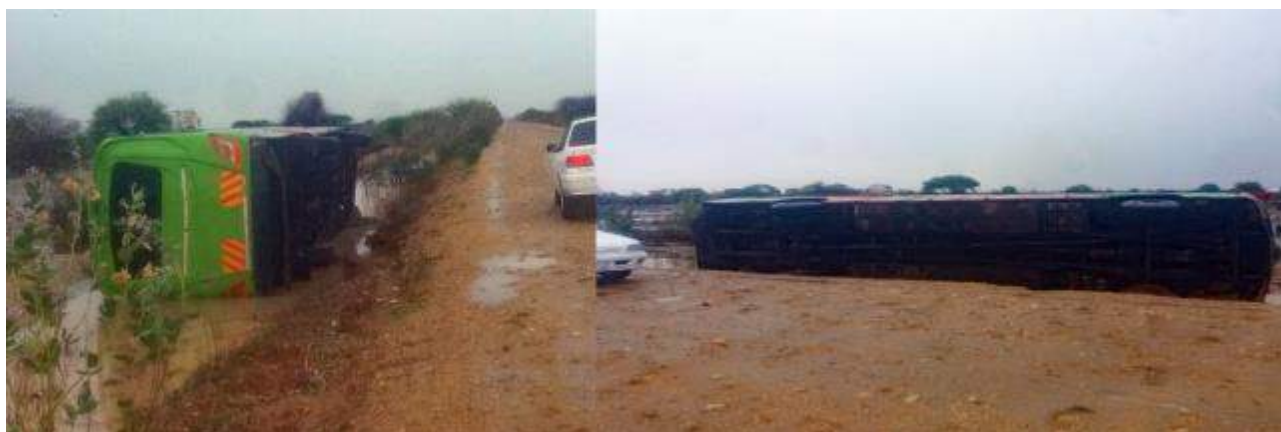
There is widespread agreement that the road improvements reduced travel times significantly. Before the investments, the journey from Mpunguzi-Mwitikira on a slow-moving bus, repeatedly changing to low gears to go through potholes, could take one hour, or more. With the road improvements, that time halved, allowing a bus to travel the distance in half an hour. Motorcycles and cars could travel even more quickly, and this is reported to have led to several crashes. Anecdotal reports suggested that seven people were killed in the first two years following the road improvements. The causes of the crashes were said to be loss of control due to high speeds. In one car, two people were killed when the car went off the road and turned over. Several motorcyclists were also killed when they lost control. With the eroded surface and over-sized stone, traffic speeds are reported to have gradually decreased, but they are still much greater than before rehabilitation. During the survey work in November 2019, a large bus lost control and toppled over, as seen in Figure 80. In this case there were no fatalities.

Figure 80 Large bus that lost control on the Mpunguzi-Mwitikira road in November 2019

Road improvements can lead to increases in crashes, despite the good intentions of the agencies involved. Good straight roads tend to encourage drivers to speed, and at high speeds it is more difficult to control vehicles, when there are issues such as undulations and road surface imperfections. On gravel roads, traffic calming measures such as speed bumps tend to erode quickly and can become hazards as well.

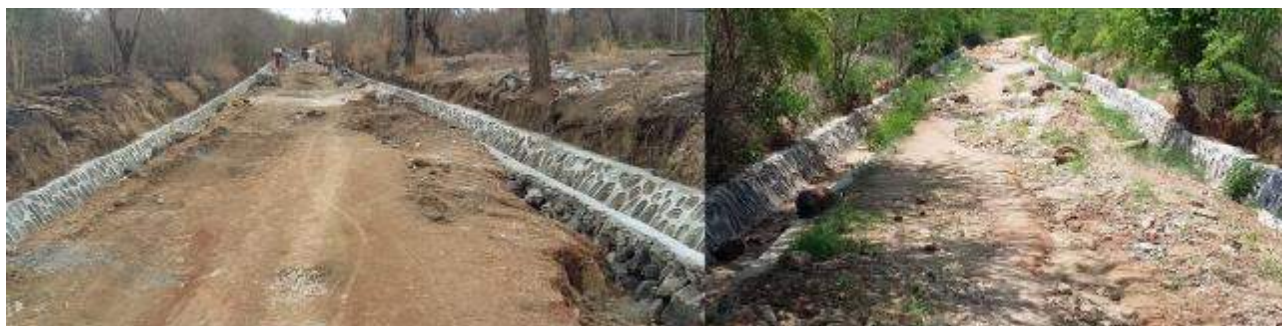
Between 2014 and 2016, IRAT supported six 'bottleneck' interventions on the upper sections of the road, at points where the road was vulnerable to damage and traffic disruption. It was hoped that this investment might encourage midibuses to use this route as a shortcut to Ngeregere. Different pavement solutions were applied to the six areas, including concrete on a steep section, concrete strips, a drift/causeway, lined drains and gravel surfacing. In 2015, the investments included one solid drift, one single-cell box culvert, lined ditches, a concrete pavement on a difficult slope, and parallel concrete strips on another difficult slope. Figure 82 shows a section with side drains being constructed in 2014.

Figure 82 Side drains being constructed during IRAT rehabilitation in 2014 (left) and their state later in 2014 (right)

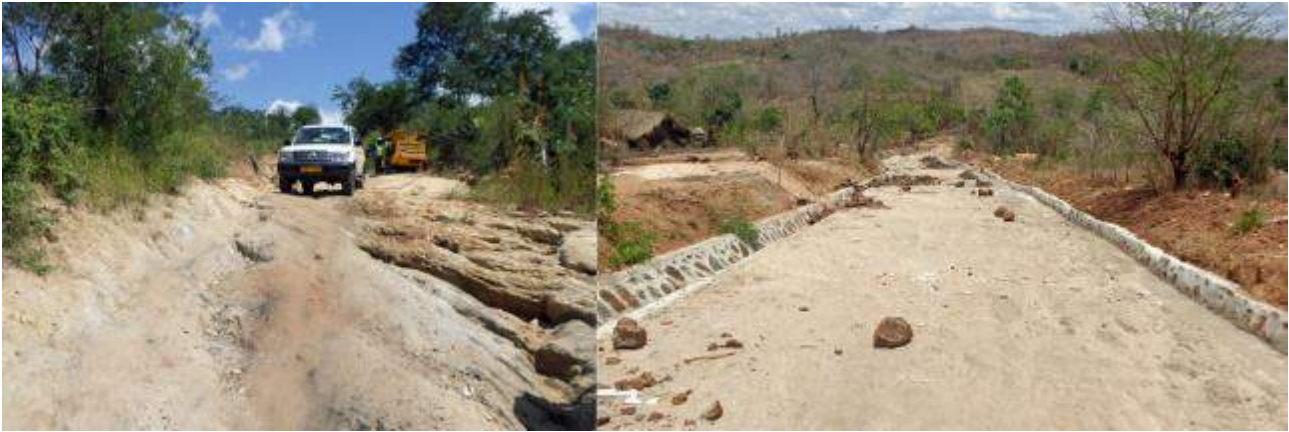
Figure 83 shows a badly eroded road section in 2015 that was replaced by a concrete pavement.

Figure 83 Eroded slope before IRAT rehabilitation in 2015 (left) and subsequent intervention (right)

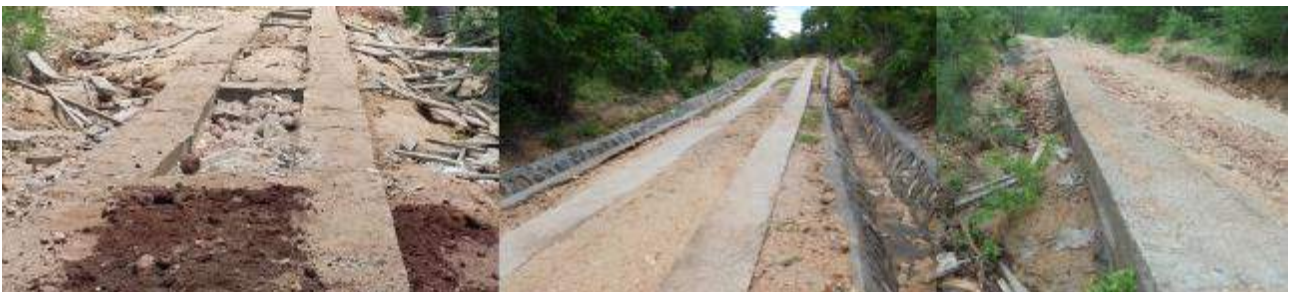
Figure 84 shows parallel concrete strips during and after construction in 2015.

Figure 84 Parallel concrete strips constructed under IRAT rehabilitation interventions in 2015

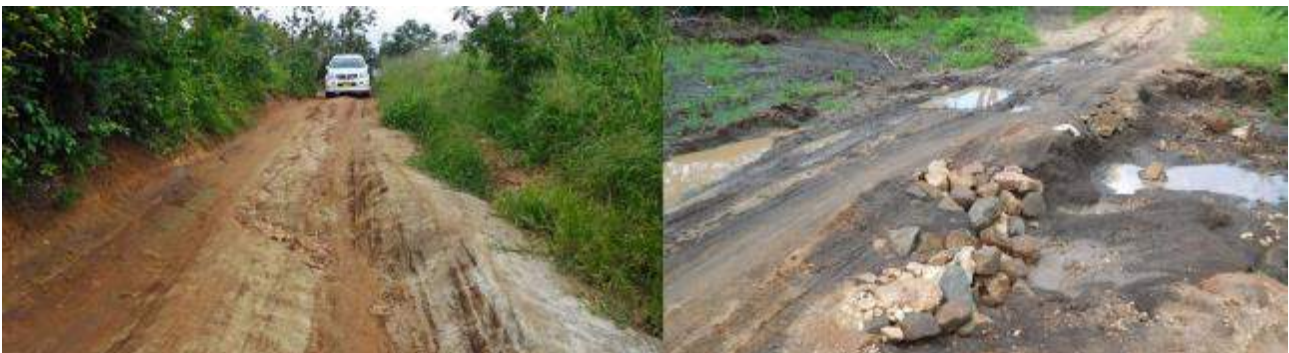
Figure 85 shows photos taken during an inspection in 2016, showing that additional bottleneck problems remained despite the IRAT investments.

Figure 85 Condition of parts of the road in 2016 showing need for further bottleneck interventions

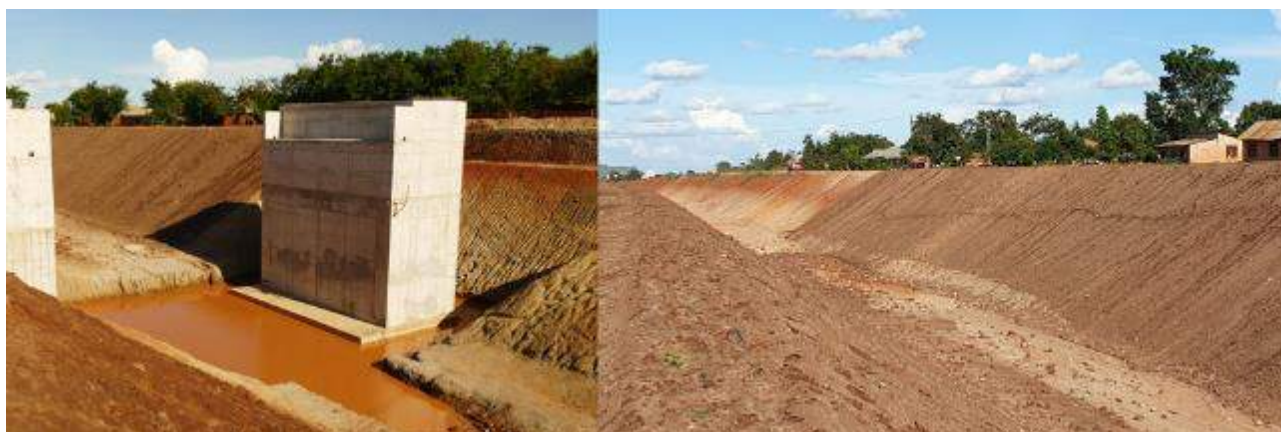
In 2018-2019, the TANROADs regional road from Mikese to Mvuha benefited from a major rehabilitation (not funded by IRAT). This road crossed the Metegowa Simba-Ngeregere road and provided an alternative, and better link to the T1 highway. Then, in 2019, the first section of the Metegowa Simba-Ngeregere road was severed as the new standard gauge railway construction progressed towards Morogoro (see Figure 86). This means the road now effectively starts at Mikese, using the regional road to reach it.

Figure 86 Construction of the new railway causing severance of the first section of the survey road

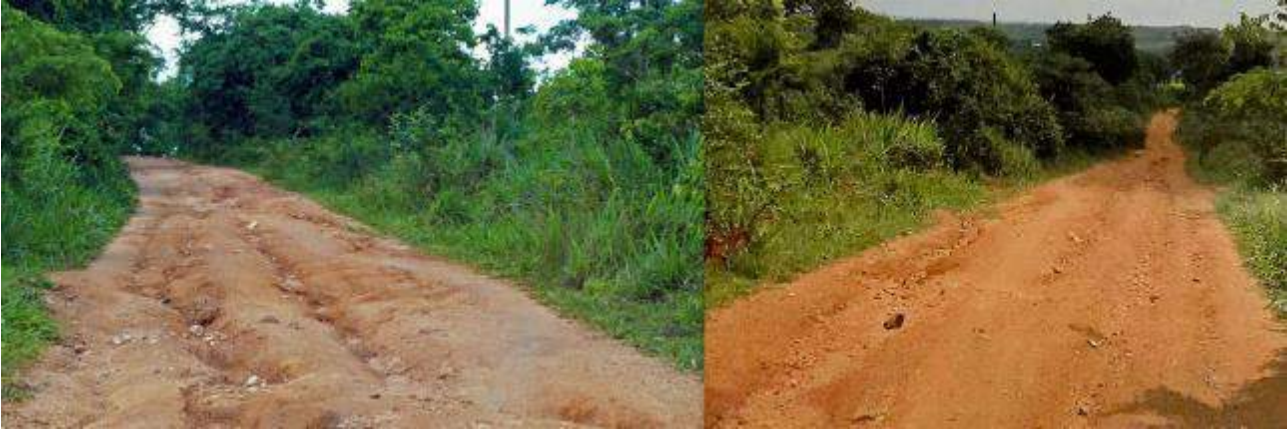
On the steeper untreated sections there is evidence of erosion, longitudinally on the carriageway, which has damaged side drains and has caused them to become blocked. This can be seen in Figure 90.

Figure 90 Eroded slopes on the Mikese-Ngeregere road in 2019

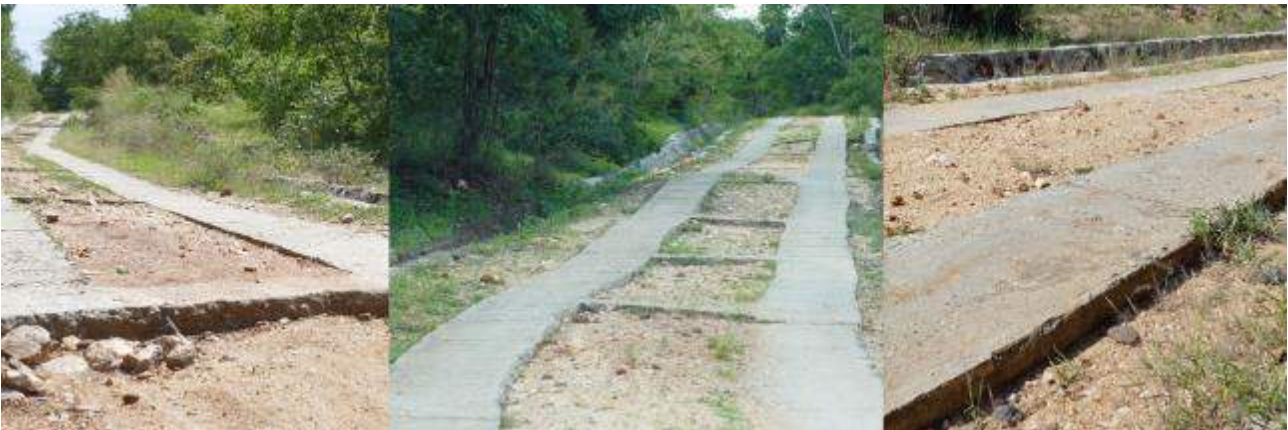
The concrete strips section is still in good condition, although there is erosion of the areas outside the concrete which means the concrete is often proud of the gravel base (see Figure 91). This can cause difficulties for bicycles and motorcycles and is a safety hazard. The side drains on the concrete strip section are lined and in good condition.

Figure 91 Parallel concrete strips showing proud concrete that is a safety problem for motorcycles

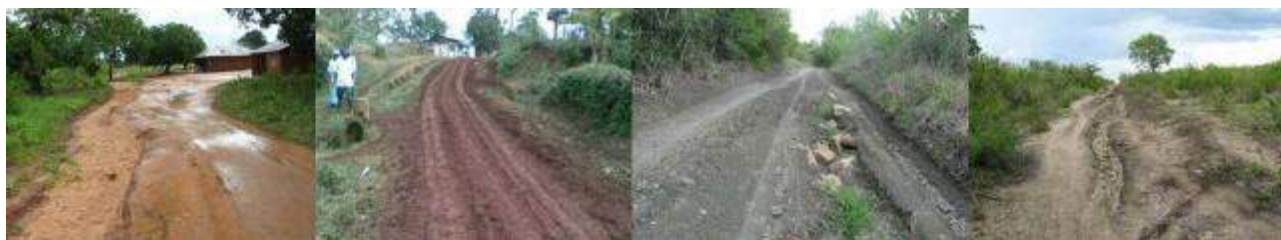
In 2009, the road was difficult to pass in the rainy season, with some eroded and/or slippery sections, as shown in Figure 97.

Figure 97 Examples of road condition in 2009 before AFCAP1 intervention

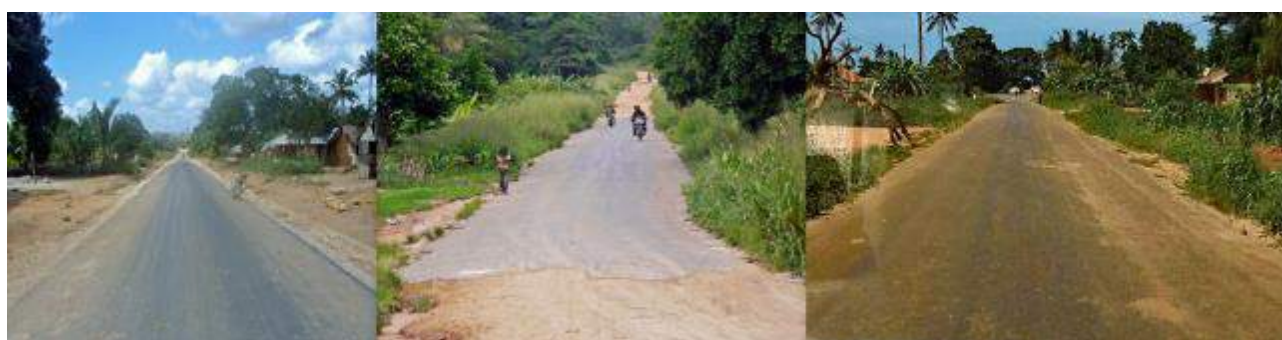
The road starts at the Bago junction with a bituminous paved section which is a single Otta seal with a sand seal above. This section is in fair condition with a few small potholes. There is some bleeding, but this is not uncommon for an Otta seal surface, especially as it has had an additional bituminous layer applied above. The condition of this section in 2011, 2015 and 2019 is illustrated in Figure 97.

Figure 100 Otta seal section near Bago in 2011, 2015 and 2019 (L-R)

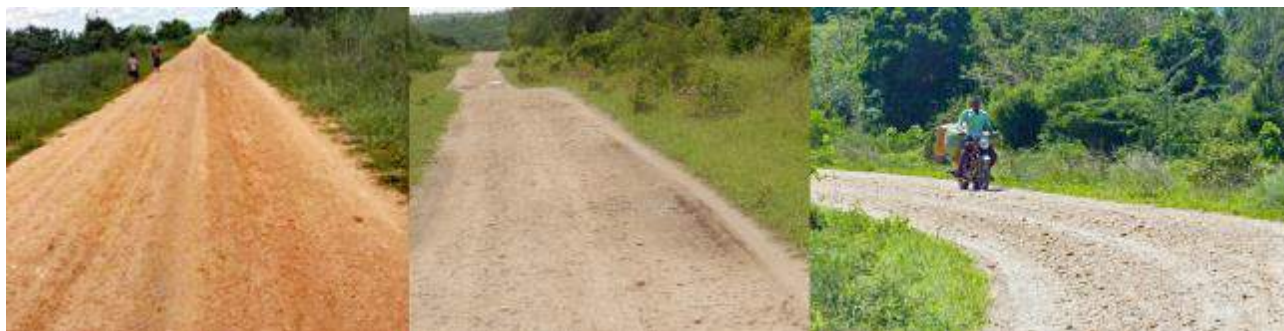
From the initial bituminous paved section to 5.3 km the surface varies between earth and gravel. The road passes through a small village and intersperses between gravel and an earthen surface. The earthen surfaces tend to be quite coarse or sandy. Width is generally 3-3.5m. Through the village the road appears to be maintained, but outside the village there are some areas of bad erosion, which would make the road difficult to pass in the wet season. Drifts, rather than culverts, are mainly used in the valleys. Examples of the condition of gravel sections in 2011, 2015 and 2019 are shown in Figure 101.

Figure 101 Gravel sections in 2011 (left), in 2015 (centre) and 2019 (right)

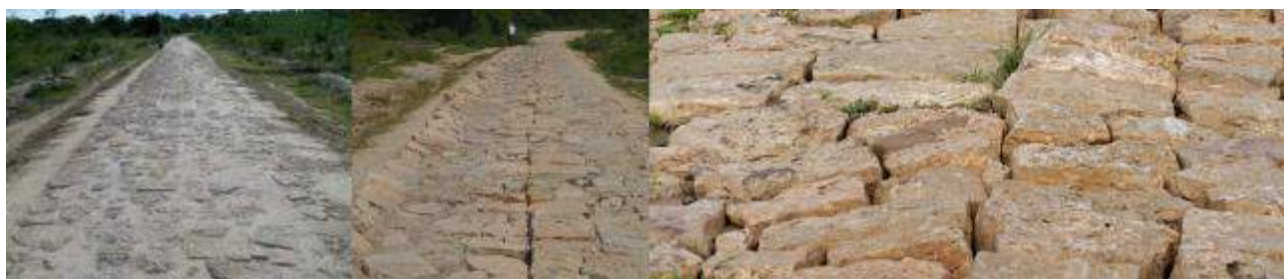
From 5.3 km there is a surface of hand packed stone. This was originally constructed without kerbs as shown in Figure 102 (far left) in a photo taken in 2011, soon after construction. The voids between the stones were filled with sand. However, this system did not survive a year before failing. The sand was washed away, and with vehicle movements, the stones rose up towards the edge and separated from each other as shown in Figure 102 (centre and right).

Figure 102 Hand-packed stone section in 2011 (far left), in 2012 (centre) and 2015 (right)

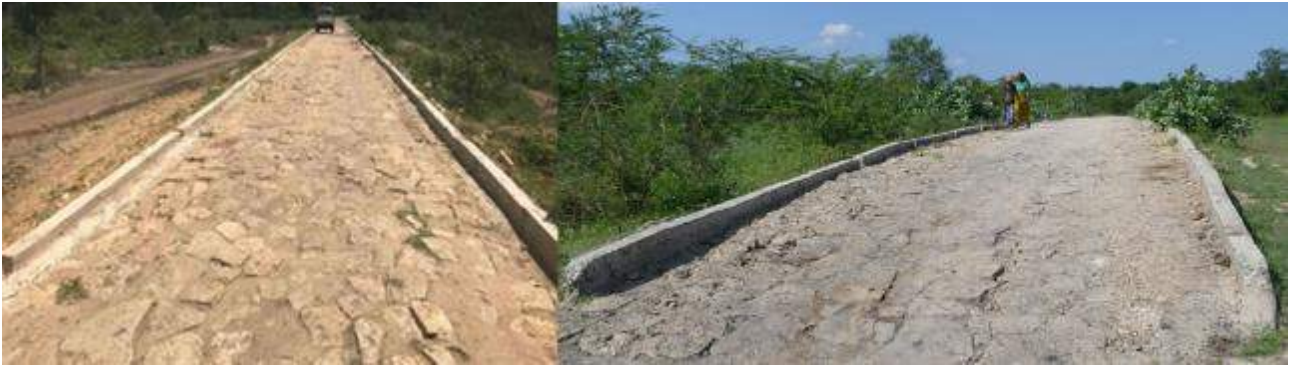
The failed section had to be repaired, and this time high kerbs were installed to retain the surface. Gaps were left in the kerbs every 5 m to facilitate drainage into side drains, which are wide and flat alongside the road (see Figure 104). This system has survived for several years, although the surface is uneven, mainly due to the nature of the materials and the way the stone was dressed. It is still in good condition with little sign of recent deterioration. However, there is vegetation growing between the stones in the non-trafficked areas, and if left to grow this will eventually damage the surface.

Figure 104 Re-habilitated packed stone section in 2016 (left) and 2019 (right)

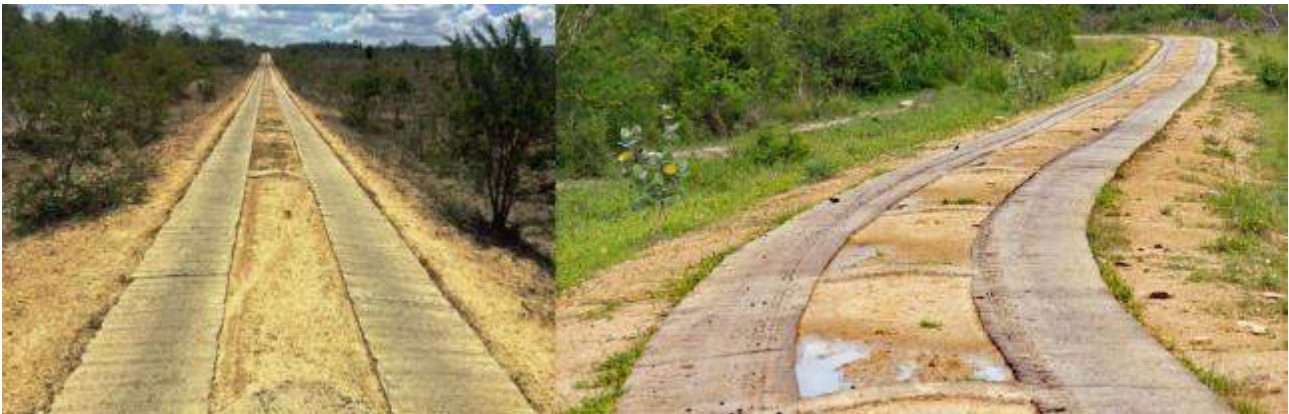
There are two sections with parallel concrete strips, which are joined by concrete connectors between the strips. The first section is not reinforced, while the second section was constructed with reinforced concrete. On both sections, the concrete is in good condition but there is erosion of the gravel base alongside the strips, which causes a slight vertical edge, as can be seen in Figure 105. This is a risk to motorcycles and bicycles that have to move on and off the strips to avoid other vehicles.

Figure 105 Parallel concrete strip sections in 2011 (left) and in 2015 (right)

The quality of construction appears to have been better on the Bagomoyo road, although from the outset there were some proud edges (see Figure 105), that inevitably worsened with erosion. While the contractor

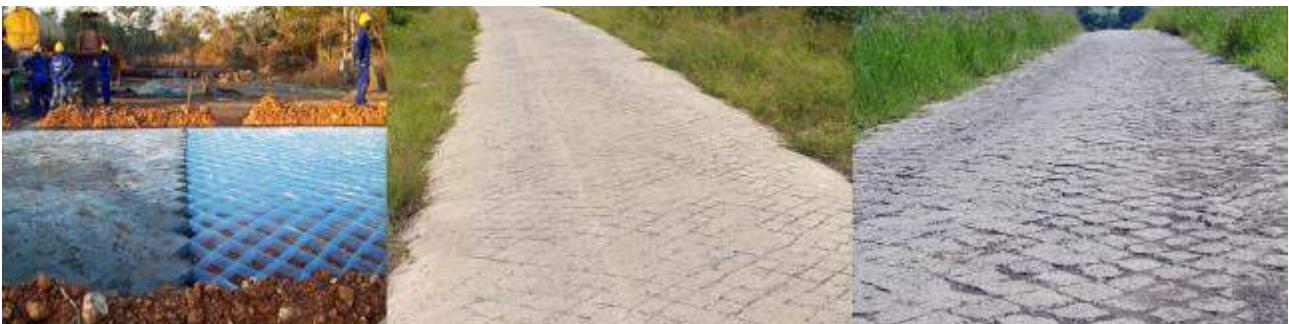
There is a section of block paving or geocells, as shown in Figure 107. The blocks have been cemented together at the edges of the road to form a type of kerb, which retains the blocks in place. At the start and end of the section there is damage where vehicles have run over the shoulder to access the carriageway, but apart from that the section is in fair condition and is motorable all year. The surface is uneven due to the slight settlement of some of the blocks, and this shows as slight rutting in some areas. There is vegetation growing between the blocks that are not in the main traffic lines, which will eventually cause damage if left unchecked. Earthen drains are in place and are effective.

Figure 107 The geocell section in 2011 (left), 2015 (centre) and 2019 (right)

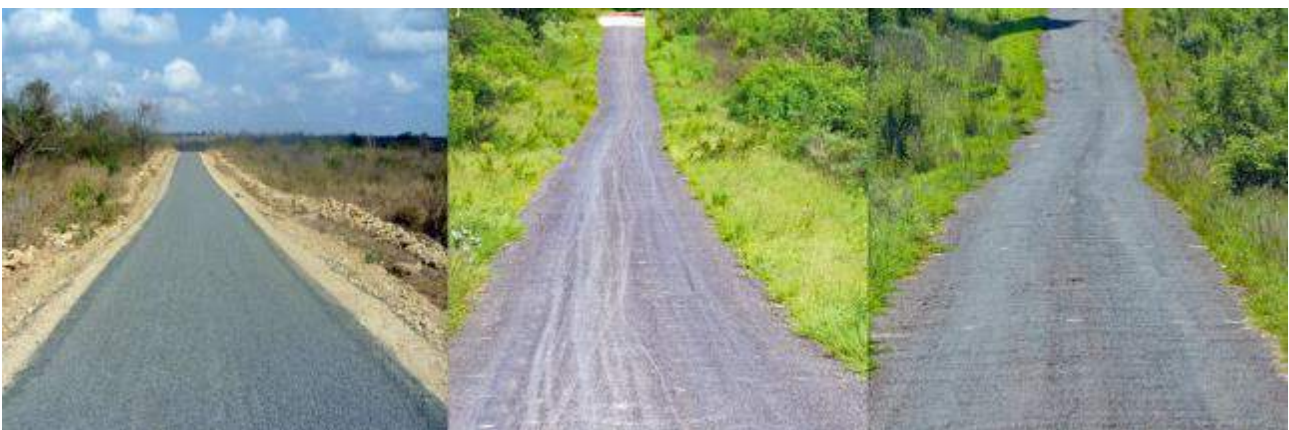
Another trial section of approximately 250 m constructed with a double surface dressing on a gravel base. This is shown in Figure 108. The surface is generally in good condition, with few cracks or potholes. There is some encroachment by vegetation at the edges of the road, but the camber is maintained and there does not appear to be any deterioration, apart from where the end of the bituminous paved section meets the adjoining gravel section, which is to be expected. The surface still has a good riding quality.

Figure 108 The double surface dressing section in 2011 (left), 2015 (centre) and 2019 (right)

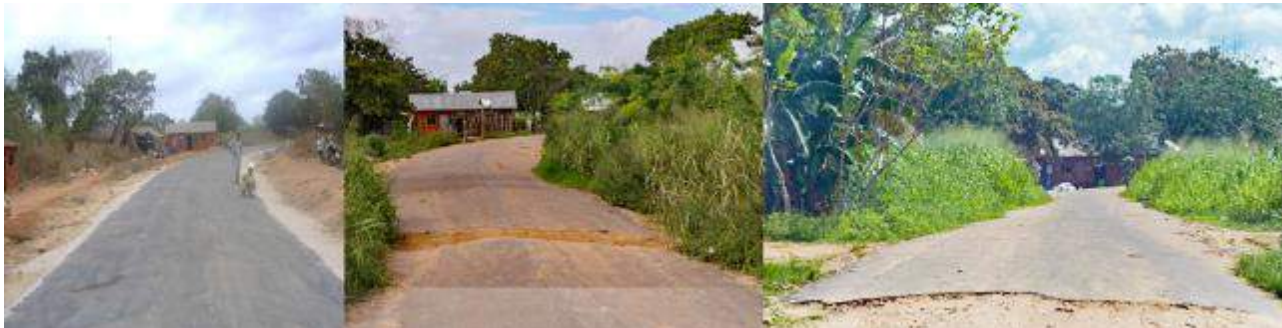
Another road section has a double sand seal. This surface was laid on a gravel base. This section runs through a village and it is probable that this section was used here to reduce dust for the inhabitants. The surface is still smooth, and is in fair condition, but with some erosion especially at edges and at junctions where vehicles access the main carriageway, as can be seen in Figure 109.

Figure 109 The double sand seal section in 2011 (left), 2015 (centre) and 2019 (right)

The villagers appreciated the dust reduction properties of the double sand seal, but not the scope it provided for fast but quiet traffic movements. They therefore, on their own initiative, created three traffic calming humps, before, inside and after the village, as can be seen in Figure 109 (centre) and Figure 110. One of these involved digging a trench across the road.

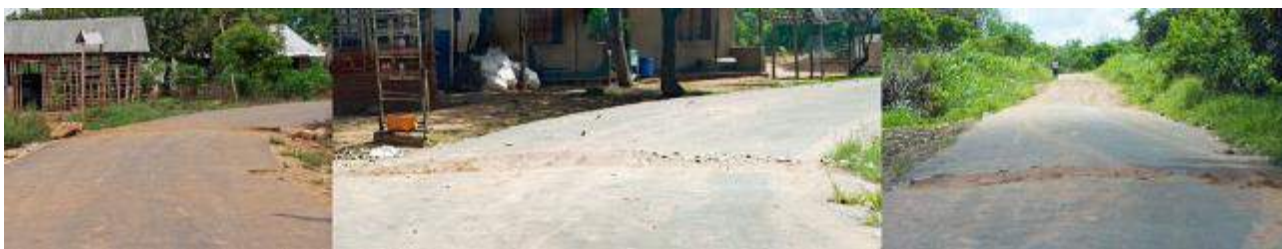
Figure 110 Village attempts at traffic calming on a double sand section in 2015 (left) and in 2019

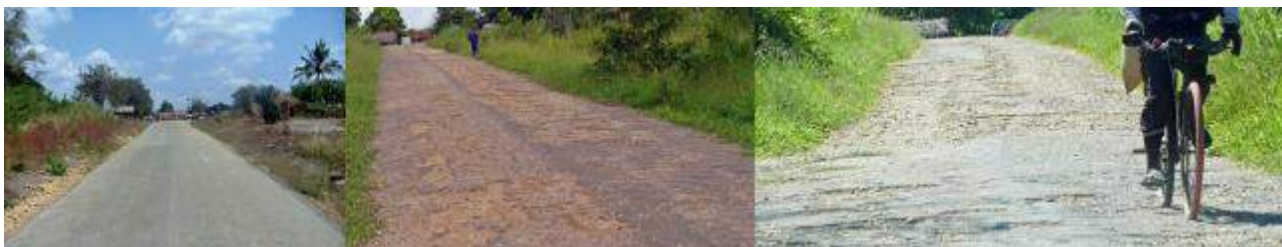
The final section of road as it approaches Talawanda is slurry seal. This is badly deteriorated, where much of the surface is missing and the base is exposed. Figure 111 shows the condition of this section in 2011, 2015 and 2019, showing that much of the surface had eroded by 2015. Despite this, deep potholes have not developed, which suggests that this section had a good foundation. It is also well drained and has low traffic levels. The side drains are overgrown but seem to be functional as the road has maintained its shape. There is no apparent maintenance, judging by the condition of the surface. The section is short, at approximately 200 m, and the road is narrow at the start, approximately 3m wide.

Figure 111 Slurry seal section in 2011, 2015 and 2019

Though most of the trial sections have been effective in providing a good to fair riding quality with all-season access, some sections have had drainage related issues since the trials. Some of the surfacings have not performed well, such as the slurry seal which is badly deteriorated.
