Interactions between improved rural access infrastructure and transport services provision

Report of Tanzania Surveys

ReCAP GEN2136A

June 2020

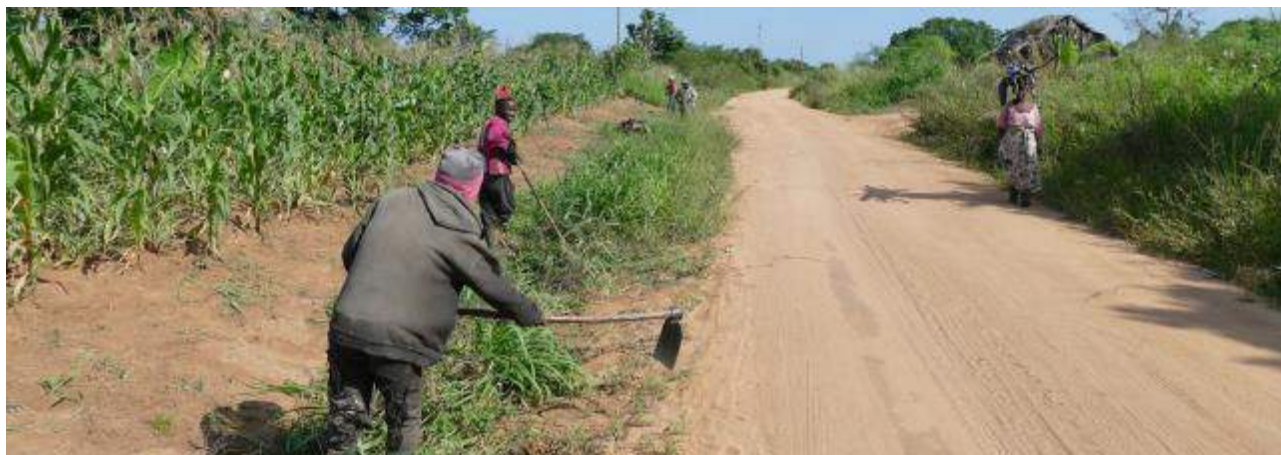
Maintenance is evident on this road, although improvements could be made if more funds could be made available. Maintaining effective drainage is key to keeping this road open all year. Some farmers clear the vegetation growing on the road shoulders adjacent to their fields, as shown in Figure 112.

Figure 112 Farm workers clearing vegetation on road shoulders adjacent to their fields

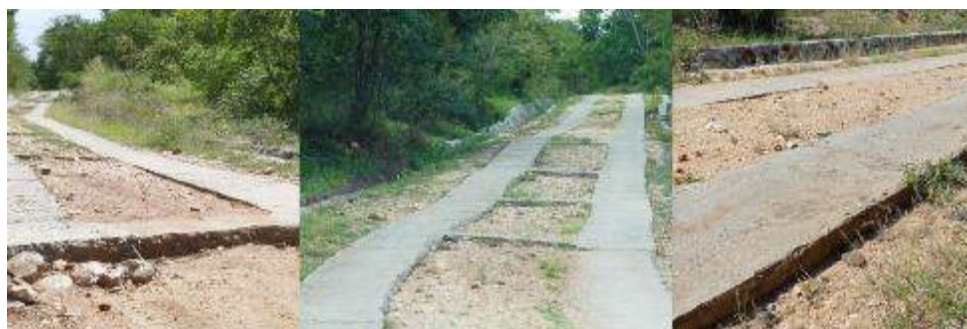
Parallel bituminised strips were developed in Zimbabwe as a low-cost solution for low volume rural roads. For most of the time the cars and small trucks (the main vehicles using those roads at that time) could drive on both the strips, only moving onto the surrounding gravel if they met another vehicle or if a vehicle from behind wished to overtake. This was a cost-effective solution for the small number of vehicles driving in rural areas. The concept was developed with the suggestion that parallel concrete strips could be used on potentially difficult slopes to allow cars, pickups and small buses to gain traction, with a construction price much cheaper than a road-width, concrete slab. The concept is entirely valid when designing roads for small numbers of four-wheel vehicles. However, it becomes invalid if most of the wheeled road users are motorcyclists or bicyclists (as is now the case in Tanzania). Concrete strips have vertical edges, and proud vertical edges are a risk to bicycles and motorcycles, as they can cause the cycles to skid and crash when moving on or off the concrete. When most traffic comprises motorcycles and bicyclists, riders have to move off a strip to pass another cyclist. Less frequently they have to move off the strips to allow a four-wheel vehicle to pass. Each time they move on or off the concrete can be a risk, if there is a proud edge. The concrete strips on the Morogoro road seem to have been quite badly constructed from the outset and had vertical sides from the start (see Figure 91). These worsened with erosion and lack of maintenance, as shown in Figure 120.

Figure 120 Parallel concrete strips on Morogoro road showing dangerous proud vertical edges
