**TARGETED INTERVENTIONS UNDER THE  
RURAL ROAD INVESTMENT PROGRAMME IN  
MOZAMBIQUE (PHASE 1)**

**Construction/Progress Report**

**CLIENT PROJECT REPORT CPR 470**

**by K Mukura, S Done and Dr J Rolt**

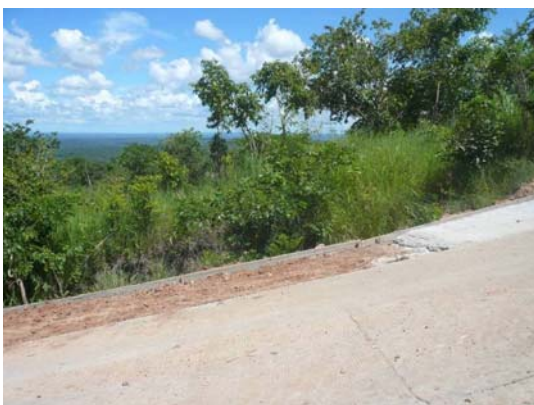
View across a steep section of the ramp

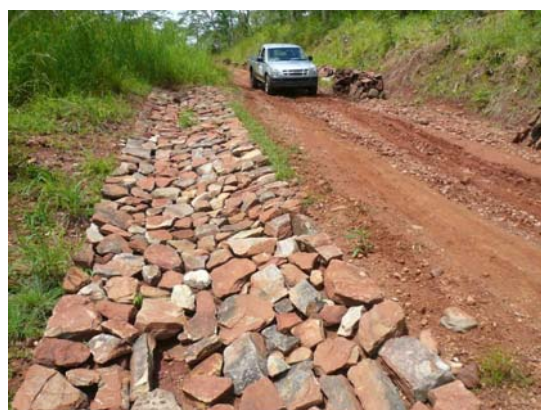
Preparation of mortared stone pitched side drain

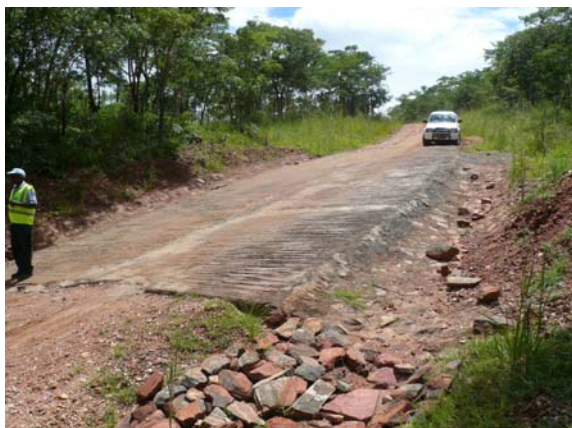
Short trial section of surfacing

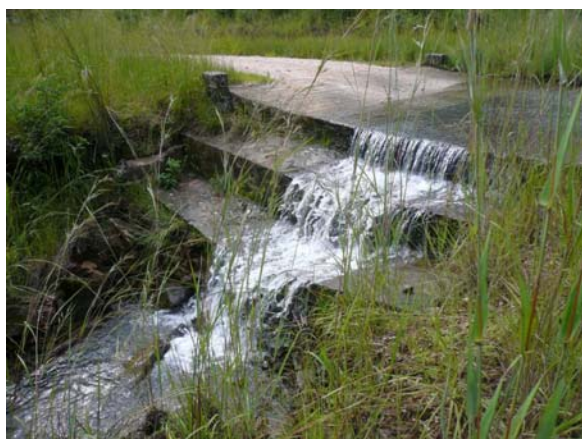
Well designed drift outlet

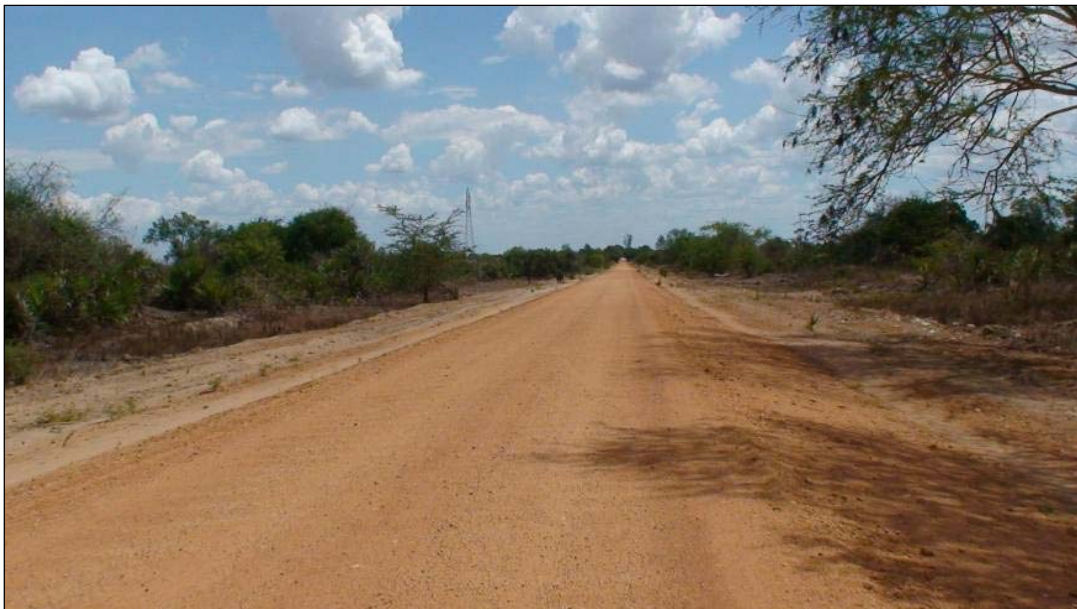
Section of the completed Zero Mopeia road

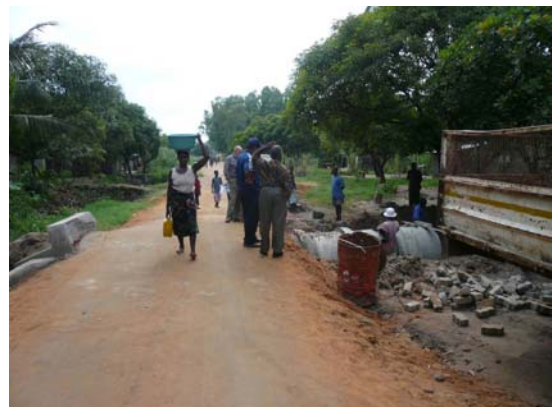
Raised culvert construction in the urban area

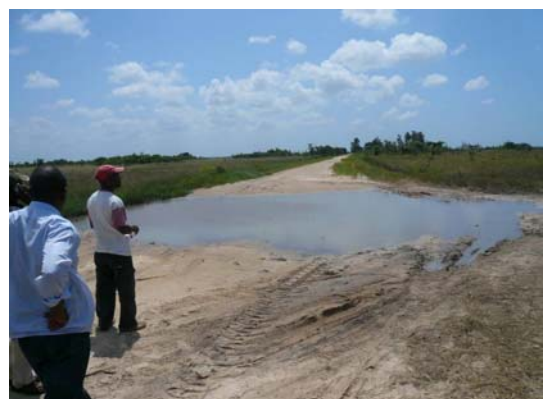
Site of ponding water on the coastal flood

plain

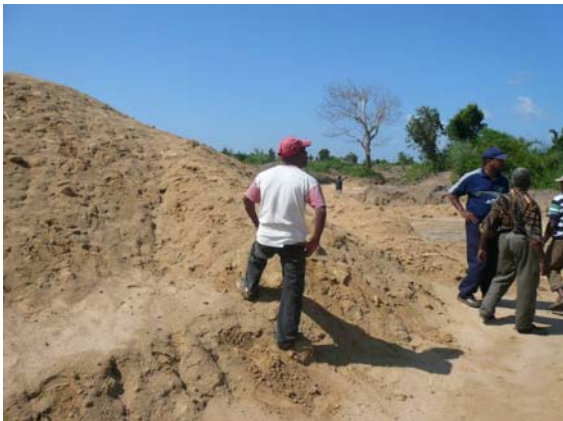
Stockpile of sandy gravel

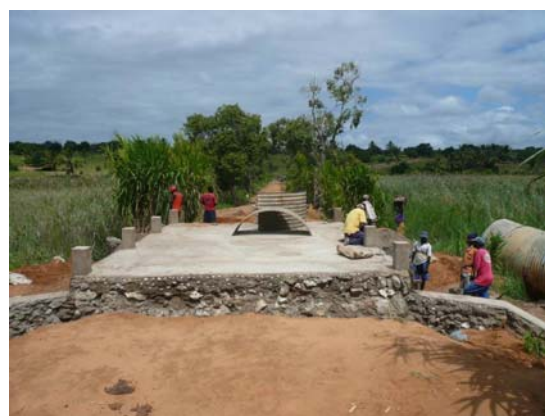
The Rio Cudingene crossing with the bridge in the foreground and the replaced culvert pipes to the right

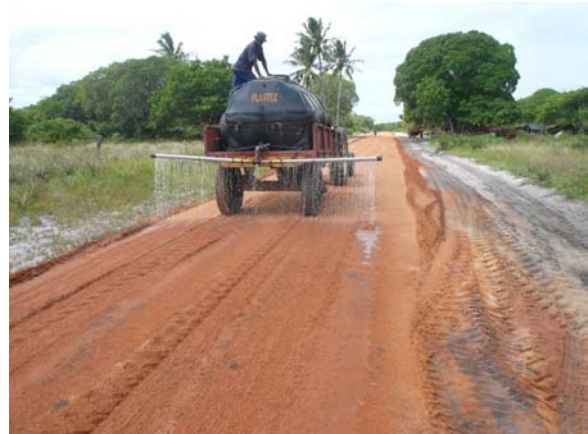
Completed red sand gravel beyond the RRIP funded improvements

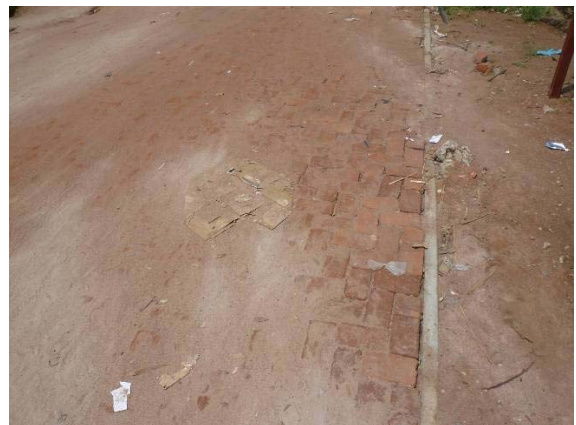
Section 1: Surface detail

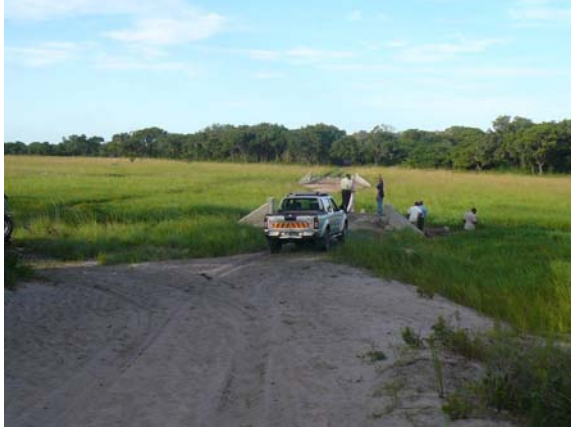
Swamp crossing with two culverts

1. It is essential that all parts of the embankments, including what may be temporary ramps over each culvert, should be properly constructed with good quality materials and adequate compaction.
2. It was recommended that embankments are constructed as soon as culverts are complete while culvert construction continues further along the road.

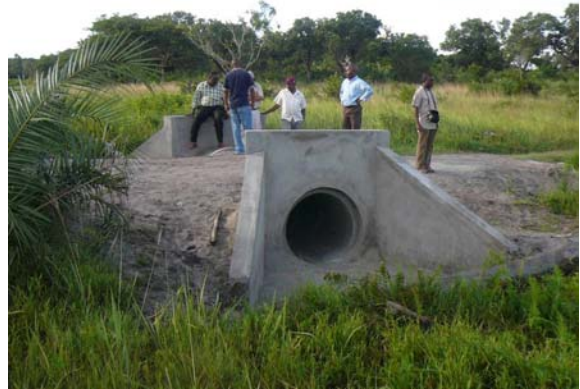
Short access ramps up to soffit level
