Back Analysis of Previous Low Volume Rural Roads in Mozambique

DRAFT PROJECT INCEPTION REPORT

Report No. CPR 1410

Transport Research Laboratory

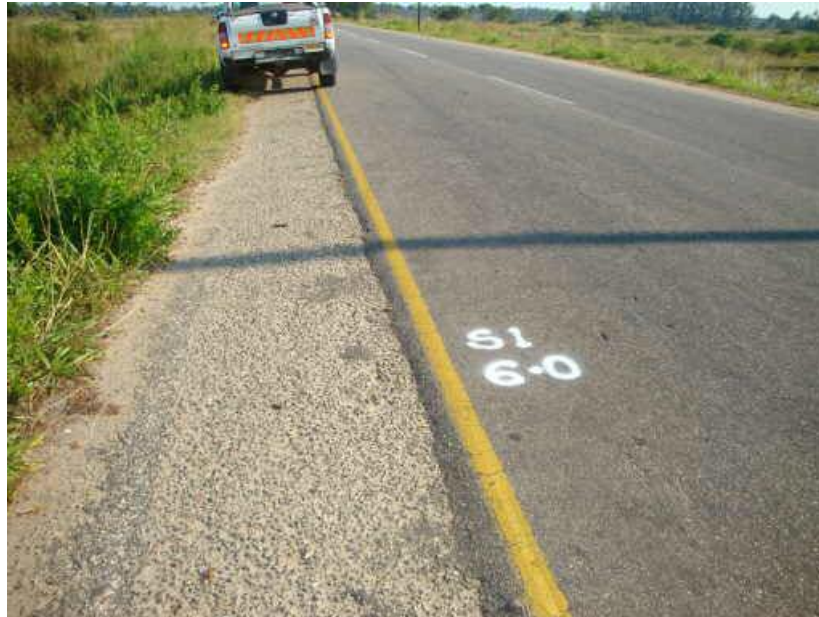
Section 1

Figure 7-5 Typical sections of the Quelimane – Namacurra Road

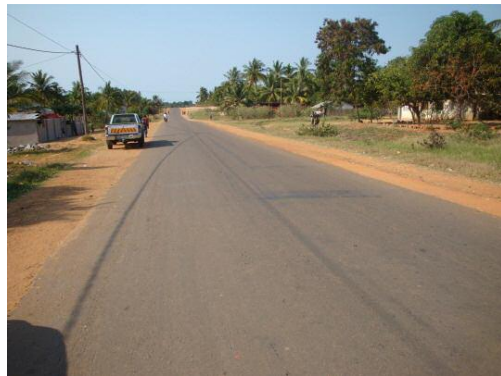
Section 1

Figure 7-6 Typical sections of the Nametil-Angoche road

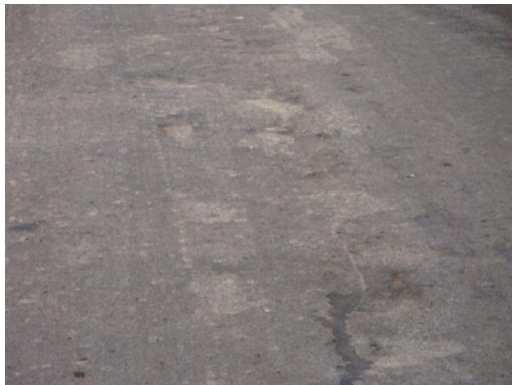
Section 8 is 1.5km long and lies within rolling/undulating and low-lying terrain. It is in a fair condition and is characterised by marginal rutting within the wheel paths, cracking and minor potholes.

Figure 7-9 Typical sections of the Lichinga-Mandimba road

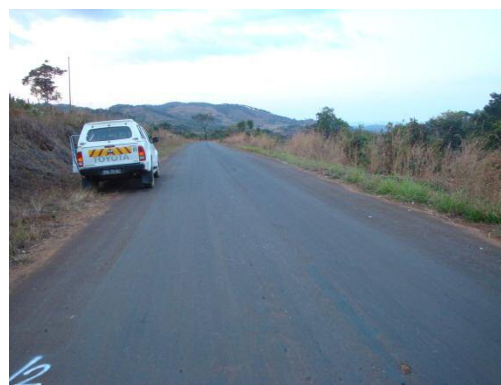
Section 9 is 2km long and lies within rolling/undulating and low-lying terrain. It is in good condition and is characterised by minor rutting, cracking and potholes.
