Climate Adaptation: Risk Management and Resilience Optimisation for Vulnerable Road Access in Africa

Visual Assessment Manual

AfCAP Project GEN2014C

November 2018

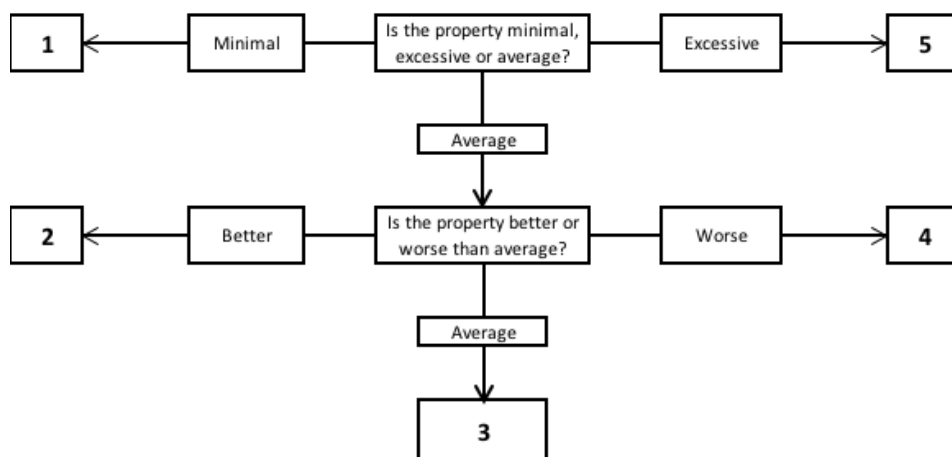
Figure 1 Flow diagram for assessing the degree of defects

A flow diagram illustrating the use of the five-point classification system is shown in Figure 1. The most important categories of degree are 1, 3 and 5. If there is any uncertainty regarding the condition between degrees 1 and 3 or 3 and 5, the defect may be assessed as 2 or 4, respectively.

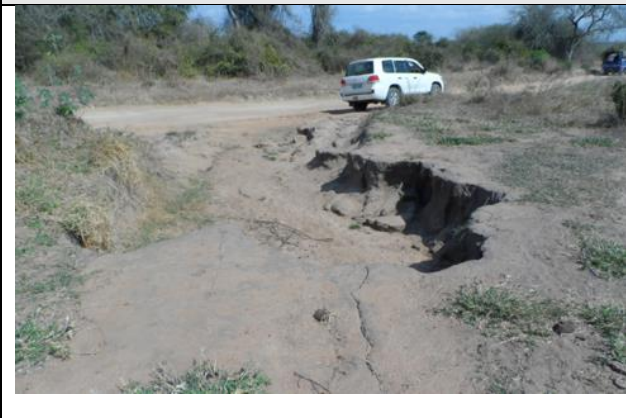
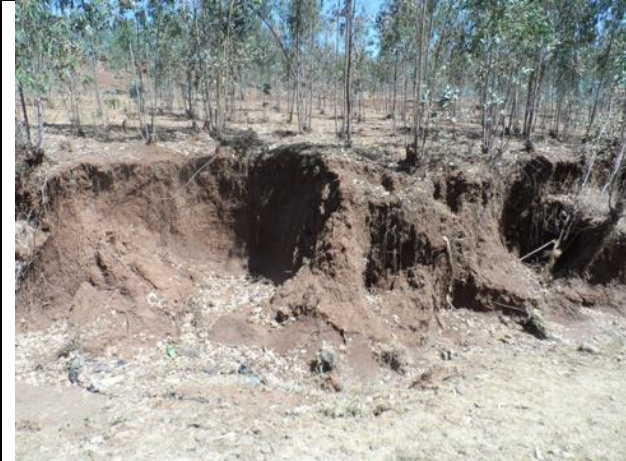
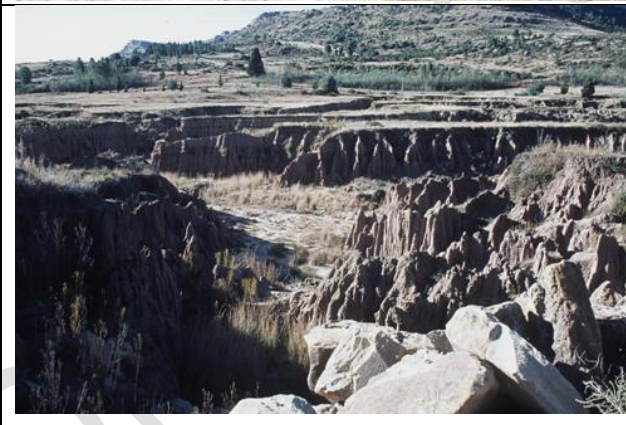
Figure 3 Erosion of areas around the road

Degree	Description
1	Minor evidence of water damage
3	Can be easily seen – protection measures should be considered. Channels >75mm deep x 300mm wide
5	Severe loss of vegetation and material and deposition in drains. Channels > 200mm deep x > 300mm wide – adaptation measures urgently required

1				
		X	2	3	4	5
		Evidence of localised material loss due to channelized water flows

3				
		1	2	X	4	5
		Obvious surface erosion and channelling of water

5				
		1	2	3	4	X
		Severe loss of material and formation of deep erosion gullies

The descriptions of degrees of the various types of erosion are given in Table 3 to Table 6 with degrees 2 and 4 being interpolated between 1 and 3 and 3 and 5 respectively and illustrated in Figure 3 to Figure 6 respectively.

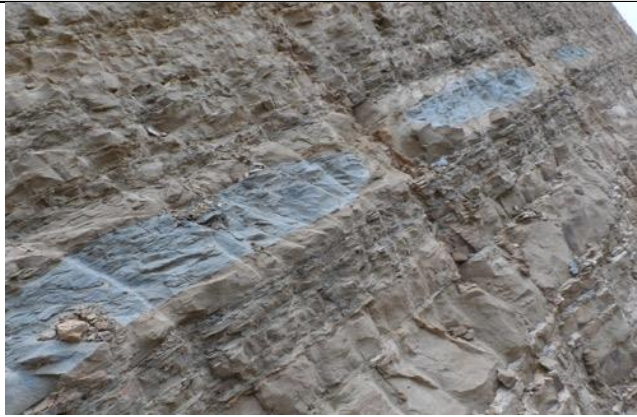
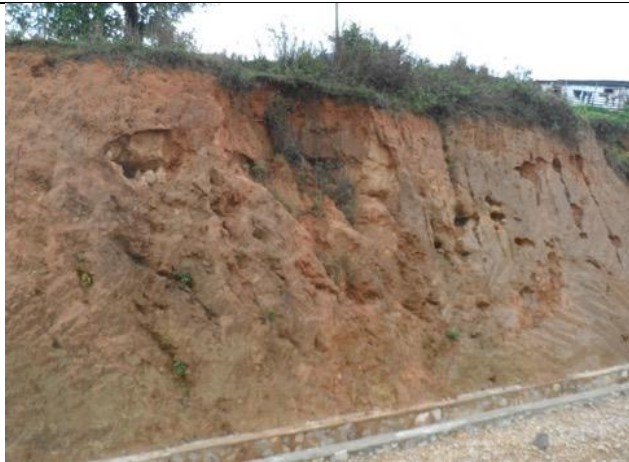
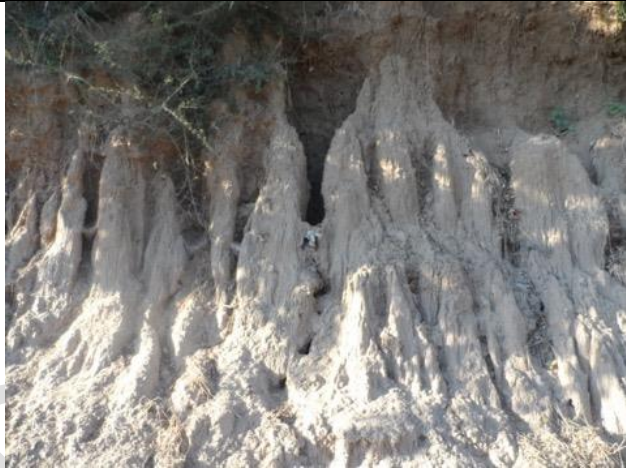
Figure 6 Erosion of cut slopes

1				
	X	2	3	4	5
	Minor evidence of water damage

3				
	1	2	X	4	5
	Channels on slopes and notable loss of slope material. Channels >75 mm deep x 300 mm wide

5				
	1	2	3	4	X
	Severe loss of material and development of deep channels (> 200 mm deep x >300 mm wide)

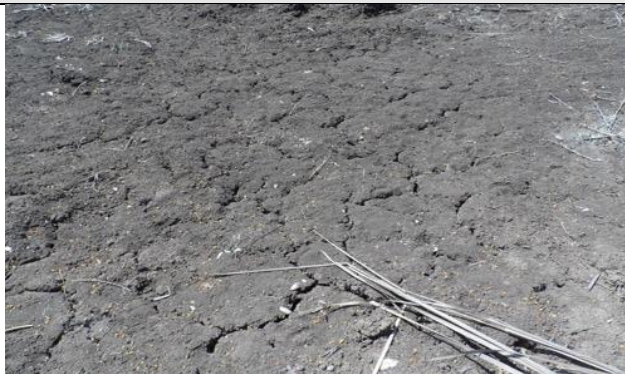
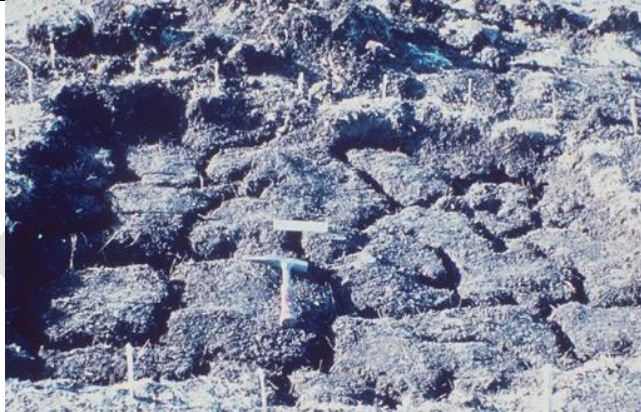
Figure 7 Expansive clays

Usually black, dark grey or red. Shows distinctive cracking with wide, open cracks. May be masked by vegetation and so one needs to look for open exposed areas. If no cracks are observed the material will be identified as non-expansive. If wide cracks (Degree 5 in Figure 7) are observed, the material should be identified as highly expansive. These materials also tend to slake (disintegrate to clay) when placed in water.

3				
	1	2	X	4	5
	Moderately expansive clays – cracks 5 – 10 mm wide

5				
	1	2	3	4	X
	Highly expansive clays – cracks > 10 mm wide

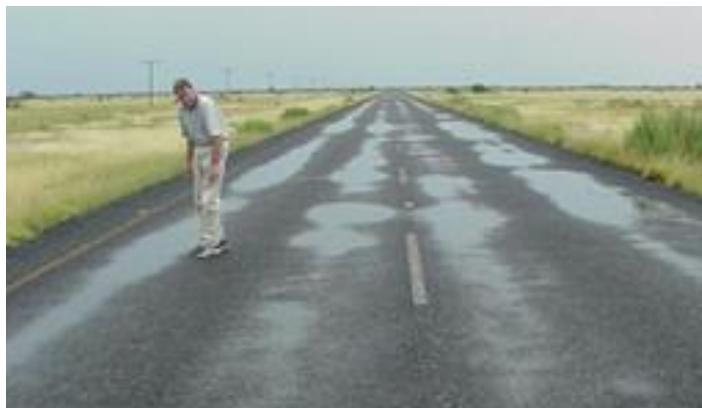
Figure 8 Typical manifestation of collapsible soils in paved road

Collapsible soils are difficult to identify in the field without very close inspection. These soils consist of individual particles of hard sands that are supported by clay, iron or calcite “bridges” and often contain obvious voids (pinholes). When these materials are loaded under wet conditions, the “bridges” collapse and the material decreases in volume, usually manifested as distinctive rutting in the wheel tracks (Figure 8). Most collapsible soils consist of highly weathered granites or sandstones, or else transported sandy

soils, although various other materials may have a collapsible structure. In the field, it is thus important to identify the type of material and look for signs of collapse on similar materials in the area. Local engineering knowledge will often be available if collapsible soils are present.

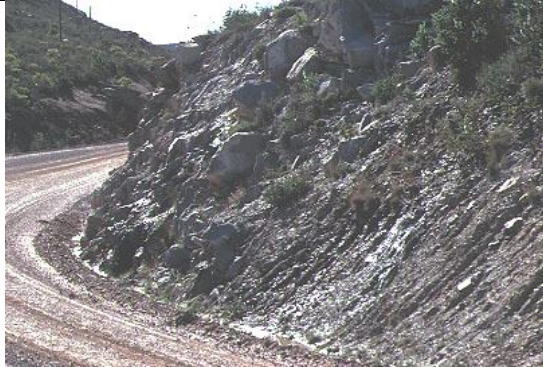
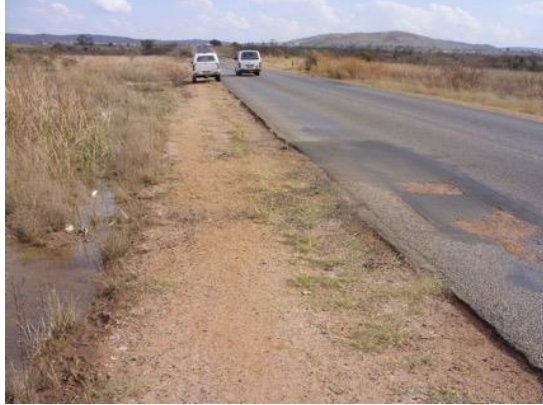
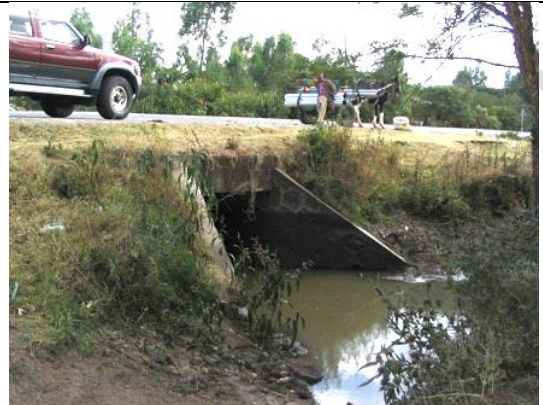
Figure 10 Wet areas

1				
	X	2	3	4	5
	Minor evidence of localised, but controllable water problems

3				
	1	2	X	4	5
	Standing water adjacent to road surface or evidence of perennial water accumulation

5				
	1	2	3	4	X
	Permanent high water-tables

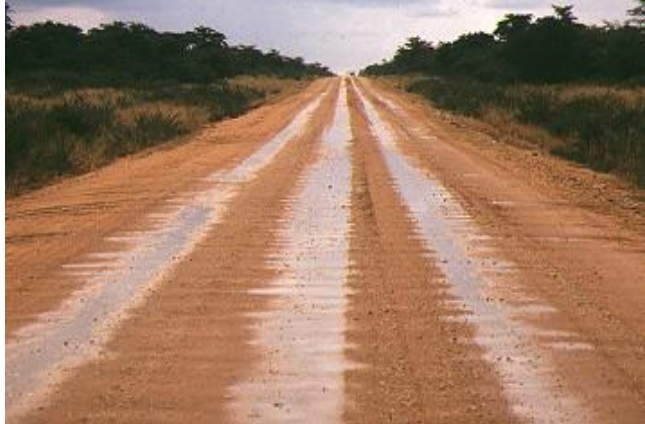
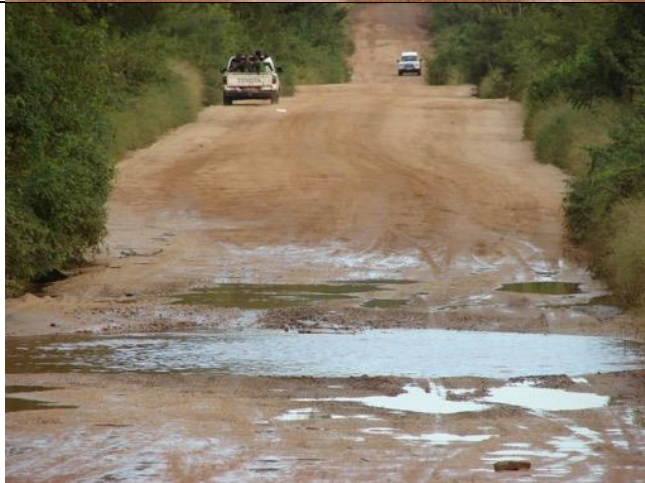
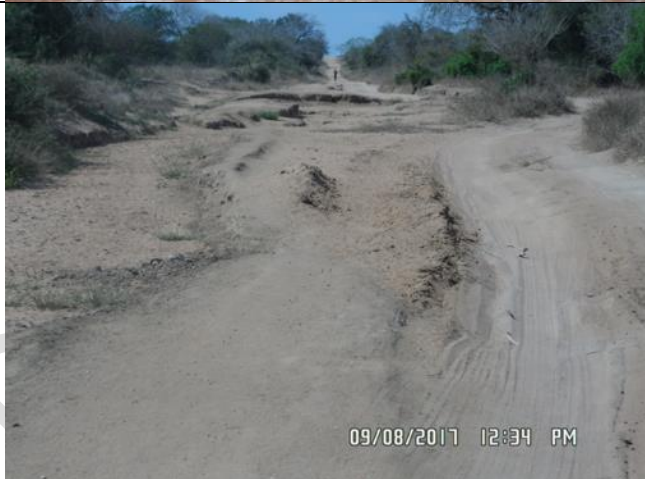
Figure 12 Road shape (unpaved roads)

Degree	Description
1	Good shape and cross-fall - Minor susceptibility to retaining shallow water on the surface.
3	Uneven road with poor camber leading to ponding of water on road surface
5	Road is below surrounding ground level and water will not be removed before distress is caused

<p data-bbox="582 1630 817 1659">09/08/2017 12:34 PM</p>		5				
		1	2	X	4	5
		Uneven road with poor camber leading to ponding of water				
		1	2	3	4	X
		Road is below surrounding ground level and water will not be removed before distress is caused

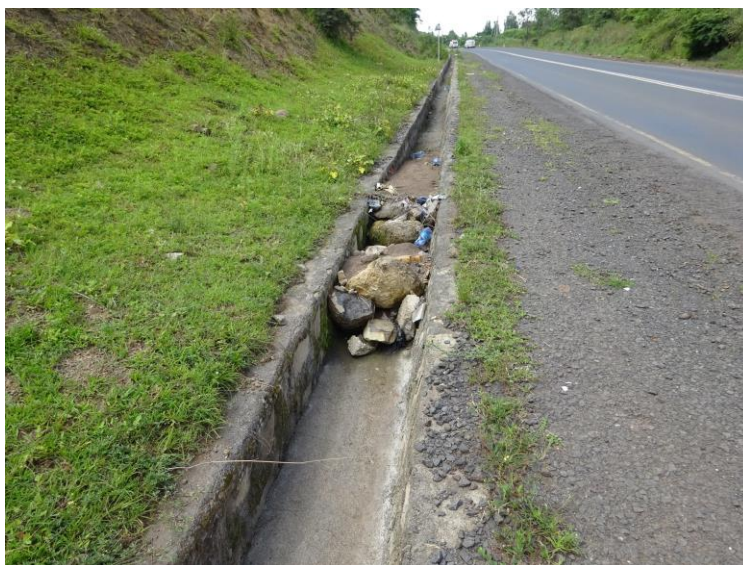
Figure 15 Unpaved area between impervious seal and lined drain allowing access of water into the pavement (Note poor maintenance of side drain as well)

The assessment should indicate whether the shoulders are shaped to remove water from the road surface towards the side slopes and side-drains. A common observation is the presence of unpaved areas between the sealed road pavement and the lined side-drains, which is considered unacceptable (Figure 15) as water will penetrate through these areas into the pavement layers.

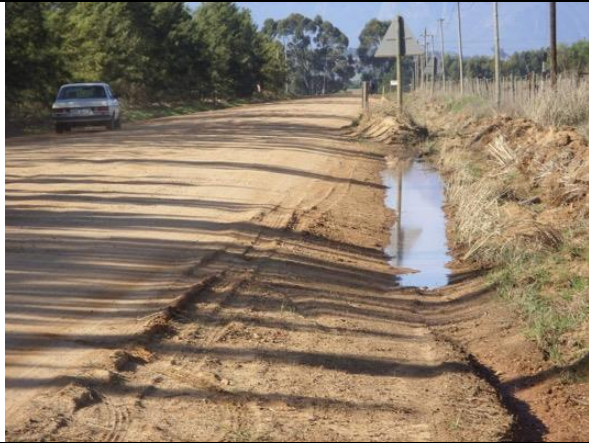
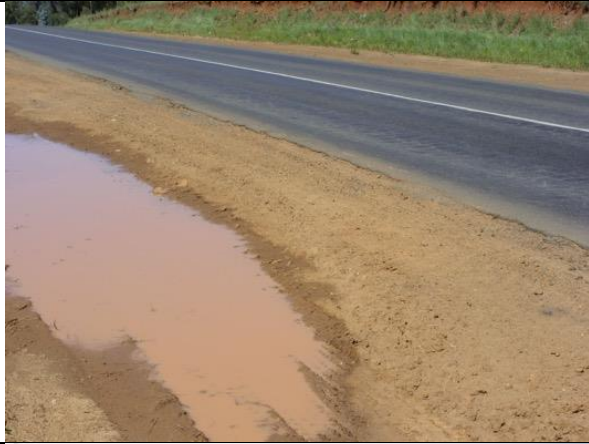
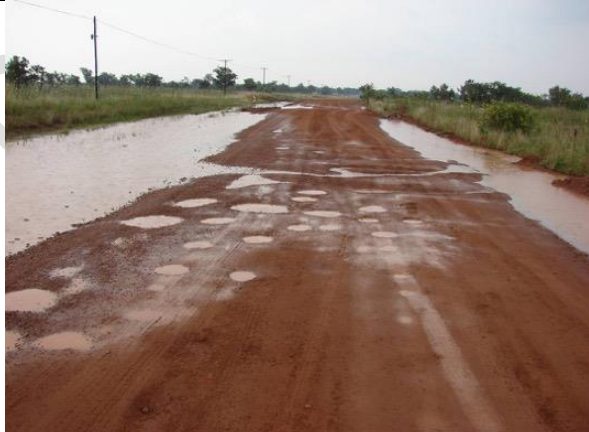
Figure 17 Effectiveness of side drains

Degree	Description
1	Most water is effectively removed but localised ponding of short duration may occur
3	Drains are incorrectly graded or have uneven surfaces, that retain water for prolonged periods
5	No effective drains or else water is not removed from road side

<table border="1"> <tr> <td colspan="5">1</td> </tr> <tr> <td>X</td> <td>2</td> <td>3</td> <td>4</td> <td>5</td> </tr> <tr> <td colspan="5">Most water is effectively removed but localised ponding of short duration may occur</td> </tr> </table>	1					X	2	3	4	5	Most water is effectively removed but localised ponding of short duration may occur				
	1															
	X	2	3	4	5											
Most water is effectively removed but localised ponding of short duration may occur

<table border="1"> <tr> <td colspan="5">3</td> </tr> <tr> <td>1</td> <td>2</td> <td>X</td> <td>4</td> <td>5</td> </tr> <tr> <td colspan="5">Drains are incorrectly graded or have uneven surfaces, that retain water for prolonged periods.</td> </tr> </table>	3					1	2	X	4	5	Drains are incorrectly graded or have uneven surfaces, that retain water for prolonged periods.

<table border="1"> <tr> <td colspan="5">5</td> </tr> <tr> <td>1</td> <td>2</td> <td>3</td> <td>4</td> <td>X</td> </tr> <tr> <td colspan="5">No effective drains or else water is not removed from road side</td> </tr> </table>	5					1	2	3	4	X	No effective drains or else water is not removed from road side				
	5															
	1	2	3	4	X											
No effective drains or else water is not removed from road side

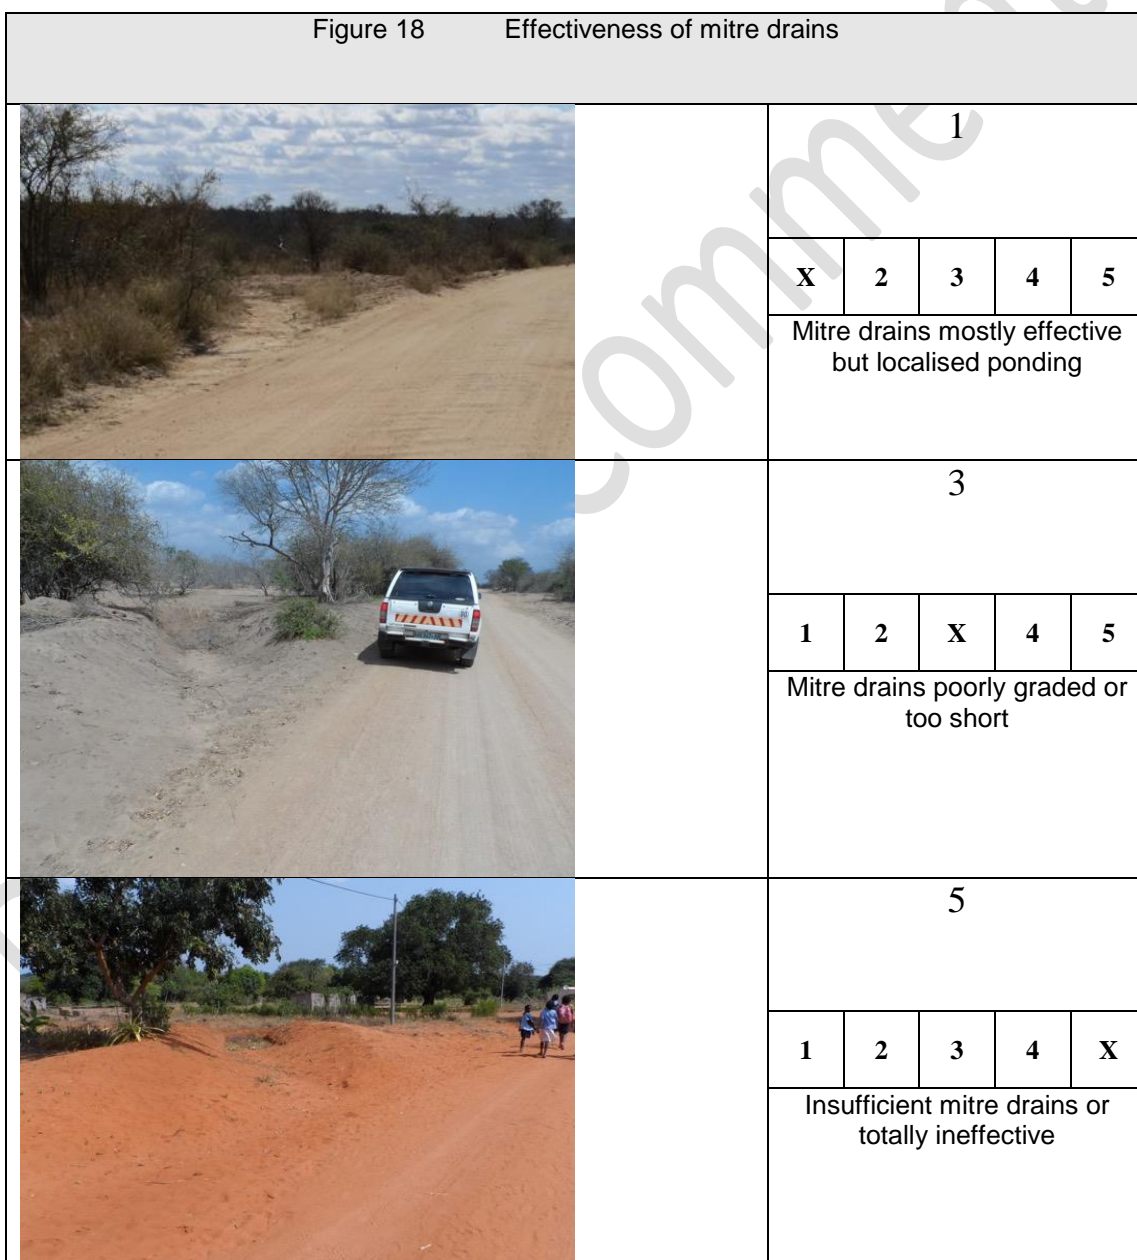
Table 12 Effectiveness of mitre drains

Degree	Description
1	Mitre drains mostly effective but localised ponding
3	Mitre drains poorly graded or too short
5	Insufficient mitre drains or totally ineffective

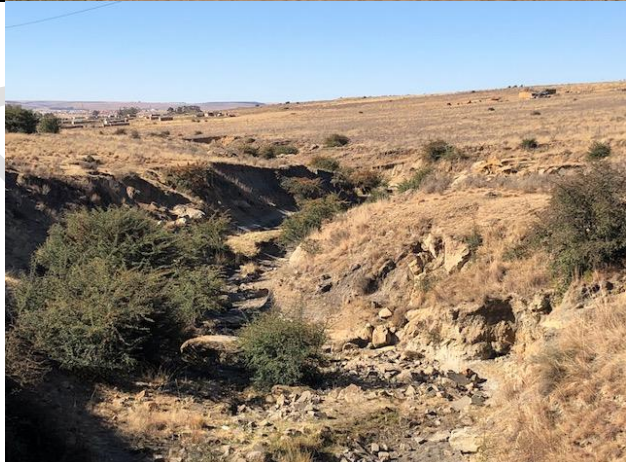
Degree	Description
1	Minor evidence of stream erosion
3	Loss of material from river banks. Signs of erodibility
5	Severe erosion and loss of material from river/stream banks near structure

Figure 21 Erosion of river/stream banks					
 	1				
	X	2	3	4	5
	Minor evidence of stream erosion				
 	3				
	1	2	X	4	5
	Loss of material from river bank. Signs of erodibility

5				
	1	2	3	4	X
	Severe erosion of river banks near structure

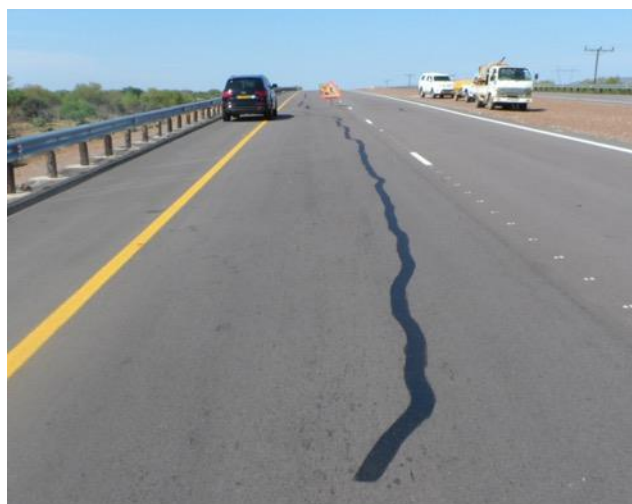
Figure 24 Cracking of embankment due to overstressing

The stability of embankments must be assessed. Unlike cuts, there is usually evidence of arcuate cracking on the surface of the embankment prior to failure and evidence of such cracking should be investigated. Many high embankments develop one or two longitudinal cracks which are indicative of tensile strains in the upper portion of the fill (Figure 24), but provided that they are timeously sealed, will not usually lead to failure.

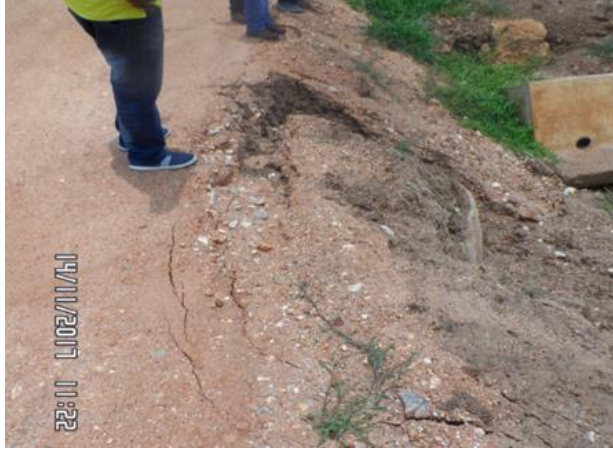
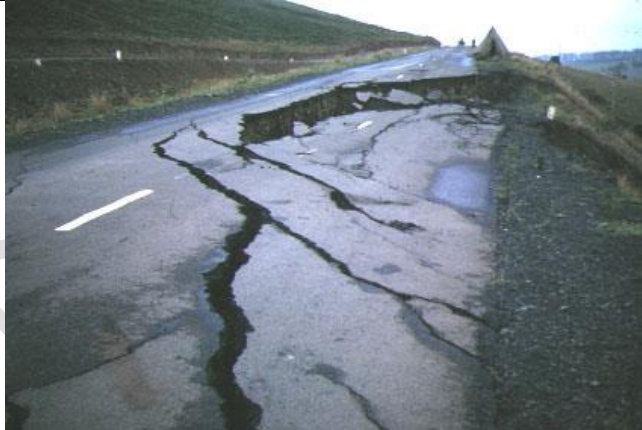
Figure 25 Stability of embankments

Degree	Description
1	Minor evidence of surface instability – localised arcuate cracking of road surface
3	Evidence of widespread or large arcuate cracks with minimal vertical displacement – failure unlikely (restricted to one lane) or will only cause short-term disruptions to traffic flow
5	Evidence of or potential for large failure causing closure of road for extended period

1					
	<table border="1"> <tr> <td style="text-align: center;">X</td> <td style="text-align: center;">2</td> <td style="text-align: center;">3</td> <td style="text-align: center;">4</td> <td style="text-align: center;">5</td> </tr> </table>	X	2	3	4	5
	X	2	3	4	5	
<p>Minor evidence of surface instability</p>						
 	3					
	<table border="1"> <tr> <td style="text-align: center;">1</td> <td style="text-align: center;">2</td> <td style="text-align: center;">X</td> <td style="text-align: center;">4</td> <td style="text-align: center;">5</td> </tr> </table>	1	2	X	4	5
	1	2	X	4	5	
<p>Evidence of widespread or large arcuate cracks with minimal vertical displacement – short-term disruptions to traffic flow</p>

1	2	3	4	X	
<p>Evidence of or potential for large failure causing closure of road for extended period</p>

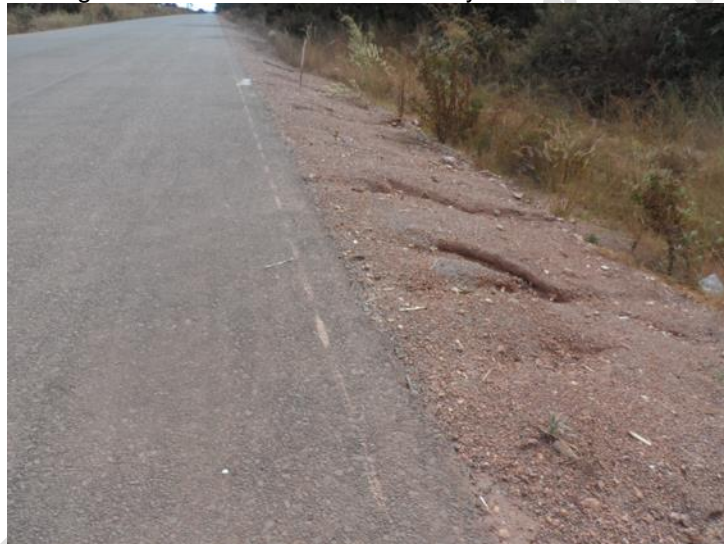
Figure 26 Poor finish of newly constructed road

The overall finish of the road should be visually assessed in terms of the impression that a good job was done during construction. Typically, poor finishing off and a product that does not look neat is indicative of the possibility that the construction quality was not ideal (Figure 26). A typical example of this on unpaved roads, is the presence of excessive oversize material, when the specification included a limit on the maximum size.

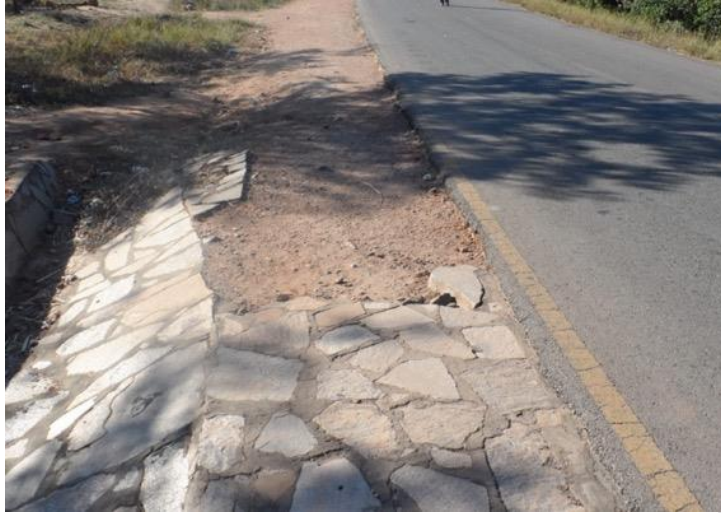
All erosion protection measures should be assessed to ensure that they are intact, integral and do not allow water to enter behind or through them. This is normally a simple visual inspection (Figure 27), although the presence of “anchoring beams” may be difficult to observe in some areas.

Figure 27 Poor finish of protection works resulting in failure – no “anchor” beams

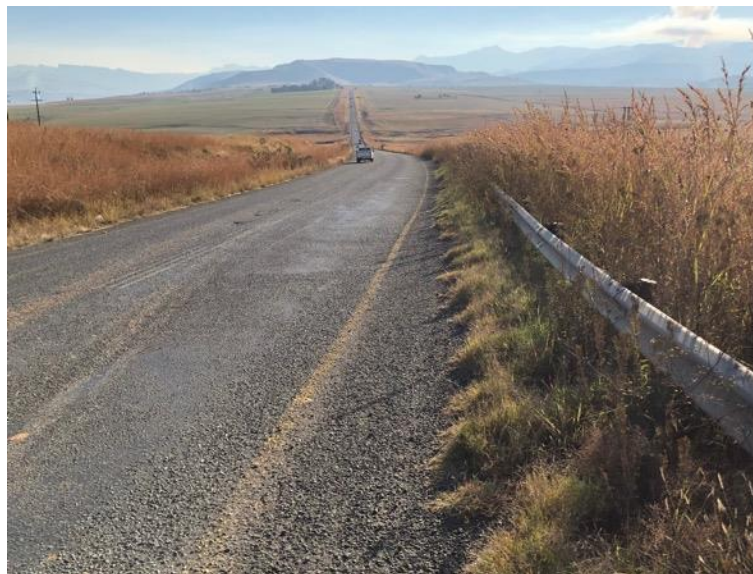
This can also only be assessed if maintenance has been carried out recently before the assessment. Issues to be looked at include vegetation control, cleaning of drains, shaping of gravel shoulders, repair of potholes and cracks in paved roads, grading of unpaved roads, etc. The extent rating would normally be 0

or 5 for routine maintenance, excluding pothole patching or crack sealing. It is unusual for vegetation control or shoulder maintenance to be carried out over limited sections, although this is possible.

Figure 28 Thick vegetation alongside road indicating insufficient maintenance (rated at 5/5)

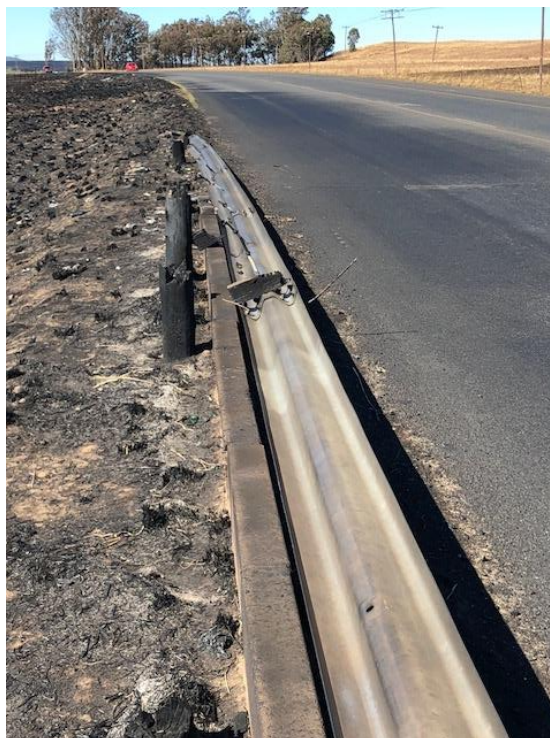
Recently, the impact of wildfires combined with extremely windy conditions has been noted on guard rail supports (Figure 30). Burning of the wooden supports has resulted in collapse of the guard-rail. In addition, obvious damage to the bitumen seal (on the left side of the photograph) can be clearly noted in the Figure. Such instances would be recorded under comments.

Figure 30 Damage to guardrail posts and bitumen surfacing caused by wildfire
