The use of appropriate high-tech solutions for road network and condition analysis, with a focus on satellite imagery

Tanzania report

*AFCAP Project Reference
Number. GEN2070A*

30th April 2018

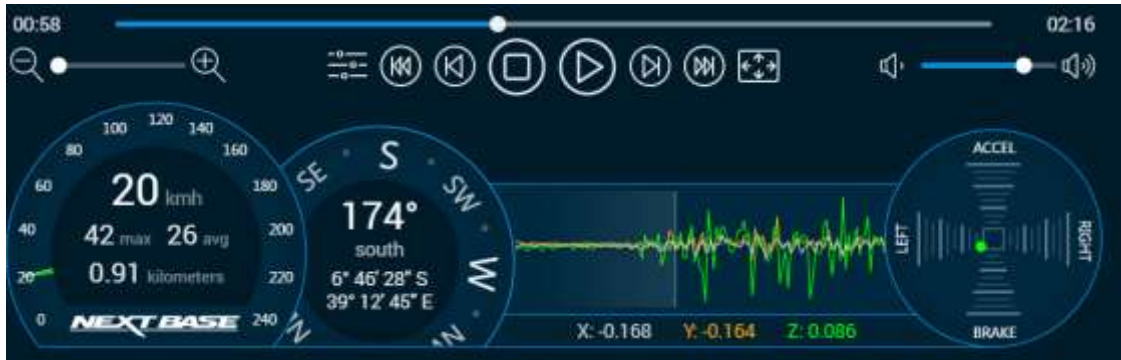
Figure 1: Accelerometer readings from DashCam

and Z movement of the equipment is recorded and displayed on a graph in the video software (Figure 1), which has the potential to be linked to road roughness. These DashCams were found to be very useful and there would be scope to develop a low-cost product specifically for this use.

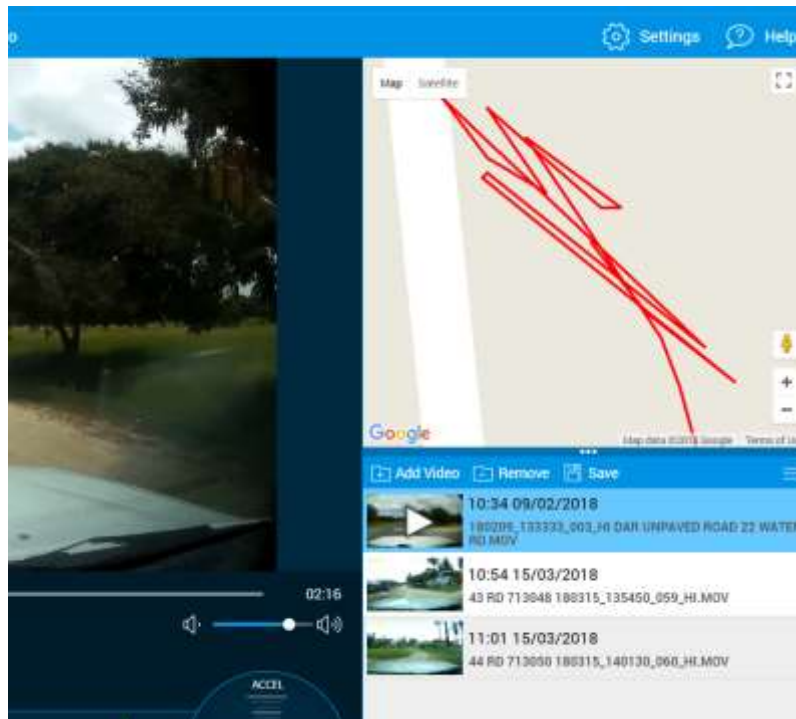
Figure 2: GPS creep

It was noticed that the distance measured by the GPS in the DashCam can vary slightly. Upon further investigation it was found that when the recording is turned on too early whilst the vehicle is stationary the GPS experiences creep as the satellite connections change. This is demonstrated in Figure 2, which shows the start of the GPS track as a red line when the vehicle was stationary for approximately two minutes. The result is that the camera should only be turned on when the vehicle is ready to move, and not before, and should be stopped immediately as the vehicle comes to halt.

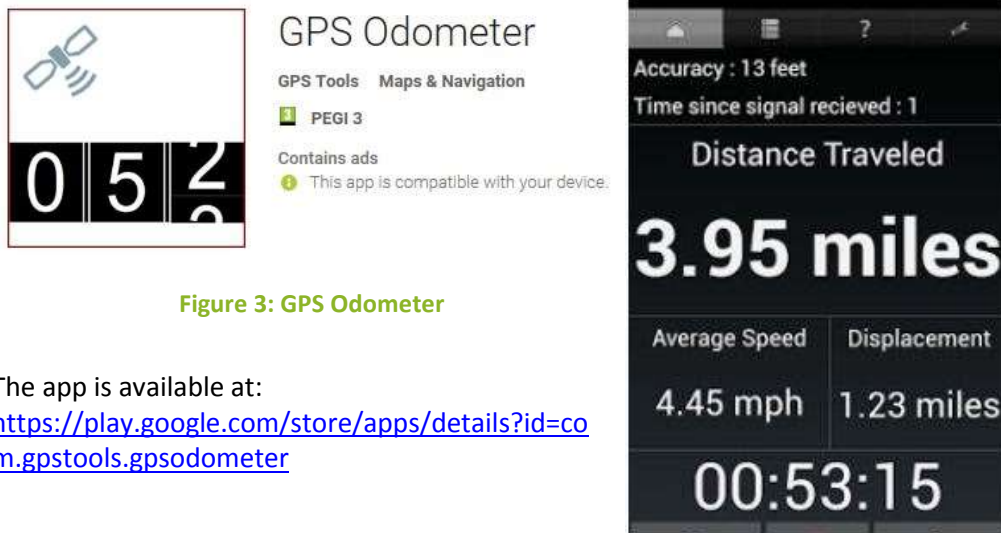
Figure 3: GPS Odometer

- An app called ‘GPS odometer’ was used to record road length. This does not require connection to internet or data, so was effective in rural areas, so long as satellites were readily contactable (some issues could arise in very hilly areas). This records the horizontal distance travelled, as well as the displacement between the start and end points (distance ‘as the crow flies’) and time. It also records the current or average speed travelled. The frequency of GPS signals received and the probable accuracy are also shown. The odometer can be set to record in miles or kilometres, Figure 3 shows the app logo and a sample of the app readout.

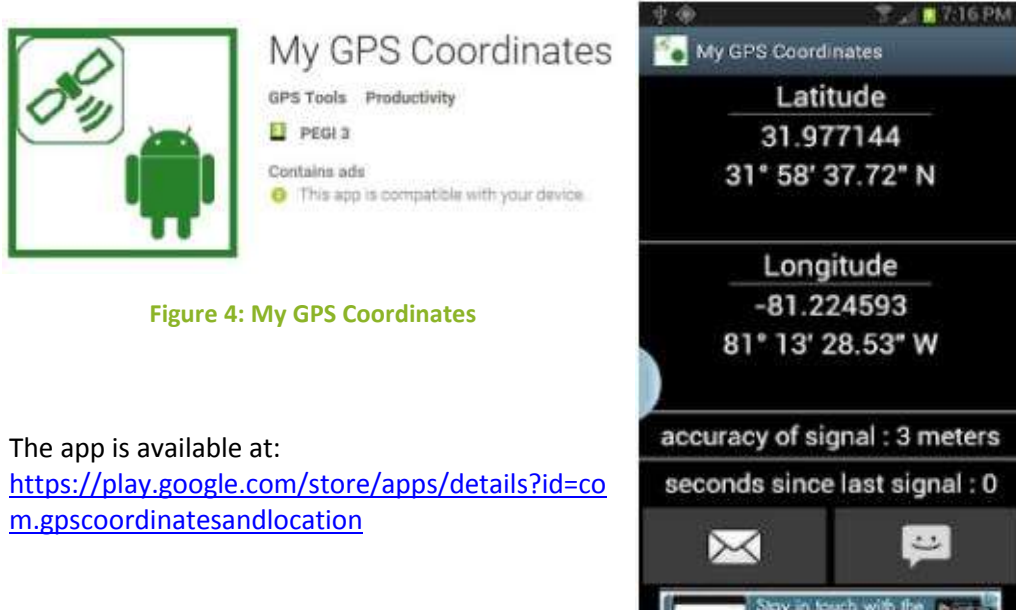
Figure 4: My GPS Coordinates

- An app called ‘My GPS Coordinates, shown in Figure 4, was also used to determine geographical coordinates at a certain location. This app simply shows the coordinates of the smartphone in both Longitude/Latitude and UTM Easting/Northing and does not require an internet connection. The frequency of GPS signals received and the probable accuracy are also shown.

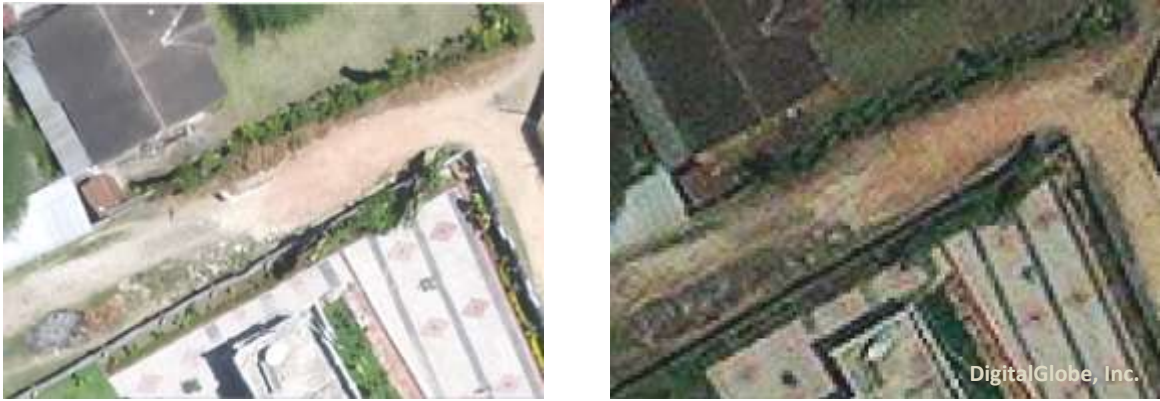
Figure 5: Comparison on semi-urban roads

The imagery in Figure 5 is a typical semi-urban road in Dar es Salaam, which is in poor/bad condition. There is more definition in the drone image, for example the roofs are well defined and the areas of dark on the road in the satellite image, can be identified as piles of materials on the drone image.

The World Bank has also provided UAV imagery for the area of Dar es Salaam that overlaps the satellite imagery, so that synergies can be explored. This imagery was collected during the training in April 2018 and a comparison of the imageries is shown below. These high-tech solutions and their potential application in Tanzania were discussed at the training, as noted in Annex 2. In all of the following images the drone image is shown on the left, and the satellite image is shown on the right.

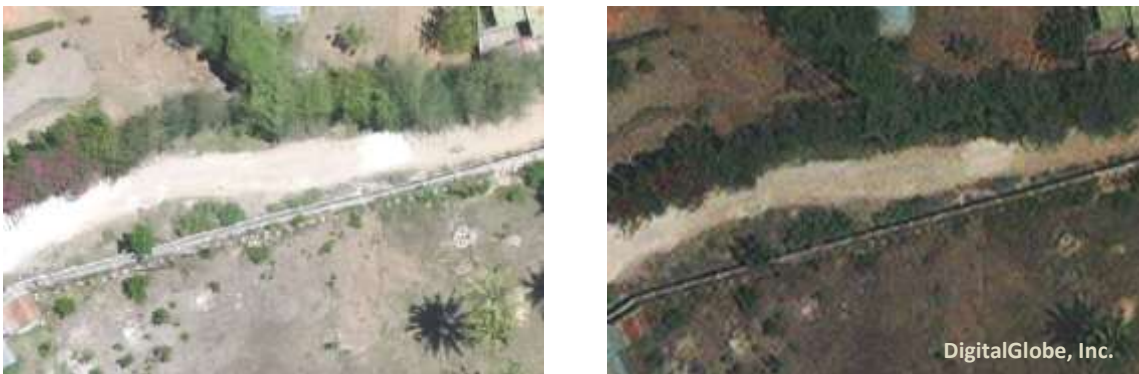
Figure 6: Rural road comparison

Figure 6 shows a road in a more rural area. Because of the processing of the image, and the lower zoom, the details of the road surface are as clear, if not clearer, in the satellite image on the right. This demonstrates how the processing affects the clarity of the image. It is important to have the imagery processed to suit the purpose at hand. As the drone imagery is intended for monitoring the Bus Rapid Transport (BRT) roads in Dar es Salaam, it is assumed that it has been processed for an asphalt surface, whereas the satellite imagery has been processed specifically for use with rural unpaved roads.

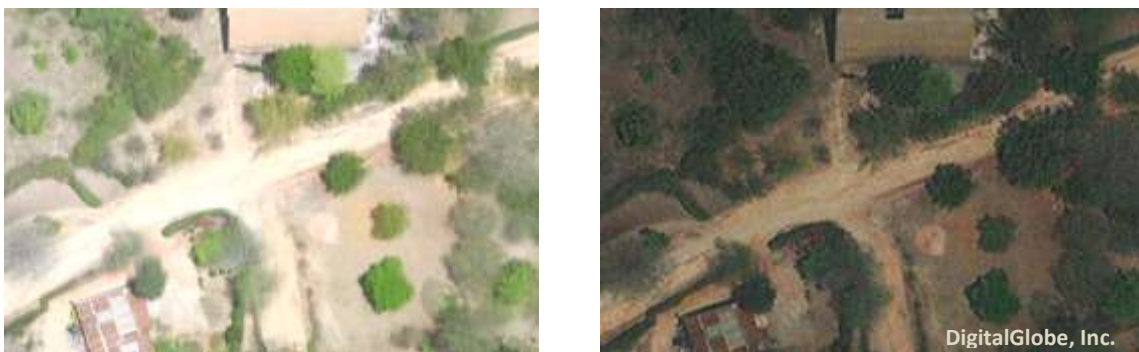
Figure 7: Comparison on brightness on rural roads

Figure 7 again shows a rural area, where the unpaved road appears as too light to be able to see details of the surface of the road. There are of course tools available in QGIS to adjust the brightness, contrast, etc. of the imagery, but the original processing (in the case of the satellite imagery the pansharpener process) is also important.

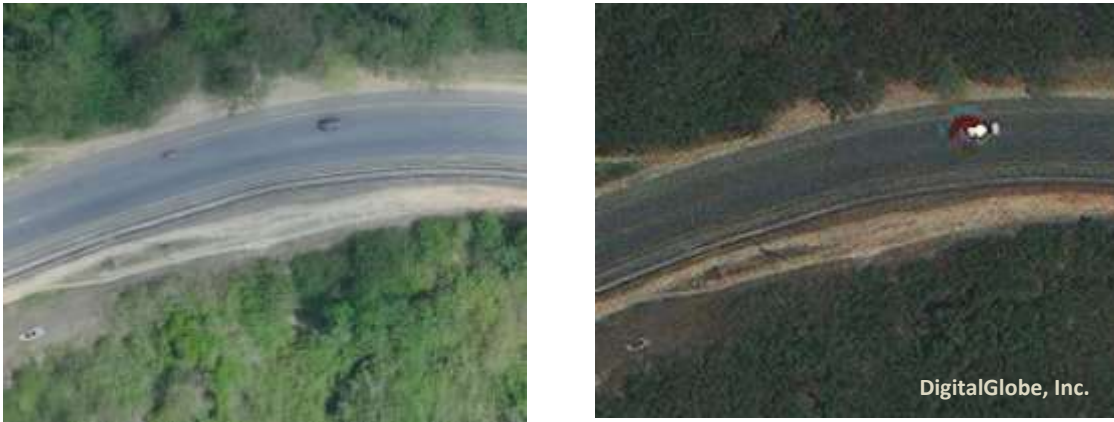
Figure 8: Paved road comparison

The processed drone imagery of paved roads does appear to be clearer, as opposed to the satellite imagery on paved roads. The pictures in Figure 8 show that more detail can be gained for the paved road.

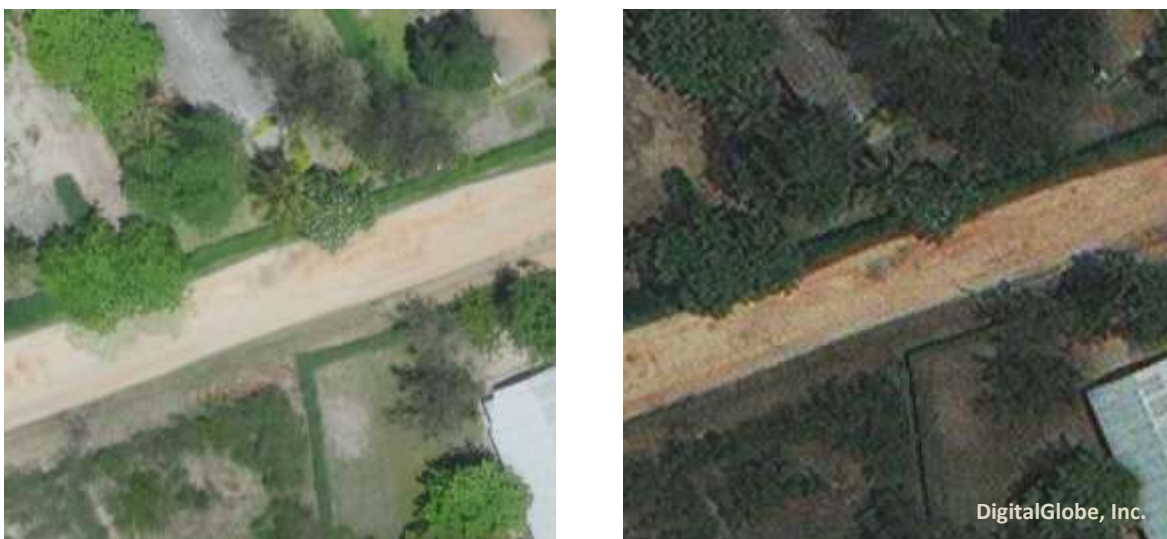
Figure 9: Unpaved road surface defects

Figure 9 shows a mainly rural road. There are clearly some defects on the road surface, which are visible on both images. As the drone image is lighter, it is arguably harder to define the defects in a manual assessment. It will be interesting to see how the project in Zanzibar manages to distinguish road surface defects using machine learning and whether that has potential for automated condition assessment. Also the drone imagery may have variable lighting as the drones fly below the clouds and the images could therefore have different brightnesses. As the drone imagery is essentially a mosaic of different images, this could make it difficult to assess the varying imagery consistently.

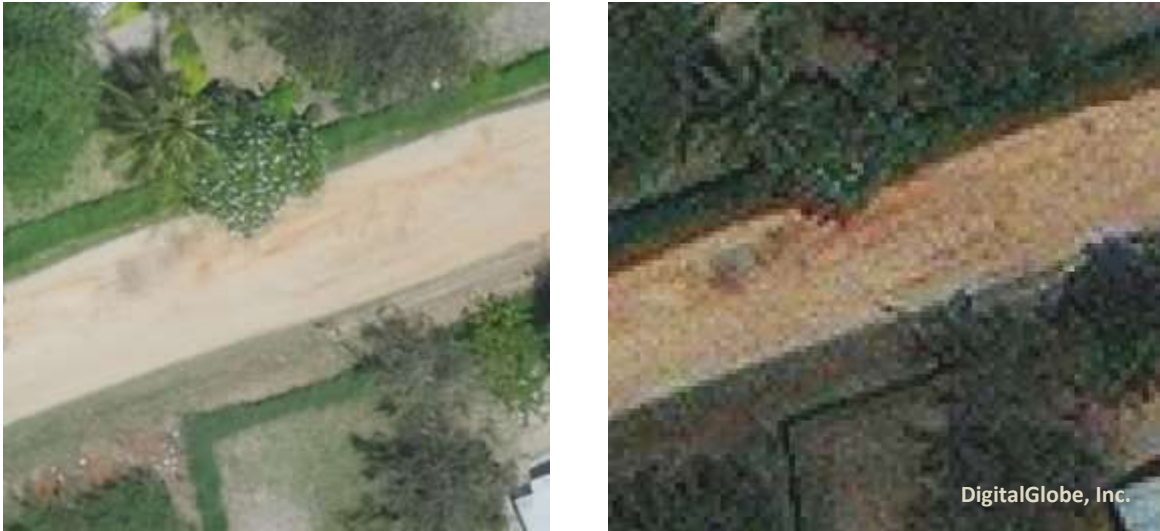
Figure 10: Close-up of unpaved road defects

Figure 10 shows the same road, but zoomed in so that the defects are more visible on the drone imagery. At the same zoom, the defects on the satellite image appear to be less clear and have become pixelated. The width of the road and the edges are also clearer in the drone image, but can still be distinguished on the satellite image.

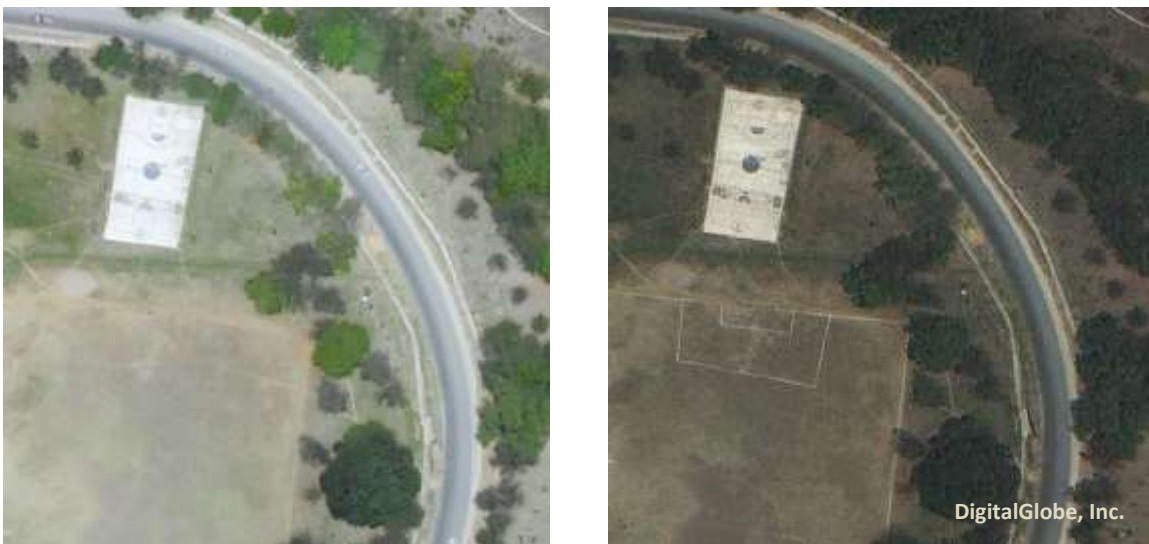
Figure 11: Processing differences between drone and satellite imagery

The difference in processing can clearly be seen in the images in Figure 11. Particular features that vary between the images are the lines on the football field and the definition of the road edges and footpaths. Given that the images were acquired within a few days of each other, this is quite a striking difference.

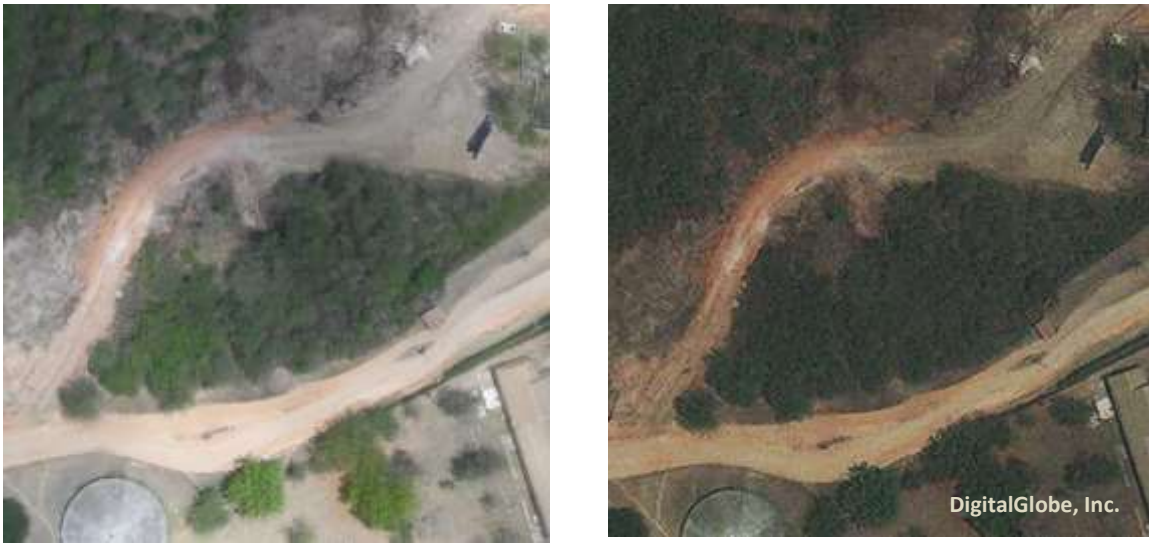
Figure 12: Differences in processing for unpaved roads

A similar effect can be seen in the images in Figure 12 where at this scale, 1:450, there appears to be little difference in the clarity of imagery. However, when the image is zoomed in the drone image will retain more and clearer detail.

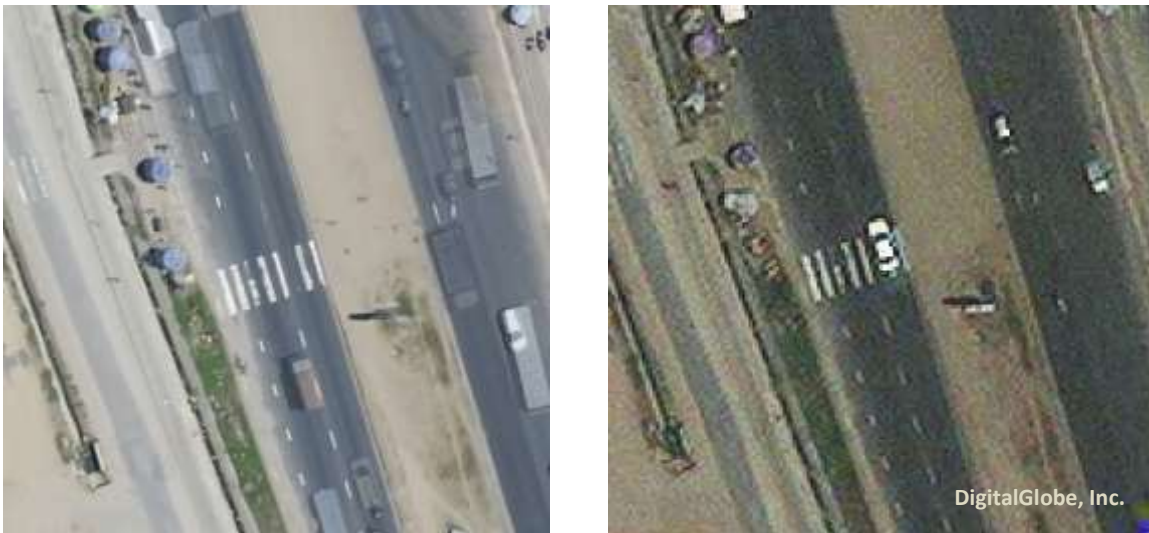
Figure 13: Main paved road comparison

Figure 13 shows a paved main road, which is the focus of the drone imagery project in Zanzibar. The drone image shows the road surface and road lining more clearly. Features such as side drains and road signs are also clearly visible.

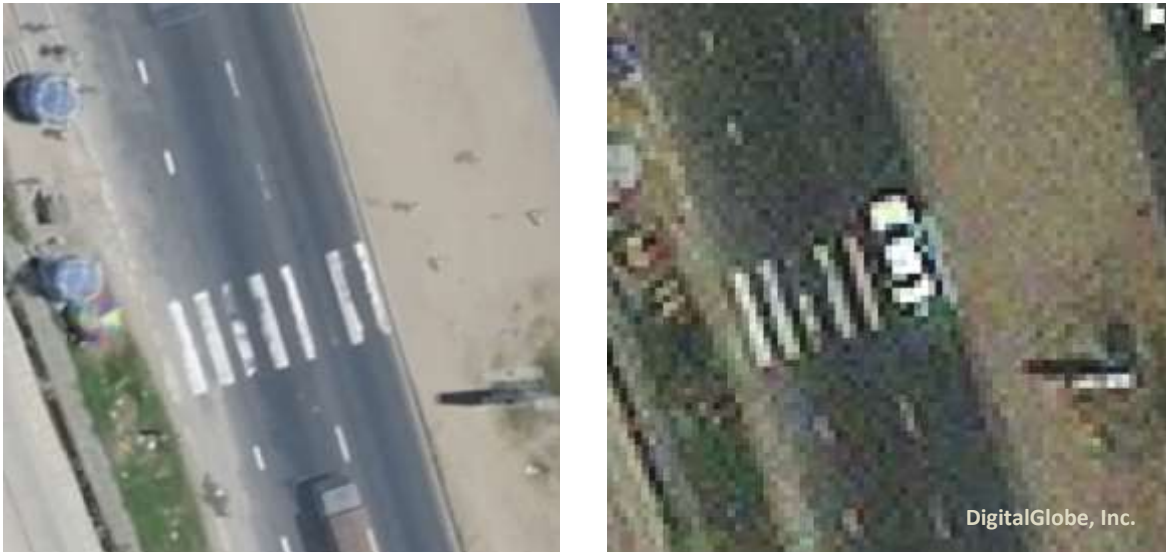
Figure 14: Main paved road, close-up

When the image is zoomed in, as per Figure 14 the drone imagery stays clear and the satellite image distorts to the extent that features become pixelated and difficult to define. It would be difficult to identify defects with the naked eye from the satellite images at this zoom.

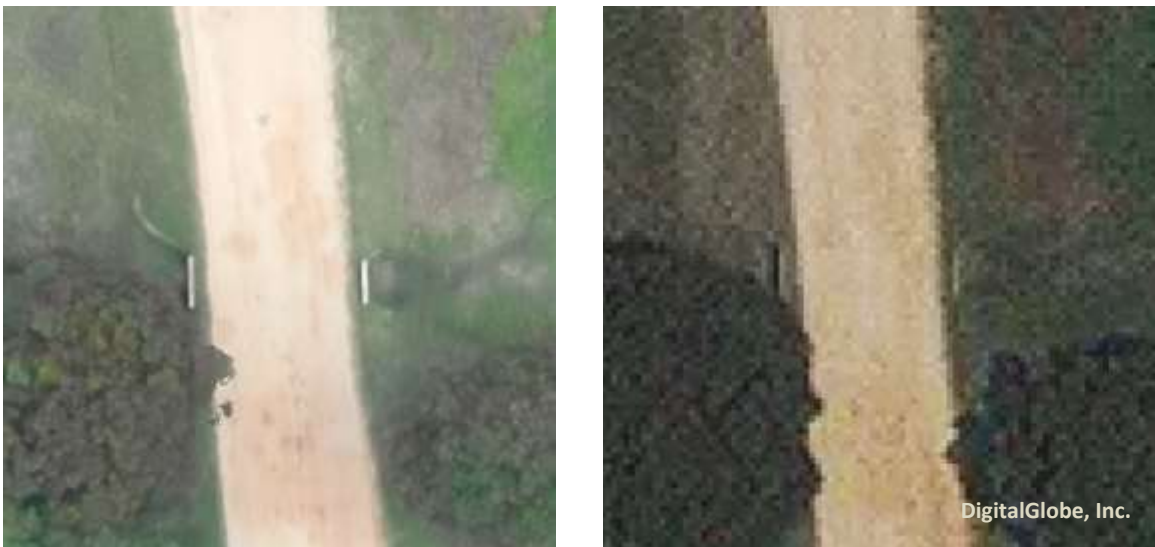
Figure 15: Identifying drainage structures

One of the main challenges of satellite imagery is to identify drainage features and other inventory. Figure 15 shows that the culvert headwalls and sidewalls are clearly visible on the drone image, but are indistinct and could easily be missed on the satellite image.

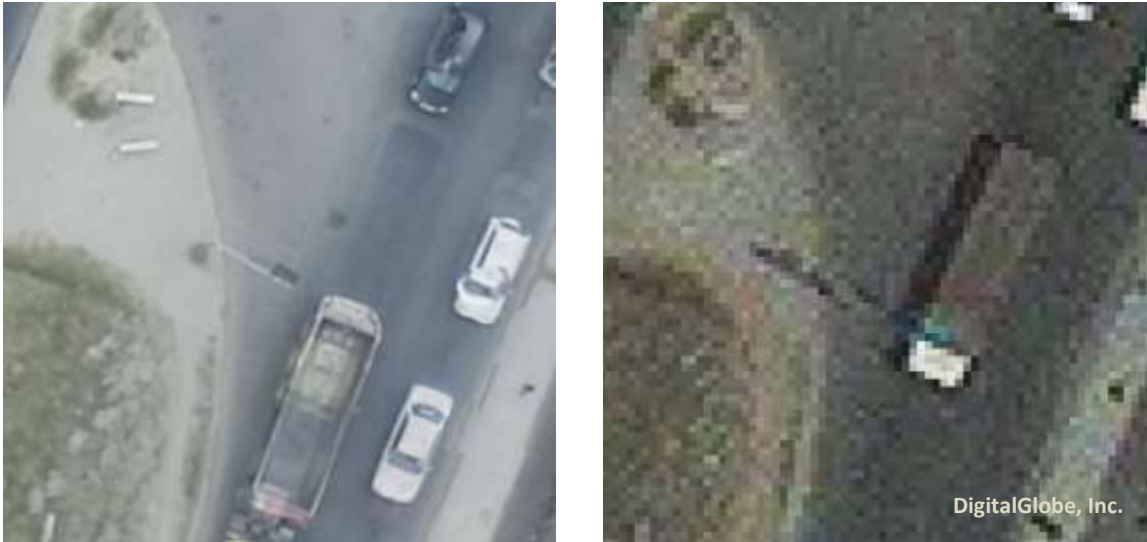
Figure 16: Identifying other road inventory features

Likewise, the images in Figure 16 clearly show an overhead traffic light in the drone image, but this is not an obvious inventory item from the satellite image on the right. The scale of this image is approximately 1:100.

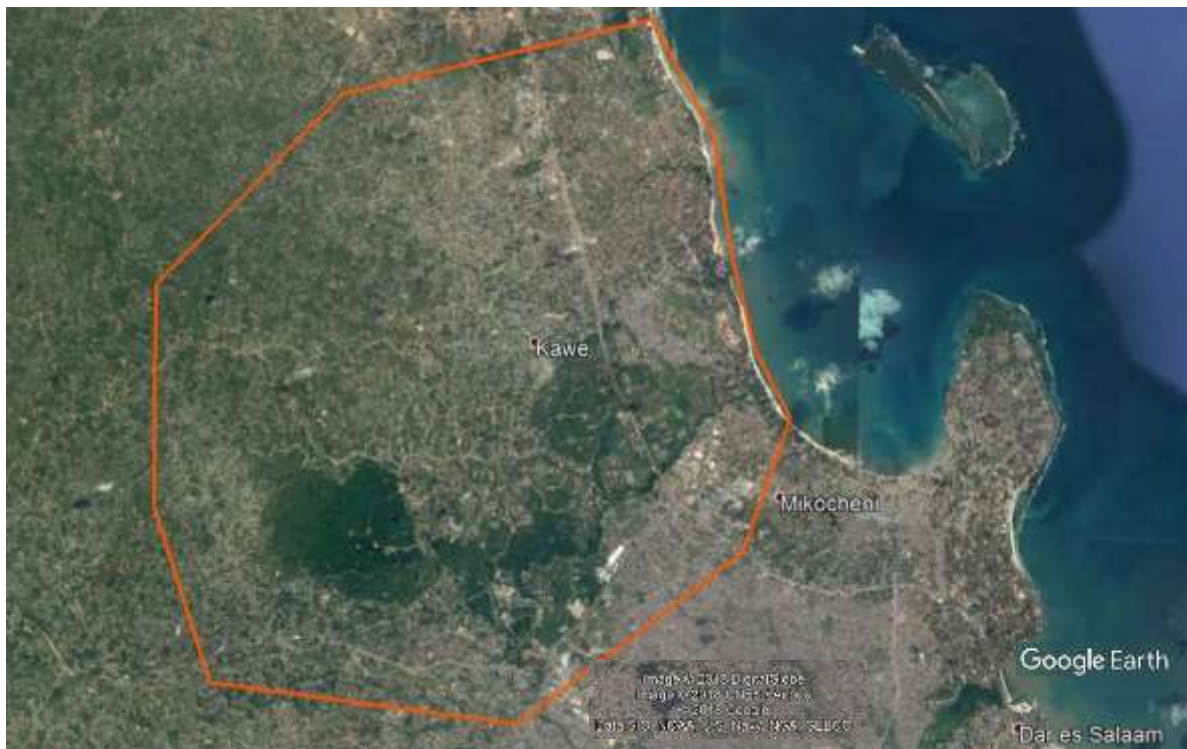
Figure 17: Dar es Salaam Aoi

The imagery areas were defined in consultation with RFB/TARURA and were acquired in November 2017 (Dar es Salaam) and December 2017 (Kilosa); the acquired Aols can be seen in Figure 17 and Figure 18, outlined in orange.

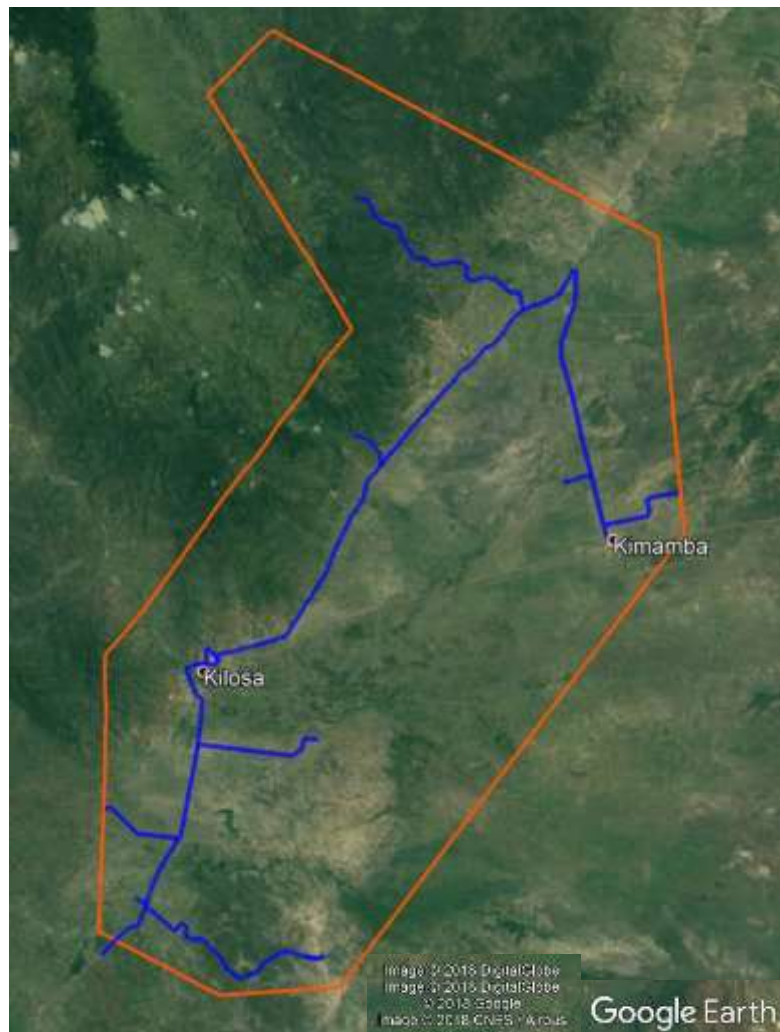
Figure 19: Kilosa roads

Approximately 3 days were spent on capturing the ground truth videos in Kilosa and Dar es Salaam. The roads that were captured can be seen in Figure 19 and Figure 20. The Aol is shown in orange, with unpaved roads shown in blue and paved roads shown in red.

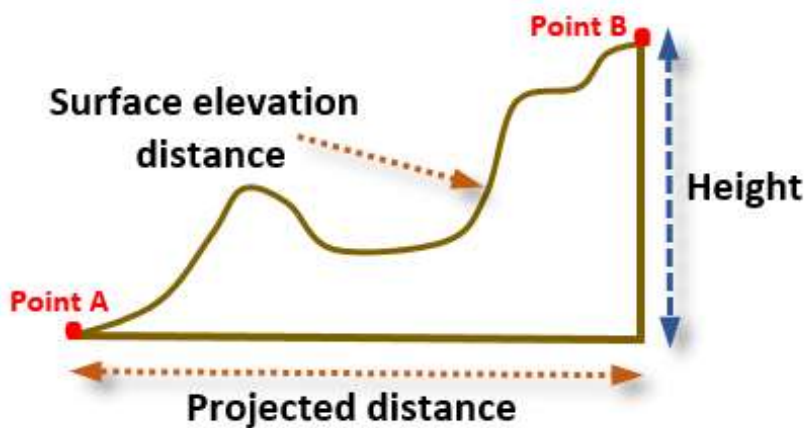
The diagram below shows the process of measuring the surface elevation distance, which can make a difference to the planar distance in hilly or mountainous areas. Tools are available for this in some GIS software, but the image also needs to have the appropriate information. DEMs can be used to measure surface elevation distance as they are essentially a 3D image of the earth's surface. In ArcGIS this is called the 'mensuration' tool.

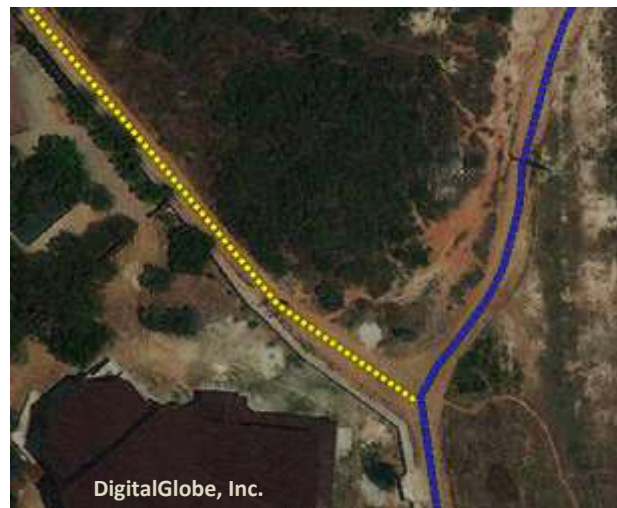
Figure B

When the ground truthing map has been completed for the sample roads, as shown in Figure B, the assessor should note the features of each condition that are common and can be identified easily from a satellite image. A guideline can then be built up that will assist the assessor in determining the condition of the roads from the satellite imagery.

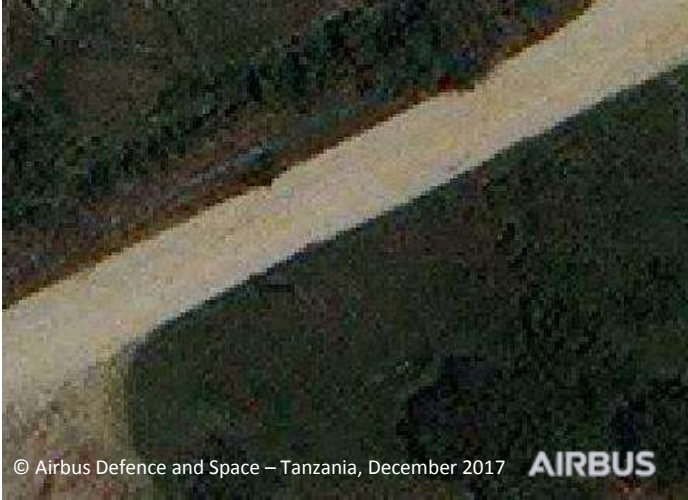
<p>Figure 1.2</p>

<u>Description</u>	<u>Example</u>
<p>Good (Green):</p> <p>Some slight differences in surface colour and texture can be seen, but generally very even.</p> <p>Negligible or slight variation in width, up to 10%.</p> <p>Edge of road consistent and straight, but may vary slightly in isolated areas.</p> <p>See Figures 1.1 to 1.4.</p> <p>Condition can be relative for earth and gravel roads. If the surface can be determined, the condition of earth roads can be shown as good when the width and edges vary slightly and some surface irregularities can be seen.</p> <p>For unpaved roads this category will normally apply to recently constructed or rehabilitated roads, or roads that have received regular maintenance and grading.</p>	<p>Figure 1.1</p>

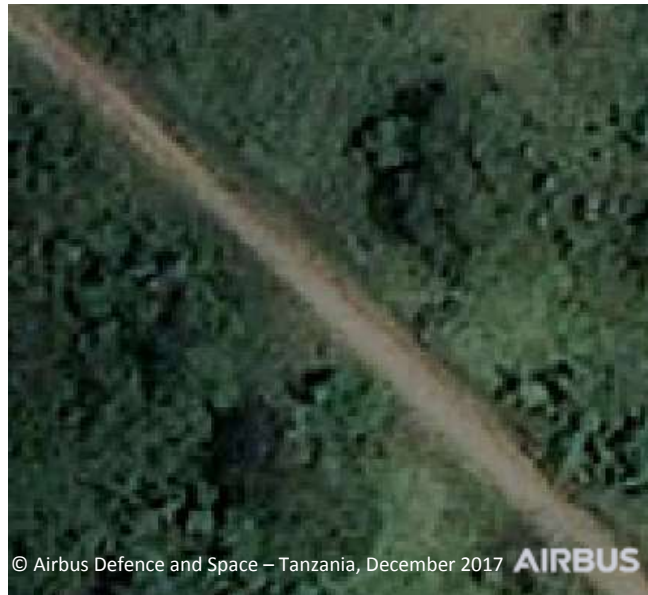
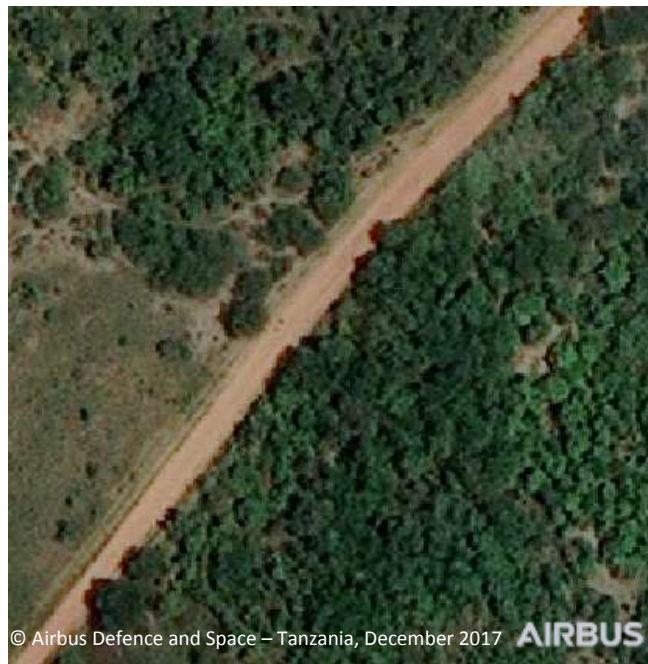
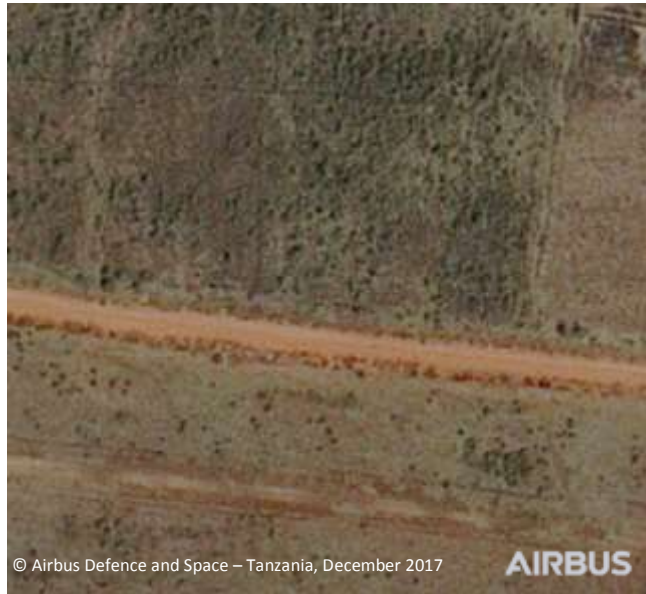
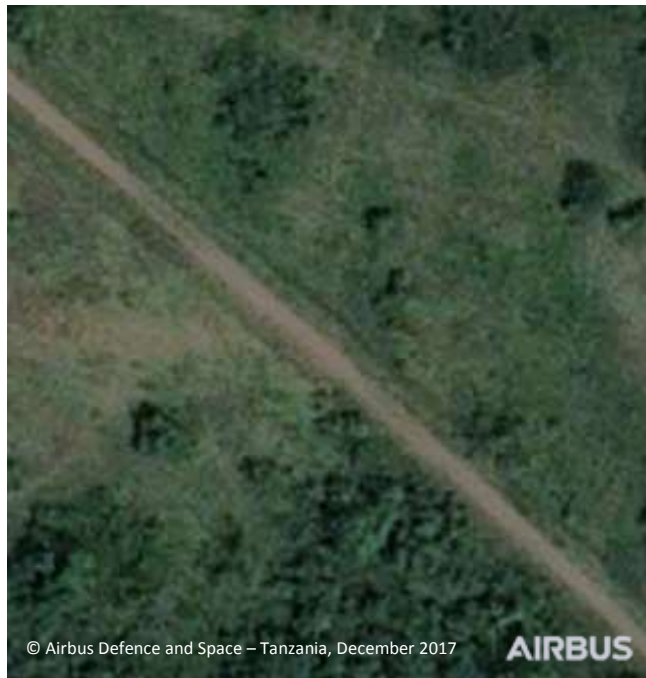
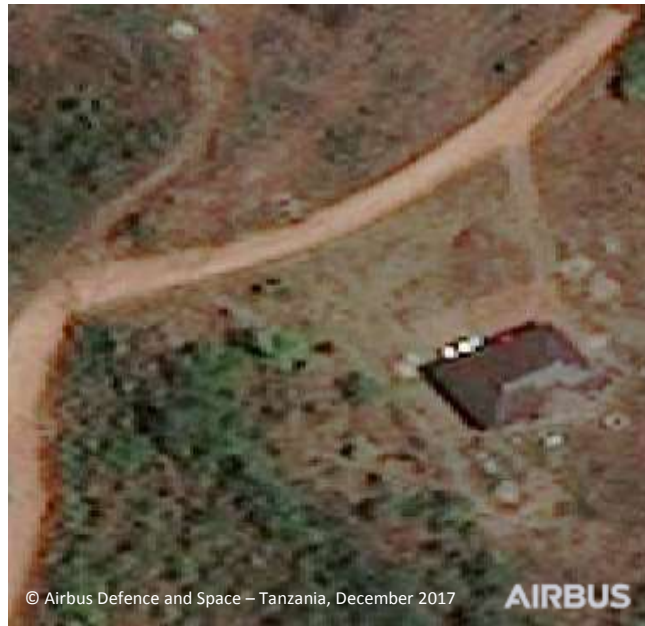
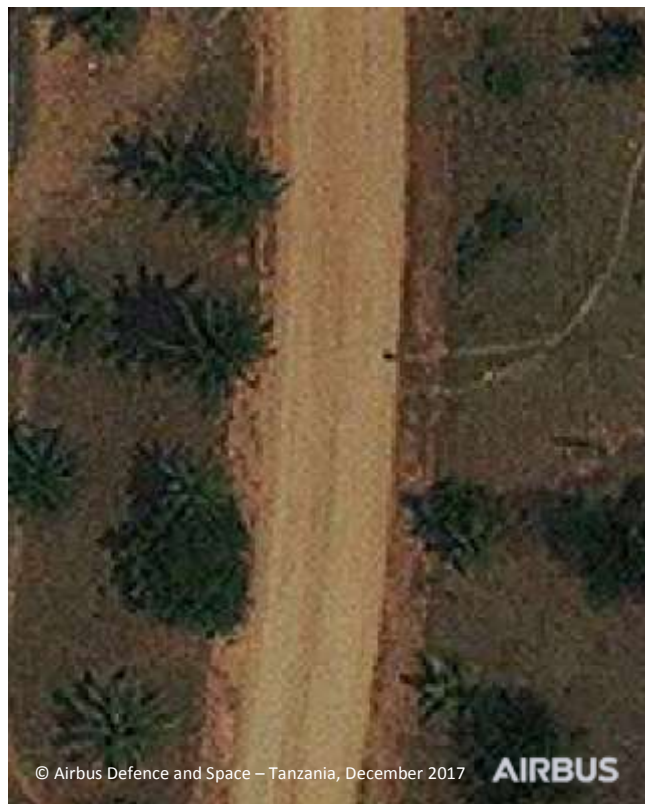
Fair (Blue):

Different shading and colours visible on road surface, but not dramatic.

Width varies slightly, in the region of 10% to 20% and edges appear more broken, although can maintain a relatively straight appearance.

See figures 2.1 to 2.6.

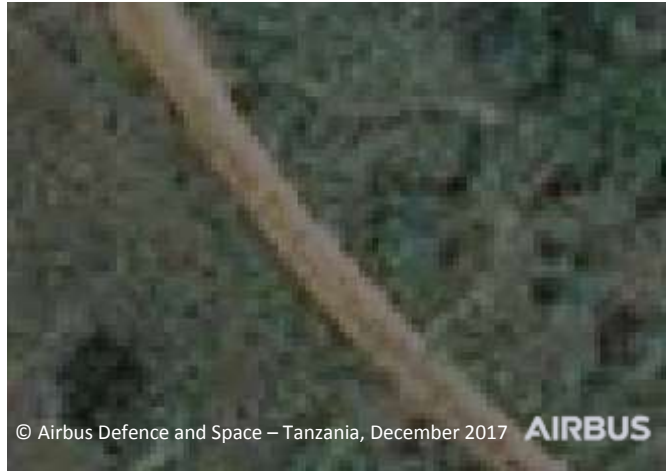
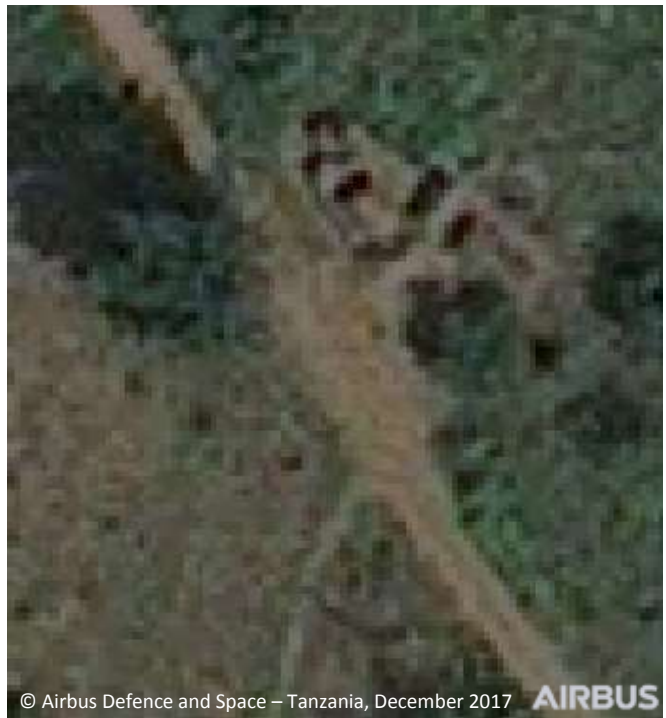
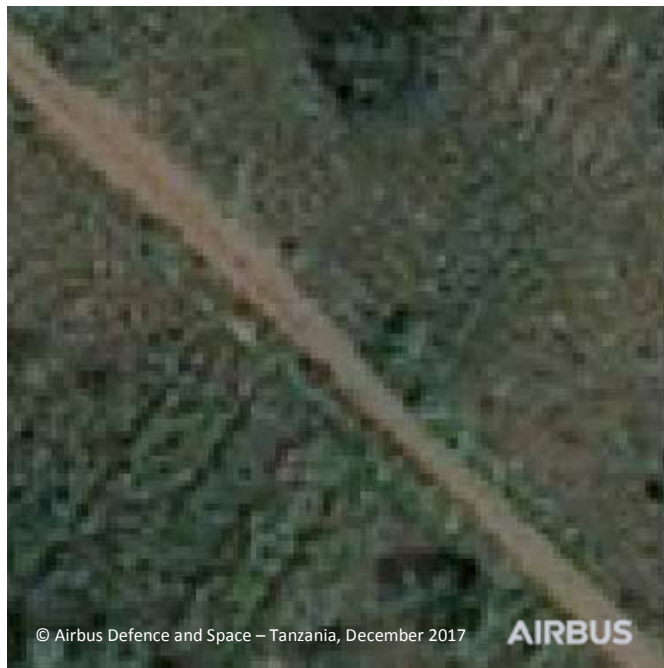
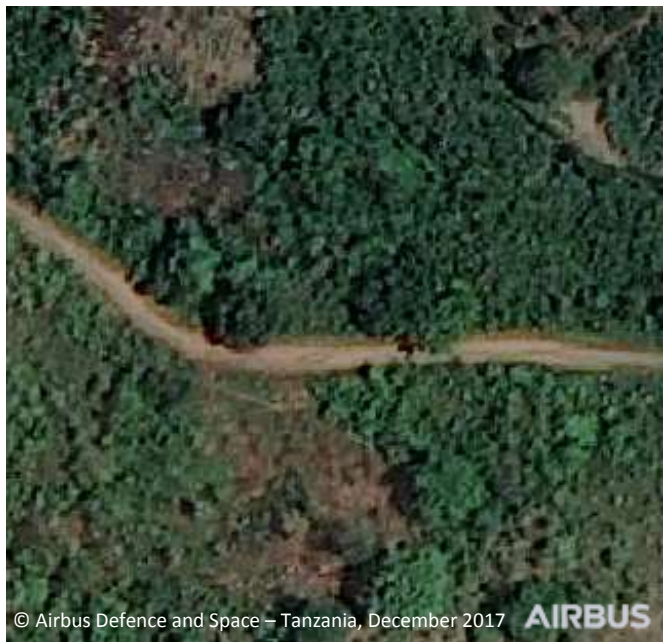
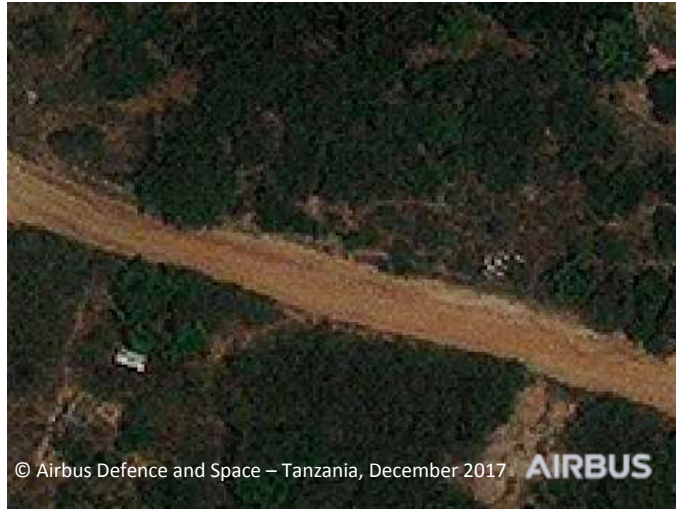
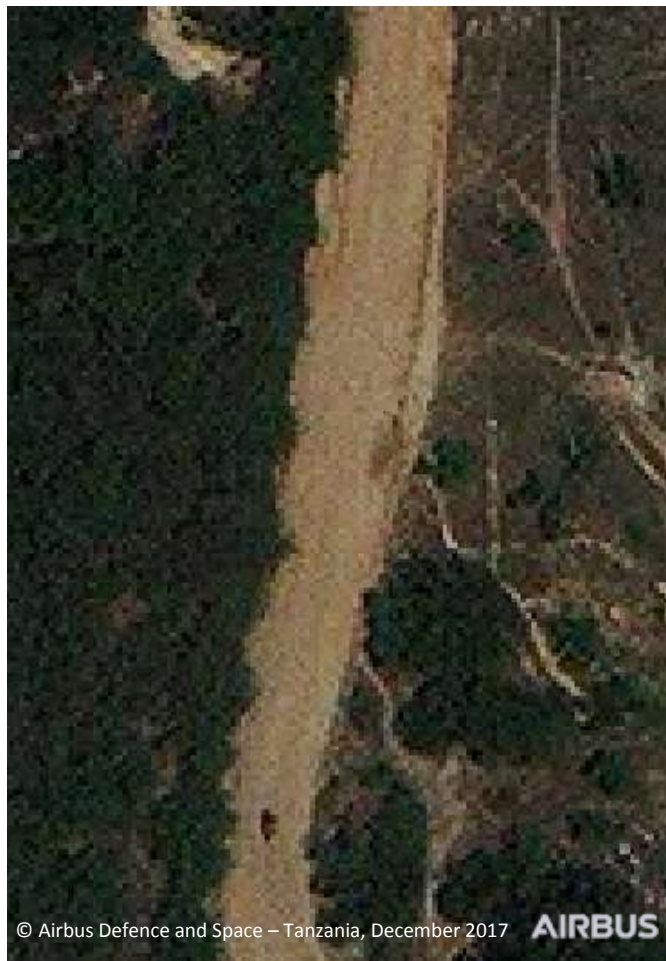
Poor (Red):

Edges of road not clear, variable and often not straight or broken and can be indistinguishable from the surrounding land.

Some wheel tracking visible, usually winding, which indicates drivers are driving to avoid defects.

See Figures 3.1 to 3.6.

Note: These roads can be narrow so details of the surface may be difficult to see.

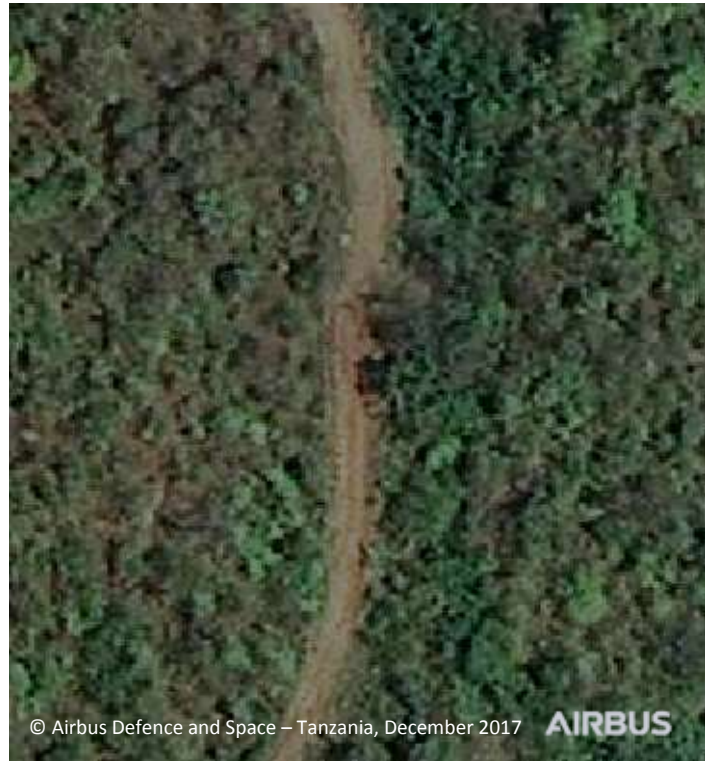
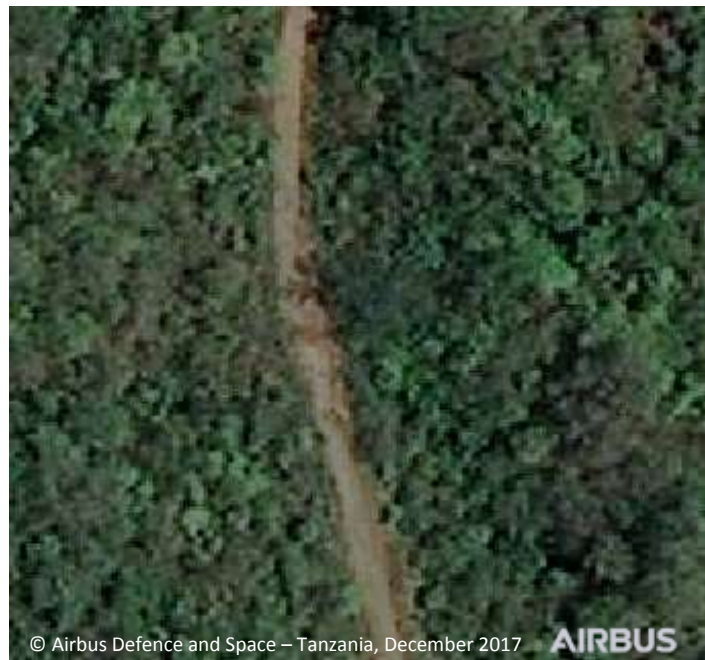
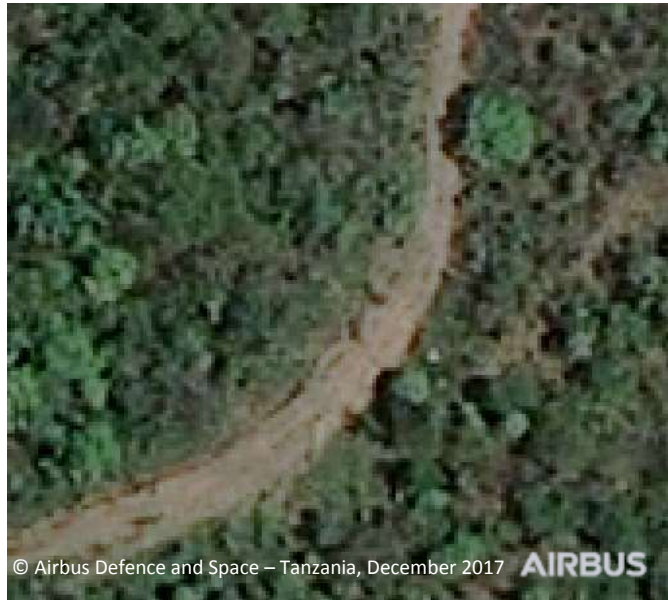
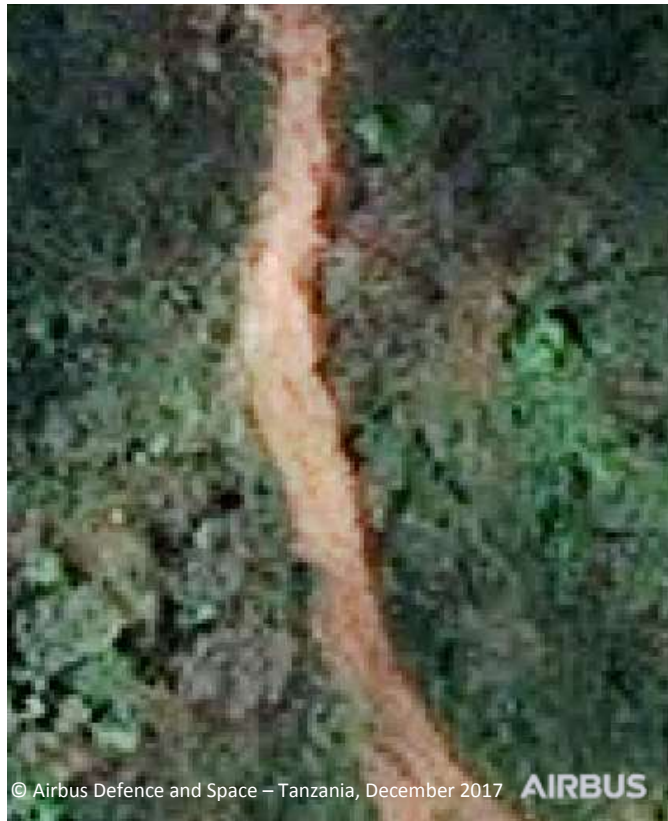
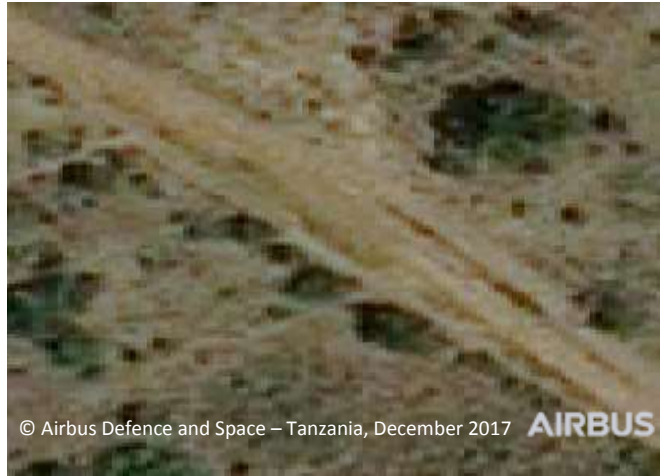
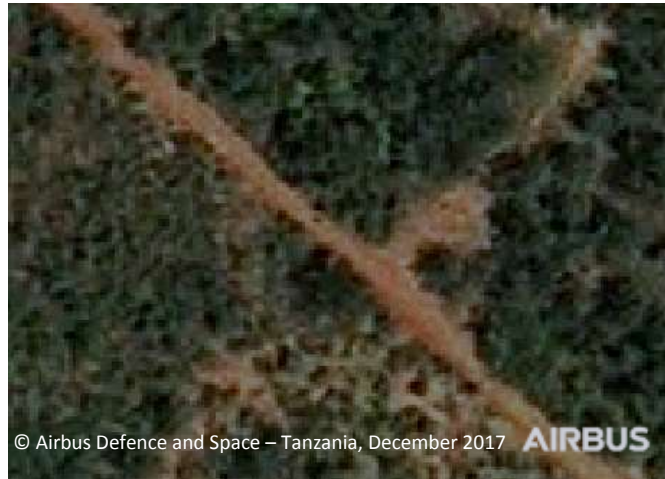
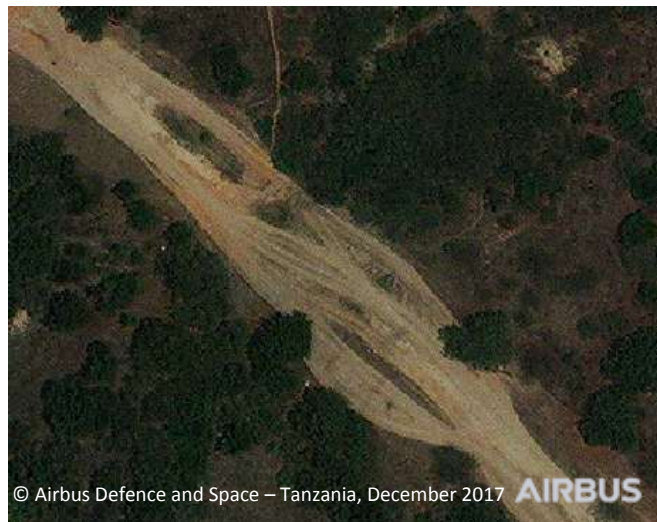
Bad (Amber):

Very significant variation in the colour and shading of the surface.

Edges of road unclear, highly variable and often very broken. Can be indistinguishable from the surrounding land and often overgrown by vegetation.

Wheel tracking often visible, winding to avoid defects and realignments common to avoid particularly bad areas.

See Figures 4.1 to 4.7.

Note: These roads are often very narrow and/or overgrown, so details of the surface will be difficult to see.
