The use of appropriate high-tech solutions for road network and condition analysis, with a focus on satellite imagery

Tanzania report

*AFCAP Project Reference
Number. GEN2070A*

30th April 2018

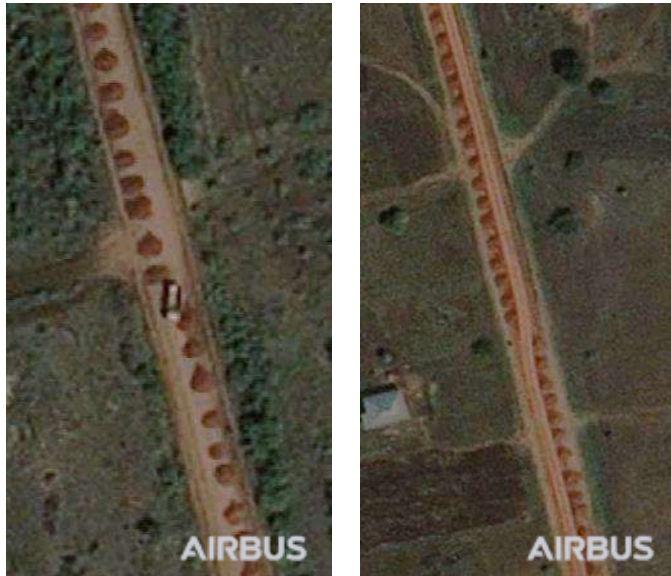
Figure 5.1 – Road rehabilitation site

Examples include figure 5.1, which is a road under rehabilitation, and Fig. 5.2, which is a railway line, which could be mistaken for a poor condition road. The features that identify the railway line are the regular parallel lines and the perpendicular lines, which represent the railway sleepers.

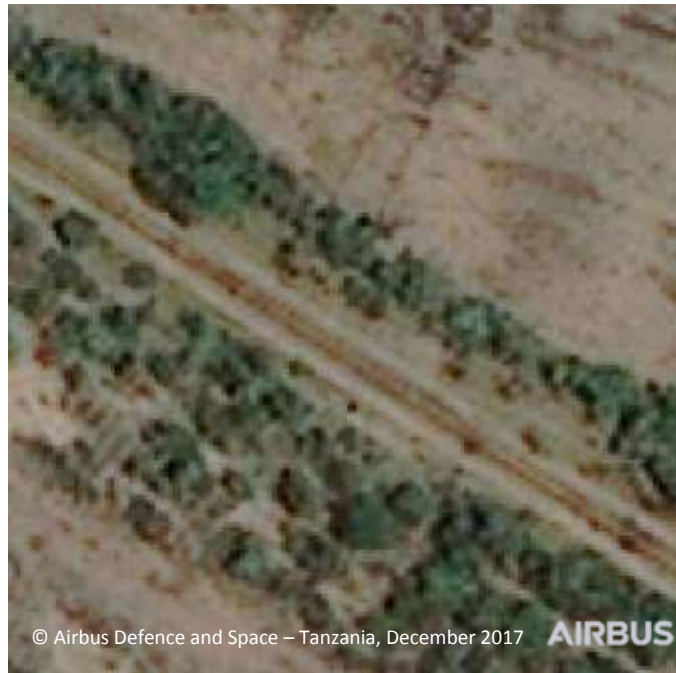
Figure 5.2 – Railway (disused)

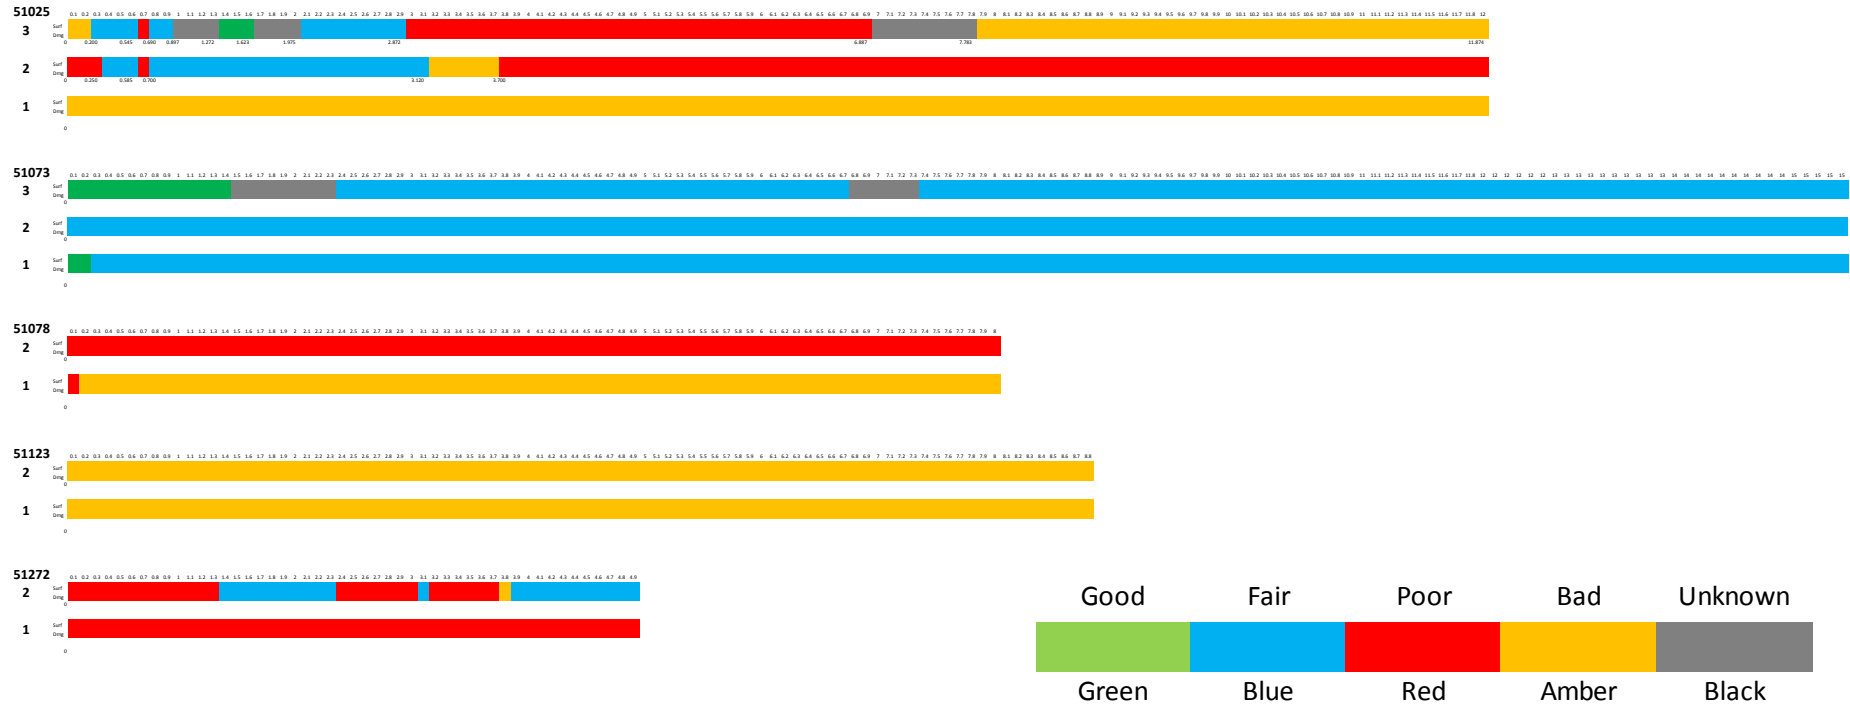
Annex 5: Condition Assessment exercise

The results shown above represent five roads from Kilosa that were assessed during the training. The standard DROMAS 2 colour coding has been used to indicate condition. The road numbers and the group numbers are shown on the left. Where there are disagreements it is mostly between Poor (red) and Bad (amber) condition, which is the new distinction introduced by TARURA recently. For many participants this was the first time they had to assess using four conditions, and some were not familiar with the condition assessment guide of TARURA, so it can be concluded that more practice should improve the overall accuracy of the assessment. In addition only two roads were available for ground truthing, plus some video, and the range of conditions was limited, so better ground truthing should also improve the accuracy of assessment.
