# International Recovery Forum 2009

### South East Asia Community Access Programme - SEACAP

#### Applications of selected research outputs for the Mitigation and Management of Crisis and Recovery Operations

## Slope Stability Hazard and Risk Assessment, SEACAP 21<sup>4</sup>, Laos PDR

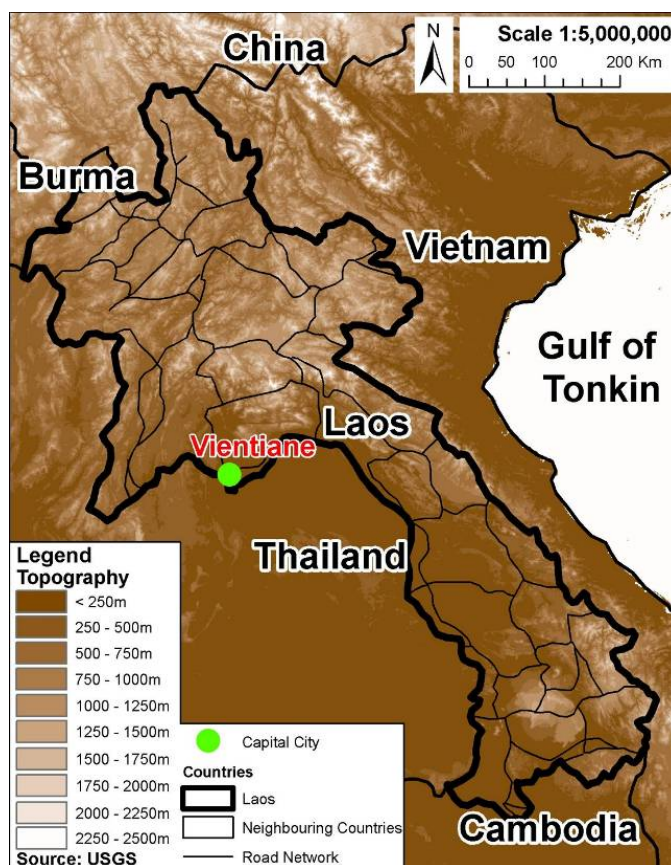
**Figure 1: The topography of Lao PDR**

Laos PDR (Fig 1) has an area of 236,800 km<sup>2</sup> of which more than 75% is mountainous, with elevations usually varying from 500 to 2000 metres above sea level. The country is roughly 1000 km long with a width varying from 140 to 500 km.

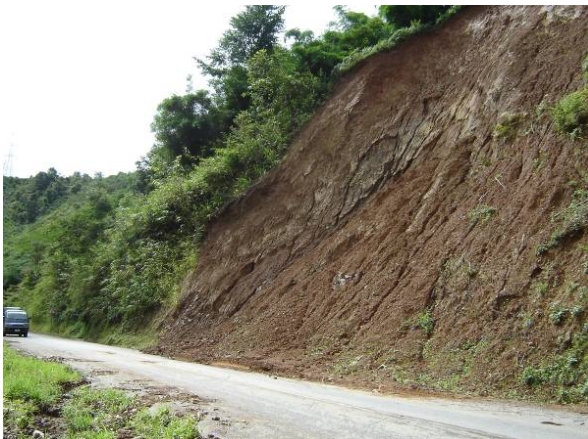
### **Figures 2 and 3 Typical Slope Failures Above and Below the Road Respectively**

The slope failure illustrated in Figure 2 below is common on the mountain road network and poses relatively low risk, in as much as the outcome is only partial blockage to the carriageway and materials can be removed relatively quickly if plant is available to do so.

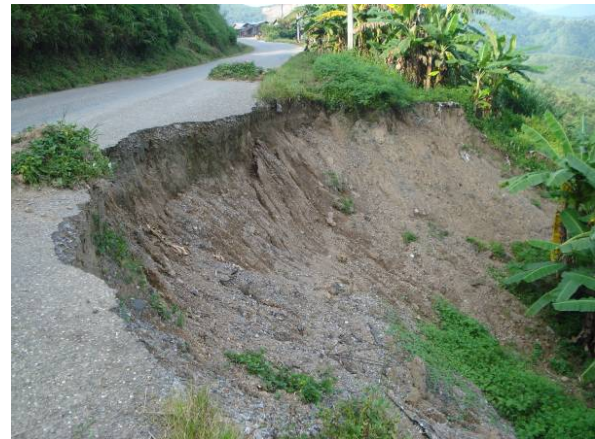
Figure 3 illustrates the case where part of the carriageway has been lost as a result of movement on the slopes below. This hazard poses significant risk to the operation of the road, as it can be difficult and expensive to rectify and can ultimately result in the loss of access. These failures are less frequent on the road network and they are often associated with the progression of large naturally occurring landslides on steep valley side.

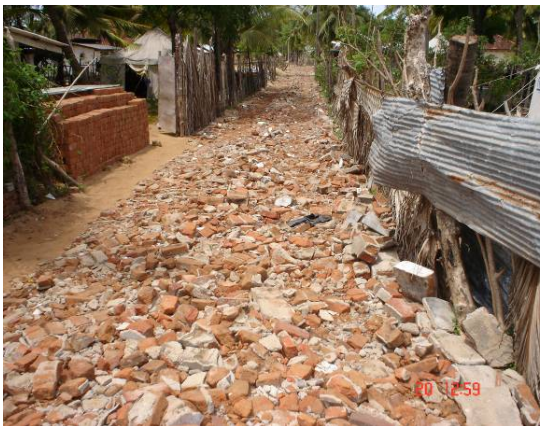
**Photo 1:** Dumping of unprocessed tsunami debris for road construction – a wasteful process.

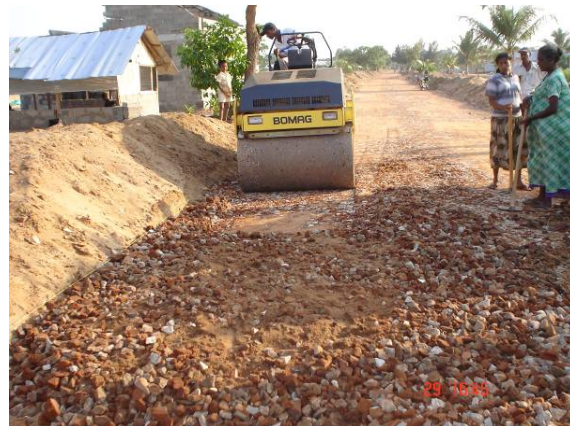
**Photo 2:** Compacting crushed and blended tsunami debris for sub-base layers.

Although much of the tsunami debris was not a health hazard, it was necessary to remove it to clear sites for reconstruction. It was decided to utilize the readily available tsunami debris, after processing, for the sub-base layer.

It should be noted that this is an existing technology. The debris primarily consisted of broken brick from buildings and crushed brick. It was then blended with sand. This is commonly done in Bangladesh due to the lack of crushed stone.

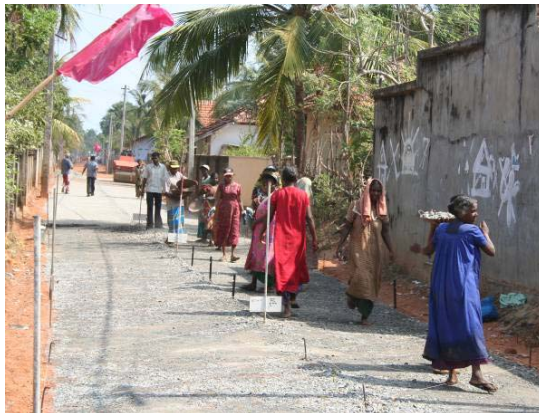
**Photo 3:** Placing base course using strings, pegs & line levels for layer thickness & camber control

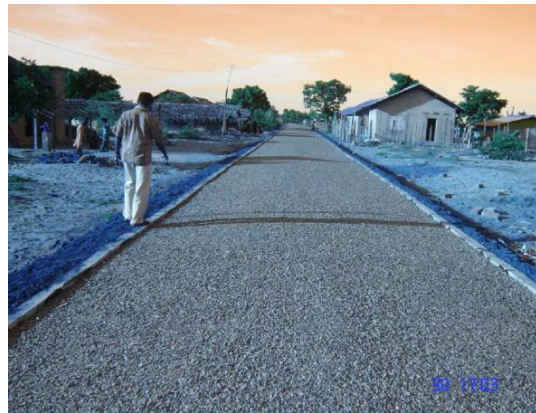
**Photo 4:** Completed road section
