**TARGETED INTERVENTIONS UNDER THE  
RURAL ROAD INVESTMENT PROGRAMME IN  
MOZAMBIQUE (PHASE 1)**

**Construction/Progress Report**

**CLIENT PROJECT REPORT CPR 470**

**by K Mukura, S Done and Dr J Rolt**

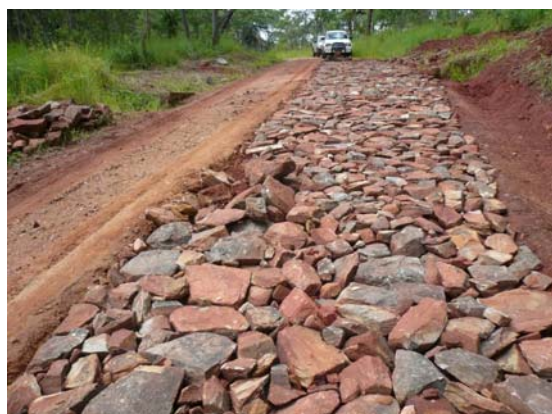
First section of stones on Fingue hill

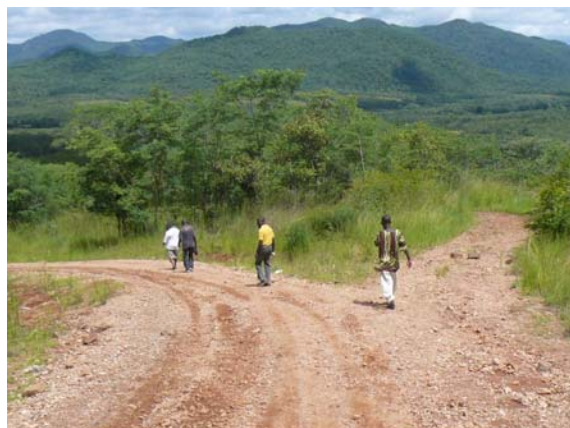
Short detour to reduce gradient

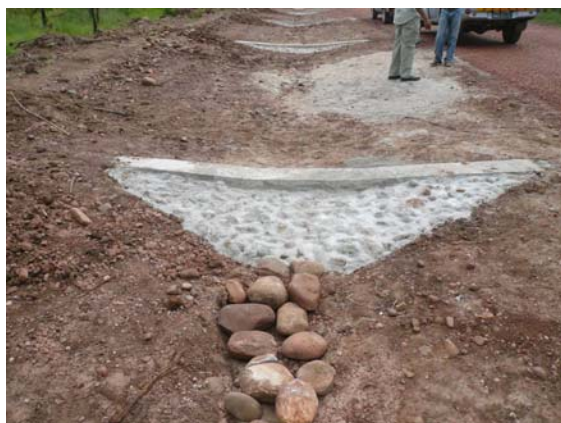
Scour checks

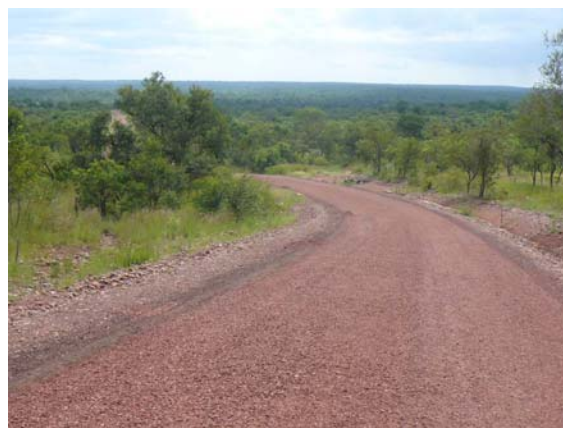
Down hill at the end of the road

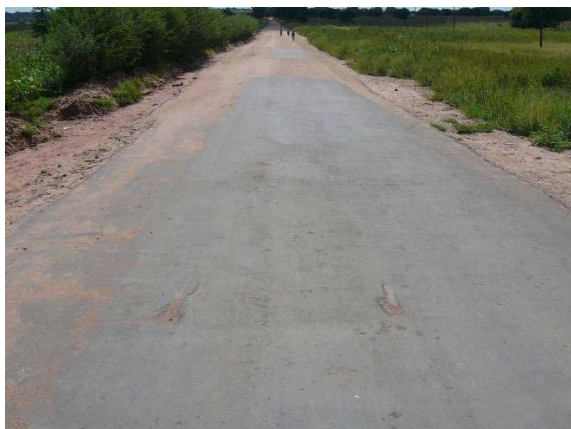
Section 4: Surface detail

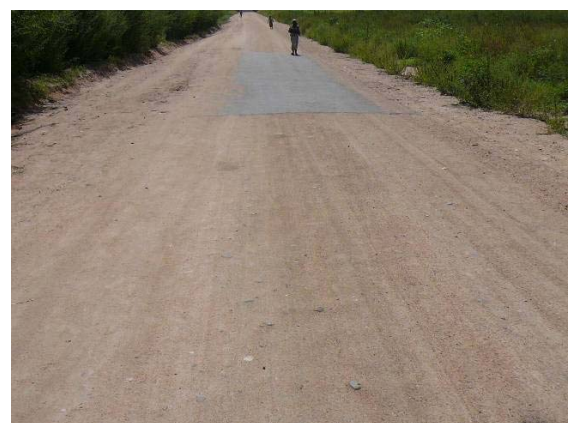
Section 5: Cracking, bleeding and surface detail

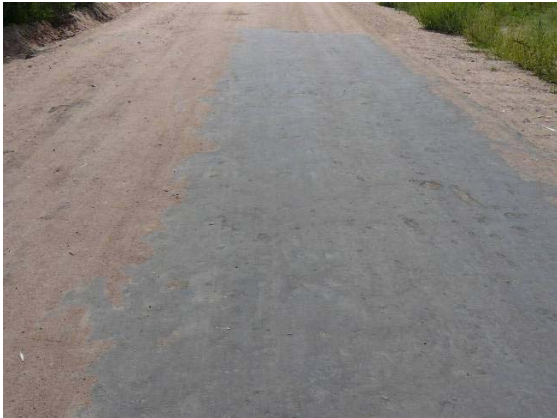
Section 6: Large stones and surface detail
